NESHAP Demolition Survey

For Asbestos Containing Building Materials

*Residential Property
1023 Garfield Avenue
Sheldon, IA*

Re: NESHAP Demolition Survey for Asbestos Containing Building Materials
Alloy Specialty Project Number 19036

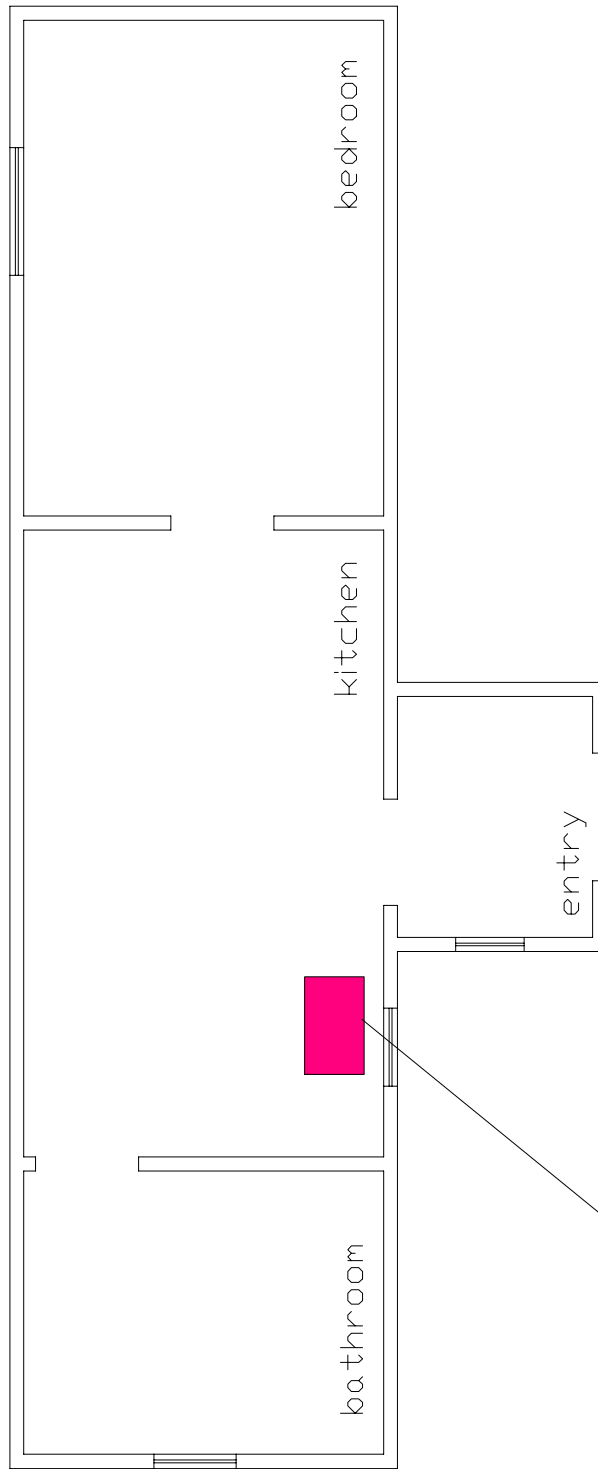
Asbestos Materials
Interior

Asbestos Containing Sink Under Coating

19-07-01130-009	9 Bathroom Wall		Off-White Brittle; Tan Fibrous; Inhomogeneous	NAD	8% Cellulose 10% Fibrous Glass 82% Non-Fibrous
19-07-01130-010	10 Kitchen Sink Undercoating		Dark Brown Coarse Powder; Tan Fibrous; Inhomogeneous	2% Chrysotile	50% Cellulose 48% Non-Fibrous
Total Asbestos: 2%					
Chrysotile present in dark brown coarse powder.

The property **has** identified non-friable materials. The identified materials must be removed prior to demolition, because of their composition. All materials must be removed in accordance to regulatory laws of the EPA, State of Iowa, and OSHA.

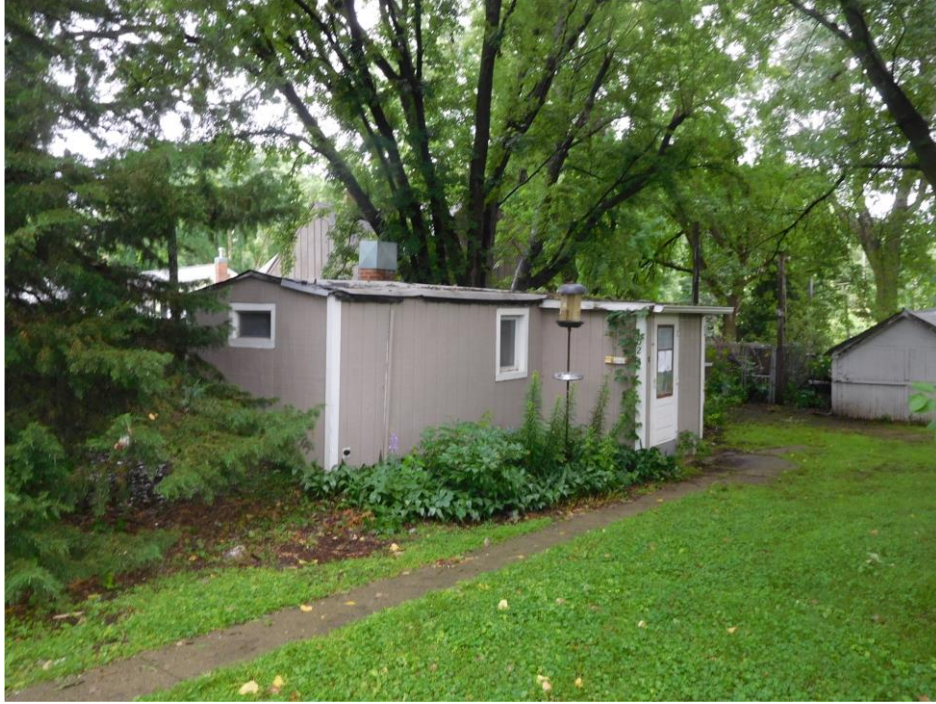
PHOTO 1:
Exterior overview of the South and West elevations of the house.

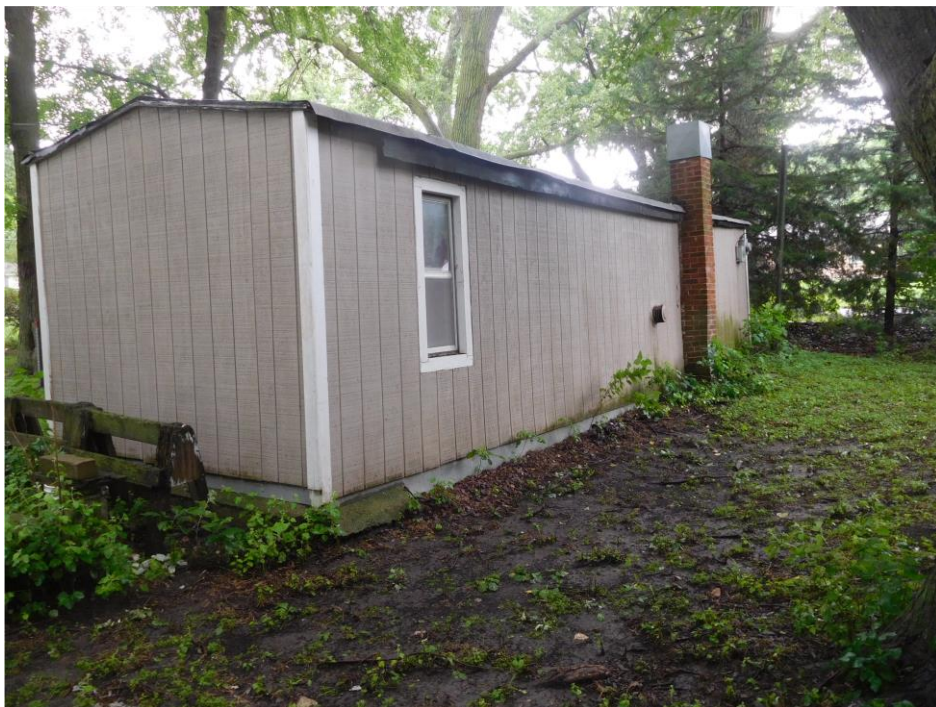
PHOTO 2:
Exterior overview of the North and East elevations of the house.

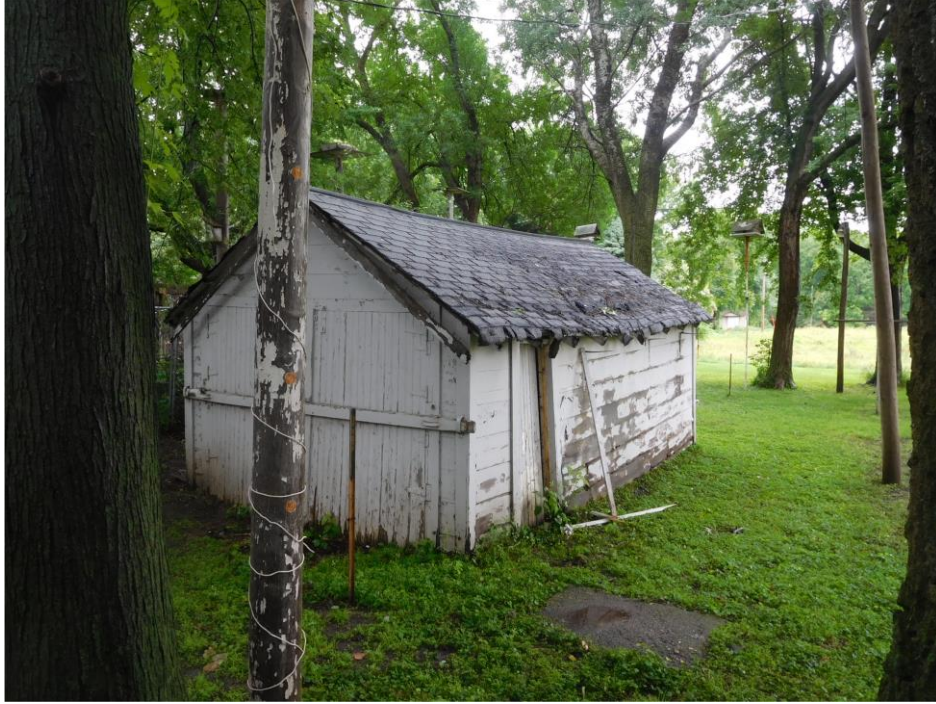
PHOTO 3:
Exterior overview of the South and West elevations of the garage.

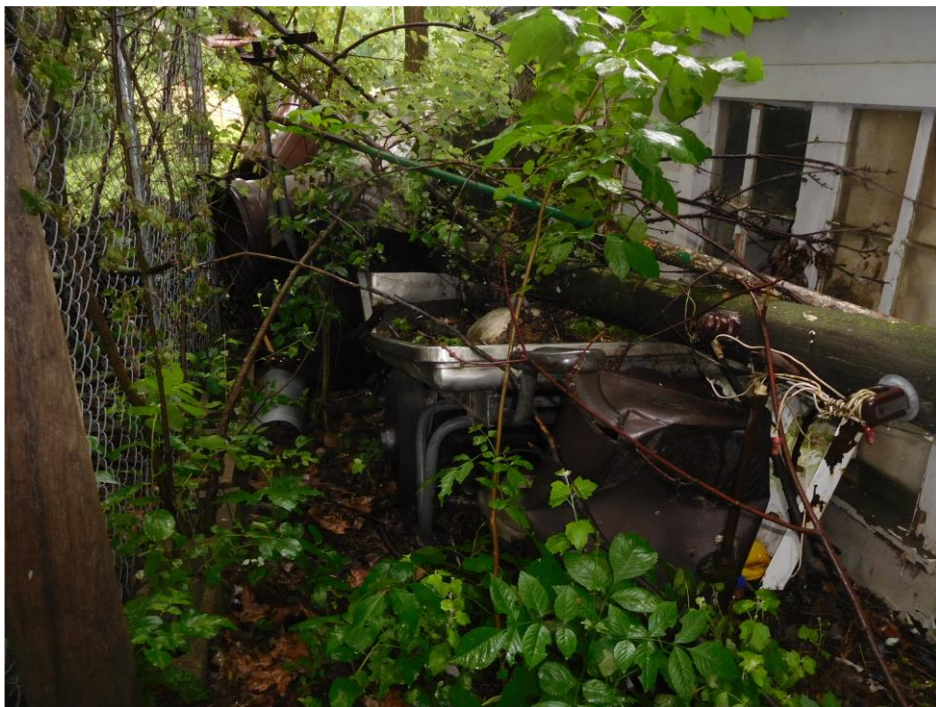
PHOTO 4:
Exterior overview of the north yard adjacent to the garage. Scrap metal and misc. household items.

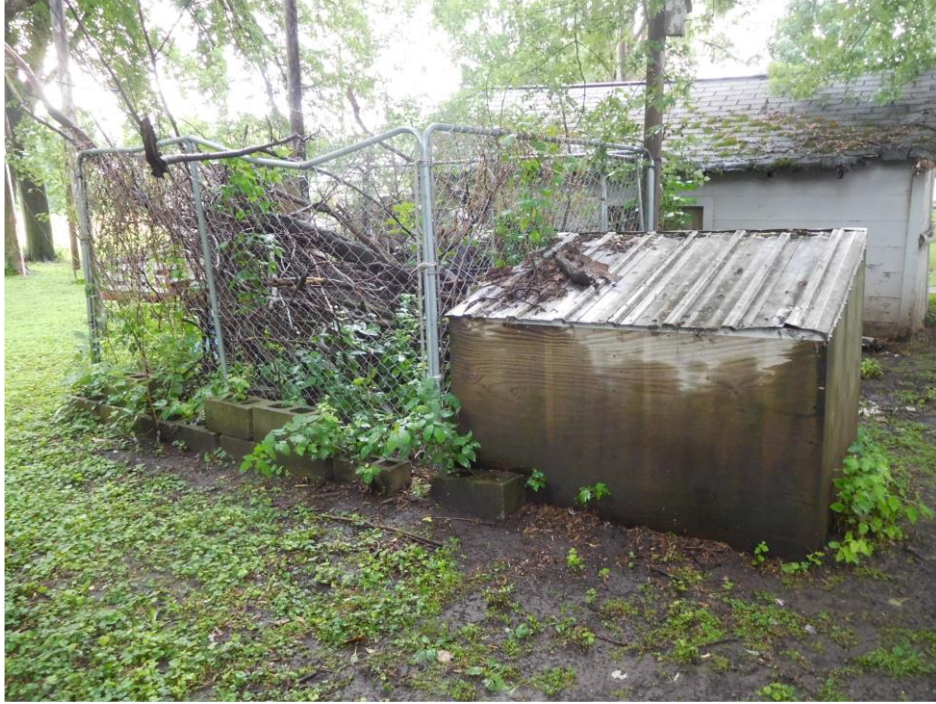
PHOTO 5:
North of garage, a former dog house and kennel area. Now filled with trees.

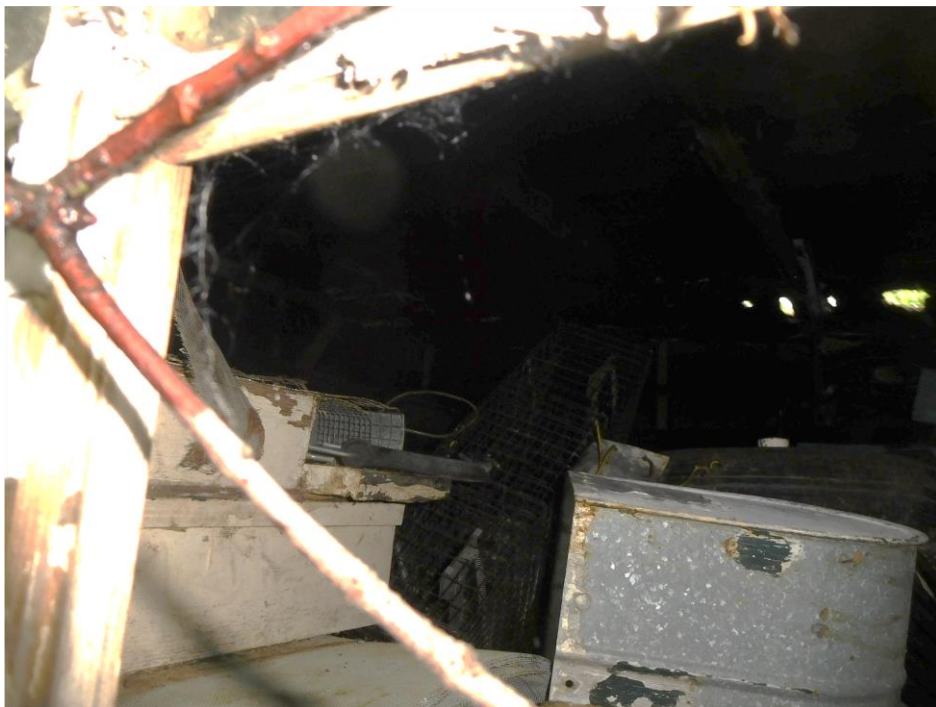
PHOTO 6:
East interior of garage. Parts of equipment, mailboxes, truck parts.

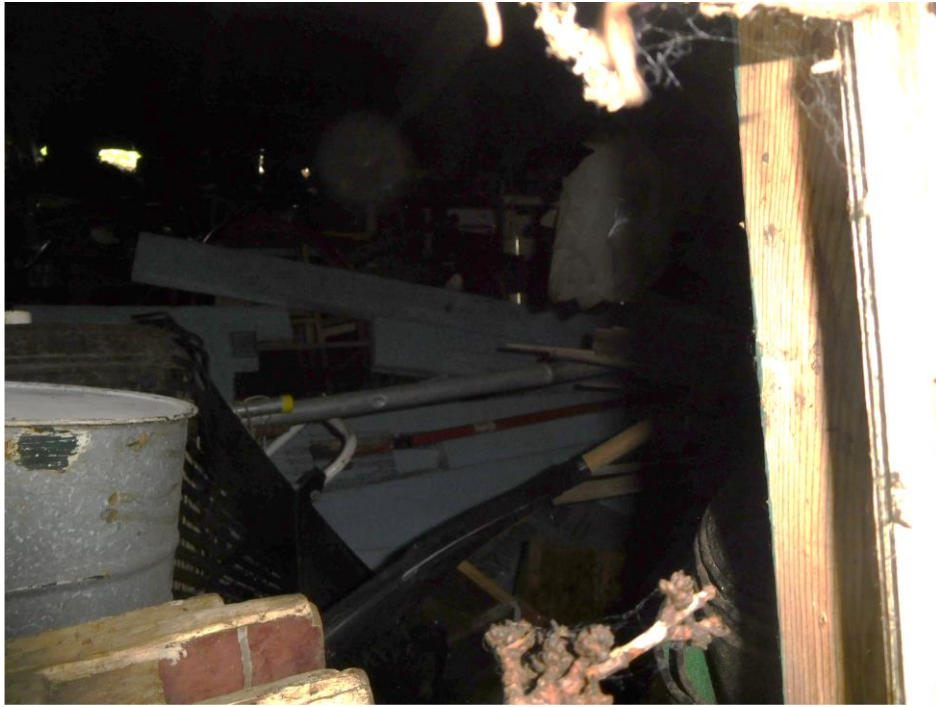
PHOTO 7:
Interior of garage, a boat was discovered.

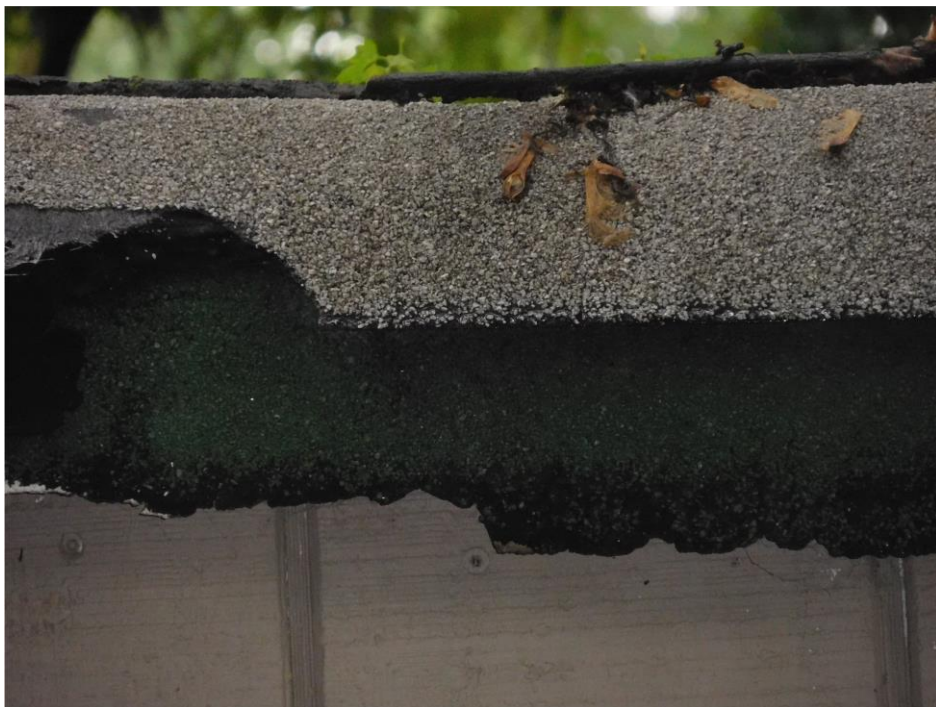
PHOTO 8:
Roof of house. Multiple layers of rolled shingles and tars. Original rolled roofing with tar and the second layer of the four layers are **asbestos containing**.

<i>Material</i>	<i>Location</i>	<i>Classification</i>	<i>Quantification</i>
Sink Undercoating	Kitchen	Non-friable, Category II	1 Sink
Rolled Roofing with Tar Original Roofing and 2 nd Layer of Roofing Materials	Roof	Non-Friable, Category I	336 sq. ft

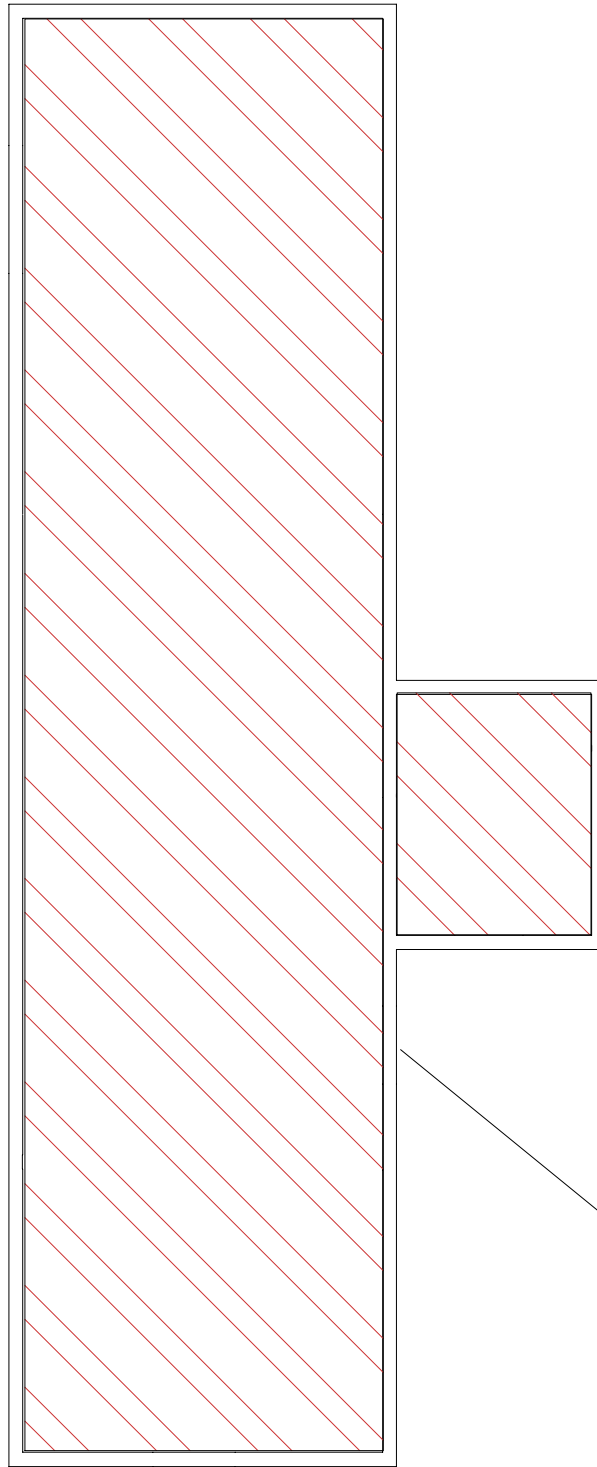
TITLE 1023 Garfield Avenue Sheldon, Iowa	SHEET Asbestos Materials Exterior	PROJECT NO. 19036

Asbestos Containing Rolled Roofing
With Tar Adhesives. Original and 2nd
Layer of Roofing.
