FACILITY CONDITION ASSESSMENT

Tommie Kunst Junior High
930 Hidden Pines Way
Santa Maria, California 93458

158764.22R000-013.017

February 23, 2023

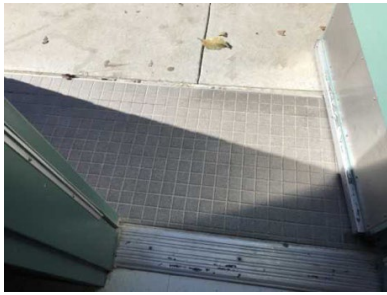
Supplemental Components in Poor condition.

Drains, Trench, 12 IN
 Site Tommie Kunst Junior High Site, southwest entry G building

Uniformat Code: D2020
 Recommendation: **Replace in 2023**
