FACILITY CONDITION ASSESSMENT

Miller Elementary
410 East Camino Colegio
Santa Maria, California 93454

158764.22R000-015.017

February 27, 2023

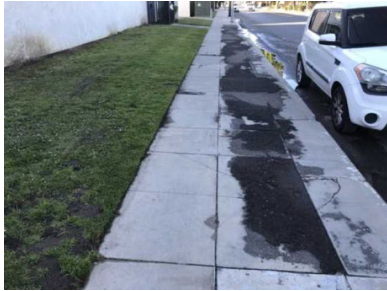
Sidewalk in Poor condition.

Concrete, Large Areas
Site Miller Elementary Site, west

The concrete sidewalk has been poorly patched with asphalt. The walkway is used heavily for drop off and is not level which presents trip hazards. - AssetCALC ID: 5265407

Uniformat Code: G2030
Recommendation: **Replace in 2023**

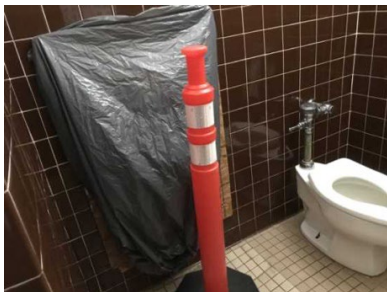
Urinal

Standard
Building 060 Miller Elementary Restroom

The replacement urinal is in the mechanical room waiting to be installed. - AssetCALC ID: 5265533

Uniformat Code: D2010
Recommendation: **Replace in 2023**
