FACILITY CONDITION ASSESSMENT

Oakley Elementary
1120 West Harding Avenue
Santa Maria, California 93458

158764.22R000-016.017

February 23, 2023

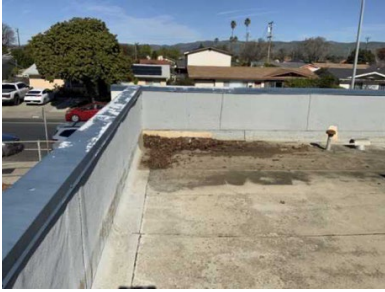
any type, Repairs per Man-Day
Building 010 Oakley Elementary Roof

Roofing in Poor condition.

Sheet metal cap flashing has deteriorated and needs repair or replacement - AssetCALC ID: 5249864

Uniformat Code: B3010
Recommendation: **Repair in 2023**

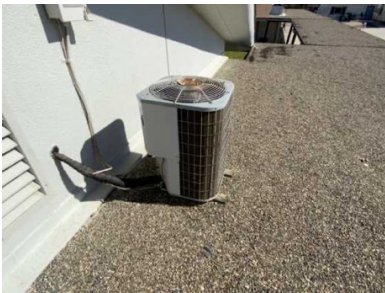
Condensing Unit/Heat Pump
Building 010 Oakley Elementary Roof

Split System in Poor condition.

Uniformat Code: D3030
Recommendation: **Replace in 2023**
