FACILITY CONDITION ASSESSMENT

Alvin Elementary
301 East Alvin Avenue
Santa Maria, California 93454

February 20, 2023

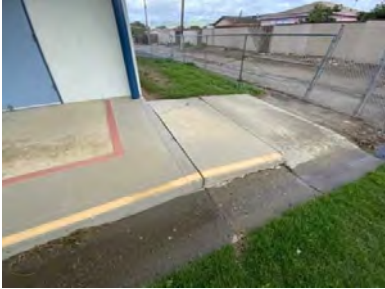
Sidewalk in Poor condition.

Priority Score: **94.9**

Damaged concrete tripping hazards - AssetCALC ID: 4866086

Uniformat Code: G2030
Recommendation: **Repair in 2023**
