FACILITY CONDITION ASSESSMENT

DLR Group

February 23, 2023

Arellanes Elementary
1890 Sandalwood Drive
Santa Maria, California 93454

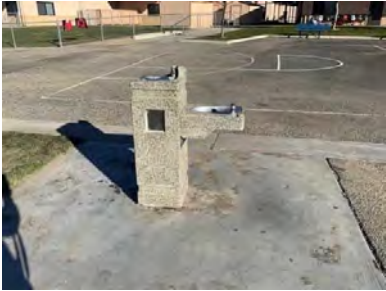
Drinking Fountain in Poor condition.

Exterior/Site, Precast Pedestal
Site Arellanes Elementary Site

Precast material is breaking apart. - AssetCALC ID: 5164451

Uniformat Code: D2010
Recommendation: **Replace in 2025**

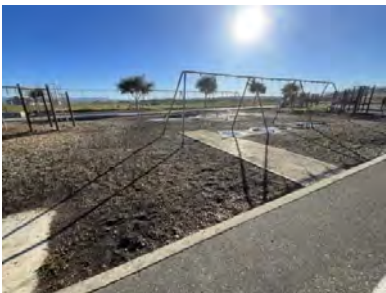
Playfield Surfaces in Poor condition.

Chips Wood, 3" Depth
Site Arellanes Elementary Site

Chips are missing, area is flooded from recent rain. - AssetCALC ID: 5164452

Uniformat Code: G2050
Recommendation: **Replace in 2024**

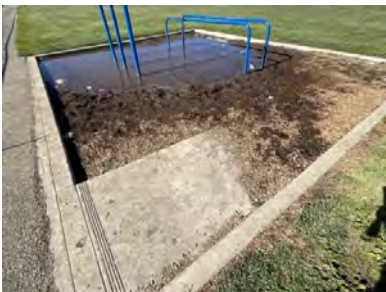
Playfield Surfaces in Poor condition.

Chips Rubber, 3" Depth
Site Arellanes Elementary Site

Chips are missing and area is flooded. - AssetCALC ID: 5164446

Uniformat Code: G2050
Recommendation: **Replace in 2024**

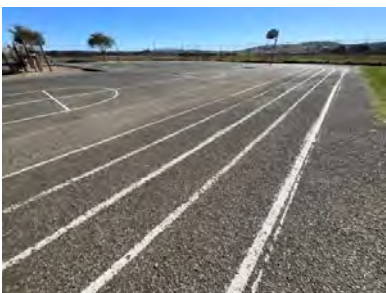
Athletic Surfaces and Courts in Poor condition.

Basketball/General, Asphalt Pavement
Site Arellanes Elementary Site

Asphalt is aged and worn down in various areas. Surface is rough. - AssetCALC ID: 5164442

Uniformat Code: G2050
Recommendation: **Mill and Overlay in 2025**

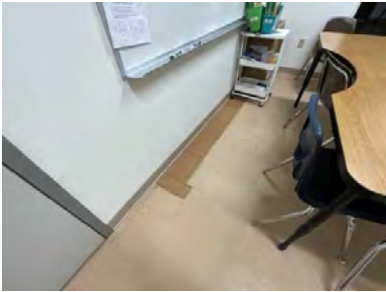
Flooring in Poor condition.

Vinyl Tile (VCT)
Building 050 Arellanes Elementary Throughout building

Tiles near the door have been replaced with different tiles. Tiles do not sit flush with each other. - AssetCALC ID: 5164243

Uniformat Code: C2030
Recommendation: **Replace in 2025**

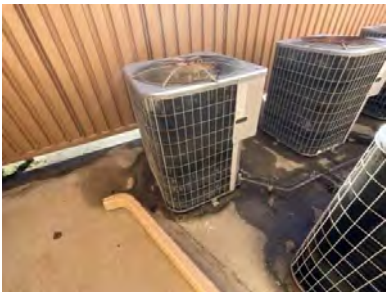
Split System in Poor condition.

Condensing Unit/Heat Pump
Building 500 Arellanes Elementary Building exterior

Unit is rusted and leaking - AssetCALC ID: 5164315

Uniformat Code: D3030
Recommendation: **Replace in 2025**

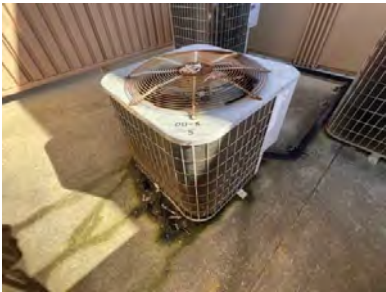
Split System in Poor condition.

Condensing Unit/Heat Pump
Building 200 Arellanes Elementary Roof

Unit is badly rusted. Ages has passed it's expected useful life. - AssetCALC ID: 5164281

Uniformat Code: D3030
Recommendation: **Replace in 2025**

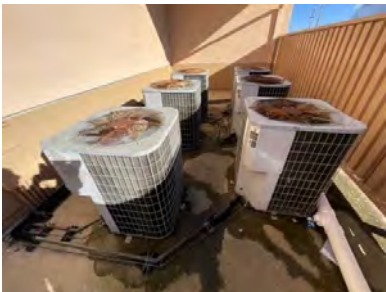
Split System in Poor condition.

Condensing Unit/Heat Pump
Building 500 Arellanes Elementary Building exterior

Units are rusted and leaking. - AssetCALC ID: 5164317

Uniformat Code: D3030
Recommendation: **Replace in 2025**
