FACILITY CONDITION ASSESSMENT

Arellanes Junior High
1890 Sandalwood Drive
Santa Maria, California 93454

158764.22R000-004.017

February 23, 2023

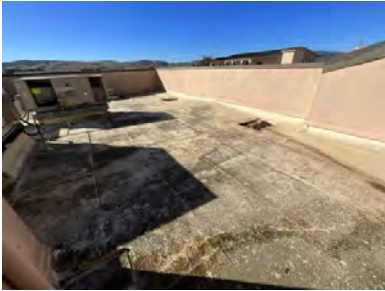
Roofing in Failed condition.

Modified Bitumen
Building 030 Arellanes Junior High Roof

Roof is sagging from water damage and has lost its integrity. Water will leak all the way through to room below and has damaged room interior as well. - AssetCALC ID: 5258062

Uniformat Code: B3010
Recommendation: **Replace in 2023**

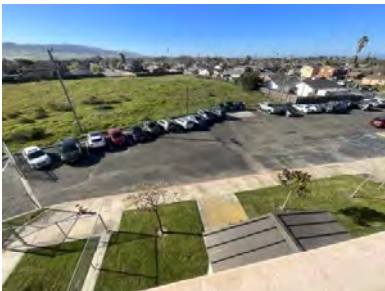
Parking Lots in Poor condition.

Pavement, Asphalt
Site Arellanes Junior High Site

Paint is fading. - AssetCALC ID: 5258578

Uniformat Code: G2020
Recommendation: **Seal & Stripe in 2024**

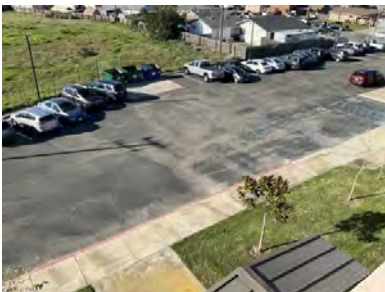
Parking Lots in Poor condition.

Pavement, Asphalt
Site Arellanes Junior High Site

Alligator cracking begging to form in some areas. Damage to asphalt around lot drain. - AssetCALC ID: 5258579

Uniformat Code: G2020
Recommendation: **Mill & Overlay in 2025**

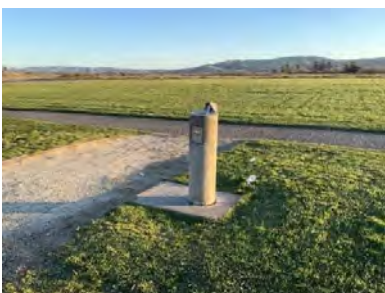
Drinking Fountain in Poor condition.

Exterior/Site, Precast Pedestal
Site Arellanes Junior High Site

Chipped and broken near the bottom of pedestal - AssetCALC ID: 5258573

Uniformat Code: D2010
Recommendation: **Replace in 2025**

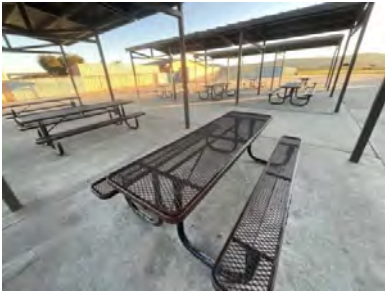
Picnic Table in Poor condition.

Metal Powder-Coated
Site Arellanes Junior High Site

Material is coming off the benches. Exposing metal underneath. - AssetCALC ID: 5258568

Uniformat Code: G2060
Recommendation: **Replace in 2023**

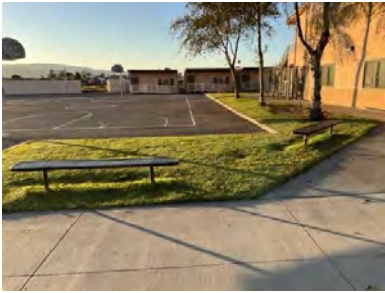
Park Bench in Poor condition.

Metal Powder-Coated
Site Arellanes Junior High Site

Material is coming off the surface and exposing rusted metal. - AssetCALC ID: 5258585

Uniformat Code: G2060
Recommendation: **Replace in 2023**

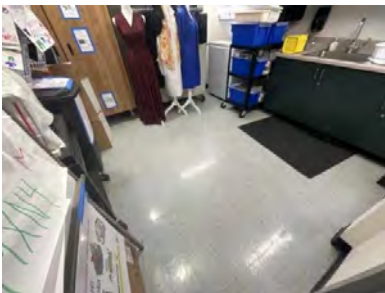
Flooring in Poor condition.

Vinyl Tile (VCT)
Building 040 Arellanes Junior High Throughout building

Tiles have been replaced. Different color tiles. Tiles are bubbling up. Evidence of high wear on surface. - AssetCALC ID: 5258449

Uniformat Code: C2030
Recommendation: **Replace in 2025**

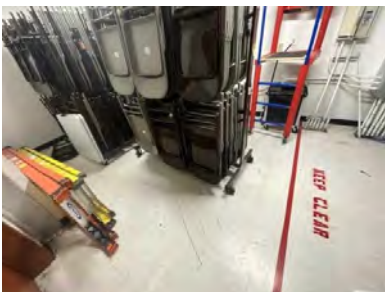
Flooring in Poor condition.

Vinyl Tile (VCT)
Building 100 Arellanes Junior High Storage closet

Tiles are badly scraped and worn down. - AssetCALC ID: 5258494

Uniformat Code: C2030
Recommendation: **Replace in 2025**
