FACILITY CONDITION ASSESSMENT

158764.22R000-005.017

February 17, 2023

Battles Elementary
605 East Battles Road
Santa Maria, California 93454

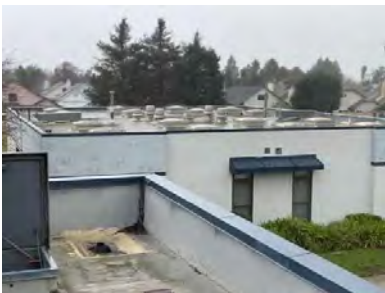
Modified Bitumen
Buildings A, B, C, D, and K Battles Elementary
Roof Building A

Roofing in Poor condition.

Roof reported to be in poor shape - AssetCALC ID: 4851957

Uniformat Code: B3010
Recommendation: **Replace in 2024**

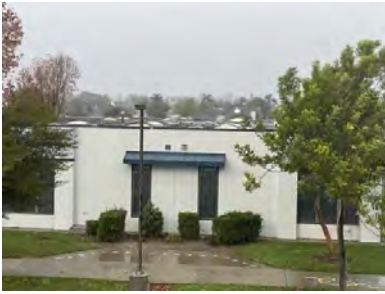
Modified Bitumen
Buildings A, B, C, D, and K Battles Elementary
Building B Roof

Roofing in Poor condition.

Roof reported to be in poor shape - AssetCALC ID: 4851943

Uniformat Code: B3010
Recommendation: **Replace in 2024**

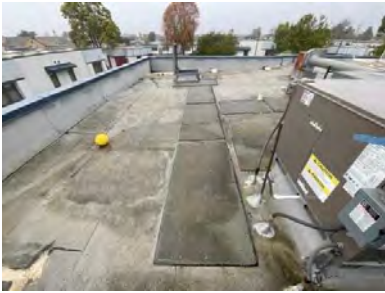
Modified Bitumen
Administration Building Battles Elementary
Roof

Roofing in Poor condition.

Roof reported to be in poor shape - AssetCALC ID: 4852156

Uniformat Code: B3010
Recommendation: **Replace in 2024**

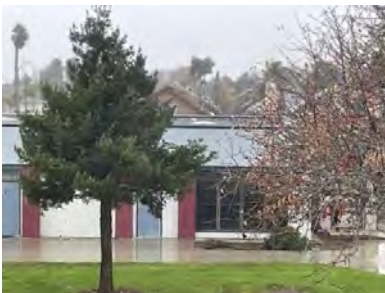
Modified Bitumen
Buildings A, B, C, D, and K Battles Elementary
Building K Roof

Roofing in Poor condition.

Roof reported to be in poor shape - AssetCALC ID: 4851992

Uniformat Code: B3010
Recommendation: **Replace in 2024**

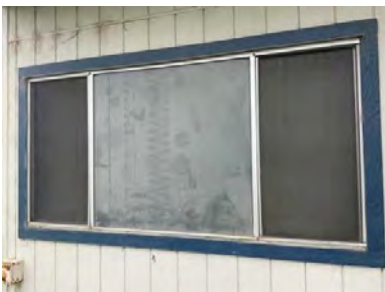
Aluminum Double-Glazed, 16-25 SF
Site Battles Elementary Portables

Window in Poor condition.

Window film peeling, screens broken, frames in poor shape - AssetCALC ID: 4852101

Uniformat Code: B2020
Recommendation: **Replace in 2024**

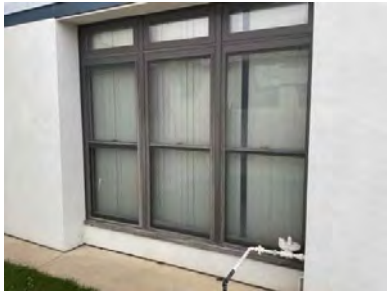
Aluminum Double-Glazed, 28-40 SF
Buildings A, B, C, D, and K Battles Elementary
Building D Exterior

Window in Poor condition.

Window film peeling, screens broken, frames in poor shape - AssetCALC ID: 4851869

Uniformat Code: B2020
Recommendation: **Replace in 2024**

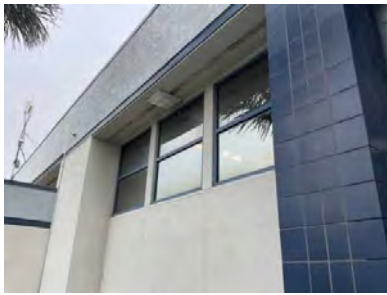
Aluminum Double-Glazed, 28-40 SF
Administration Building Battles Elementary
Building Exterior

Window in Poor condition.

Window film peeling, screens broken, frames in poor shape - AssetCALC ID: 4852177

Uniformat Code: B2020
Recommendation: **Replace in 2024**

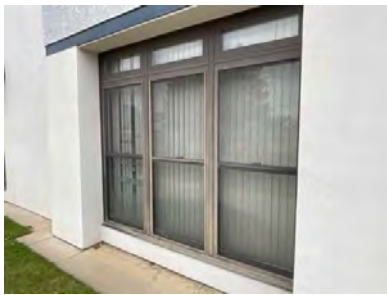
Aluminum Double-Glazed, 28-40 SF
Buildings A, B, C, D, and K Battles Elementary
Building A Exterior

Window in Poor condition.

Window film peeling, screens broken, frames in poor shape - AssetCALC ID: 4851963

Uniformat Code: B2020
Recommendation: **Replace in 2024**

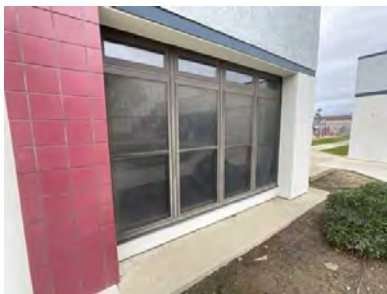
Aluminum Double-Glazed, 28-40 SF
Buildings A, B, C, D, and K Battles Elementary
Building K Exterior

Window in Poor condition.

Window film peeling, screens broken, frames in poor shape - AssetCALC ID: 4851993

Uniformat Code: B2020
Recommendation: **Replace in 2024**

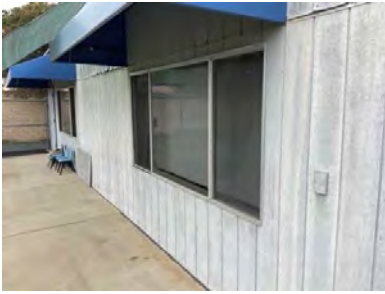
Aluminum Double-Glazed, 16-25 SF
Site Battles Elementary Los Padres Center

Window in Poor condition.

Window film peeling, screens broken, frames in poor shape - AssetCALC ID: 4852079

Uniformat Code: B2020
Recommendation: **Replace in 2024**

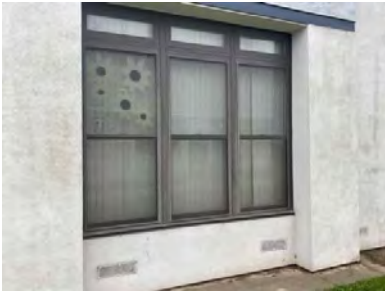
Aluminum Double-Glazed, 28-40 SF
Buildings A, B, C, D, and K Battles Elementary
Building B Exterior

Window in Poor condition.

Window film peeling, screens broken, frames in poor shape - AssetCALC ID: 4851937

Uniformat Code: B2020
Recommendation: **Replace in 2024**

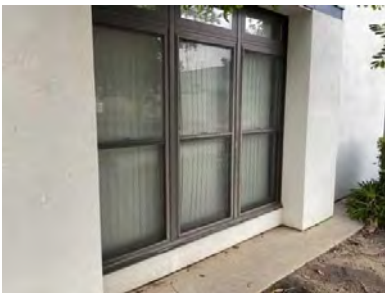
Aluminum Double-Glazed, 28-40 SF
Buildings A, B, C, D, and K Battles Elementary
Building C Exterior

Window in Poor condition.

Window film peeling, screens broken, frames in poor shape - AssetCALC ID: 4851916

Uniformat Code: B2020
Recommendation: **Replace in 2024**

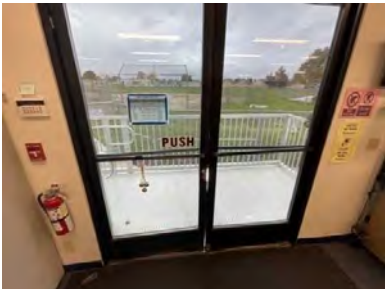
Aluminum-Framed and Glazed, Standard
Swing
Site Battles Elementary Resource Center

Exterior Door in Poor condition.

Uniformat Code: B2050
Recommendation: **Replace in 2024**
