FACILITY CONDITION ASSESSMENT

Bonita Elementary
2715 West Main Street
Santa Maria, California 93458

158764.22R000-007.017

February 20, 2023

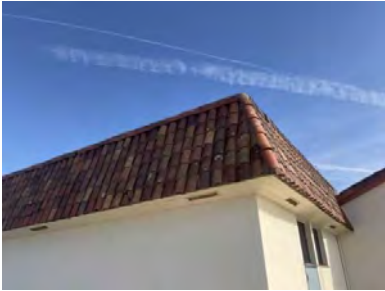
Roofing in Poor condition.

Clay/Concrete Tile
Building 010 Bonita Elementary Roof

Clay tiles have passed usable life with visible broken and cracked sections - AssetCALC ID: 5145157

Uniformat Code: B3010
Recommendation: **Replace in 2025**

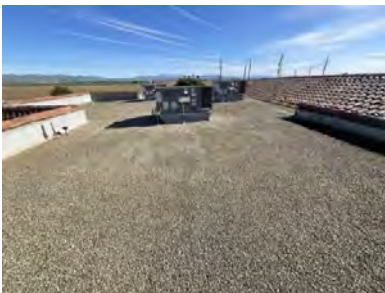
Roofing in Poor condition.

Built-Up
Building 010 Bonita Elementary Roof

Drains need repitched on roof, evidence of water buildup - AssetCALC ID: 5145149

Uniformat Code: B3010
Recommendation: **Replace in 2025**

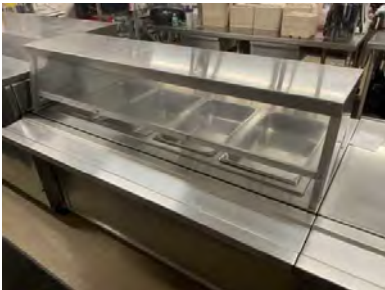
Foodservice Equipment in Failed condition.

Food Warmer, Tabletop Drawers (Set of 4)
Building 070 Bonita Elementary Kitchen

Not operating - AssetCALC ID: 5145118

Uniformat Code: E1030
Recommendation: **Replace in 2023**

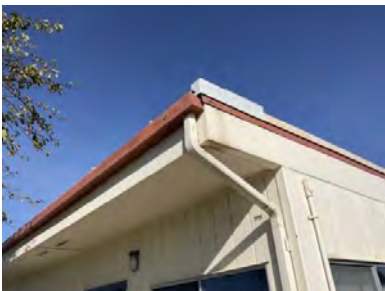
Roof Appurtenances in Poor condition.

Gutters and Downspouts, Aluminum with Fittings
Building 080 Bonita Elementary Roof

Uniformat Code: B3020
Recommendation: **Replace in 2024**
