# FACILITY CONDITION ASSESSMENT

## **DLR Group**

Bruce Elementary  
601 West Alvin Avenue  
Santa Maria, California 93458

*February 21, 2023*

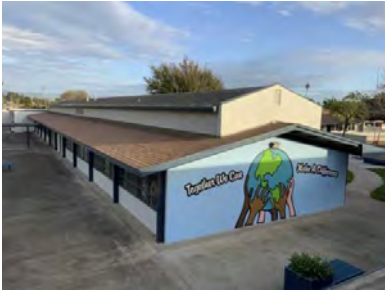
#### Roofing in Poor condition.

Asphalt Shingle, 20-Year Standard Building 020 Bruce Elementary Roof

Roofing has failed in several large areas and needs replacing. - AssetCALC ID: 4866316

Uniformat Code: B3010  
Recommendation: **Replace in 2023**

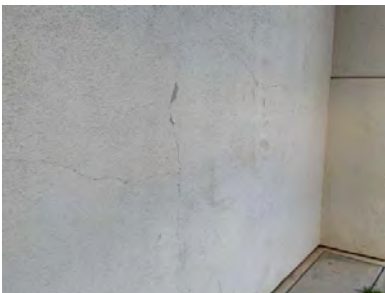
#### Exterior Walls in Poor condition.

Stucco Building 160 Bruce Elementary Building exterior

Repair stucco damage to exterior wall near entry - AssetCALC ID: 4866290

Uniformat Code: B2010  
Recommendation: **Repair in 2023**

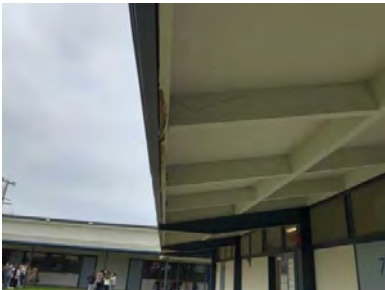
#### Soffit/Fascia in Poor condition.

Wood Building 020 Bruce Elementary Exterior Building

Wood fascia board shows deterioration and needs replacing. - AssetCALC ID: 4866453

Uniformat Code: B3080  
Recommendation: **Replace in 2023**

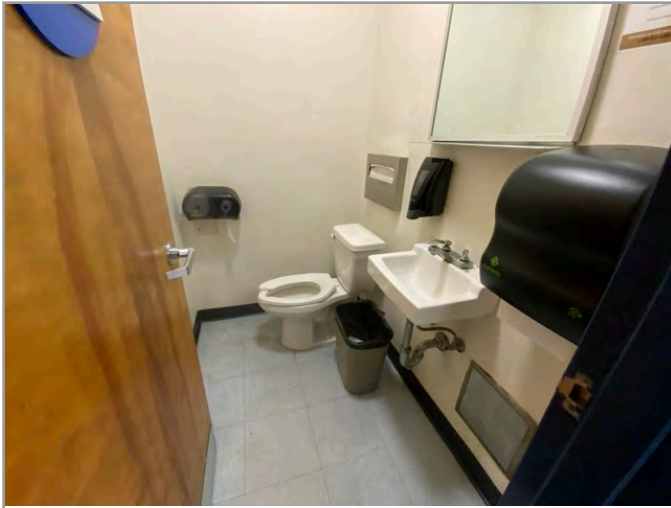
TOILET STALL OVERVIEW

Question		Yes	No	NA	Comments
1	Do publicly accessible toilet rooms appear to have a minimum compliant floor area ?		✗		Restroom does not have the minimum clear floor clearances
2	Does the lavatory appear to be mounted at a compliant height and with compliant knee area ?	✗			
3	Does the lavatory faucet have compliant handles ?	✗			
4	Is the plumbing piping under lavatories configured to protect against contact ?		✗		No pipe wrap on plumbing pipes
5	Are grab bars provided at compliant locations around the toilet ?		✗		No grab bars around toilet
6	Do toilet stall doors appear to provide the minimum compliant clear width ?			✗
