# FACILITY CONDITION ASSESSMENT

El Camino Junior High  
219 West El Camino Street  
Santa Maria, California 93458

*February 27, 2023*

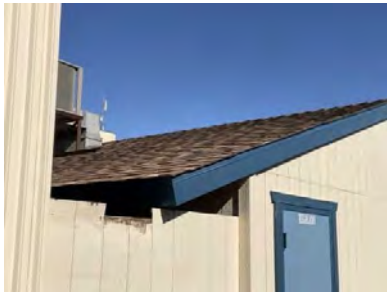
### Roofing in Poor condition.

Asphalt Shingle, 20-Year Standard  
Regalado Building El Camino Junior High Roof

Leaks reported - AssetCALC ID: 5353763

Uniformat Code: B3010  
Recommendation: **Replace in 2025**

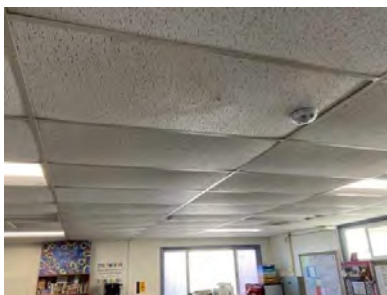
### Suspended Ceilings in Poor condition.

Acoustical Tile (ACT)  
Regalado Building El Camino Junior High  
Throughout building

Reported leaks causing the tiles to discolor and sag - AssetCALC ID: 5353762

Uniformat Code: C1070  
Recommendation: **Replace in 2025**
