# FACILITY CONDITION ASSESSMENT

## **DLR Group**

Fairlawn Elementary  
120 North Mary Drive  
Santa Maria, California 93458

*February 21, 2023*

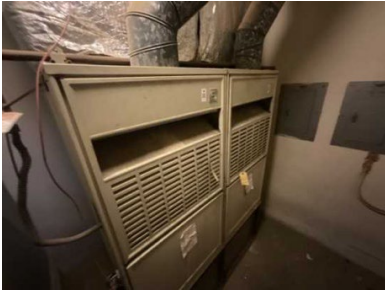
#### Furnace in Failed condition.

Gas  
Building 060 Fairlawn Elementary Mechanical room

Locked out, not currently operating - AssetCALC ID: 5085885

Uniformat Code: D3020  
Recommendation: **Replace in 2023**

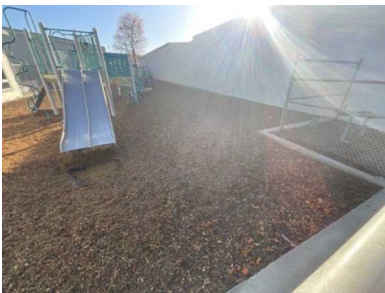
The campus contains several play structures on wood chip playing surfaces, it was observed that excessive fungal growth was occurring on the Southwest play area. The two parking lots will require a fresh stripe procedure in the next couple of years, however the concrete is still in good condition. Recently baseball backstops were removed from the field, in favor of construction of a new dirt running track completed last year.

#### Playfield Surfaces in Poor condition.

Chips Wood, 6" Depth  
Site Fairlawn Elementary Playground

Uniformat Code: G2050  
Recommendation: **Replace in 2023**

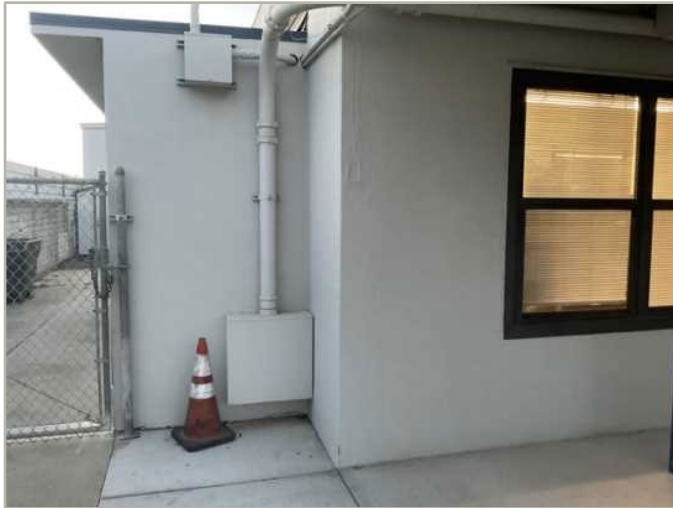
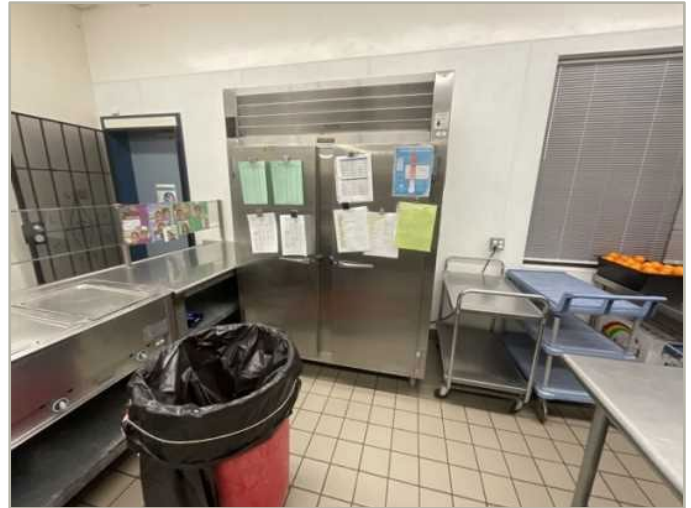
<b>Building 060: Systems Summary</b>		
<b>HVAC</b>	Non-Central System: Furnaces with split-system condensing units Supplemental components: Indoor rotating fans	Fair
<b>Fire Suppression</b>	Fire extinguishers only	Fair
<b>Electrical</b>	Source and Distribution: Main switchboard with copper wiring Interior Lighting: Linear fluorescent Emergency Power: None	Fair
<b>Fire Alarm</b>	Alarm panel with smoke detectors, heat detectors, alarms, strobes, pull stations, back-up emergency lights, and exit signs	Fair
<b>Equipment/Special</b>	Commercial kitchen equipment	Fair
<b>Accessibility</b>	Presently it does not appear an accessibility study is needed for this building. See Appendix D.	
<b>Key Issues and Findings</b>	Furnace was tagged out with gas line disconnected.

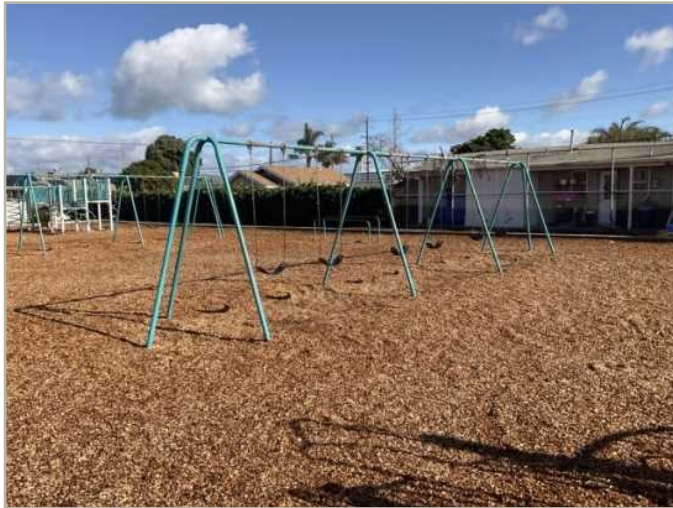
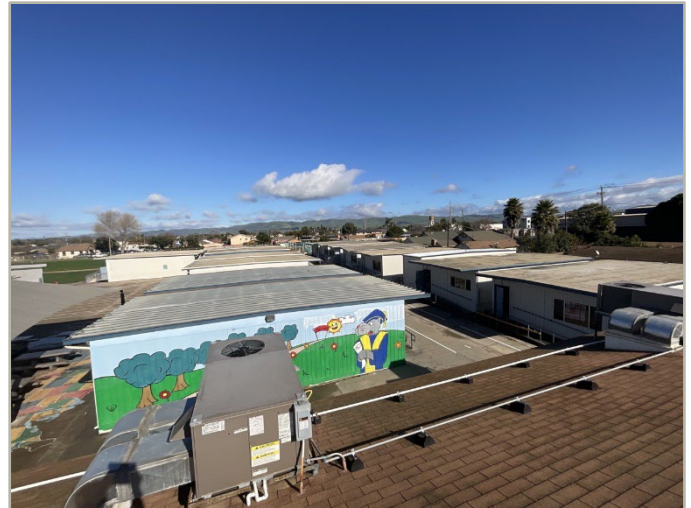
<b>Key Issues and Findings</b>	fungal growth present at SW playground

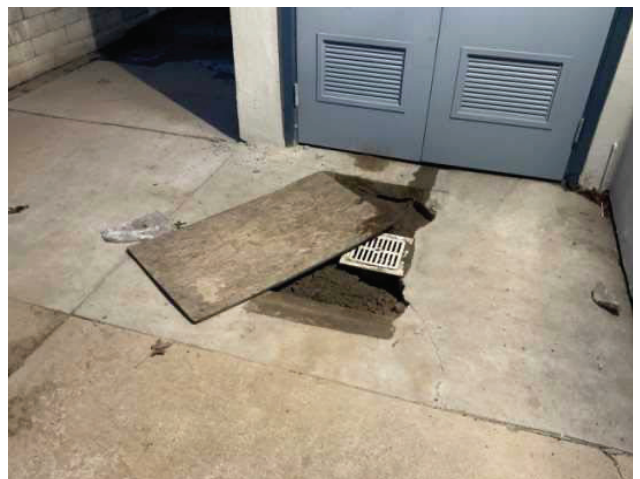
36 - CONCRETE FAILURE, TRIP HAZARD
