FACILITY CONDITION ASSESSMENT

Fesler Junior High
1100 West Fesler Street
Santa Maria, California 93454

158764.22R000-011.017

February 23, 2023

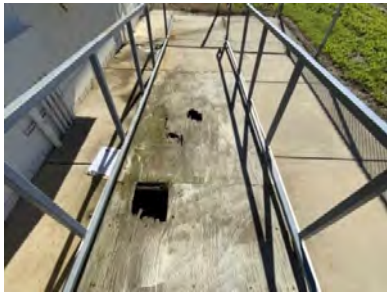
Wood Ramp in Failed condition.

Wood
Building 250 Fesler Junior High Rear exit

Deteriorated rear wood ramp - AssetCALC ID: 5124581

Uniformat Code: B1080
Recommendation: **Repair in 2023**

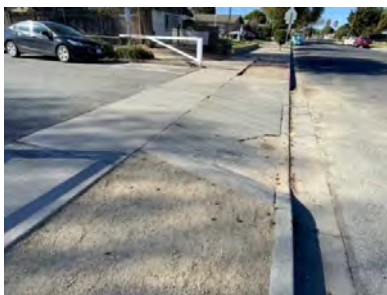
Parking Lots in Poor condition.

Pavement, Concrete
Site Fesler Junior High Parking area entry

Repair of deteriorated concrete entry apron - AssetCALC ID: 5124684

Uniformat Code: G2020
Recommendation: **Replace in 2025**

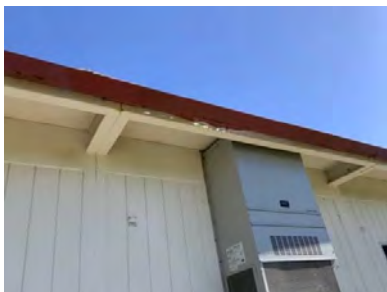
Roof Appurtenances in Poor condition.

Gutters & Downspouts, Aluminum w/ Fittings
Building 250 Fesler Junior High Roof

Gutter has deteriorated, repair or replacement is required - AssetCALC ID: 5124624

Uniformat Code: B3020
Recommendation: **Replace in 2023**
