FACILITY CONDITION ASSESSMENT

DLR Group

March 1, 2023

Jimenez Elementary
1970 South Biscayne Street
Santa Maria, California 93458

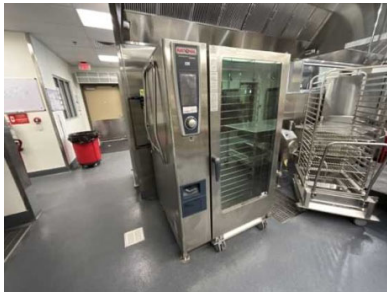
Foodservice Equipment in Poor condition.

Convection Oven, Double
Multi-Purpose Building Jimenez Elementary
Kitchen

Gas pressure is too high for the oven, and it causes the lines to leak gas. - AssetCALC ID: 5349462

Uniformat Code: E1030
Recommendation: **Replace in 2023**

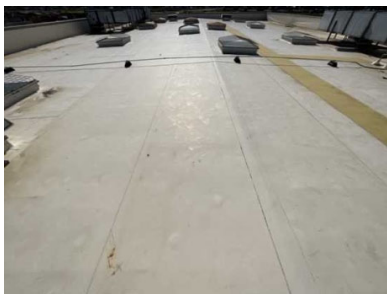
Roofing in Poor condition.

Single-Ply Membrane, TPO/PVC
Multi-Purpose Building Jimenez Elementary
Roof

Roof shows signs of patching and leaks reported during the rainy weather. - AssetCALC ID: 5349442

Uniformat Code: B3010
Recommendation: **Replace in 2025**
