# FACILITY CONDITION ASSESSMENT

## **DLR Group**

Ontiveros Elementary  
930 West Rancho Verde  
Santa Maria, California 93458

*February 27, 2023*

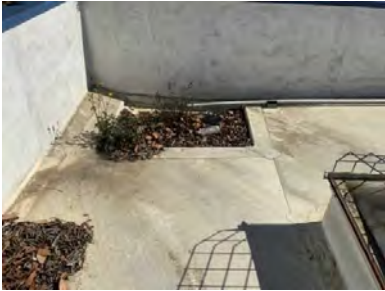
#### Roofing in Poor condition.

any type, Repairs per Man-Day  
Building 050 Ontiveros Elementary Roof

Roof drains need to be maintained - AssetCALC ID: 5271159

Uniformat Code: B3010  
Recommendation: **Repair in 2023**

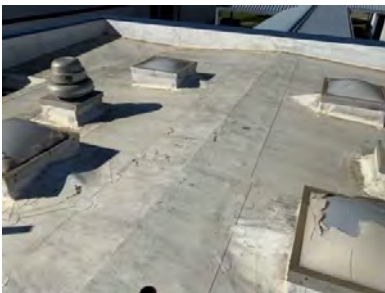
#### Roof Skylight in Poor condition.

per unit, up to 20 SF  
Building 080 Ontiveros Elementary Roof

Skylights have deteriorated and need to be replaced - AssetCALC ID: 5296741

Uniformat Code: B3060  
Recommendation: **Replace in 2023**

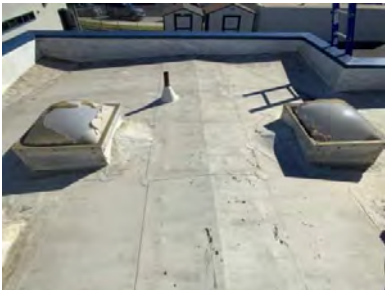
#### Roof Skylight in Poor condition.

per unit, up to 20 SF  
Building 070 Ontiveros Elementary Roof

Damaged skylights need to be replaced - AssetCALC ID: 5296740

Uniformat Code: B3060  
Recommendation: **Replace in 2023**

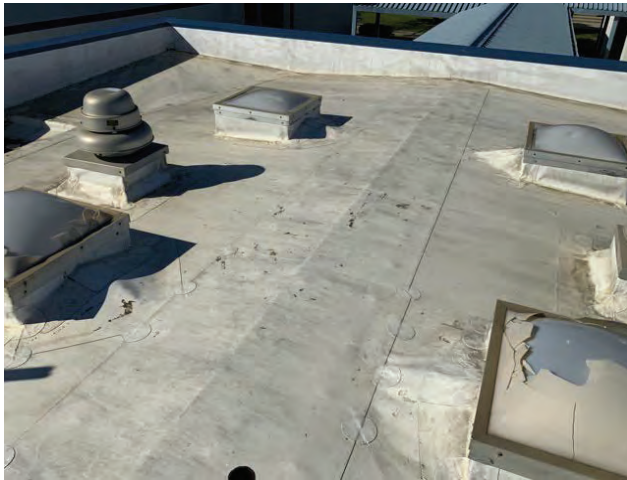
13 - DAMAGED SKYLIGHTS
