# FACILITY CONDITION ASSESSMENT

*158674.22R000-018.017*

*February 28, 2023*

Rice Elementary  
700 East Vickie Avenue  
Santa Maria, California 93454

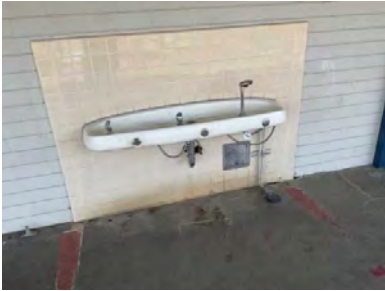
#### Drinking Fountain in Poor condition.

Exterior/Site, Metal Pedestal  
Building 030 Rice Elementary Building exterior

Half of the faucets are inoperable - AssetCALC ID: 5351255

Uniformat Code: D2010  
Recommendation: **Replace in 2024**

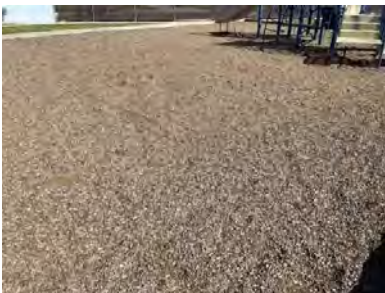
#### Playfield Surfaces in Poor condition.

Chips Wood, 3" Depth  
Site Rice Elementary Playground

Uniformat Code: G2050  
Recommendation: **Replace in 2023**
