FACILITY CONDITION ASSESSMENT

Sanchez Elementary
804 West Liberty Street
Santa Maria, California 93458

158764.22R000-019.017

March 1, 2023

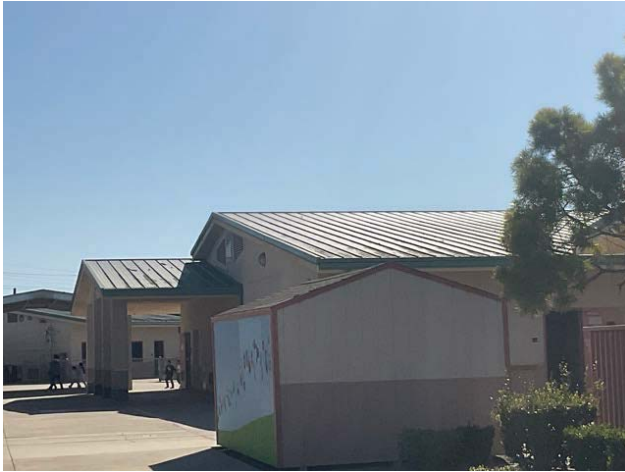
7 – METAL FINISH ROOFING

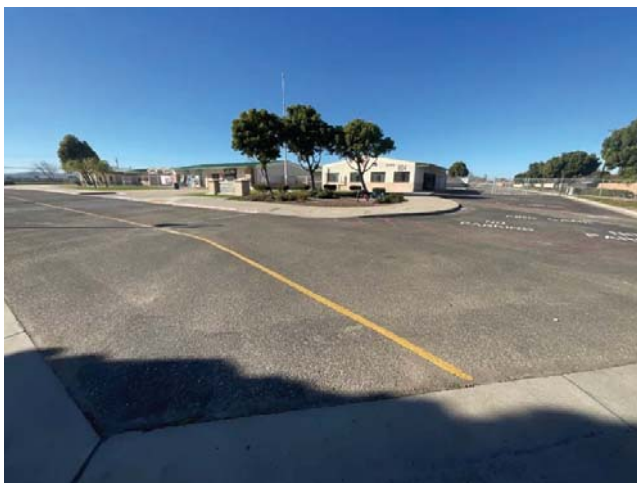
23 - ASPHALT PAVEMENT
