FACILITY CONDITION ASSESSMENT

Tunnell Elementary
1248 Dena Way
Santa Maria, California 93454

158764.22R000-021.017

March 2, 2023

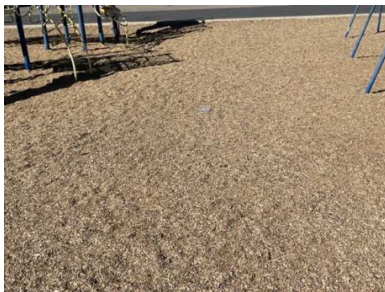
Playfield Surfaces in Poor condition.

Chips Wood, 6" Depth
Site Tunnell Elementary Playground

Unifomat Code: G2050
Recommendation: **Replace in 2024**

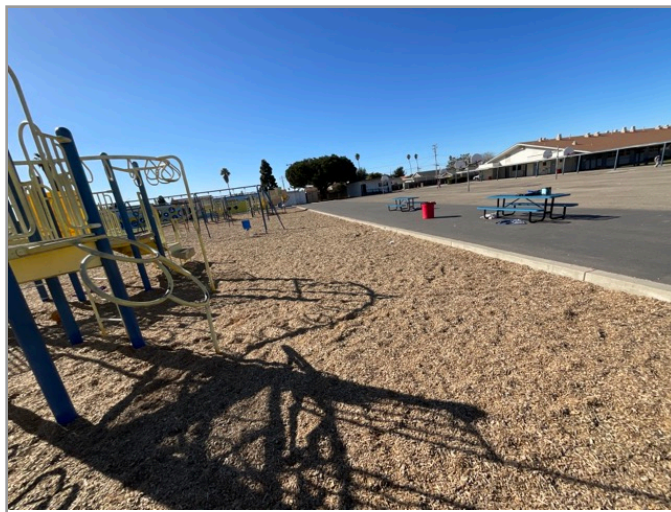
NO ACCESSIBLE ROUTE TO PLAYGROUND

Question		Yes	No	NA	Comments
1	Is there an accessible route to the play area / s?		✗		Play ground has no accessible entrance
2	Has the play area been reviewed for accessibility ?			✗	
3	Are publicly accessible swimming pools equipped with an entrance lift ?			✗
