FACILITY CONDITION ASSESSMENT

District (Souza Student Support)
708 South Miller Street
Santa Maria, California 93454

158764.22R000-022.017

February 23, 2023

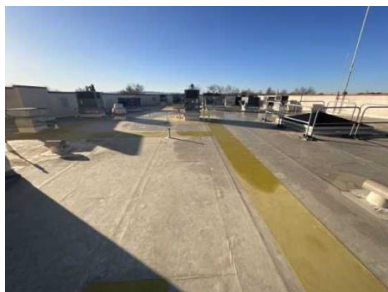
Roofing in Poor condition.

Single-Ply Membrane, TPO/PVC
District (Souza Student Support) Roof

Roof was reported to have leaks - AssetCALC ID: 5249467

Uniformat Code: B3010
Recommendation: **Replace in 2025**

Cost Estimate: \$516,100

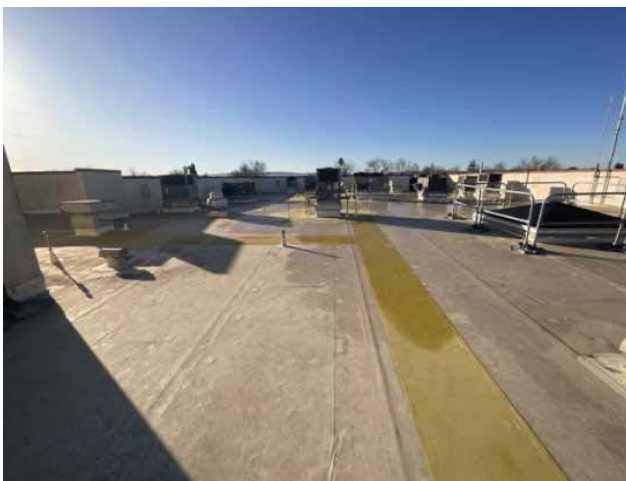
5 - ROOFING

The buildings architecture and structure are from the original construction and are in fair condition. There is wear and tear in wall paint, doors, and windows. Although the roof was replaced fairly recently, it has numerous leaks throughout.

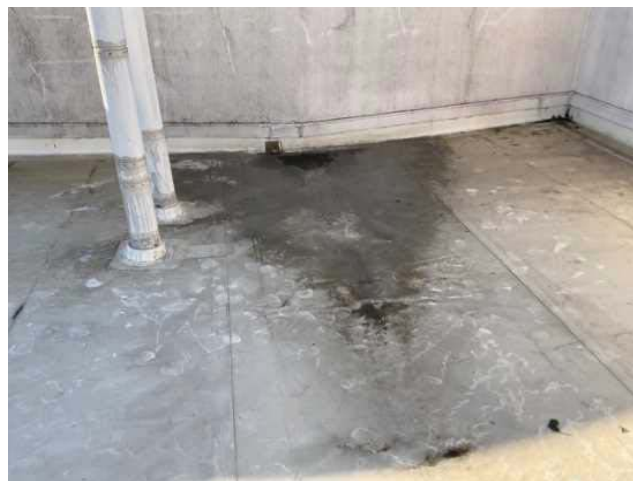
6 - ROOF PONDING

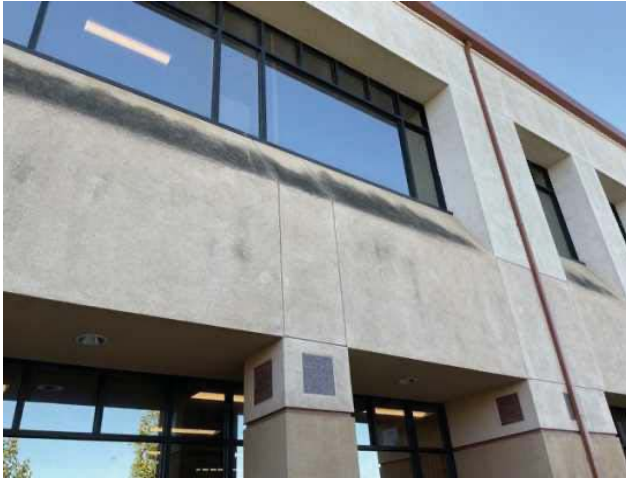
25 - MILDEW PRESENT ON EXTERIOR WALLS
