FACILITY CONDITION ASSESSMENT

DLR Group

Maintenance and Operations
321 North Thornburg Street
Santa Maria, California 93454

February 22, 2023

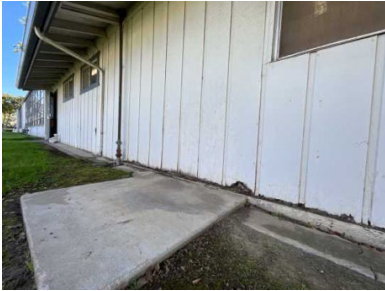
Exterior Walls in Poor condition.

Wood Siding
Building 3 Maintenance and Operations
Building Exterior

Wood siding is rotted at the bottom and falling apart from the ground up. - AssetCALC ID: 5162691

Uniformat Code: B2010
Recommendation: **Replace in 2024**

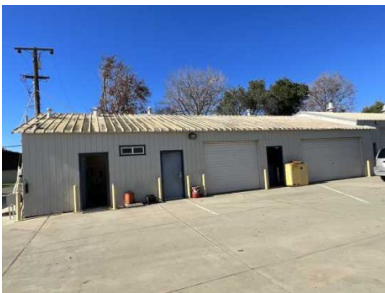
Roofing in Poor condition.

Metal
Building 2 Maintenance and Operations Roof

Roof is bent, rusted, and missing paint. Evidence of leaking in the roof, water has rusted the metal underside of the building due to leakage. - AssetCALC ID: 5162668

Uniformat Code: B3010
Recommendation: **Replace in 2024**

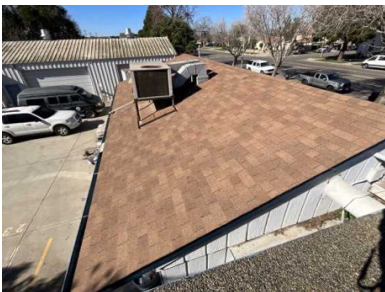
Roofing in Poor condition.

Asphalt Shingle, 20-Year Standard
Building 3 Maintenance and Operations Roof

The roof has leaked water into the walls on the side of the building. Specifically, the hallway leading to the lounge from the office. - AssetCALC ID: 5162732

Uniformat Code: B3010
Recommendation: **Replace in 2025**

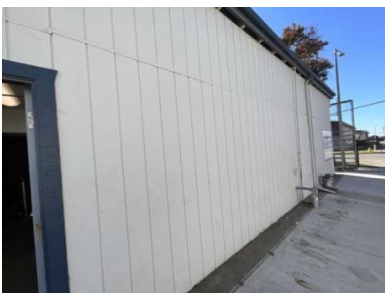
Exterior Walls in Poor condition.

Wood Siding
Building 1 Maintenance and Operations
Building Exterior

Wood siding is deteriorating at the bottom. - AssetCALC ID: 5162682

Uniformat Code: B2010
Recommendation: **Replace in 2025**

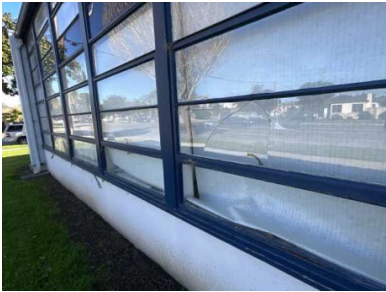
Window in Failed condition.

Steel, 16-25 square feet
Building 3 Maintenance and Operations
Building Exterior

Glass window is broken near the bottom. Broken window glass all over the front facade. - AssetCALC ID: 5162764

Uniformat Code: B2020
Recommendation: **Replace in 2023**

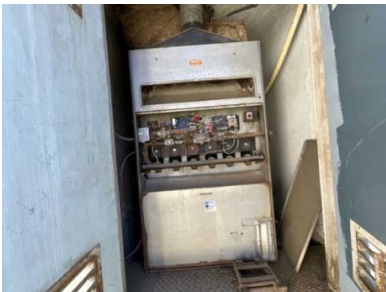
Furnace in Poor condition.

Gas
Building 3 Maintenance and Operations
Building Exterior

Item is rusted and beyond its useful life. - AssetCALC ID: 5162749

Uniformat Code: D3020
Recommendation: **Replace in 2025**

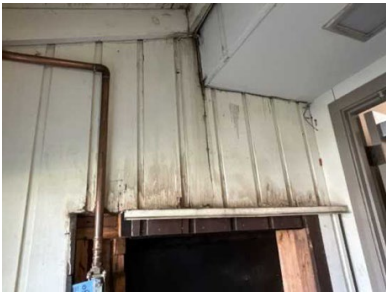
Wall Finishes in Poor condition.

Wood Paneling, Raised Architectural Wainscot
Building 3 Maintenance and Operations Office
to Lounge Hallway

Water damage and wood is rotting. - AssetCALC ID: 5162745

Uniformat Code: C2010
Recommendation: **Replace in 2023**

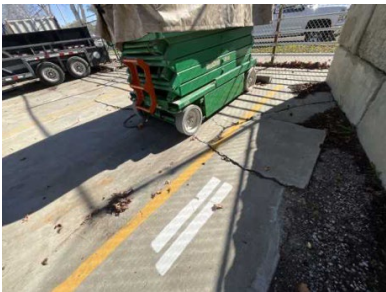
Parking Lots in Failed condition.

Pavement, Concrete
Site Maintenance and Operations Site

Large cracks in concrete - AssetCALC ID: 5162763

Uniformat Code: G2020
Recommendation: **Repair in 2023**

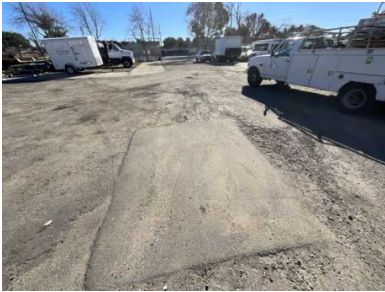
Parking Lots in Failed condition.

Pavement, Asphalt
Site Maintenance and Operations Site

Seal and Striping are no longer present. - AssetCALC ID: 5162748

Uniformat Code: G2020
Recommendation: **Seal and Stripe in 2023**

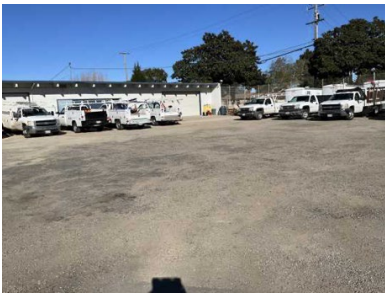
Parking Lots in Poor condition.

Aggregate/Stone, Surface Gravel
Site Maintenance and Operations Site

Gravel needs to be replenished. Large patches of exposed dirt present. - AssetCALC ID: 5162767

Uniformat Code: G2020
Recommendation: **Replenish in 2024**

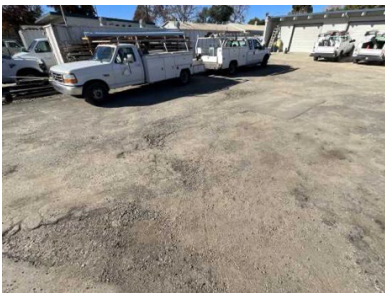
Parking Lots in Poor condition.

Pavement, Asphalt
Site Maintenance and Operations Site

Potholes along the large cracks. Alligator cracking present throughout. - AssetCALC ID: 5162702

Uniformat Code: G2020
Recommendation: **Mill and Overlay in 2024**

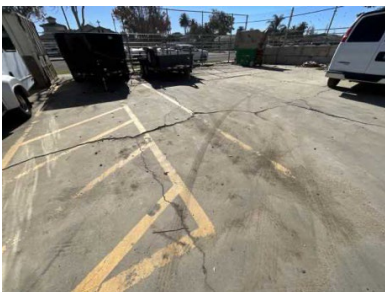
Parking Lots in Poor condition.

Pavement, Concrete
Site Maintenance and Operations Site

Large cracks through the concrete. - AssetCALC ID: 5162717

Uniformat Code: G2020
Recommendation: **Replace in 2025**

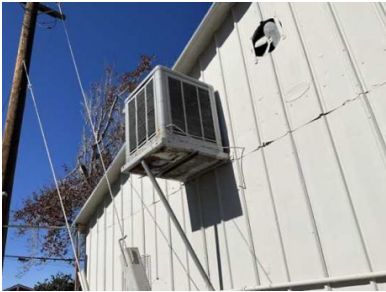
Heat Pump in Failed condition.

Packaged and Wall-Mounted
Building 2 Maintenance and Operations
Building Exterior

Item is badly corroded. No longer in operation. - AssetCALC ID: 5162752

Uniformat Code: D3030
Recommendation: **Replace in 2023**

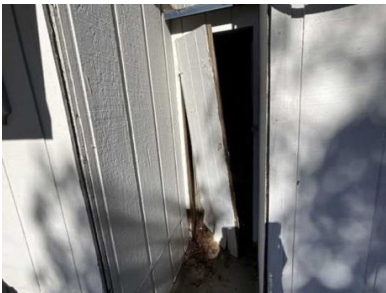
Fences and Gates in Failed condition.

Fence, Wood Board 6'
Building 3 Maintenance and Operations
Building Exterior

Door is off the hinges and badly damaged. - AssetCALC ID: 5162766

Uniformat Code: G2060
Recommendation: **Replace in 2023**

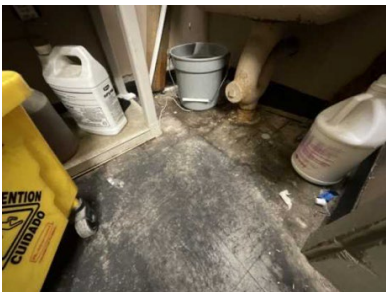
Flooring in Failed condition.

Vinyl Tile (VCT)
Building 3 Maintenance and Operations Utility
Closet

Tile is broken in numerous places and is exposing surface underneath. - AssetCALC ID: 5162755

Uniformat Code: C2030
Recommendation: **Replace in 2023**

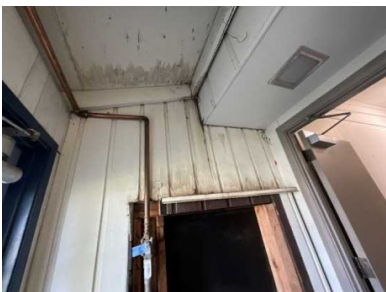
Building 3 has a portion of its structure that is in poor condition. Leaks have been reported in the hallway leading from the office to the breakroom. The wood frame has been rotted away from water damage and shows signs of termite infestation. A professional consultant must be retained to analyze the existing condition, provide recommendations and, if necessary, estimate the scope and cost of any required repairs. The cost of this study is included in the cost tables.

**Recommended Follow-up Study:
Environmental, Analysis of
Suspect Fungal Growth**

Environmental, Analysis of Suspect Fungal
Growth
Building 3 Maintenance and Operations Office
to Lounge Hallway

Interior wood is rotting and shows signs of water damage. - AssetCALC ID: 5162731

Uniformat Code: P2030
Recommendation: **Evaluate/Report in 2023**

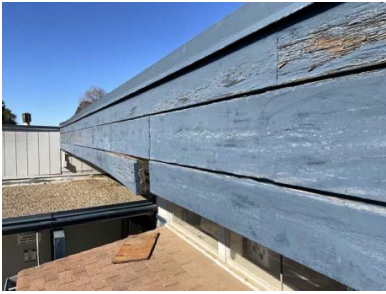
Soffit in Poor condition.

Wood
Building 3 Maintenance and Operations Roof

The wood material is warped and separating from adjacent boards. Paint is peeling and fading. - AssetCALC ID: 5162709

Uniformat Code: B3080
Recommendation: **Replace in 2024**

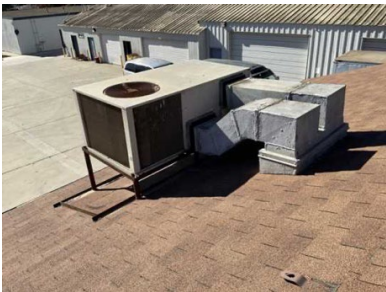
Packaged Unit in Poor condition.

RTU, Pad or Roof-Mounted
Building 3 Maintenance and Operations Roof

Unit is badly rusted and beyond it's expected life - AssetCALC ID: 5162772

Uniformat Code: D3050
Recommendation: **Replace in 2024**

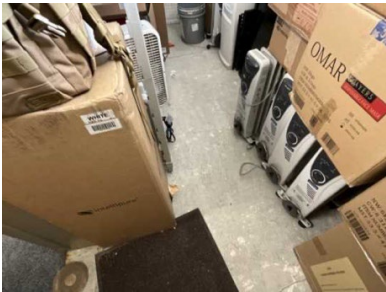
Flooring in Poor condition.

Any Surface, with Paint or Sealant
Building 3 Maintenance and Operations
Storage Room

Large cracks throughout. Needs paint or sealant after repair. - AssetCALC ID: 5162700

Uniformat Code: C2030
Recommendation: **Prep and Paint in 2025**
