**Grand Valley State University
Stormwater Management Plan
Allendale Campus**

EGLE SAW Grant No. 1143-01

**Project No. 191361
February 6, 2023**

**Prepared For:
Grand Valley State University
Allendale, Michigan**

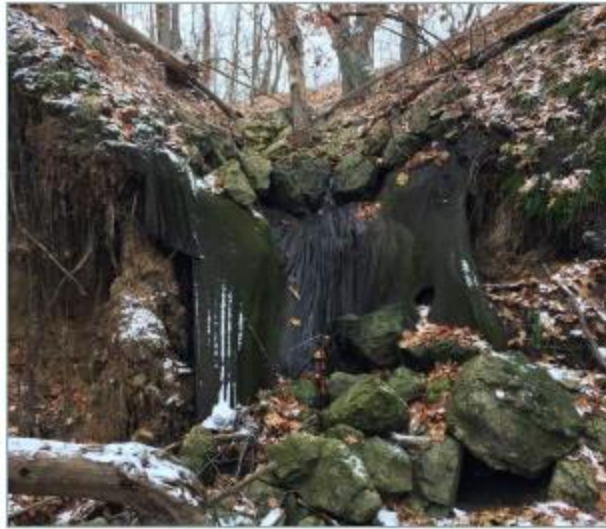
Failed stabilization measures in the Calder Ravine, Dec. 2021

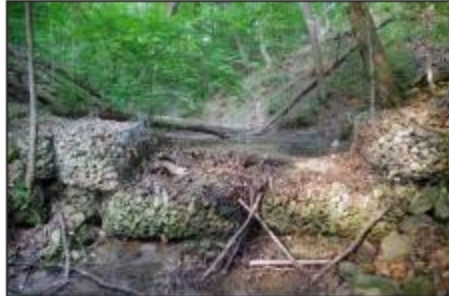
Little Mac Ravine – before

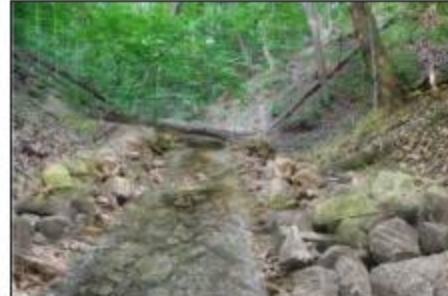
Little Mac Ravine – after

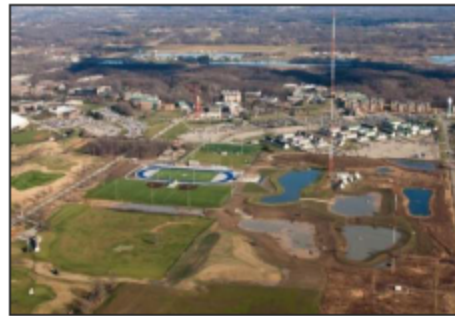
In general, the south stormwater management complex is performing well. There was good coverage of bank vegetation with minimal invasives at the forebay and both the upper and lower cells. The water level appeared close to the design elevations in all three cells. Minor issues noted with the south complex include sedimentation in the lower cell and overgrown vegetation downstream of the complex clogging the outlet channel. Periodic dredging of constructed wetlands should take place once every 15 years. Since the stormwater management complex was constructed in 2011, they will be due for dredging maintenance in 2026. Vegetation in the outlet channel should be cut back to a height of six inches each spring to ensure that the outlet channel has appropriate hydraulic capacity in case of a major storm event.

The north stormwater management complex has more serious issues that should be promptly addressed. In the upper cell of the north complex, the water surface elevation is significantly below the design water elevation. The inlet from the forebay is perched, ten to fifteen feet of muddy banks are exposed, islands are forming on the interior of the cell, and the sound of running water is clearly audible in the downstream structure. Even with the water level below the design elevation, the basin outlet is still partially submerged. Based on the visual evidence, the likely cause of the low water level is the settling or subsidence of the basin outlet. Corrective maintenance is required to reset this structure to the design elevation. Likely as a result of the draining down of the upper cell, the middle cell of the north complex has an elevated water surface compared to the design elevation. The inlet is three-quarters submerged and bank vegetation is inundated even during dry periods. The outlet control structure for the middle cell is partially submerged. The outlet is tilted to one side, which is evidence of ongoing settling or

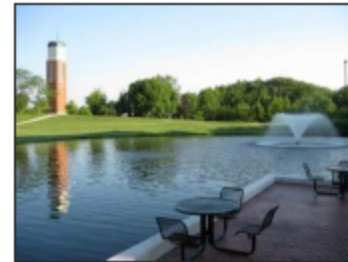
The pond was inspected on December 7, 2020, to evaluate pond function, structural integrity and provide recommendations for corrective measures. In general, the pond is in good condition and functioning largely as intended. However, water surface elevation was observed to be approximately 4" above design, which reduces overall capacity for stormwater storage. The elevated water surface elevation is likely a result of the pond not being used at that time as a water supply for irrigation. Conversations with GVSU staff indicated that previous complaints had been lodged about the appearance of the pond when the water level was at the design elevation which discouraged its use as originally intended. In addition, aluminum edging between limestone banks and landscape has been compromised and is failing. Aluminum edging is only 1/8" thick and not able to withstand heavy load from heavy equipment that traverses the area (lawn mower). Areas of erosion were noted on the north bank and are contributing sediment to the pond, which reduces overall capacity. Lastly, dislodged stone at the main outlet channel was observed.

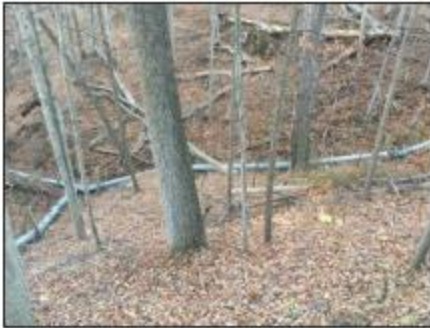
Copeland Robinson Pipe System

Storm outfalls were observed at the crest, middle and toe of steep ravine slopes, and are generally stable or no longer functional. An enclosed elevated pipe system exists in both the Au Sable and Copeland Robinson ravines and conveys stormwater from the campus floor to the toe of steep slopes. Pipes are supported on wooden braces and range in size from 12" to 24". Pipes originate at the campus floor and extend 300-500 lineal feet, or to where ravine grade begins to flatten out. Fewer impairments and greater stability of the ravines were observed in areas where enclosed pipe systems exist. Concerns with the Au Sable pipe system include site specific areas of rusting/deteriorating pipe, broken braces, and trees on top of pipe. One broken brace was noted in the Copeland Robinson pipe system.

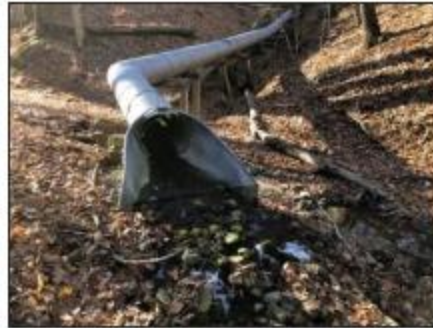
Outfall of Au Sable pipe system at toe of ravine

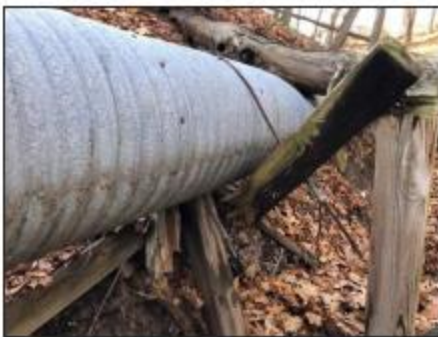
Tree and broken brace – Au Sable

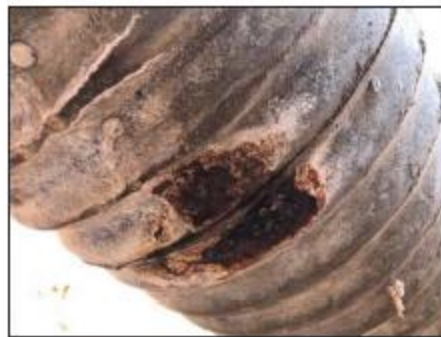
Deteriorating pipe – Au Sable

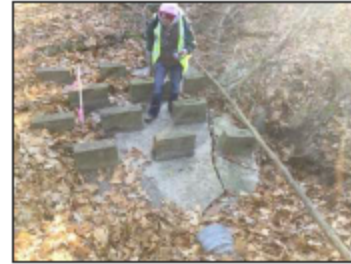
A failed 12-inch diameter CMP has rusted and failed where stormwater discharges from O-27 to the open ravine. The 12-inch CMP discharges water into a concrete energy dissipation structure. Although installed with good intent, this structure does not provide adequate grade control and directs water to ravine side slopes. The dissipation structure is cracked and failing as well. Significant erosion, downcutting and numerous fallen trees were observed in the GVA ravine. Similar to other areas, geotechnical report notes no imminent threat to catastrophic failure of the ravine or nearby structures. However, repair of the failing 12-inch CMP and adequate grade control measures are needed to ensure long-term stability in this area. GVA Ravine receives water from a medium priority drainage area.

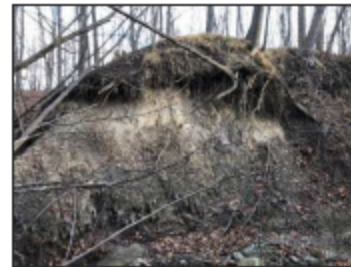
Evidence of extensive historic erosion, channel downcutting and undercutting of trees was observed throughout the east branch of the ravine. Channel bank height averages 15-25 feet. Banks are vertical and generally lack vegetative cover. Mature trees on top of banks are severely undercut, as evidenced by exposed root systems, and situated within very close proximity to edge of channel bank. Weight of these heavy trees places stress on top of the fragile channel banks which may result in their dislodgement into the main channel. Several log jams and woody obstructions were noted in the upper reach of the east branch. Channel has down-cut to clay throughout most of the area. A stormwater detention basin and underground detention discharges to the ravine's west branch. The west branch also has constructed grade control features (rock check dams). The west branch has significantly less erosion and undercutting of trees due to controlled discharge from the detention basin and grade control structures. The northern (lower end) of the ravine is most stable due to presence of wetland/floodplain area. Historic stabilization measures at outfalls appear to remain intact. This ravine receives stormwater from high and medium priority drainage watersheds.

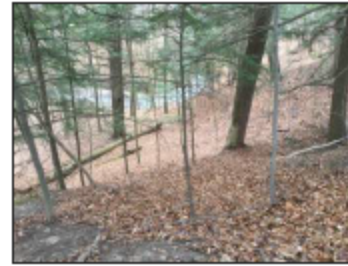
Field verification of GVSU owned parcels (178 AC total) north of M45 was conducted in December 2020 to assess natural features, development potential, and identify potential stormwater management options for the area, should future development occur. Several regulated features, including wetlands, floodplain, and streams were observed during the inspection, Figure 16. Non-regulated features noted include steep slopes and ravines. Given location and size of regulated features and steep slopes, approximately 59 of the 178 AC can be considered for development.
