FACILITY CONDITION ASSESSMENT

DLR Group

Paloma Elementary
42940 Via Rami
Temecula, California 92592

September 2, 2021

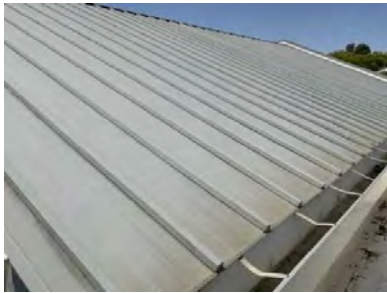
Metal
Multi Purpose Room Paloma Elementary Roof

Roofing in Poor condition.

Concealed rain gutters and metal roof underlayment failing and leaking into building - AssetCALC ID: 3179930

Uniformat Code: B3011
Recommendation: **Replace in 2021**

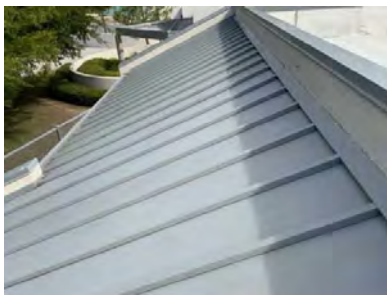
Metal
Admin Paloma Elementary Roof

Roofing in Poor condition.

Concealed rain gutters and metal roof underlayment failing and leaking into building - AssetCALC ID: 3179830

Uniformat Code: B3011
Recommendation: **Replace in 2021**

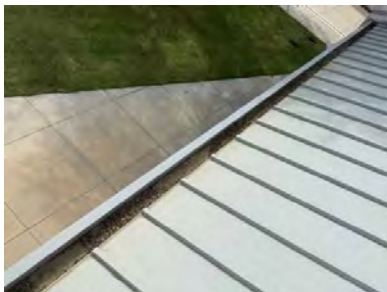
Gutters and Downspouts, Aluminum w/ Fittings
Admin Paloma Elementary Roof

Roof Appurtenances in Poor condition.

Concealed rain gutters and metal roof underlayment failing and leaking into building - AssetCALC ID: 3179841

Uniformat Code: B3027
Recommendation: **Replace in 2021**

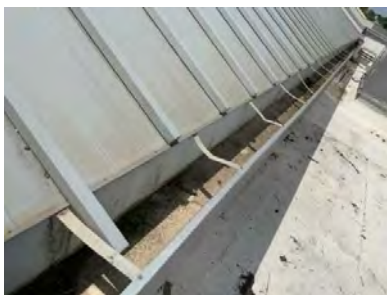
Gutters and Downspouts, Aluminum w/ Fittings
Multi Purpose Room Paloma Elementary Roof

Roof Appurtenances in Poor condition.

Concealed rain gutters and metal roof underlayment failing and leaking into building - AssetCALC ID: 3179912

Uniformat Code: B3027
Recommendation: **Replace in 2021**
