FACILITY CONDITION ASSESSMENT

DLR Group

Temecula Luiseno Elementary
45754 Wolf Creek Drive North
Temecula, California 92592

August 5, 2021

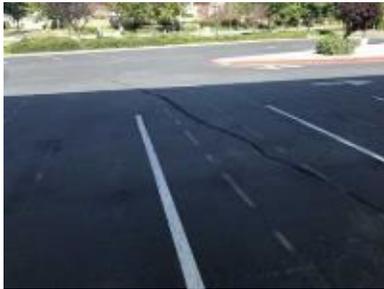
Parking Lots in Poor condition.

Pavement, Asphalt
Site Temecula Luiseno Elementary Parking lot

Isolated areas of longitudinal cracks. - AssetCALC ID: 3166129

Uniformat Code: G2021
Recommendation: **Repair in 2021**

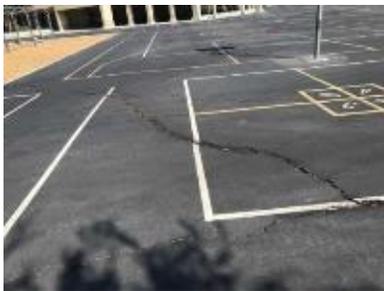
Basketball/Tennis/Play Court in Poor condition.

Pavement, Asphalt
Site Temecula Luiseno Elementary Basketball court and playground

Isolated areas of longitudinal cracks. - AssetCALC ID: 3166124

Uniformat Code: G2011
Recommendation: **Repair in 2021**

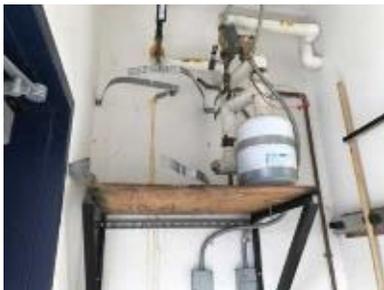
Water Heater in Failed condition.

Electric, Residential
Building D Temecula Luiseno Elementary
Custodian closet

The water heater is missing. - AssetCALC ID: 3166252

Uniformat Code: D2012
Recommendation: **Replace in 2021**

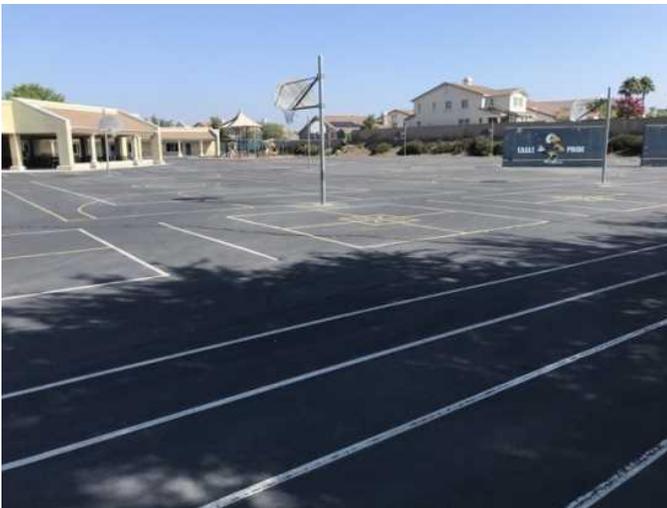
15 - BASKETBALL COURT

Key Issues and Findings	Significant longitudinal cracking at parking lot and basketball / playground areas
