FACILITY CONDITION ASSESSMENT

DLR Group

Day Middle
40775 Camino Campos Verde
Temecula, California 92591

October 21, 2021

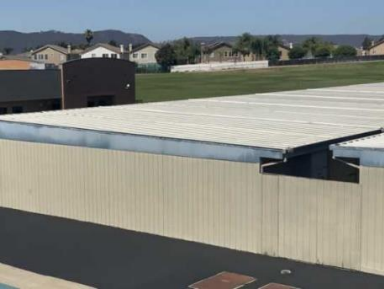
Roofing in Poor condition.

Metal
B700 Portables Day Middle Building
exterior

Roof has presented signs of leaks. Asking personnel onsite they confirmed that leaking was present. - AssetCALC ID: 3195974

Uniformat Code: B3011
Recommendation: **Replace in 2023**

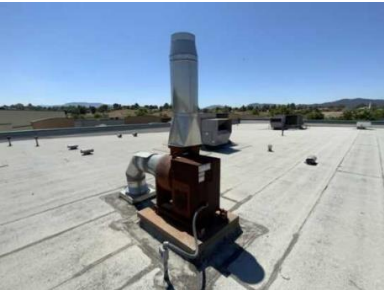
Exhaust Fan in Poor condition.

Centrifugal, 12" Damper
B500 Day Middle Roof

Excessive rusting to the exterior of fan. - AssetCALC ID: 3195655

Uniformat Code: D3063
Recommendation: **Replace in 2022**
