# FACILITY CONDITION ASSESSMENT

## **DLR Group**

Temecula Middle  
42075 Meadows Parkway  
Temecula, California 92592

*September 8, 2021*

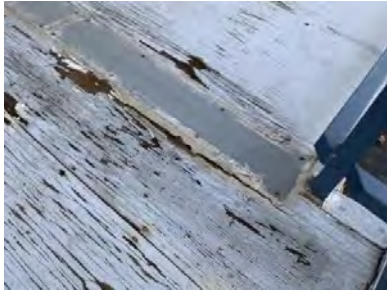
### Stair/Ramp Rails in Poor condition.

Wood  
Relos 901-905 Temecula Middle Building  
Exterior

Decayed ramp in need of repair. - AssetCALC ID: 3175203

Uniformat Code: B1085  
Recommendation: **Repair in 2021**

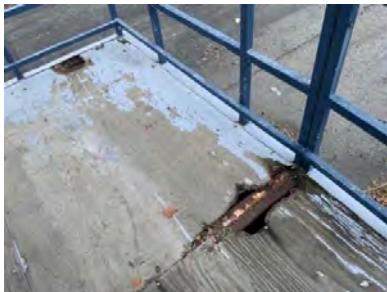
### Stair/Ramp Rails in Poor condition.

Wood  
Relos 700 Temecula Middle Building Exterior

Decayed ramp in need of repair. - AssetCALC ID: 3174645

Uniformat Code: B1085  
Recommendation: **Repair in 2021**

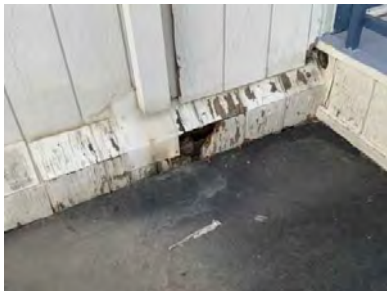
### Exterior Moldings in Poor condition.

Trim, Residential/Basic  
Relos 901-905 Temecula Middle Building  
Exterior

Exterior trim is cracked, splintering, and deteriorating - AssetCALC ID: 3175195

Uniformat Code: C2012  
Recommendation: **Replace in 2023**

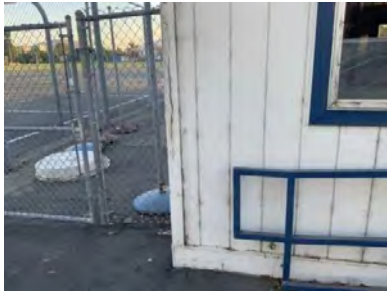
## Exterior Moldings in Poor condition.

Trim, Residential/Basic  
Relos 700 Temecula Middle Building Exterior

Exterior trim is cracked, splintering, and deteriorating - AssetCALC ID: 3174637

Uniformat Code: C2012  
Recommendation: **Replace in 2023**
