# FACILITY CONDITION ASSESSMENT

## **DLR Group**

District Office  
31350 Rancho Vista Road  
Temecula, California 92592

*September 1, 2021*

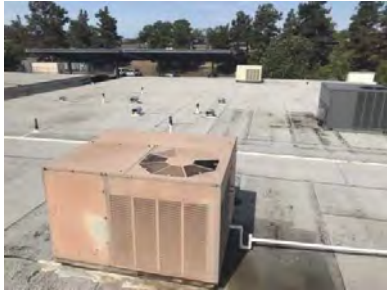
### Roofing in Poor condition.

Modified Bitumen  
Building 24 - Risk Management District Office  
Roof

Roof leaks in portables - AssetCALC ID: 3164586

Uniformat Code: B3015  
Recommendation: **Replace in 2023**

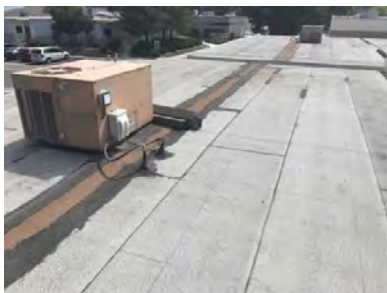
### Roofing in Poor condition.

Modified Bitumen  
Building 15 - Behavioral Health District Office  
Roof

Roof leaks in portables - AssetCALC ID: 3164473

Uniformat Code: B3015  
Recommendation: **Replace in 2023**

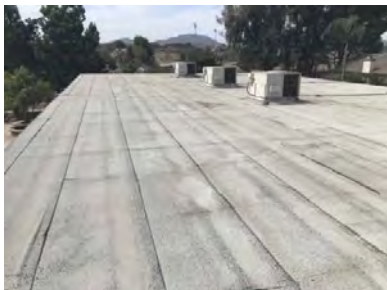
### Roofing in Poor condition.

Modified Bitumen  
Building 14 - Special Education District Office  
Roof

Roof leaks in portables - AssetCALC ID: 3164364

Uniformat Code: B3015  
Recommendation: **Replace in 2023**

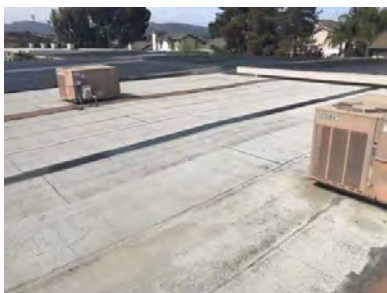
### Roofing in Poor condition.

Modified Bitumen  
Building 16 - Curriculum, Instruction District  
Office Roof

Roof leaks in portables - AssetCALC ID: 3164514

Uniformat Code: B3015  
Recommendation: **Replace in 2023**

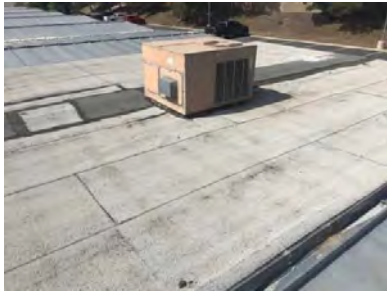
### Roofing in Poor condition.

Modified Bitumen  
Building 21 - HRD District Office Roof

Roof leaks in portables - AssetCALC ID: 3164546

Unifomat Code: B3015  
Recommendation: **Replace in 2023**

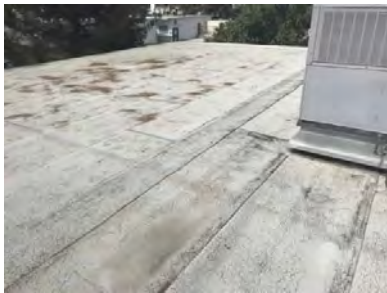
### Roofing in Poor condition.

Modified Bitumen  
Building 25 - IMS District Office Roof

Roof leaks in portables - AssetCALC ID: 3164614

Unifomat Code: B3015  
Recommendation: **Replace in 2023**

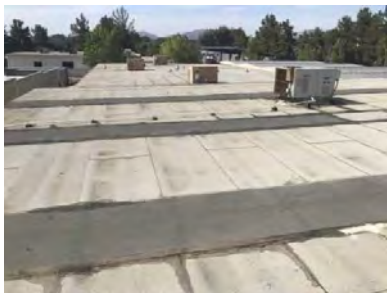
### Roofing in Poor condition.

Modified Bitumen  
Building 22 - Facilities Development District Office Roof

Leaking roofs in portables - AssetCALC ID: 3164569

Unifomat Code: B3015  
Recommendation: **Replace in 2023**

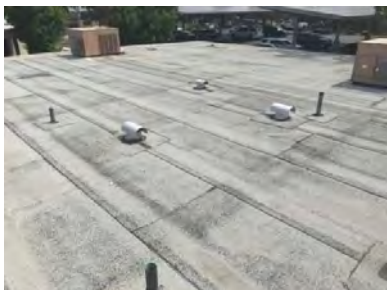
### Roofing in Poor condition.

Modified Bitumen  
Building 12 - Accountability and Assessment District Office Roof

Reports of leaking - AssetCALC ID: 3164300

Unifomat Code: B3015  
Recommendation: **Replace in 2023**

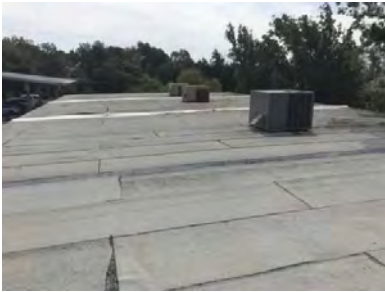
**Roofing in Poor condition.**

Modified Bitumen  
Building 13 - Centralized Enrollment District  
Office Roof

Roof leaks in portables - AssetCALC ID: 3164334

Unifomat Code: B3015  
Recommendation: **Replace in 2023**
