SpotOn Property Inspections, LLC

Your Property Inspection Report

123 Sample Address, Butler, PA 16001
Inspection prepared for: First Name Last Name
Date of Inspection: 6/5/2014 Time: 2pm
Age of Home: Approx. 40 yrs Size: 3 bed / 1.5 bath
Weather: 68 degrees / sunny
Buyers and their agent were present for the inspection.

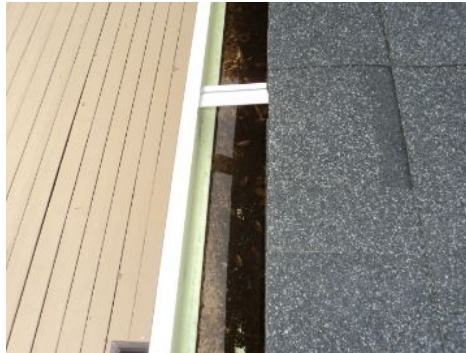
- The gutter on the rear of the house is low in the middle causing water to collect and not run to the end and drain properly. Repair is recommended.

The gutter on the rear of the house is low in the middle causing water to collect and not run to the end and drain properly. Repair is recommended.

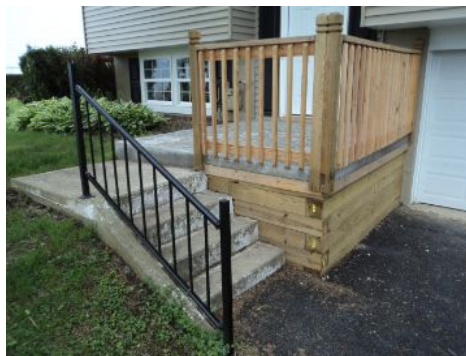
Front steps, new landing, and new retaining wall with railing.

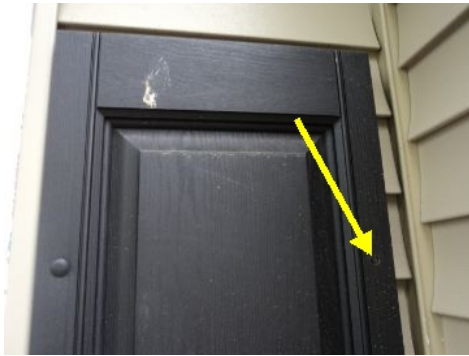
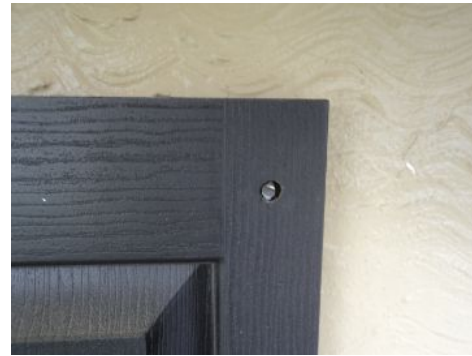
The shutter to the right of the front door and to the right of the lower front window are slightly loose from the cap of the fastener coming off. Monitor and repair if necessary.

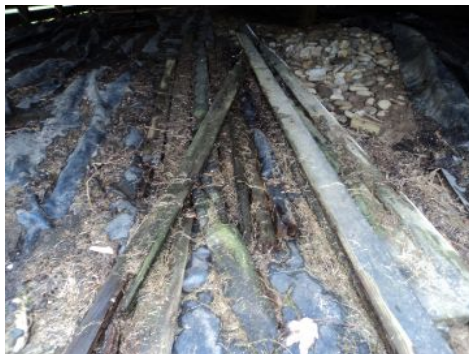
Old boards and wood scraps were noted under the back deck. It's recommended to keep this area clean as this is a prime location for wood destroying insects to enter the property.

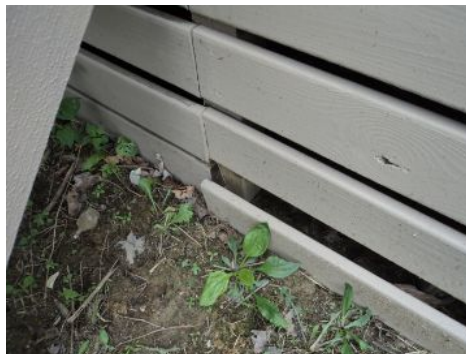
A board was separated from the post which may be a trip hazard and/or an entry point for pest. Repair is recommended.

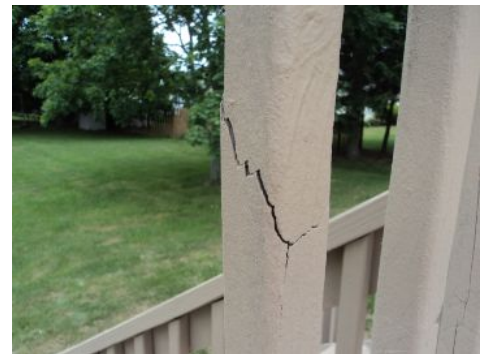
There was 1 broken spindle and 2 cracked spindles on the back deck. For safety reasons repair is recommended.

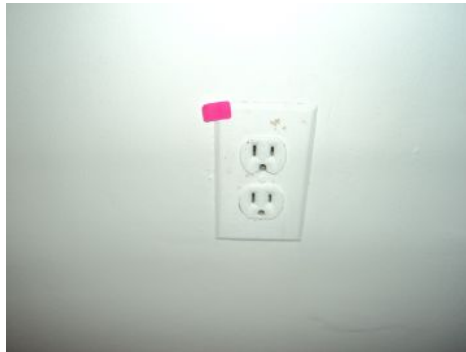
A hot-neutral reversed outlet was present in the garage to the left of the door walking in. It's marked with a pink sticker. This means that the black and white wires in the circuit have been reversed, and may be a concern with items such as computers and electronic devices. Recommend repair.

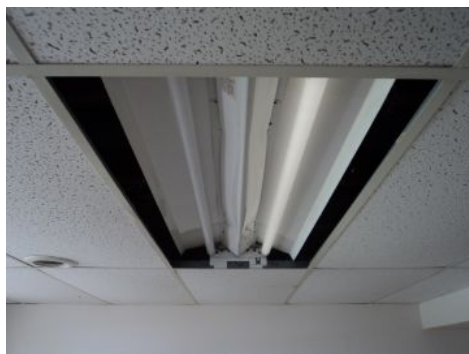
The light fixture in the basement is missing the cover. Adding one is recommended.

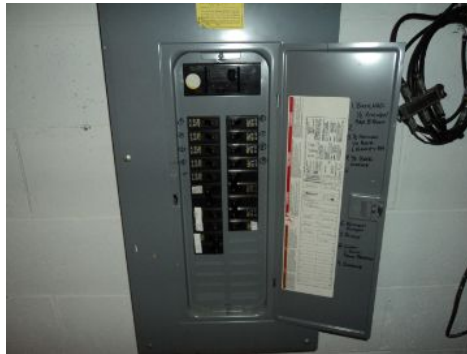
Main panel - Location in the garage.

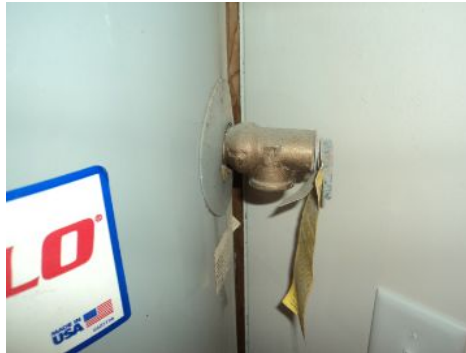
Temperature – Pressure drain line is missing. One should be installed to terminate within six inches of the floor to minimize personal injury which may be caused by scalding water, in the event of a pressure blow-off.

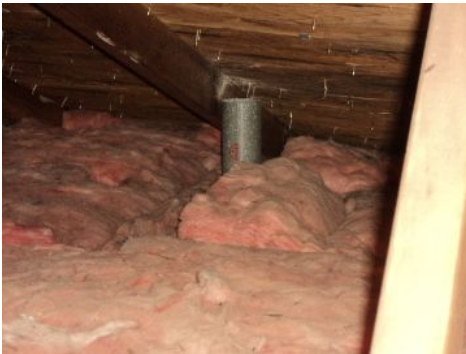
Exhaust fan duct from the main bathroom appears to terminate in attic. Have duct routed to exterior to minimize moisture and possible development of mold.

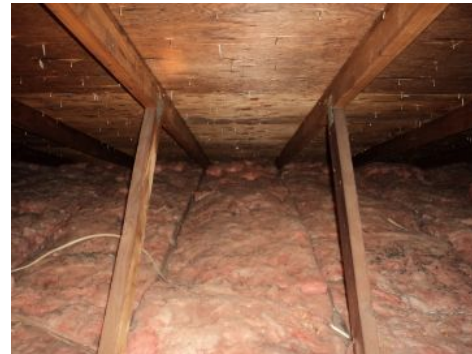
The insulation was installed the whole way in to the eaves which minimizes the air flow from the soffit vents. Repair may be necessary to provide proper ventilation to the attic.

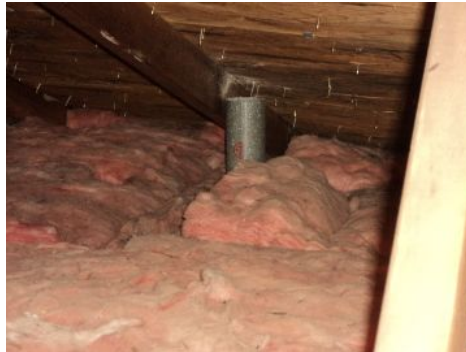
Page 16 Item: 1 Attic

Exhaust fan duct from the main bathroom appears to terminate in attic. Have duct routed to exterior to minimize moisture and possible development of mold.
