120 Volt Household Current Testing on Corrugated Stainless-Steel Tubing Types and Schedule 40 Black Iron Gas Piping.

Prepared For: National Association of State Fire Marshals
PO Box 948238
Maitland, FL 32794

February 16, 2018

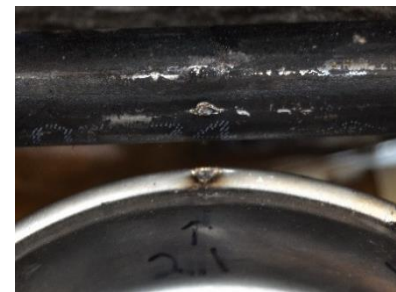
Figure 18 Result of Test 2.1.

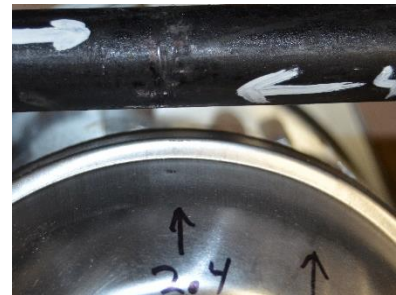
Figure 19 Results of Test 2.4.

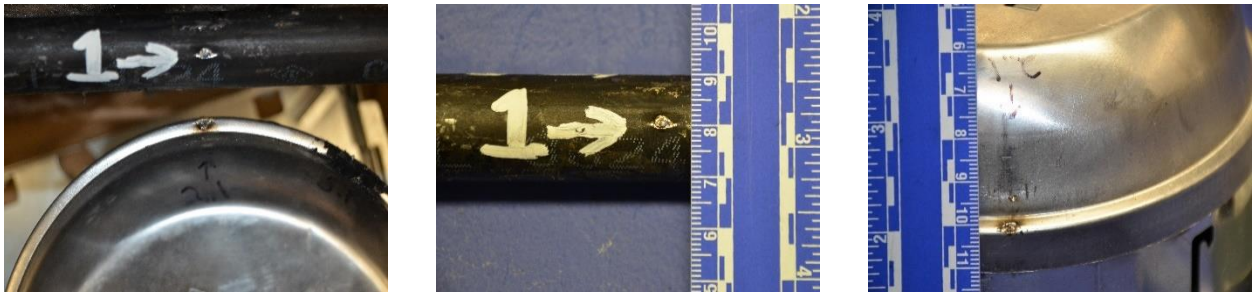
Figure 20 Test 2.1 post-test damage.

When the light switch was turned ON, an arc occurred between the light fixture housing and the gas pipe. The circuit breaker did trip, de-energizing the circuit without perforating the gas pipe. The recessed light fixture's metal housing sustained minor surface damage in the form of a small arc mark, accompanied by localized discoloration. The black iron pipe also sustained a corresponding arc mark.

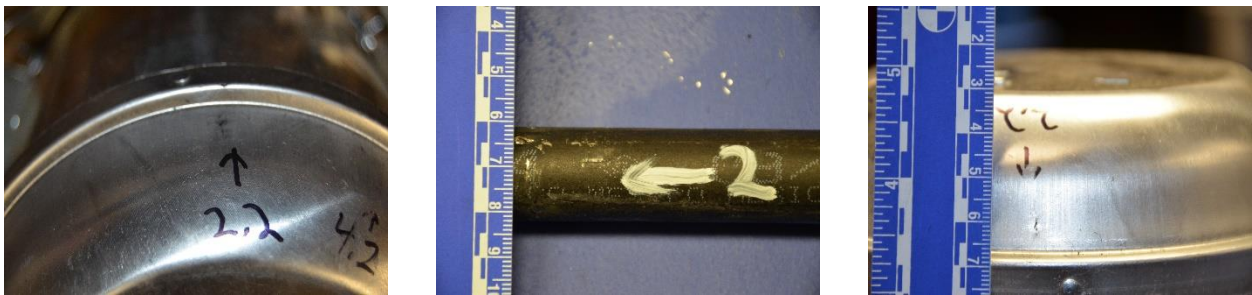
Figure 21 Test 2.2 post-test damage.

When the light switch was turned ON, an arc occurred between the light fixture housing and the gas pipe. The circuit breaker did trip, de-energizing the circuit without perforating the gas pipe. The recessed light fixture's metal housing sustained minor surface damage in the form of a small arc mark, accompanied by localized discoloration. The black iron pipe also sustained a corresponding arc mark.

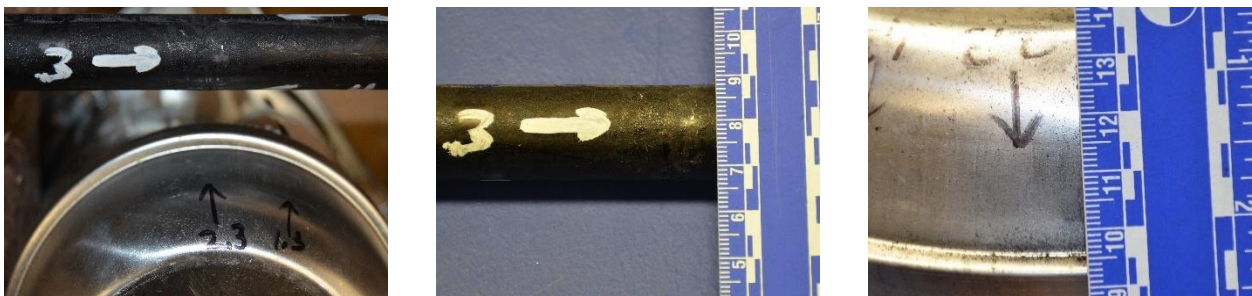
Figure 22 Test 2.3 post-test damage.

When the light switch was turned ON, an arc occurred between the light fixture housing and the gas pipe. The circuit breaker did trip, de-energizing the circuit without perforating the gas pipe. The recessed light fixture's metal housing sustained minor surface damage in the form of a small arc mark, accompanied by localized discoloration. The black iron pipe also sustained a corresponding arc mark.

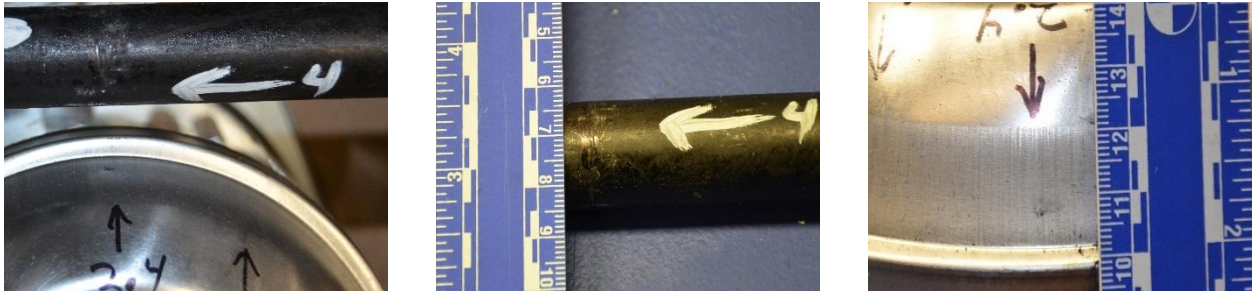
Figure 23 Test 2.4 post-test damage.

When the light switch was turned ON, an arc occurred between the light fixture housing and the gas pipe. The circuit breaker did trip, de-energizing the circuit without perforating the gas pipe. The recessed light fixture's metal housing sustained minor surface damage in the form of a small arc mark, accompanied by localized discoloration. The black iron pipe also sustained a corresponding arc mark.

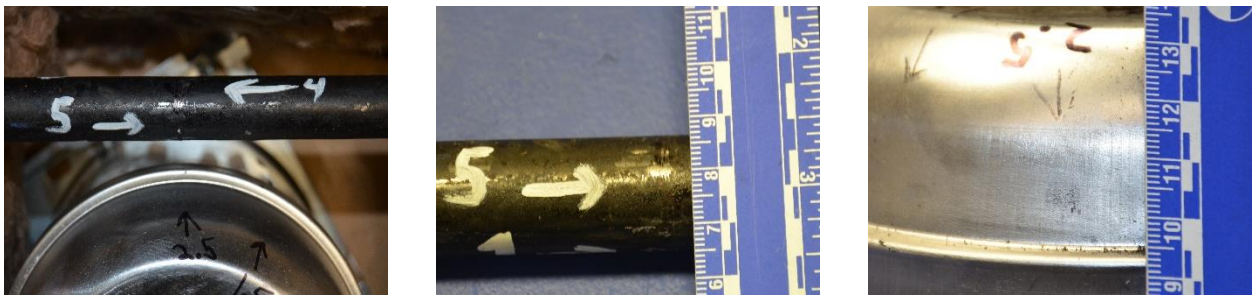
Figure 24 Test 2.5 post-test damage.

When the light switch was turned ON, an arc occurred between the light fixture housing and the gas pipe. The circuit breaker did trip, de-energizing the circuit without perforating the gas pipe. The recessed light fixture's metal housing sustained minor surface damage in the form of a small arc mark, accompanied by localized discoloration. The black iron pipe also sustained a corresponding arc mark.

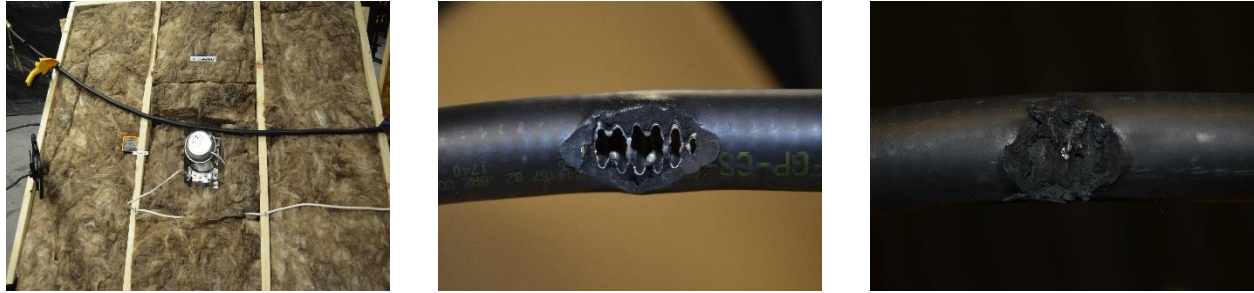
Figure 25 Test series 3 in place (left). Range of damage incurred to CounterStrike® CSST across test series 3 (center & right).

When energized, arcing occurred between the gas pipe’s outer jacket and the recessed light housing. The circuit faulted and tripped the circuit breaker. Both the recessed light fixture’s housing and the CounterStrike® CSST sustained damage. The damage varied, from perforations spanning approximately 6 corrugations in length, to unperforated pits on both the CSST and the light fixture.

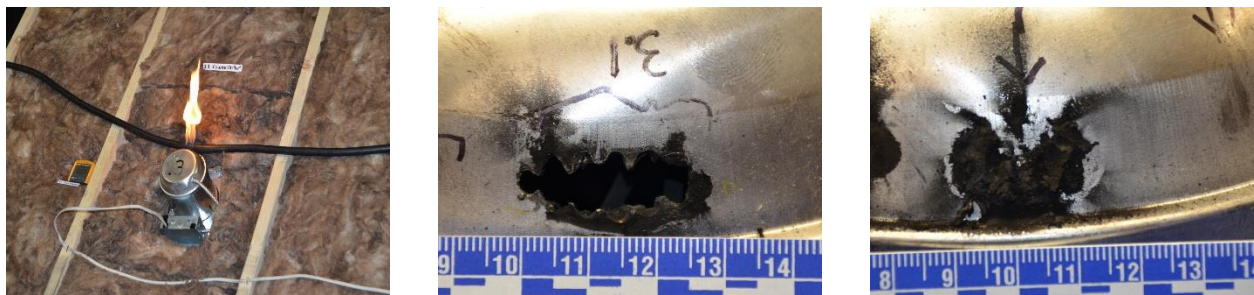
Figure 26 Example of fire resulting during test series 3 (left). Range of damage incurred to light fixtures across test series 3 (center & right).

Fires resulted in 4 out of 5 tests within this series.

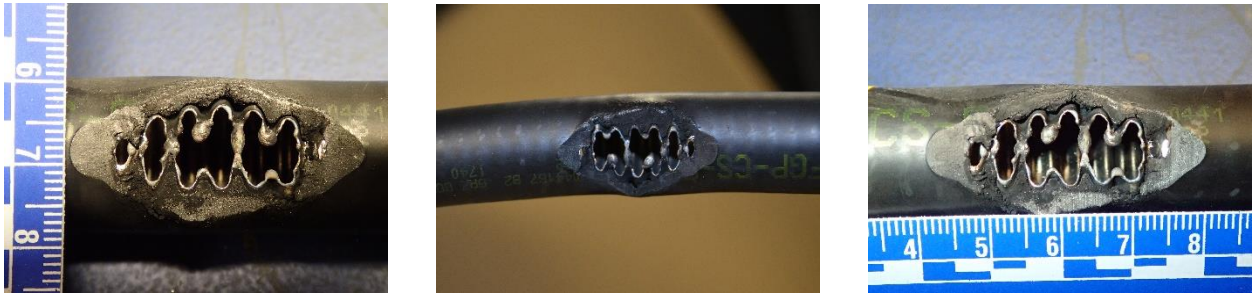
Figure 27 Damage to CounterStrike® CSST in test 3.1.

The CounterStrike® CSST gas pipe sustained similar damage. The perforations span approximately 6 corrugations in length.

Perforations did occur in both the light fixture's metal housing and the CounterStrike® CSST gas pipe.

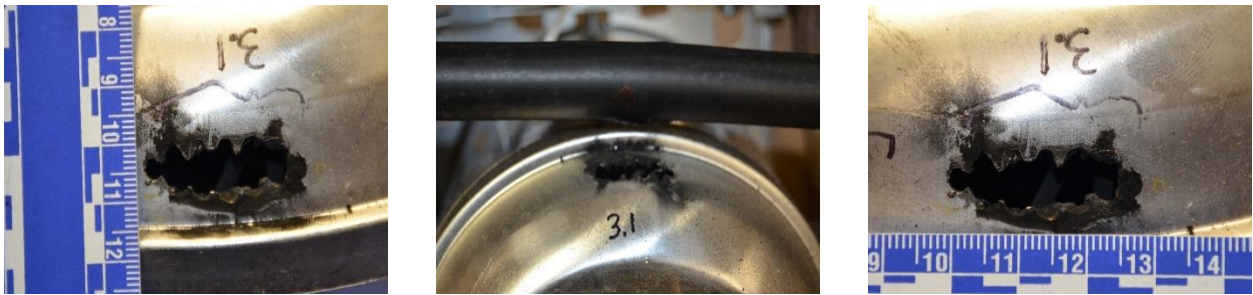
Figure 28 Damage to light fixture in test 3.1.

The recessed light fixture's metal housing sustained damage, leaving a hole matching the corrugations of the CSST gas pipe. The perforations span approximately 6 corrugations in length.

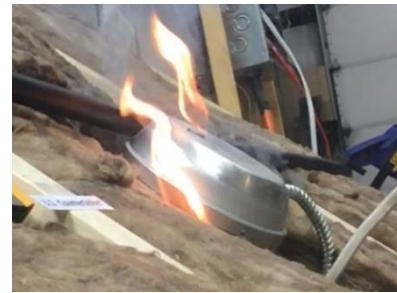
Figure 29 Test 3.1 fire.

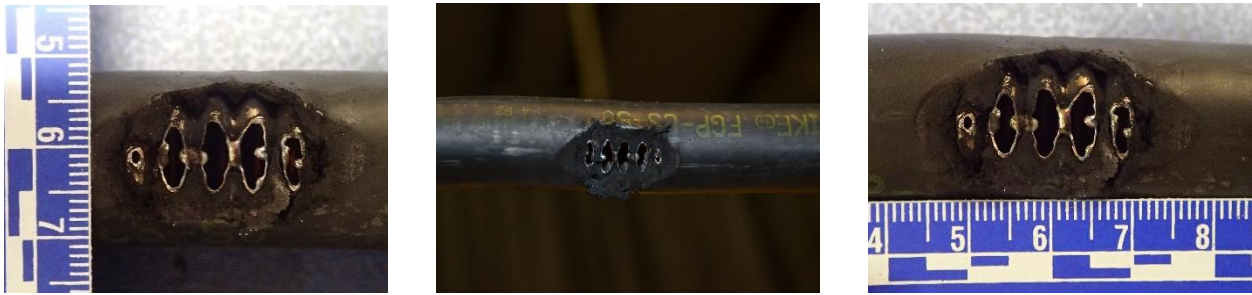
Figure 30 Damage to CounterStrike® CSST in test 3.2.

The CounterStrike® CSST gas pipe sustained damage. The perforations span approximately 5 corrugations.

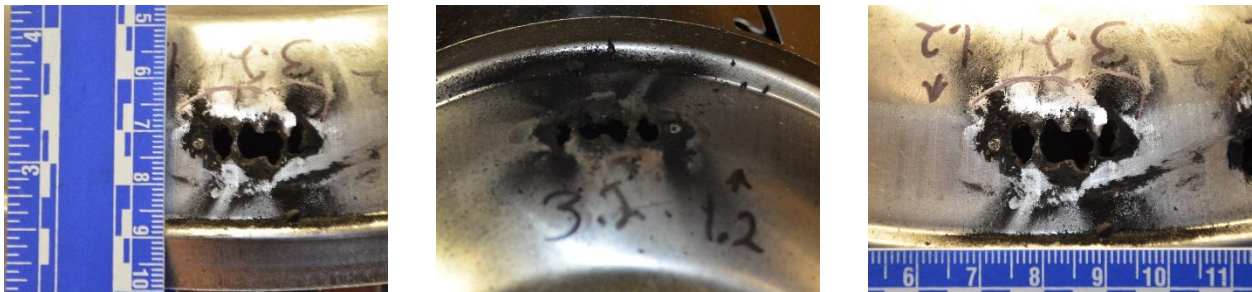
Figure 31 Damage to light fixture in test 3.2.

The recessed light fixture's metal housing sustained damage, leaving a series of holes matching the corrugations of the CSST gas pipe. The damage spans approximately 5 corrugations.

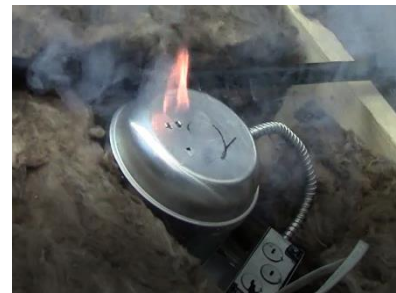
Figure 32 Test 3.2 fire.

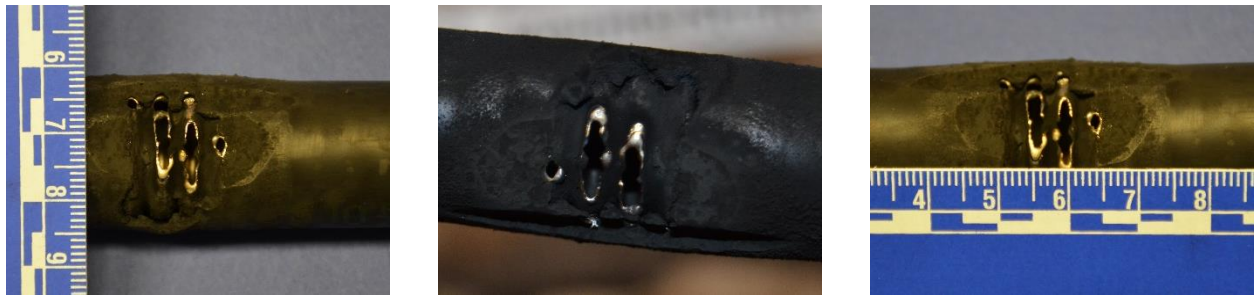
Figure 33 Damage to CounterStrike® CSST in test 3.3.

The CounterStrike® CSST gas pipe sustained damage. The perforations span approximately 3 corrugations.

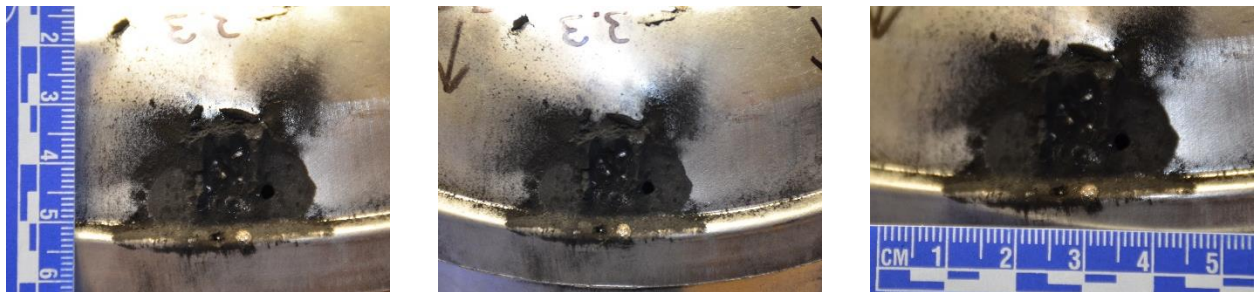
Figure 34 Damage to light fixture in test 3.3.

The recessed light fixture's metal housing sustained damage, leaving a damaged area that matched the corrugations of the CSST gas pipe, and these holes span approximately 3 corrugations.

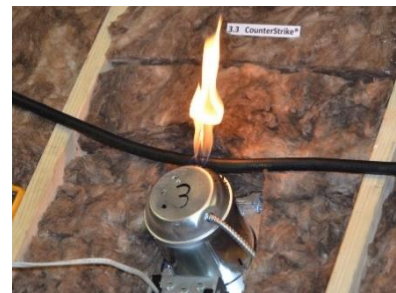
A fire did result.

Figure 35 Fire resulting from test 3.3.

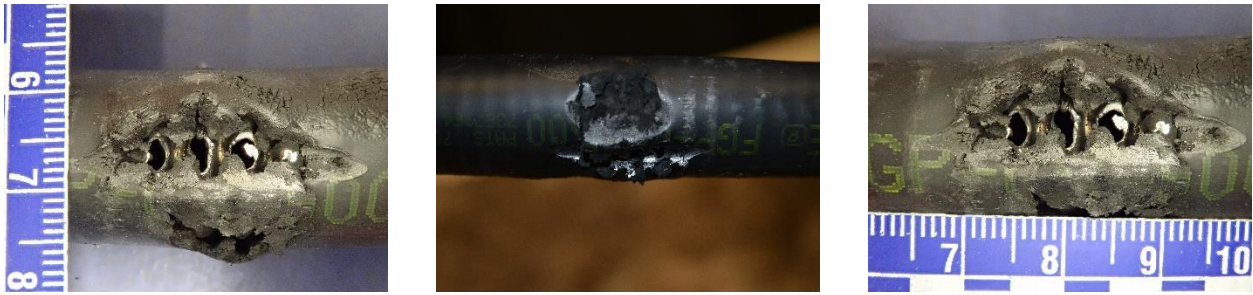
Figure 36 Damage to CounterStrike® CSST in test 3.4.

The CounterStrike® CSST gas pipe sustained similar damage. The perforations span approximately 4 corrugations in length.

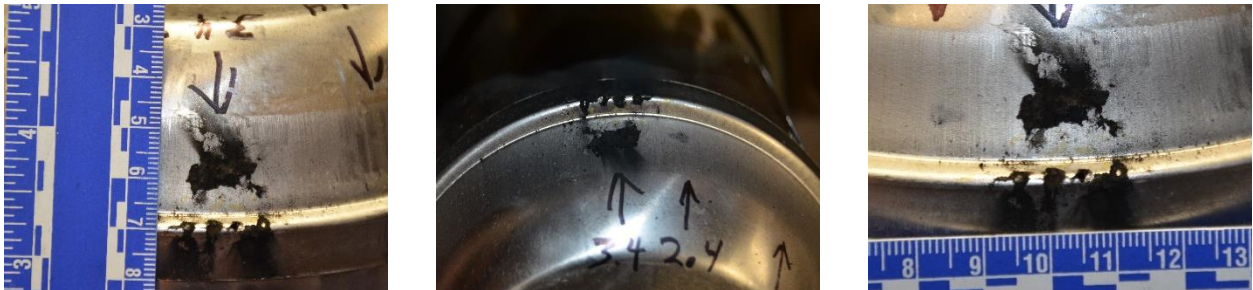
Figure 37 Damage to light fixture in test 3.4.

The recessed light fixture's metal housing sustained damage, leaving a series of holes matching the corrugations of the CSST gas pipe, and these holes span approximately 4 corrugations in length.

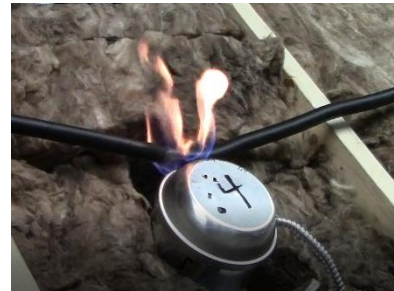
A fire did result.

Figure 38 Test 3.4 fire.

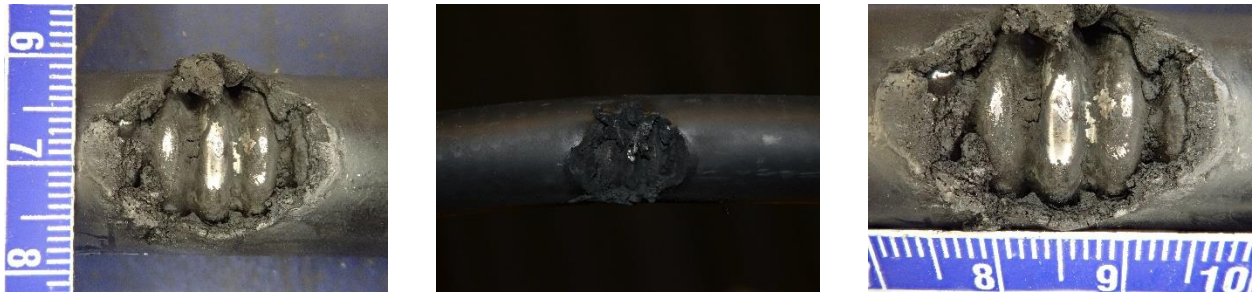
Figure 39 Damage to CounterStrike® CSST in test 3.5.

The CounterStrike® CSST gas pipe sustained damage to its conductive outer jacket. Within the area of material loss, there was a small arc mark on the underlying stainless-steel tubing.

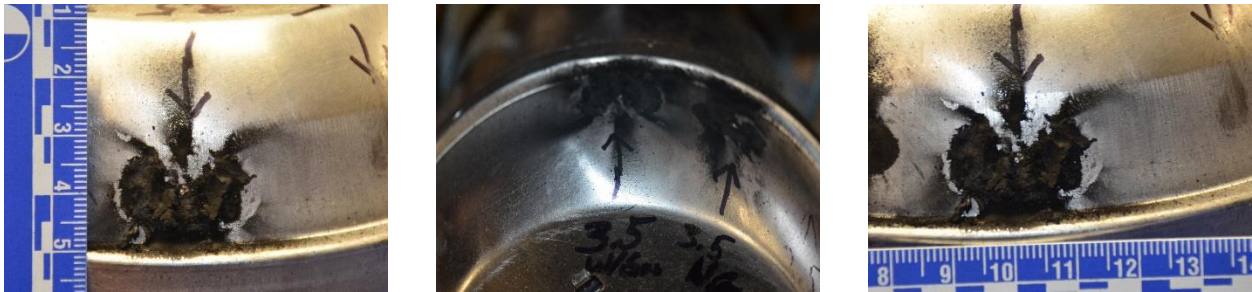
Figure 40 Damage to light fixture in test 3.5.

The recessed light fixture's metal housing did sustain damage. There was an accumulation of soot build-up, and a small pit in the fixture's metal housing.

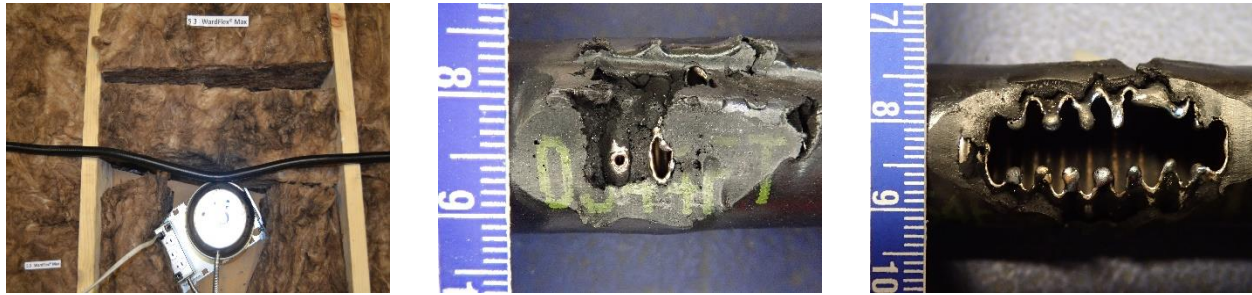
Figure 48 Test series 5 in place (left). Range of damage to WARDFlex® Max CSST in series 5 testing (center & right).

When energized, arcing occurred between the gas pipe and light fixture's metal housing. The circuit faulted and tripped the circuit breaker. Both the recessed light fixture's housing and the WARDFlex® Max CSST sustained damage. The perforations ranged in damage from approximately 3 to 11 corrugations.

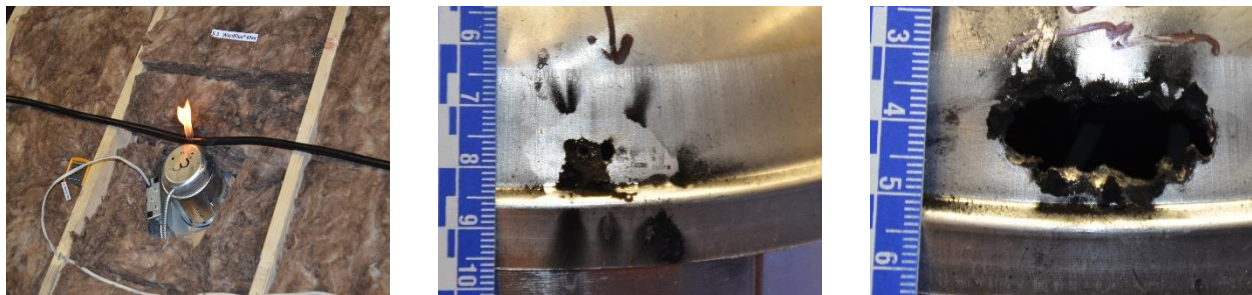
Figure 49 Example of fire resulting in test series 5 (left). Range of damage to light fixtures in series 5 testing (center & right).

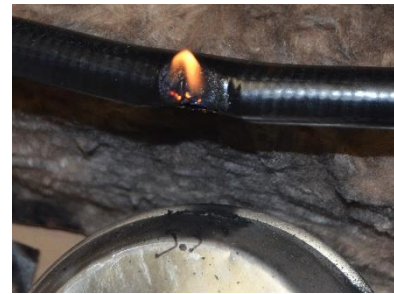
Figure 50 WARDFlex® Max CSST outer jacket burning without gas.

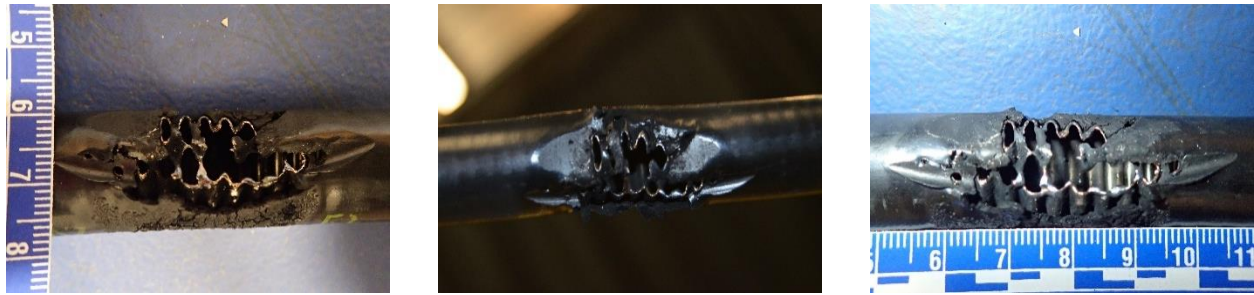
Figure 51 Damage to WARDFlex® Max CSST in test 5.1.

The WARDFlex® Max CSST gas pipe sustained damage. The perforations stretched approximately 11 corrugations.

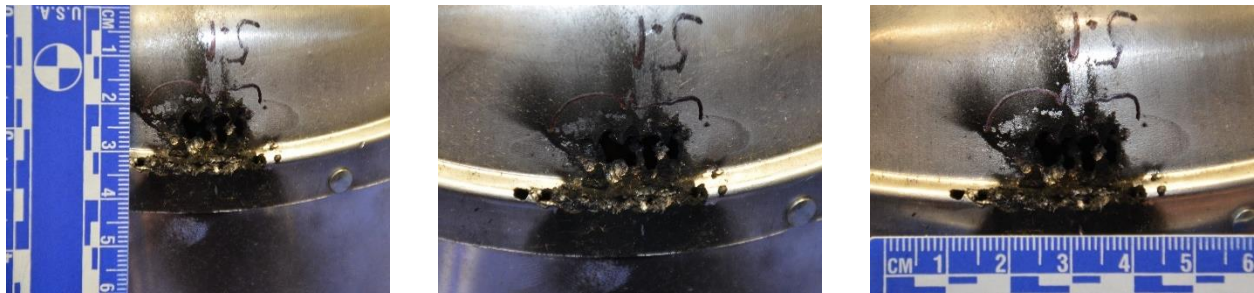
Figure 52 Damage to light fixture in test 5.1.

The recessed light fixture's metal housing sustained damage, leaving a series of holes matching the corrugations of the CSST gas pipe. The damage stretched approximately 11 corrugations in length.

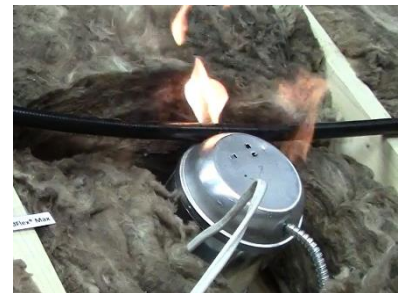
A fire did result.

Figure 53 Test 5.1 fire.

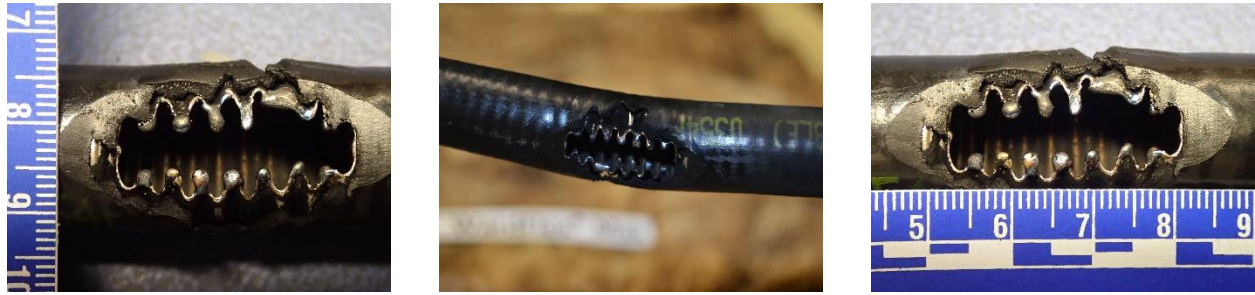
Figure 54 Damage to WARDFlex® Max CSST in test 5.2.

The WARDFlex® Max CSST gas pipe sustained damage. The perforations stretched approximately 9 corrugations in length.

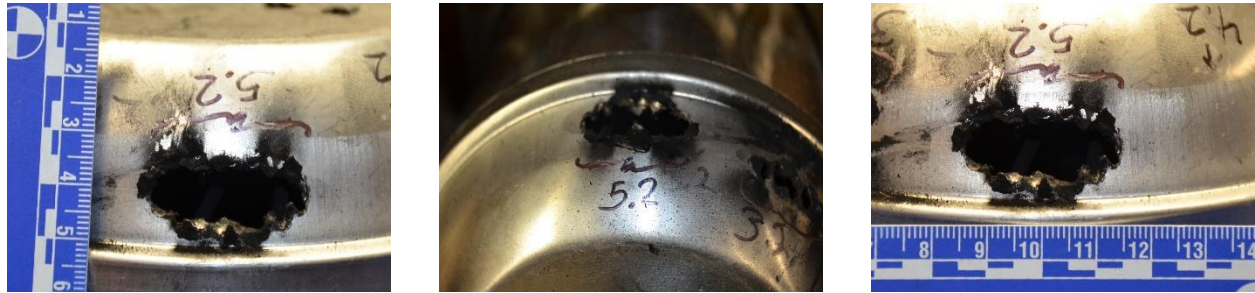
Figure 55 Damage to light fixture in test 5.2.

The recessed light fixture's metal housing sustained damage, leaving a series of holes matching the corrugations of the CSST gas pipe. The damage stretched approximately 9 corrugations in length.

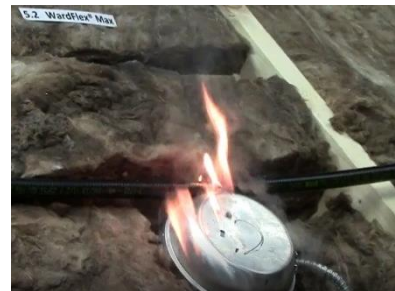
A fire did result.

Figure 56 Test 5.2 fire.

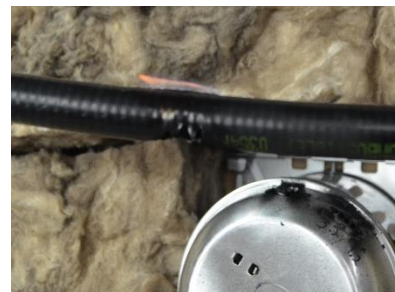
Figure 57 WARDFlex® Max outer jacket burning with gas turned off.

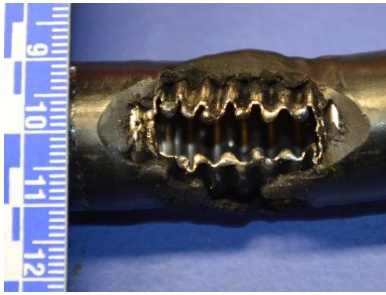
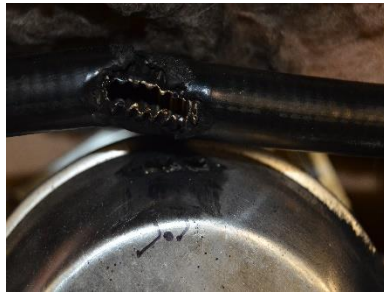
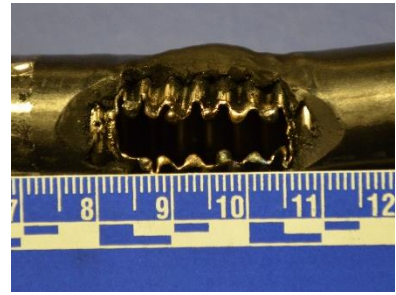
Figure 58 Damage to WARDFlex® Max CSST in test 5.3.

The WARDFlex® Max CSST gas pipe sustained damage. The perforations stretched approximately 7 corrugations in length.

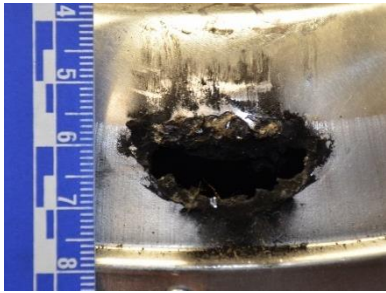
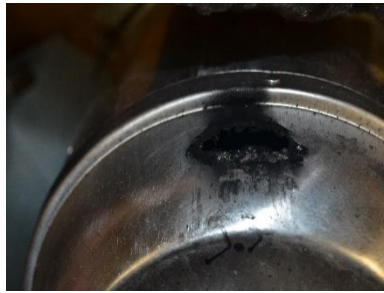
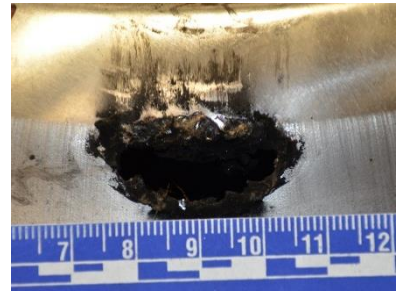
Figure 59 Damage to light fixture in test 5.3.

The recessed light fixture's metal housing sustained damage, leaving a series of holes matching the corrugations of the CSST gas pipe. The damage stretched approximately 7 corrugations in length.

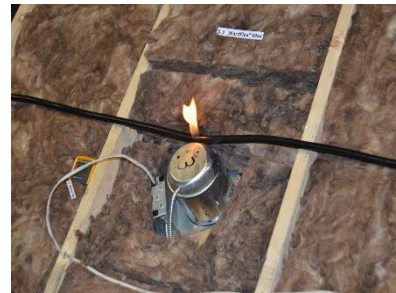
A fire did result.

Figure 60 Fire resulting from test 5.3.

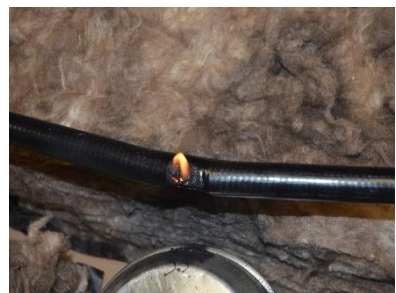
Figure 61 WARDFlex® Max outer jacket burning with gas turned off.

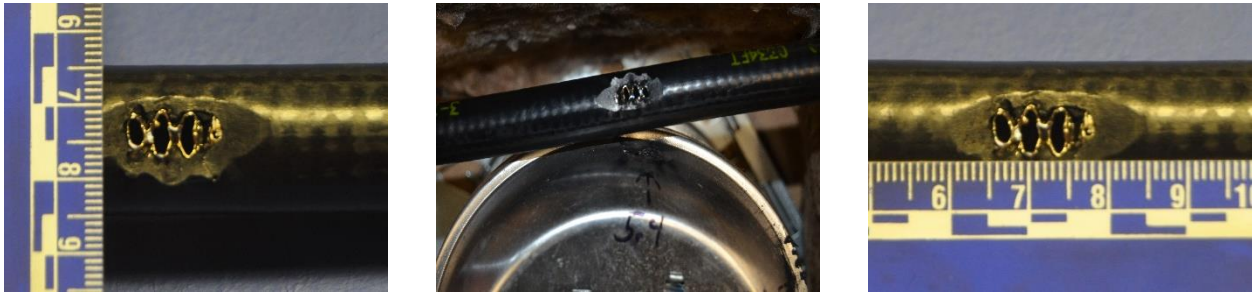
Figure 62 Damage to WARDFlex® Max CSST in test 5.4.

The WARDFlex® Max CSST gas pipe sustained damage. The perforations stretched approximately 4 corrugations in length.

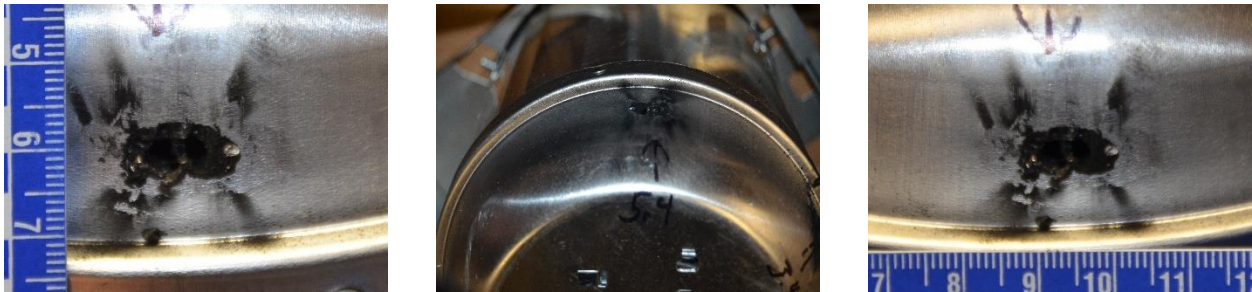
Figure 63 Damage to light fixture in test 5.4.

The recessed light fixture's metal housing sustained damage, leaving a series of holes matching the corrugations of the CSST gas pipe. The damage stretched approximately 4 corrugations in length.

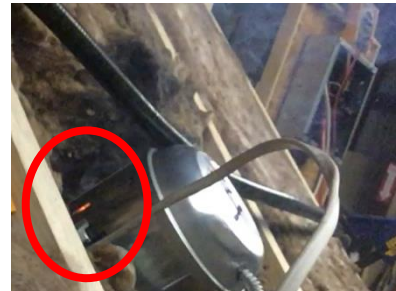
A fire did result.

Figure 64 Test 5.4 fire, inside the light fixture's housing.

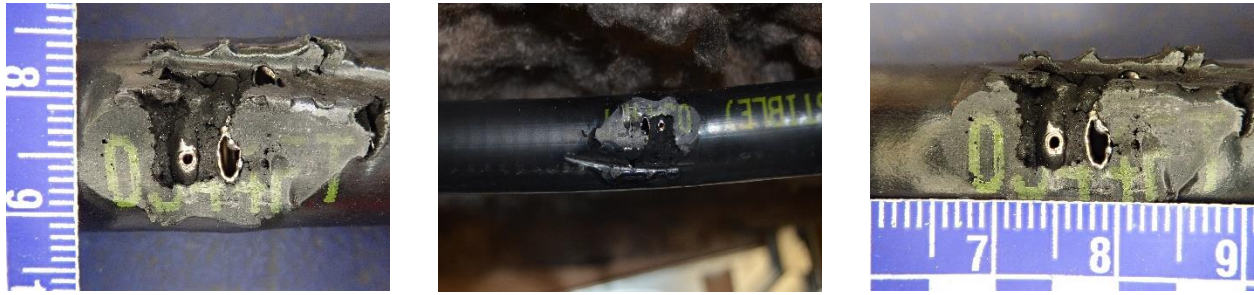
Figure 65 Damage to WARDFlex® Max CSST in test 5.5.

The WARDFlex® Max CSST gas pipe sustained damage. The perforations stretched approximately 3 corrugations in length.

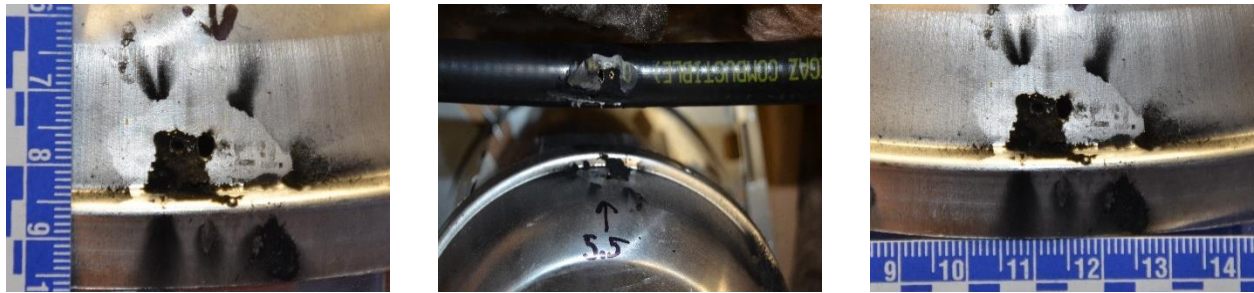
Figure 66 Damage to light fixture in test 5.5.

The recessed light fixture's metal housing sustained damage, leaving a series of holes matching the corrugations of the CSST gas pipe. The damage stretched approximately 3 corrugations in length.

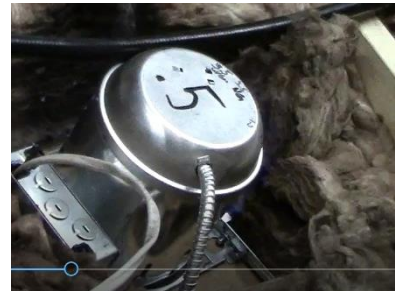
A fire did result with flame inside the recessed light's housing.

Figure 67 Test 5.5 escaping gas sustained burning on the inside of the recessed light's fixture's housing.
