TECHNICAL REPORT

MACHINE MAKE:	XXXXX	REPORT DATE:	23 rd July 2012
MODEL:	XXXXXX	LOCATION:	Hoopstad
INSURED:	XXXXX	CLAIM / POL No:	XXXXX
INSURER:	XXXXX	CONTACT:	XXXXX

As you are aware, I travelled to the premises of the Insured in Hoopstad to examine the above mentioned combined harvester with a view to establishing the cause of the fire broke out on the right hand side of the machine whilst in operation.

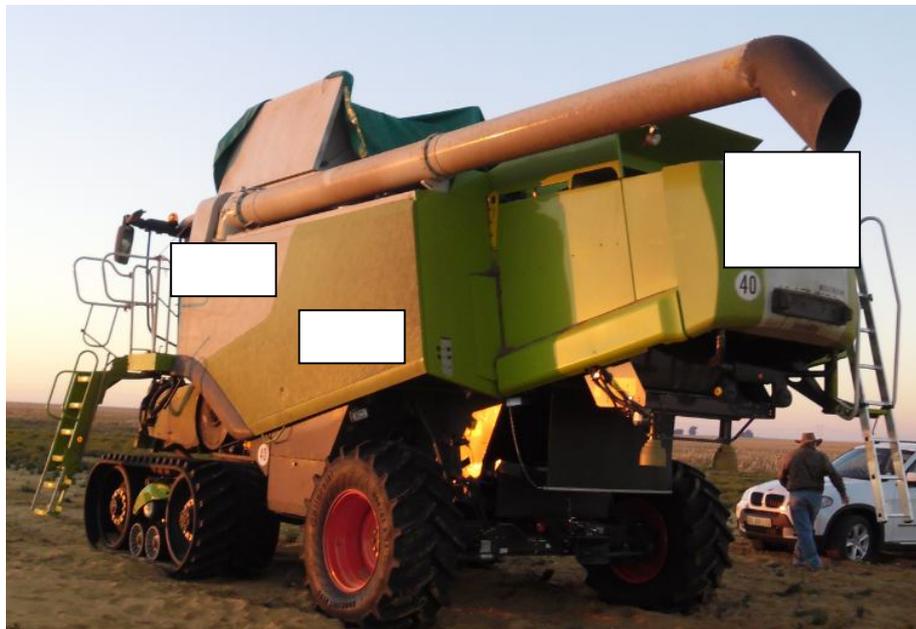
The machine as it stood on the premises of the Insured in Hoopstad

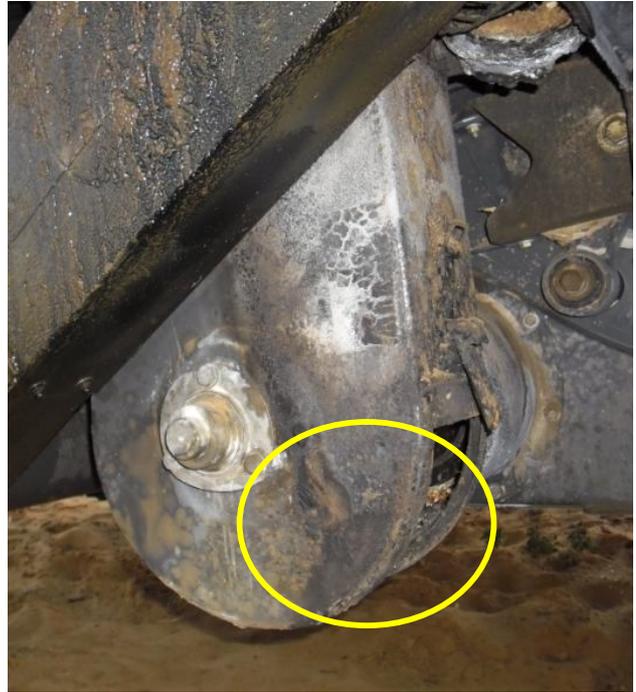
There was light thermal damage caused to many of the components that are mounted close to the grain elevator chute. The chute itself suffered severe thermal damage in its lower sections as can be seen here to the right.

Note the dark spread marks made by the combustion gases.

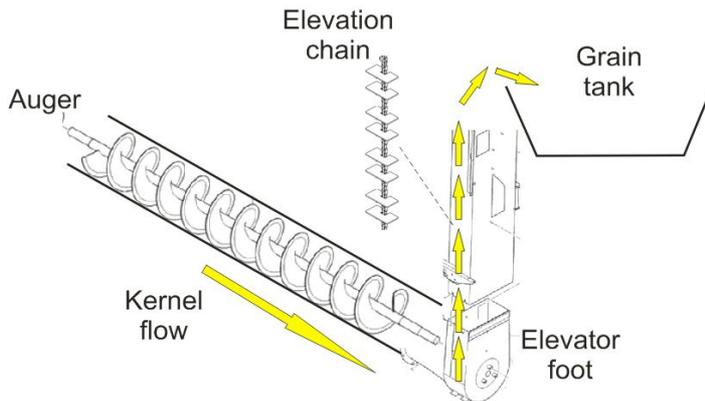
In order to understand how the fire started, you have to understand the process taking place in what is known as the elevator foot.

After being stripped in the processing plant, the corn kernels drop down into a tube that contains an auger, a large screw that feeds them along to the elevator foot.

In the elevator foot, a chain rotates with elevating paddles attached, these paddles lift the kernels carrying them up the chute and throwing them into the grain tank.

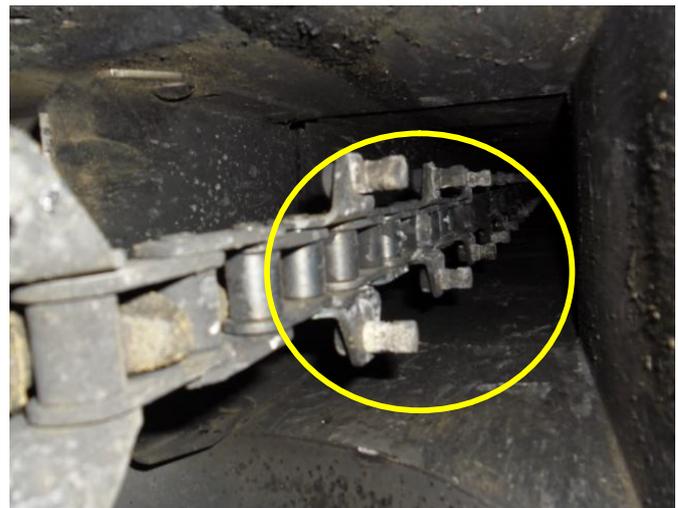
The first thing to be seen inside the elevator chute housing was that all of the paddles were missing from the chain; they appeared to have been burnt or broken off as can be seen here in the photo to the right.

The chain was damaged all along its length, which takes it up to the grain tank and back down again.

The chain was stationary when the fire was noticed yet the damage and discoloration is uniform over the length of the chain.

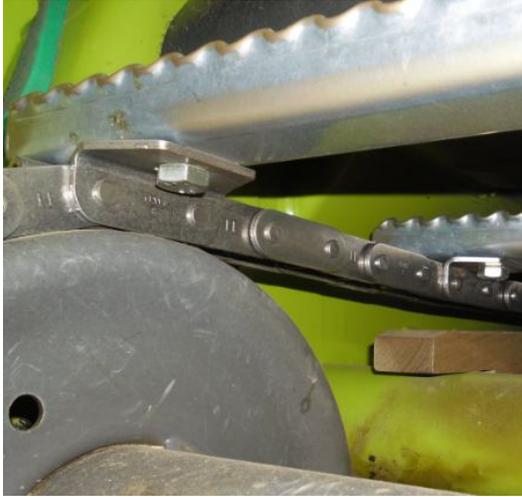
Drive chain at front of machine

Whilst examining the rest of the machine, I noticed that the chains driving sections of the processing plant at the front were all very clean, stainless steel chains, and I had noticed that the elevator chain was badly tarnished.

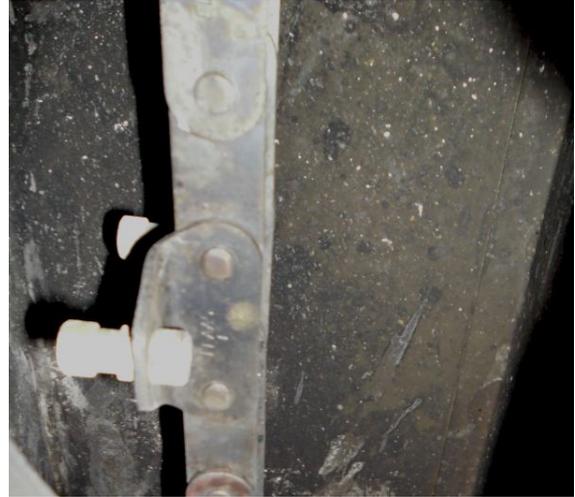
Elevator drive chain

This prompted me to examine the elevator chain more thoroughly, which revealed that the discoloration is in fact the slight tint of blue that appears as the metal is heated and is caused by a very small layer of oxidization on the surface of the chain.

Along its whole length it was varying colours of blue, a closer examination of the chain revealed that the blue was in fact due to the heat the entire chain had reached, not just normal charring from the fire.

There is not enough thermal damage to the rest of the components that are in the vicinity of the chain for it all to have been heated to a temperature in excess of 300° C by an open flame fire. I deduced the chain must be part of a situation where a tremendous amount of friction was being generated.

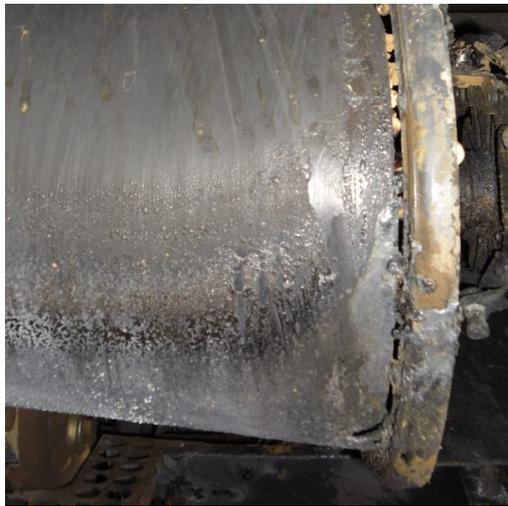
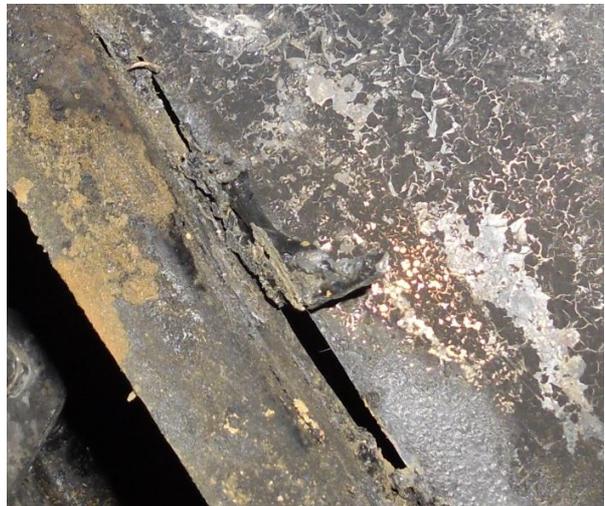
Bottom of auger tube

The damage to the bottom of the auger tube appeared at first glance to be a crack caused in the fire, if we look closely, it is the metal actually worn right through around the edge that mates with the elevator foot.

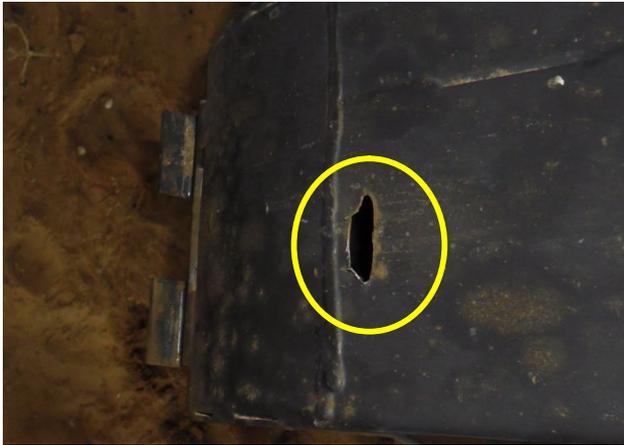
Similarly, the elevator foot itself has also worn a hole through the side of its housing. There appears to be a problem with the ratio between the amounts of product coming from the auger to how much the elevator paddles can lift which is causing a bottle neck which is resulting in a build-up of friction between the kernels, the auger and the elevator chain and its paddles.

Hole in elevator foot housing

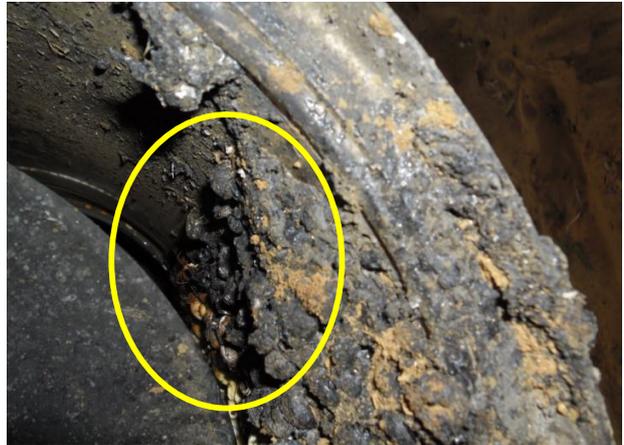
Kernels that have ignited towards the end of the auger tube

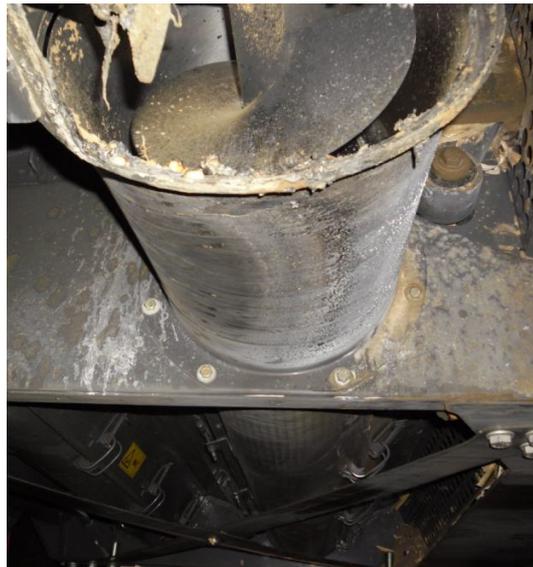
The end of the auger tube underneath

The effect of this build-up of heat in this area can be seen both inside the machine and outside. Inside, apart from the elevator chain and its components that have been damaged, the final scroll of the auger can be seen to have also suffered from excessive heat build-up. He outside of the auger tube shows clearly that the fire emanated from within this section of the machine. The thermal effect on the paint could not have been caused any other way.

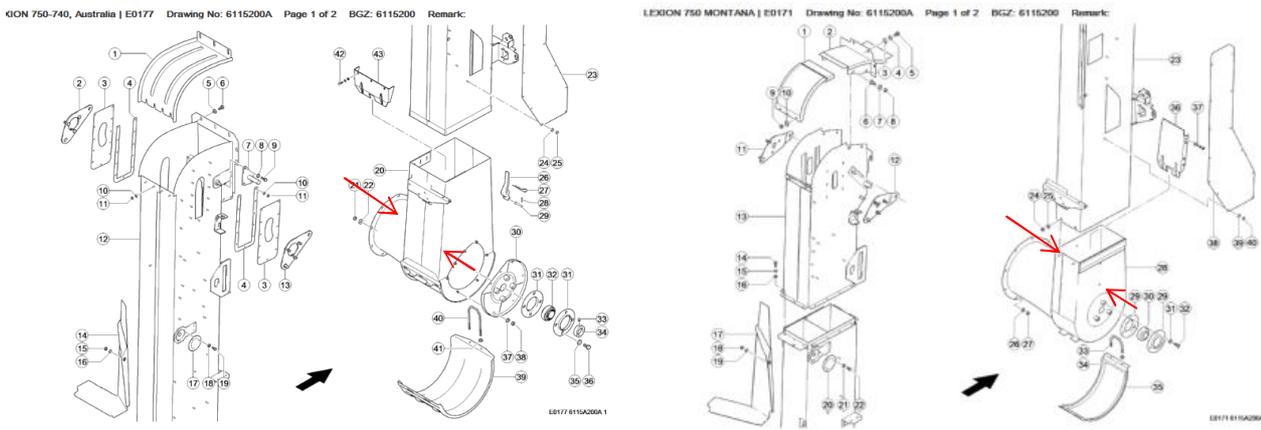
What I did find interesting when researching information on this machine is that there are at least two different models, there is the XXXXX Australia and the XXXXX Montana. The most notable difference as far as we are concerned is that the "Australia" has a much higher capacity grain elevating system than the "Montana"

The drawing from the XXXXX parts catalogue shows the difference between the two, the insured's machine is the same as the narrower one on the right. The two sets of arrows are the same distance apart.
