## TECHNICAL REPORT – ACCIDENT DAMAGE

<b>VEHICLE MAKE:</b>	Volvo	<b>REPORT DATE:</b>	24 <sup>th</sup> July 2015
<b>VEHICLE REG:</b>	XXXXXXXXXX	<b>TRAILER:</b>	XXXXXXXXXX
<b>INSURED:</b>	XXXXXXXXXX	<b>LOCATION:</b>	Hermans Centurion
<b>INSURER:</b>	XXXXXXXXXX	<b>CONTACT:</b>	XXXXXXXXXX
<b>CLAIM / POL No:</b>	XXXXXXXXXX	<b>DATE OF APP:</b>	23 <sup>rd</sup> July 2015

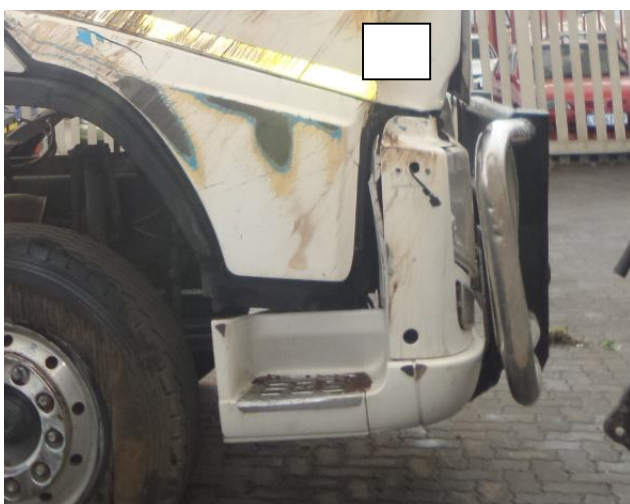
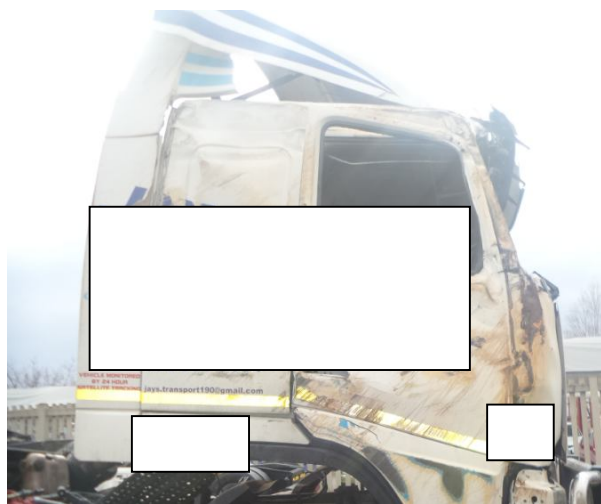
The truck tractor has suffered substantial damage to the right side of the cab from its contact with the ground.

If this were the only damage to the vehicle, it would be a close call as to whether or not it is economically repairable.

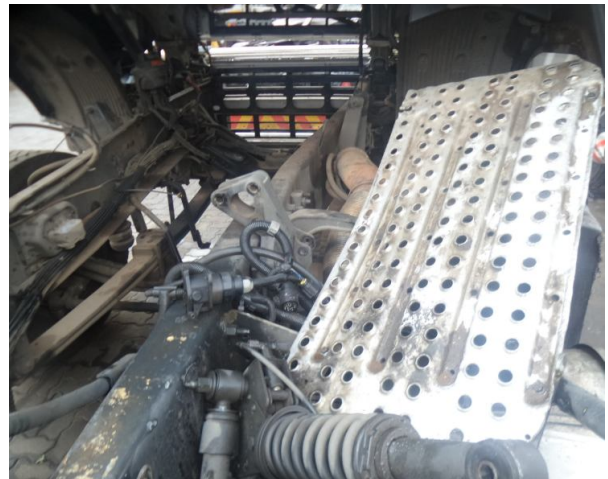
However, as can be seen to the right, as the engine had carried on running whilst the vehicle was lying on its side, the engine had been removed for a detailed strip and quote and although I have not seen the quotation, I was informed by Herman's that there is a substantial amount of bearing and crankshaft damage, which without a doubt renders the vehicle a total loss.

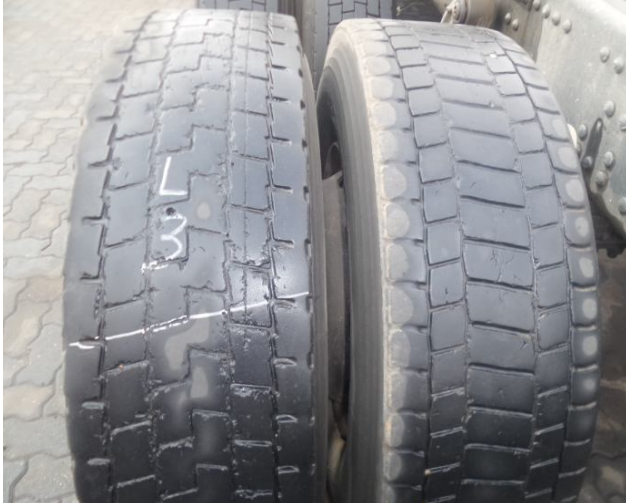
One tyre, that being the outer tyre on axle 3 left on the truck tractor, was worn down and would have needed imminent replacement, but was still in a roadworthy condition. None of the remaining tyres on the vehicle presented any problems with regards to roadworthiness; all had adequate tread life remaining and were free from any cuts or abrasions.

Axle 3 left – outer tyre worn / imminent replacement needed

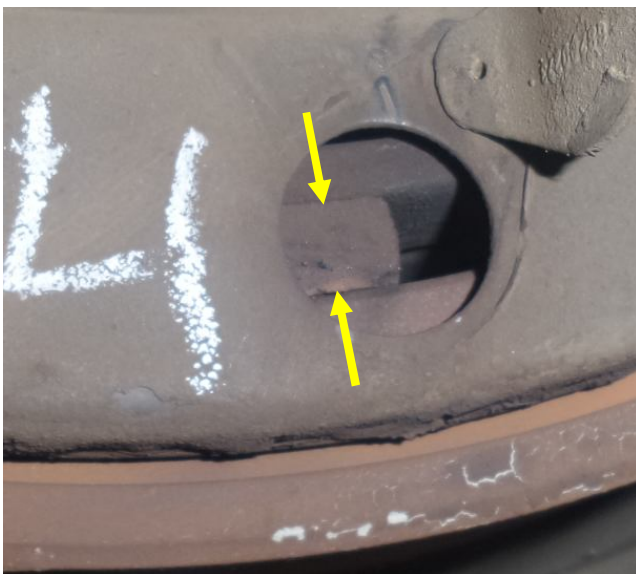
Axle 1 left – adequate linings

The brake linings and drums of axle 1 appeared to be in good condition, linings thickness is more than adequate, the only concern being that the bright orange appearance indicating operation at temperatures above the brake assembly’s norm.

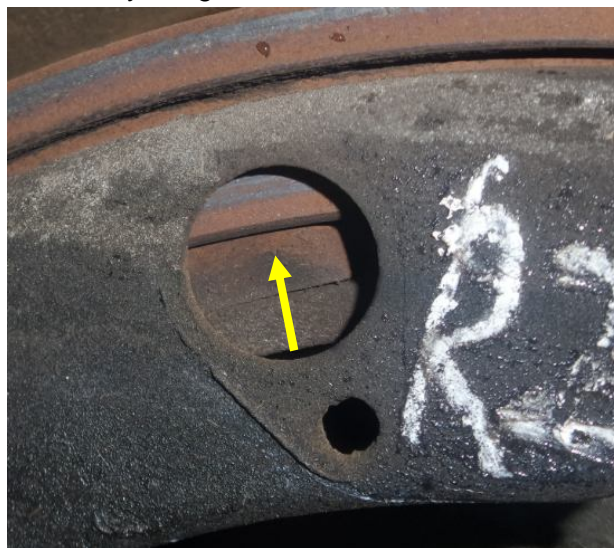
Axle 2 right – adequate linings though overheated

The change of colour of the brake lining itself as highlighted in the photo above right is typical of all the linings on the truck tractor and is a further indication of the brakes reaching higher than normal operating temperatures.

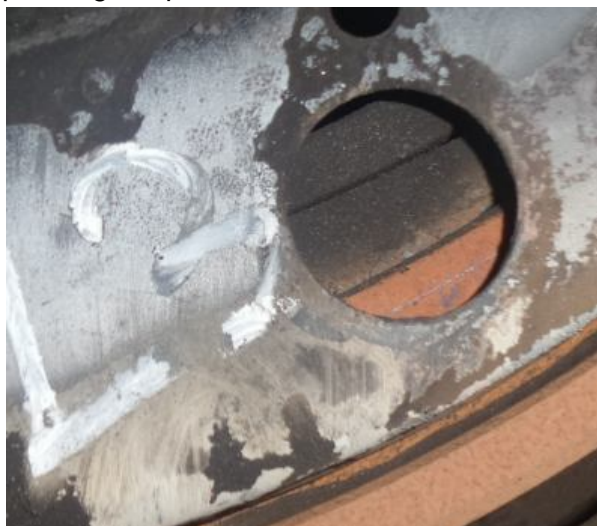
In addition, the paint on the backing plates of all four brake assemblies of the two drive axles had blistered due to the excessive heat and two of them had actually caught fire.

Axle 3 left – overheated brake – paint caught alight

The two brake assemblies seen above are those reported by the driver to have been alight and then smouldered without igniting the tyres.

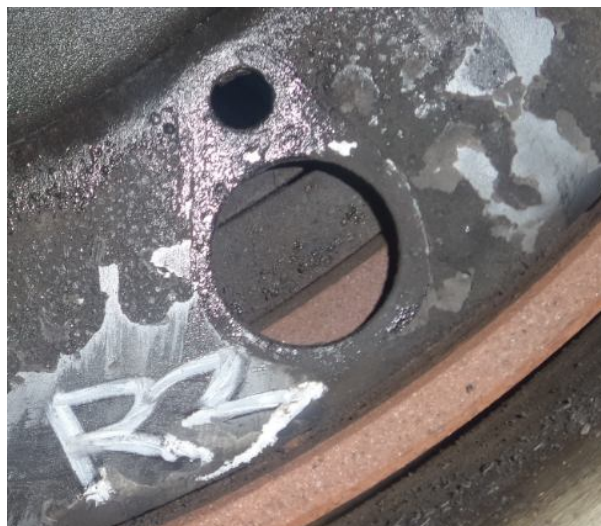
Axle 3 right – overheated brake – paint caught alight

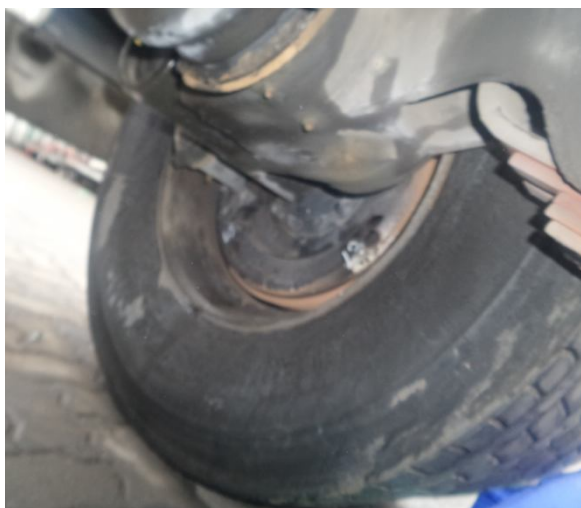
The tyre of axle 3 left seen here was on the verge of ignition, had this tyre have caught alight, there would have been very little to stop the combination from burning out.

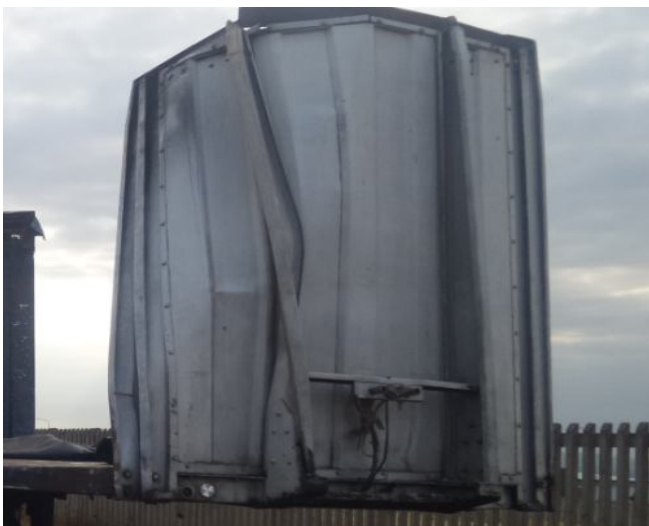
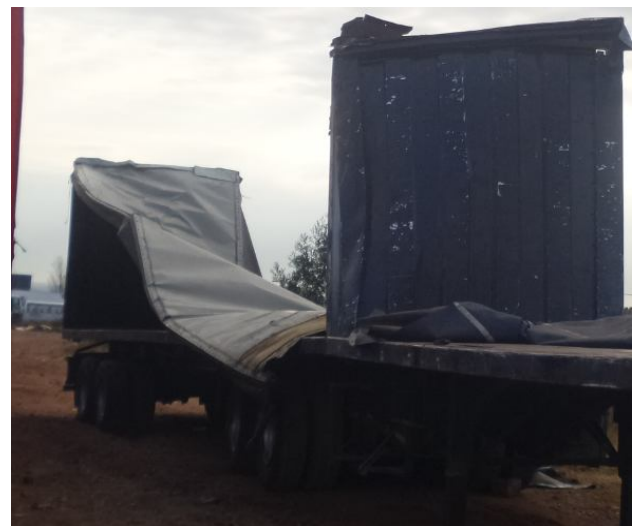
The load bodies of both trailers have suffered substantial damage, there is also some wheel and tyre damage, but both trailers are in my opinion repairable.

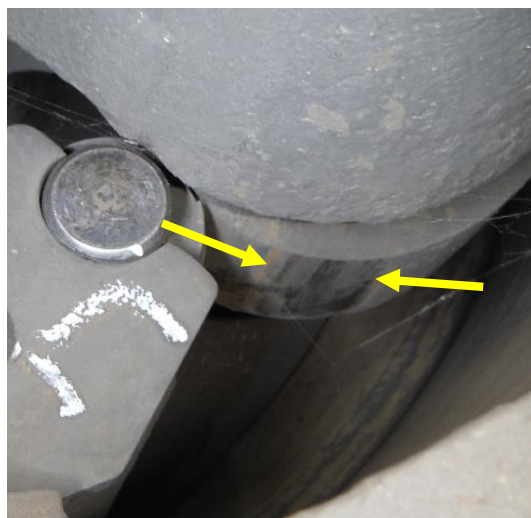
Axle 1 left – excessive roller marks on “S” cam faces

Although as previously mentioned, all of the slack adjusters on the trailers had been tampered with, the tell tale roller marks on three of the four wheels on the leader trailer show that the necessary brake adjustment was not carried out.

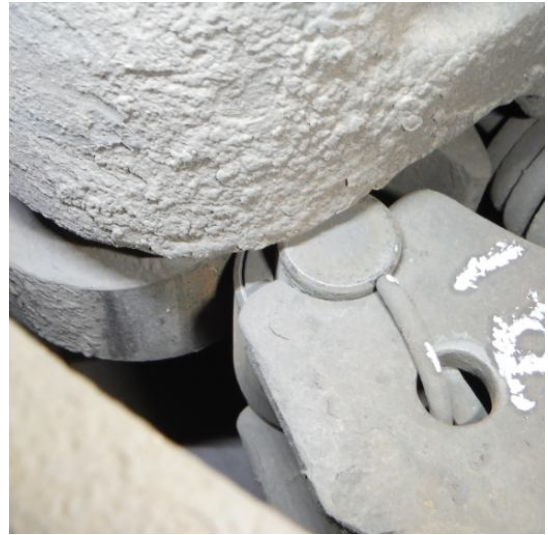
Axle 1 right – excessive roller marks

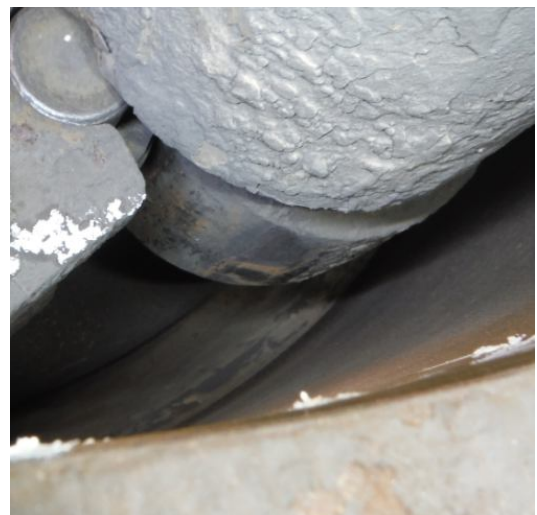
Axle 2 right – excessive roller marks

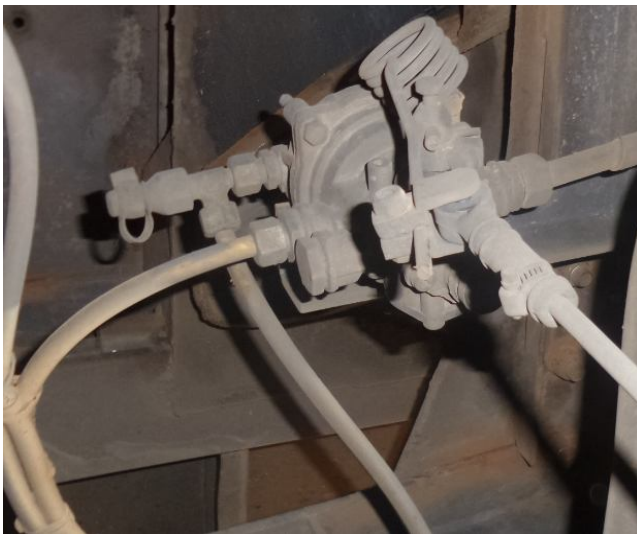
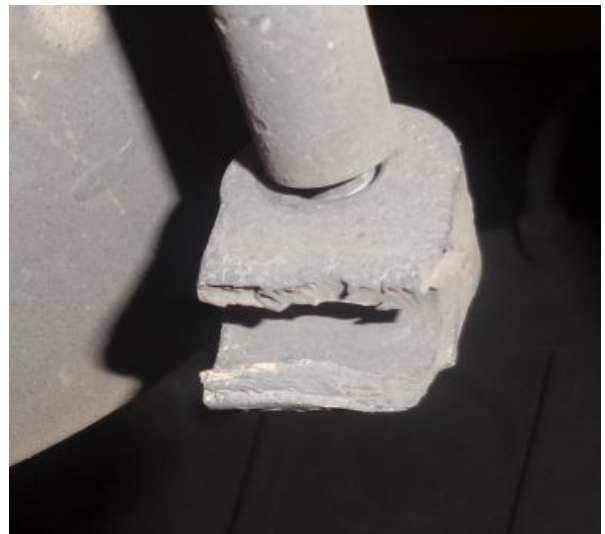
The lack of brake performance due to poor adjustment was amplified by the fact that the load sensing valve linkage has been broken for some time.

I find more trailer load sensing valve linkages broken than intact when inspecting vehicles following accidents, it is usually difficult to say whether the linkage broke during the accident or was a victim of poor maintenance, however in this case, the condition of the broken rubber joint is a clear indication that the linkage has been in this state long before the accident.

This means that when loaded as this combination was at the time of the accident, the best we could have expected from the leader trailers' brakes had they been correctly adjusted, was a performance level that was less than half of what was required of them.

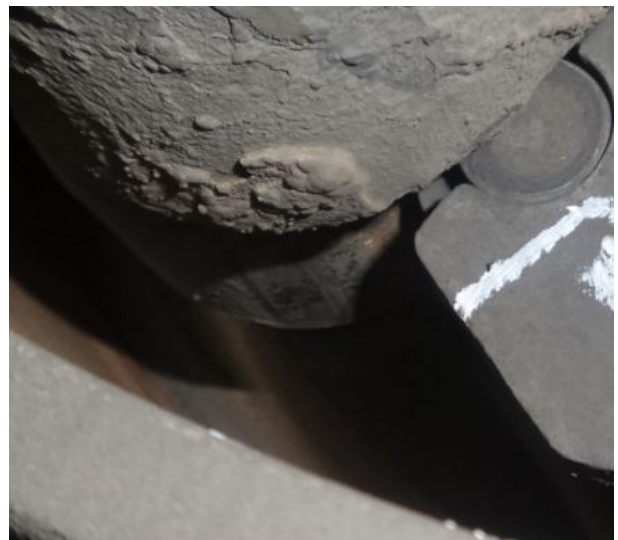
The foundation brakes of the follower trailer were found in a very similar state as the leader, there were adequate brake linings, automatic slack adjusters replaced by with manual units that lacked proper adjustment.

Axle 1 left – excessive roller marks on “S” cam faces

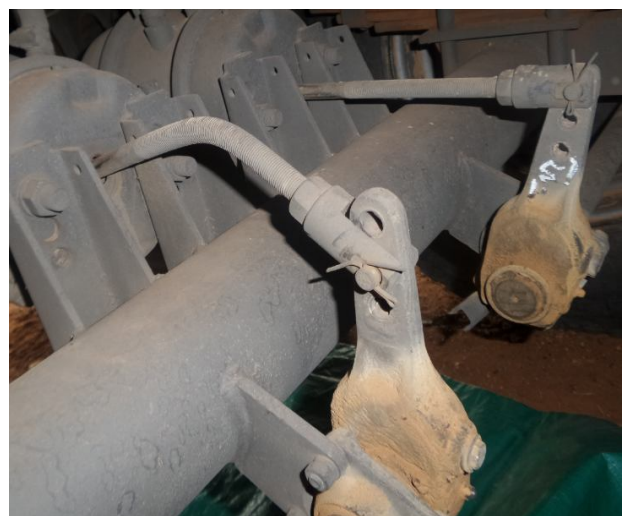
The actuator push rod on the brake assembly of axle 1 right had bent, this is not an uncommon sight when the brake is out of adjustment and the angle of the slack adjuster travels beyond 90°

Axle 1 right – pushrod bent

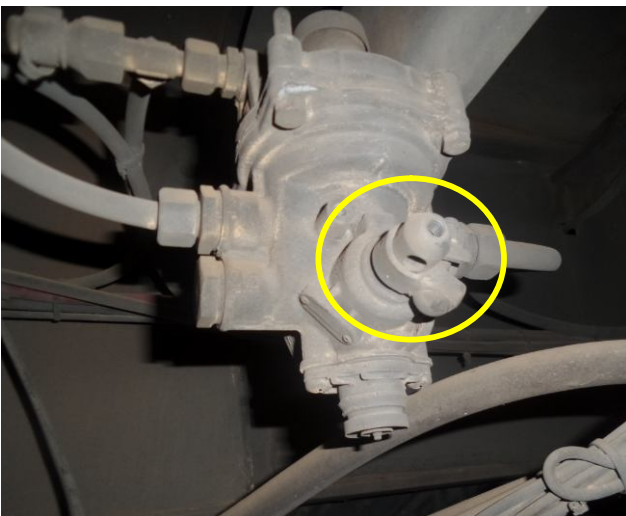
On the follower trailer, the benefit of the doubt regarding the condition of the load sensing valve operation is not a consideration as the linkage has been removed entirely. I can't imagine how someone has knowingly robbed this vehicle of at least 50% of its braking ability when laden and then allowed a driver to take it out on to a public road.

Load sensing valve linkage removed

The spring loaded lever that mounts onto the valve camshaft, the rubber joints and the rod have been removed.

These parts could not have fallen off and simply been missed during a routine service. As with the leader, this meant that when laden, the follower trailer was being provided with air pressure far below that being supplied to the brakes of the truck.

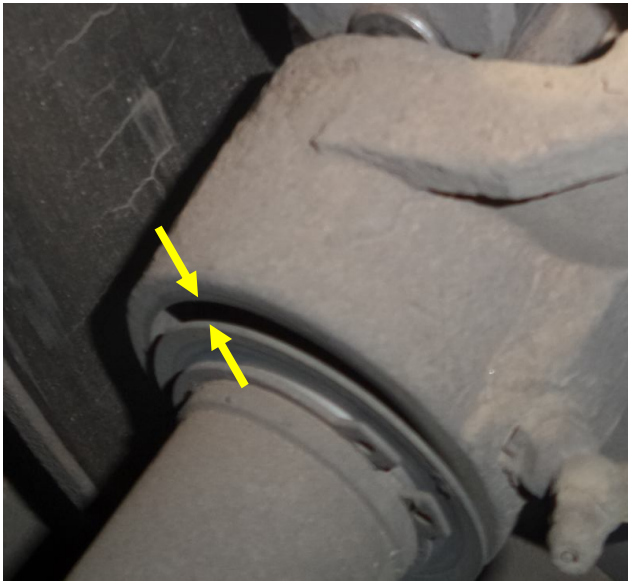
Although the Insured claims that the combination was regularly serviced and in good condition, further issues indicate the contrary. I found all of the inner “S” camshaft bushes to be worn and without the expected presence of grease either around the bushes or on the greasing points.

Badly worn “S” cam bush

The worn “S” cam bushes further hinder the brake’s ability to perform as required.

The clip to the left from the manufacturers repair manual describes excessive wear in the “S” cam bushes as being if you can feel the movement, here you don’t need to feel the play, the gap is visible with the naked eye.

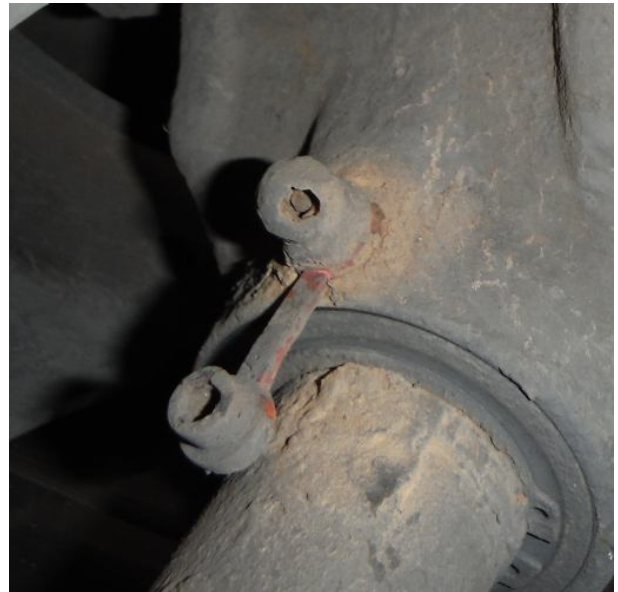
Lubrication point

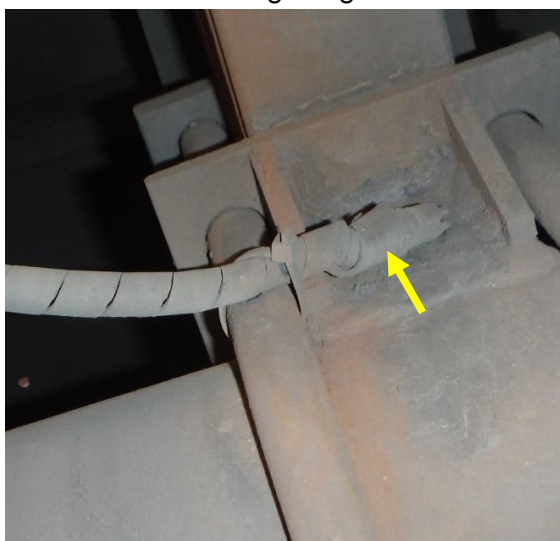
As mentioned previously, the ABS systems of both trailers were inoperative, with components being disconnected or missing altogether.

Sensor cable tied up – no sensor fitted

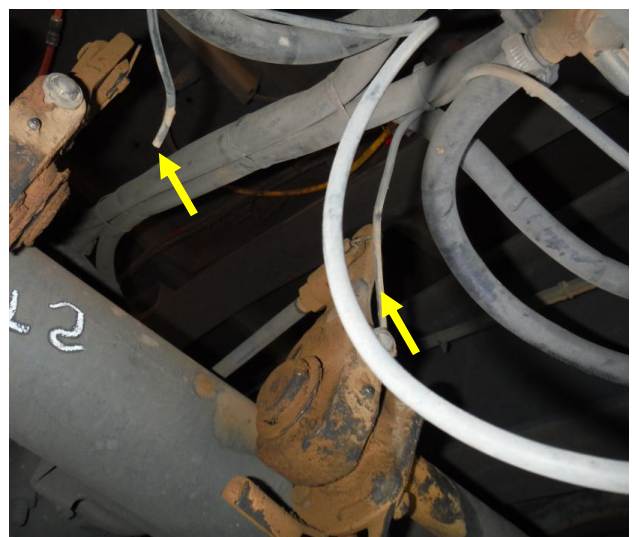
ABS cables cut and left loose

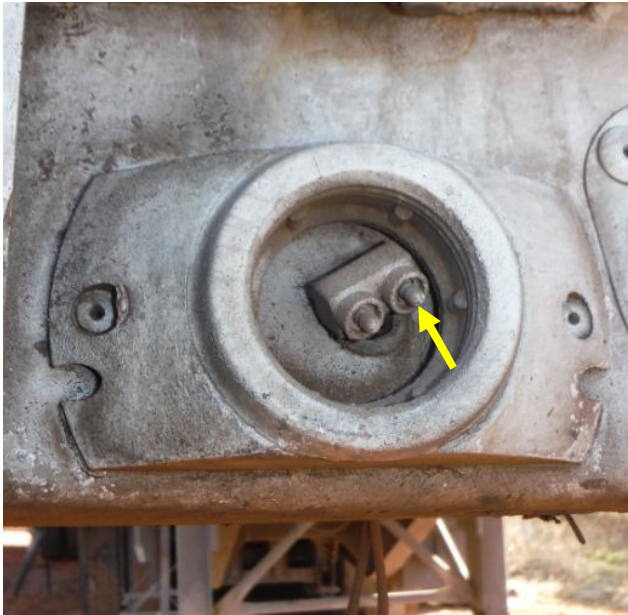
ABS info lamp broken and painted over

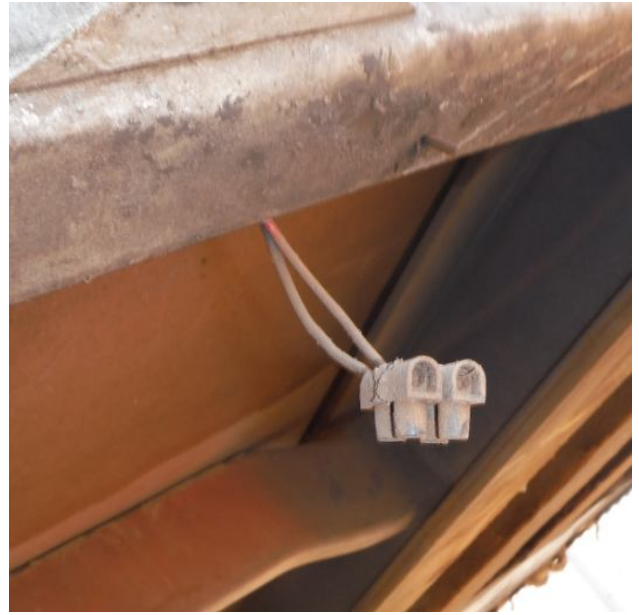
ABS info lamp not connected

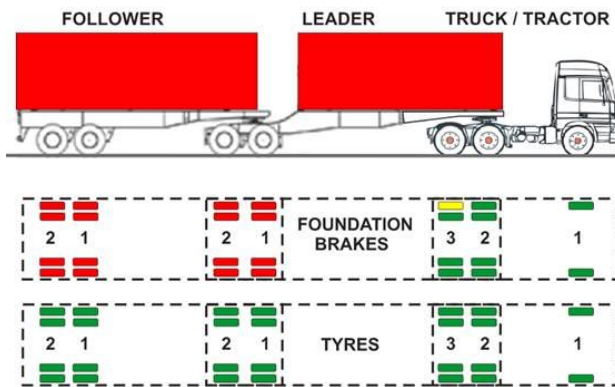
I am certain that the brakes on both trailers had issues that would render them individually unroadworthy and obviously the combination as a whole the same.

The easy to understand graphic to the left indicates my opinion as to the condition of the brakes and tyres prior to the accident.
