### TECHNICAL REPORT – FIRE INVESTIGATION

<b>VEHICLE MAKE:</b>	XXXXXXXX	<b>REPORT DATE:</b>	13 <sup>th</sup> September 2015
<b>VEHICLE REG:</b>	XXXXXXXX	<b>DATE OF LOSS:</b>	XXXXXXXX
<b>INSURED:</b>	XXXXXXXXXXXX	<b>LOCATION:</b>	XXXXXXXXXXXX
<b>INSURER:</b>	XXXXXX	<b>CONTACT:</b>	XXXXXXXXXX
<b>CLAIM / POL No:</b>	XXXXXXXX	<b>DATE OF APP:</b>	XXXXXXXX

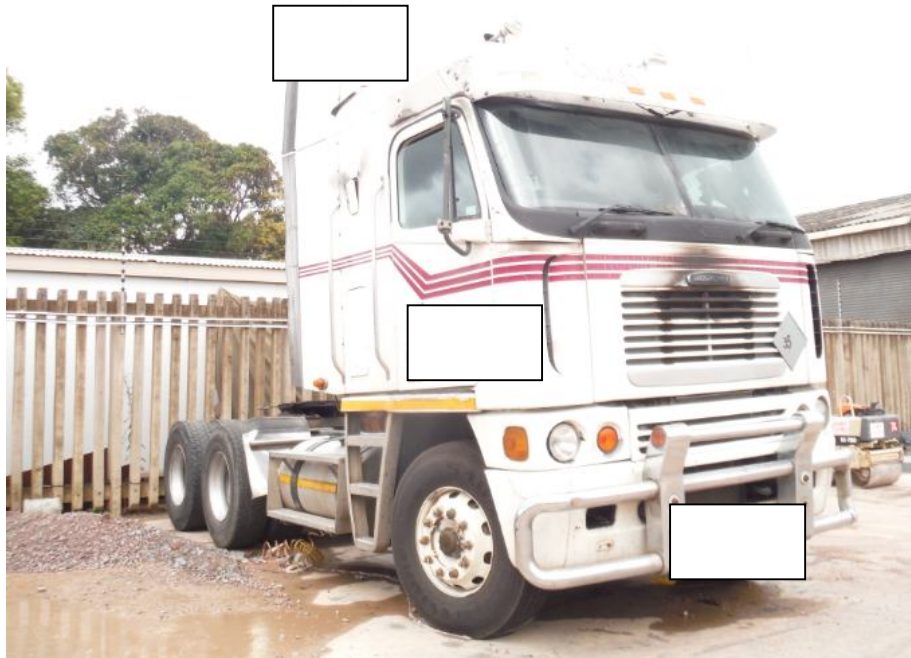
The vehicle as seen in Durban

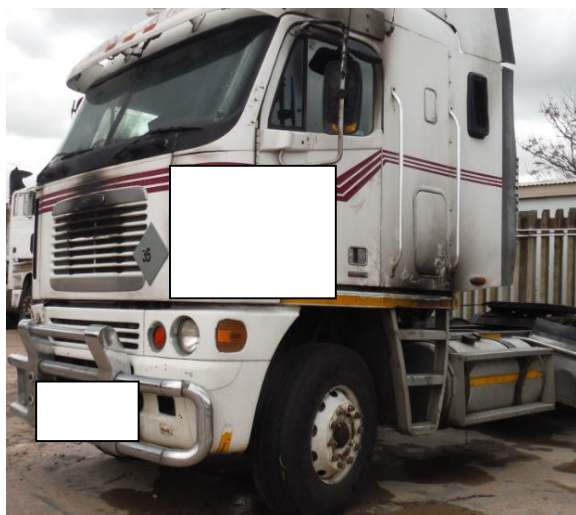
Smoke damage on cab exterior

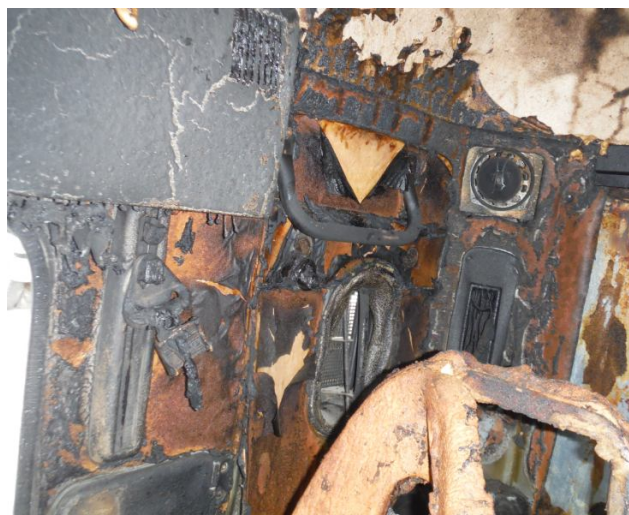
Thermal damage to cab interior

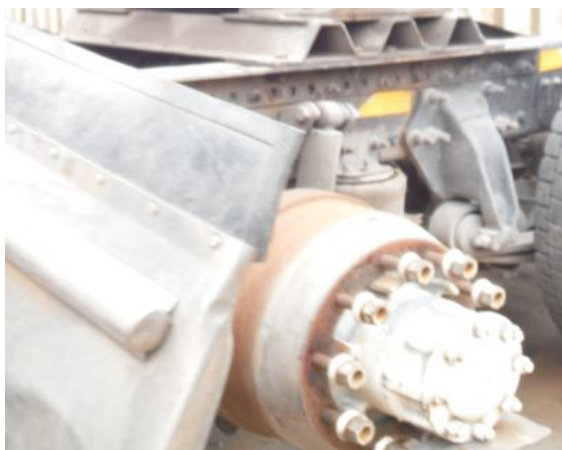
Axle 2 left – tyres missing

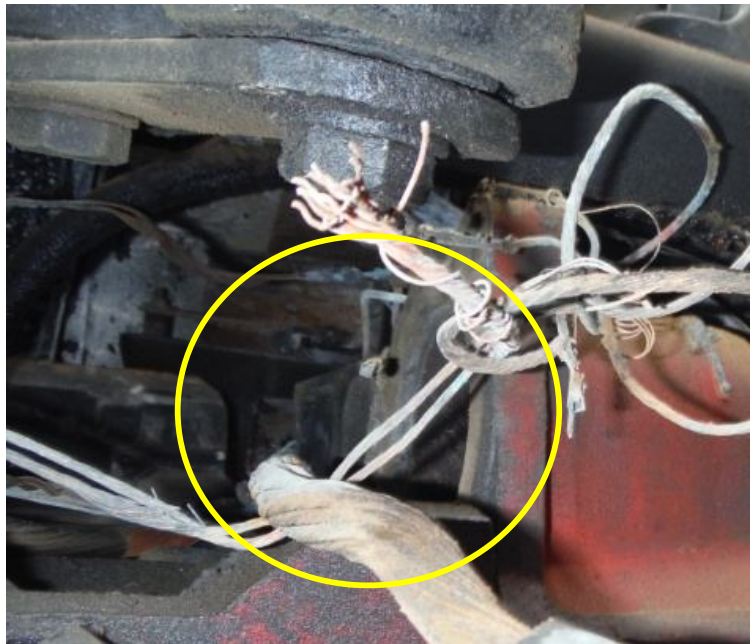
It was no surprise to find that the starter motor had been removed. I spoke to the manager at the Insured's yard asking where the starter motor was and for some time I was given the run around.

Missing starter motor

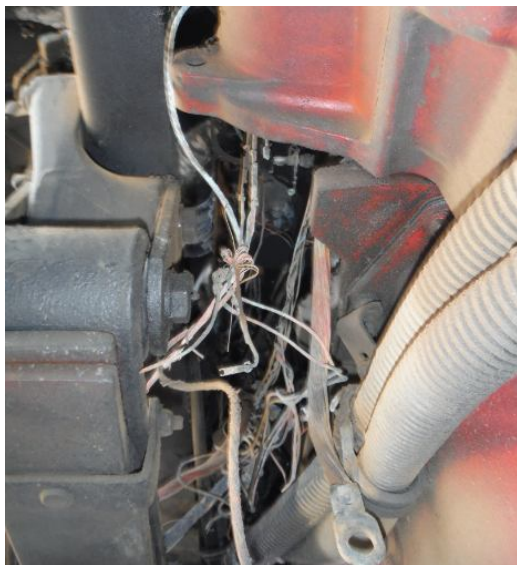
I could already see from the state of the control wiring and main feed cables to the solenoid of the starter that a huge electrical overload had occurred at the starter motor.

Control wiring around starter

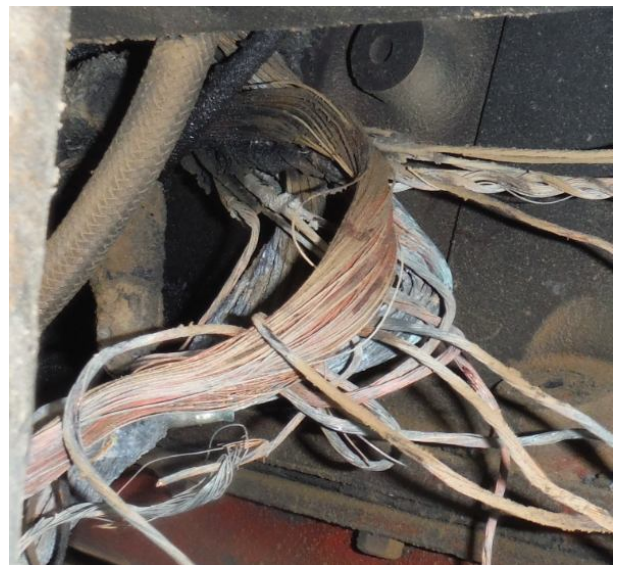
Axle 3 right

The differences in the colour of the copper wires in the photo above right indicate the electrically overloaded cable which turns a brighter gold color and the oxidized green color wires that have only been affected by the heat of the fire.

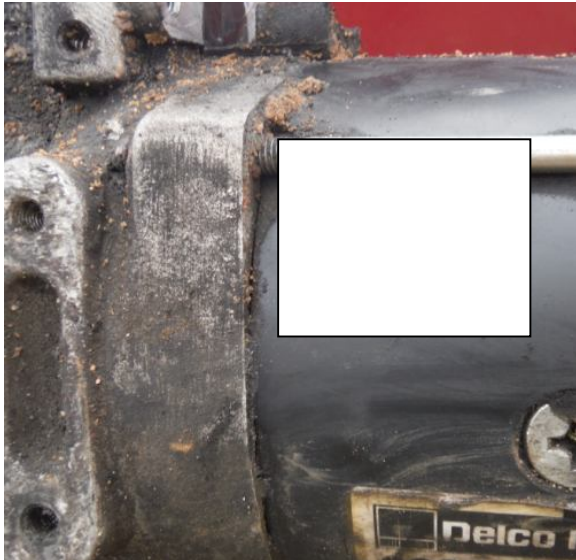
The starter motor had been repaired (more than likely several times) in the past, which was identifiable by the job card number engraved on the stator housing and the solenoid was a replacement part of Chinese origin.

Repair job card number on starter

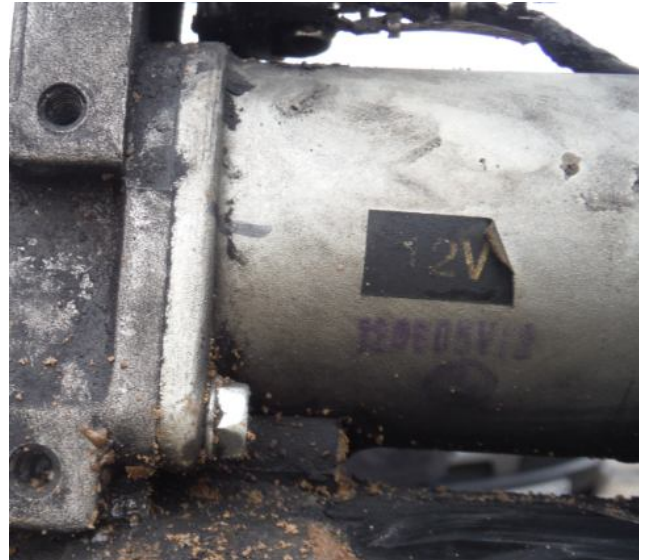
Non original solenoid

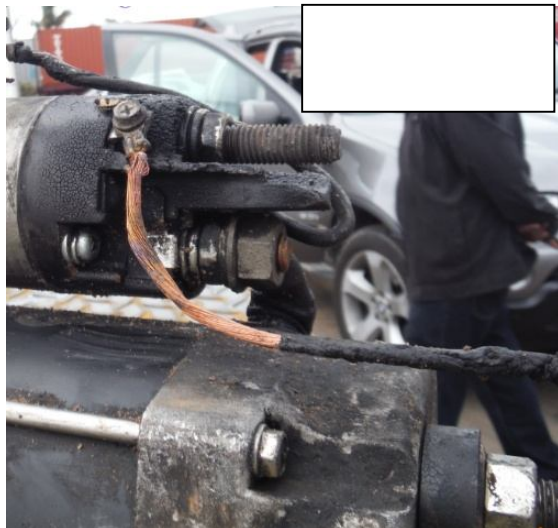
The wire that connects the main starter motor pole to the solenoid seen below left had clearly been overheated.

Overheated solenoid wire

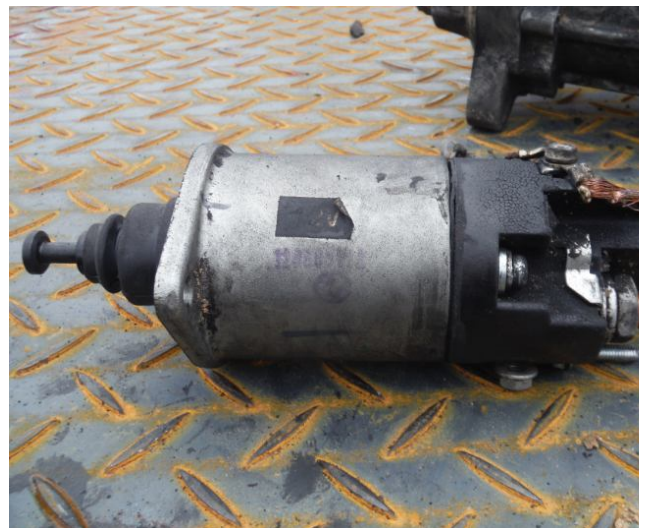
Non original solenoid

The plastic housing where the two solenoid supply poles are mounted had melted and once its retaining screws had been removed, the smell of the burnt electrical insulator on the solenoid windings was present.

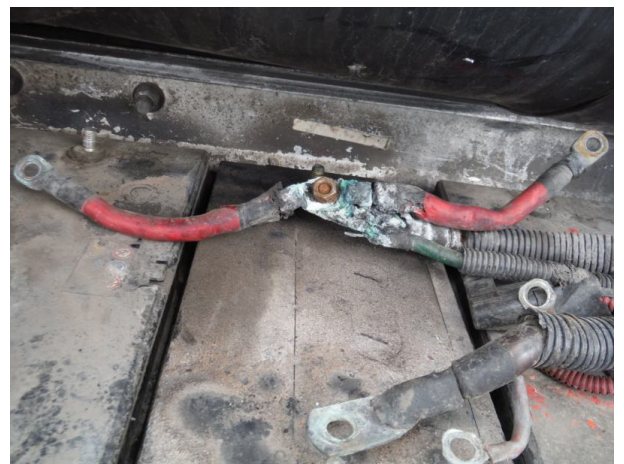
The photo above right shows more evidence that this vehicle, as do most Argosy's, had suffered battery / starter supply issues where the main battery cables have undergone a lot of work in the past.
