TECHNICAL REPORT – ACCIDENT DAMAGE

VEHICLE MAKE:	Volvo	REPORT DATE:	29 th JuNE 2014
VEHICLE REG:	XXXXXXXXXX	TRAILER:	XXXXXXXXXX
INSURED:	XXXXXXXXXX	LOCATION:	XXXXXXXXXX
INSURER:	XXXXXXXXXX	CONTACT:	XXXXXXXXXX
CLAIM / POL No:	XXXXXXXXXX	DATE OF APP:	XXXXXXXXXX

To inspect the above mentioned three vehicle combination and to offer expert opinion on the condition of the vehicles, in particular, the components of the brake system and any influence they had in the overall roadworthiness in terms of complying to SANS 10047 – “The testing of motor vehicles for roadworthiness” of the individual vehicles as well as my views as to vehicle braking and handling dynamics immediately prior to and during the incident in which they were damaged.

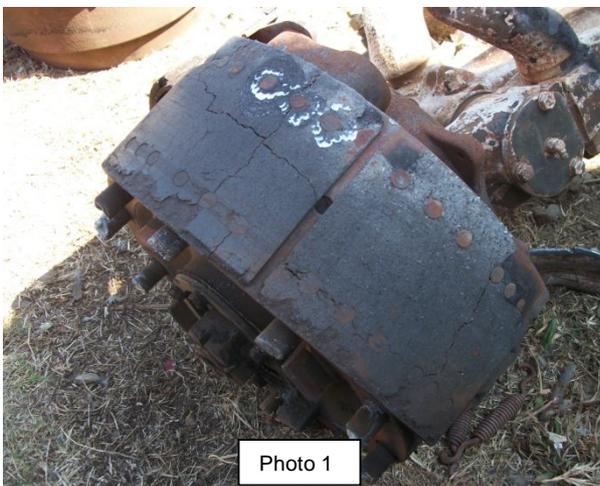
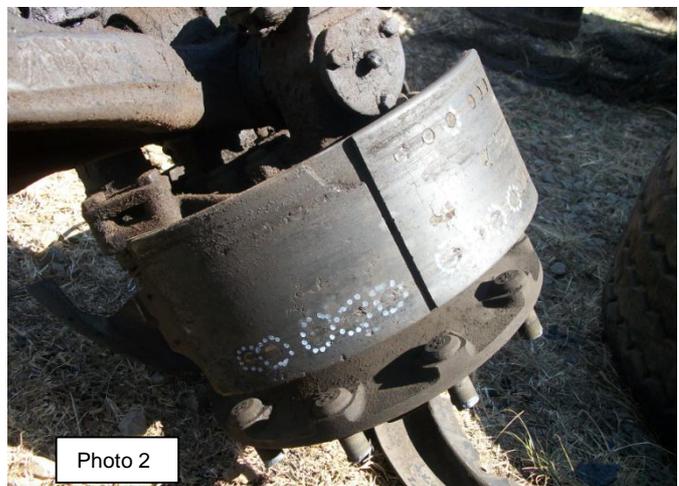
From the photos preceding of the left and right shoes of the front (No 1) axle of the truck tractor, one can clearly see the marks on the lining retaining rivets where they have been rubbing on the brake drum.

With worn linings the ability for the lining to handle the heat being generated during severe braking actions is greatly reduced due to its lack of mass and the problem is exacerbated in such cases by the metal to metal contact of the retaining rivet on the brake drum which increases the heat generated and prevents the lining from working as it was designed. Technically, the reduced lining to drum pressure under high heat and surface speed restricts the tiny particles of the lining material from breaking away from the lining (this is what causes normal brake lining wear) replenishing the surface with fresh, abrasive particles, maintain the coefficient of friction, this results in what is commonly known in the automotive industry as glazing of the lining and drum. This is clearly visible as the shiny area on the lining in Photo No.2.

Once the lining reaches this glazed condition, heat continues to be generated, but the coefficient of friction drops as the surfaces polish, generating more heat until the heat the temperature is high enough to break down the bonding compound of the lining and it disintegrates, as has happened to the lining from the other wheel in Photo No.1.

At this point I should mention that this type of disintegration of the linings on axle No.1 is typical of overheating while braking, not damage caused by the fire.

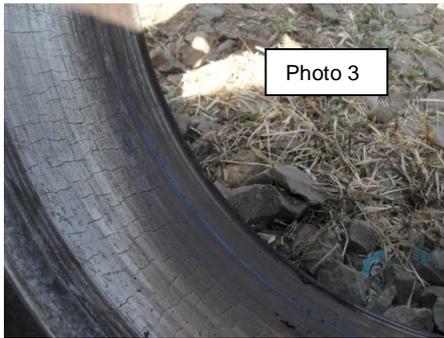
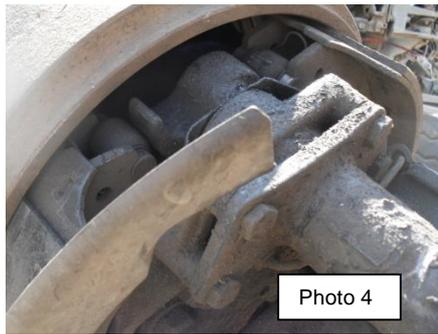
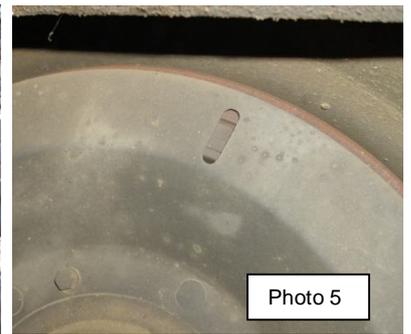
Compounding the afore mentioned problems, rivet contact with the drum removes particles of both drum and rivet, which, as the drum revolves, tear lines in the brake linings path, generating the type of uneven surface see in photo No.3.

*Reline the brakes when the lining thickness is 0.25-inch (6.3 mm) at the thinnest point. The rivets or bolts **must not touch the drum**. Damage to components will result. Meritor recommends that you replace the springs, rollers, camshaft bushings and anchor pins at each reline. Replace shoe retainer springs, check the drum, and perform a major inspection when you reline the brakes.*

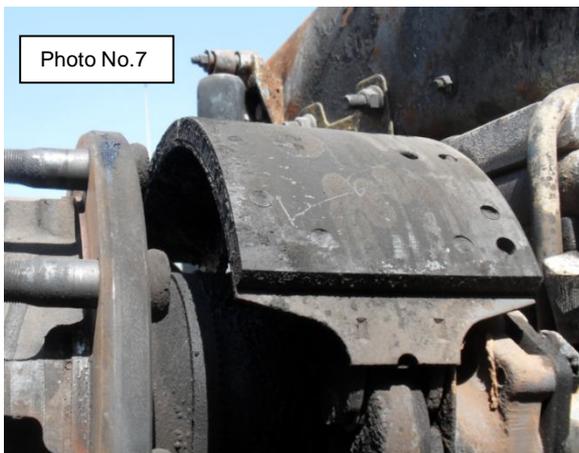
Although there are signs of slight oil contamination on the right wheel of axle No.2 on the truck tractor, it is the only wheel on the vehicle that has the physical characteristics and patent indications that it has been working extremely hard without failing.

Photo No.7 shows good contact between lining and drum and that the brake has generated extreme heat through braking actions, (the white powdery surface and a blue grey main colour), and that the lining has remained intact.

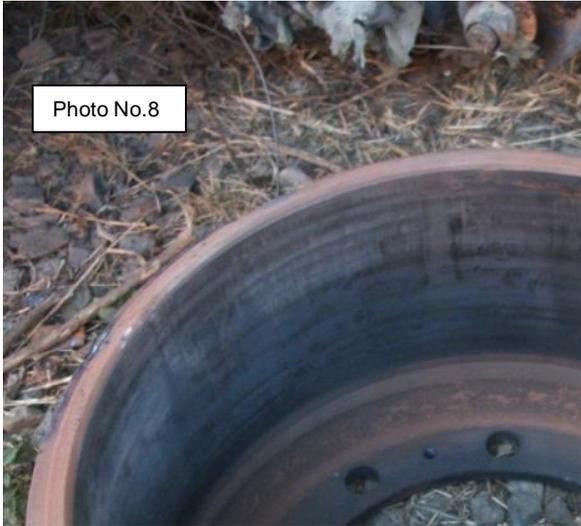
Photo No 8, shows the drum from the same right wheel of axle No.2. It is still in reasonably good condition, showing signs of extreme operation in the form of brake path discolouration and small surface heat cracks appearing.

This brake on the right of axle No.2 must surely raise the question that as all the brakes on this vehicle were exposed to the same driving situation, give or take some load movement variations; shouldn't all the brakes appear to be in a similar condition?

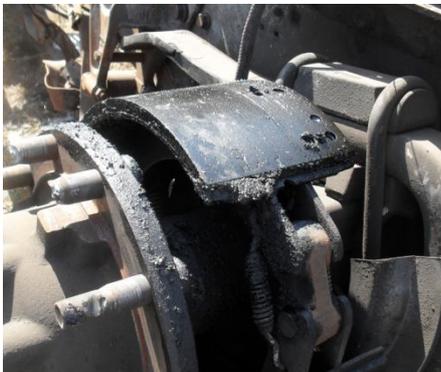
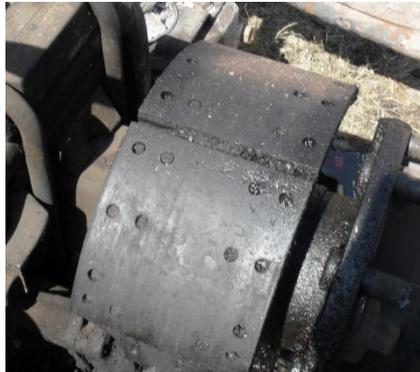
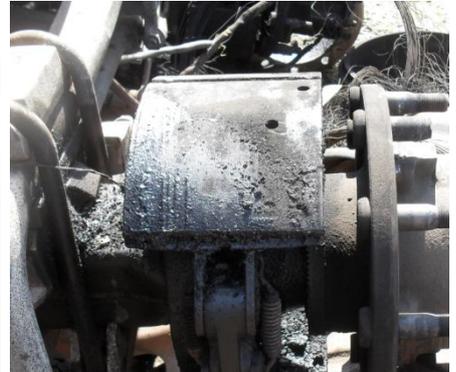
The left front wheel of axle No.2 and both left and right wheels of axle No. 3 have been contributing very little to the braking effort of this vehicle for some time. There is evidence of prolonged exposure to oil and grease. Contamination of this nature, in my experience renders the brake almost useless. I have tested many brake assemblies contaminated in such a manner and would expect them to operate at most, around twenty per cent of their designed capability.

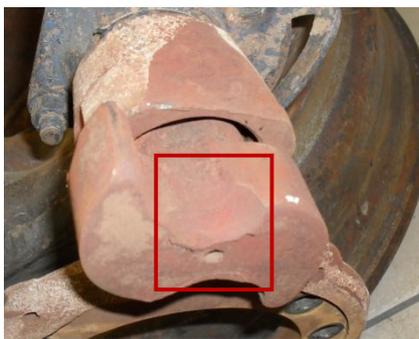
Photo NO.1

Photo No.1 highlights the piece worn out, not damaged, of the “S” camshaft on the outer edge which correlates with how the rollers would be sitting at an angle due to the bend in the brake spider that can be seen in Photo No.2. Also all four edges of the spider where the brake pins should have been are worn in the same manner (Photo No.3) where the brakes shoes would normally be sitting perpendicular to the pins and have plenty of clearance from the spider bracket.

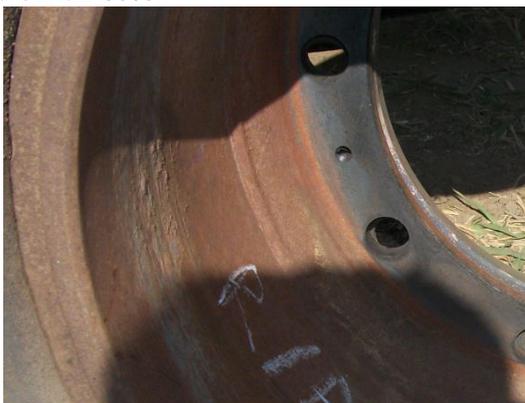
Photo No.4

While my speculation on the age of the rust and debris evident in Photo No.4, measurable in what appears to me to be close to one millimeter on the brake drum as opposed to what one would expect to measure in microns (thousandths of a millimeter) is based on my experience in dealing with many such cases, should this finding be disputed, my theory can easily be confirmed by having these components subjected to a more scientific metallurgical examination.

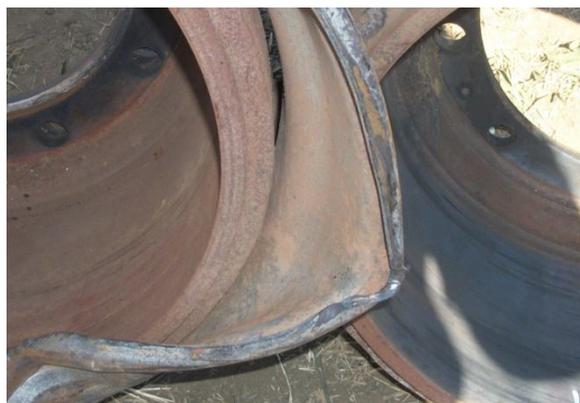
Such an examination, while being relatively fast, is quite expensive, but would be able to accurately determine the time period that the worn areas of the spider and also the brake drum have been exposed to the elements compared to that of the same surface areas of other similar components from the opposite side of the same axle. I really do not believe this to be necessary as the difference between the drums mentioned can be assessed visually in Photo No.5 by even an untrained eye.

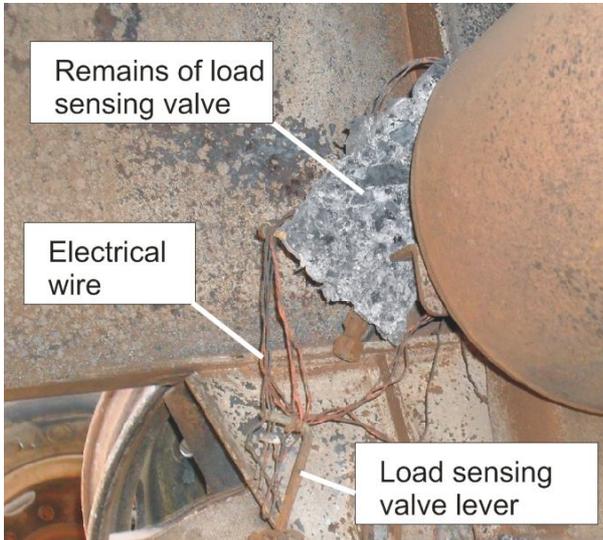
Photo No.1

The first thing that caught my eye on this vehicle was that despite the severe damage from the fire, there was clearly a piece of electrical wire tied around the lever of the vehicles' load sensing valve.

Regardless of in what position the lever had been fixed, had the vehicle been subjected to a roadworthy test with the load sensing valve in this condition, it would most definitely have been declared by the examiner as unroadworthy, being rejected for among other reasons, in accordance with the instruction to the examiner in SANS 10047: 2009, page 37,

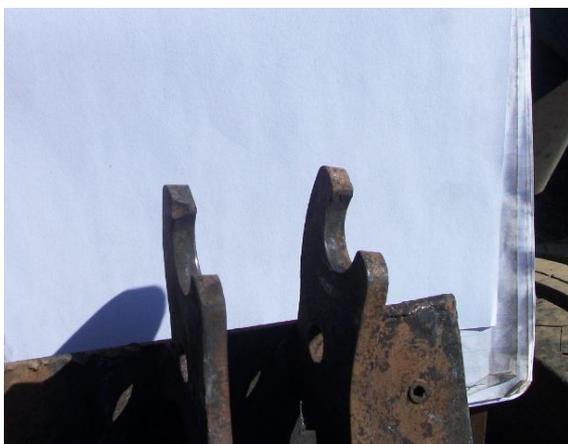
Photo No.2

Examination of the left side of axle No. 1 had a problem in that the top brake shoe had bent and had worn the brake lining in a taper. This bent shoe was forcing the lining against the drum unevenly, which created difficulty for the "S" camshaft in applying the brake effectively.

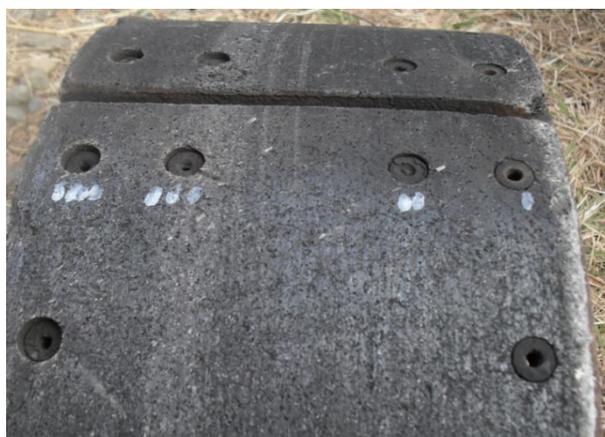
Photo No.3

The lining has worn badly on the right hand side which you can see if you compare the depth of the rivets on either side. On the right, the rivet has almost made contact with the drum.

The white line on the right of the brake lining is where the uneven pressure has caused localized overheating of the lining. This shoe, without any doubt, would hinder the braking efficiency of this wheel and cause rejection by a vehicle examiner in relation to SANS 10047: 2009 under instruction to the examiner on page 39 where:

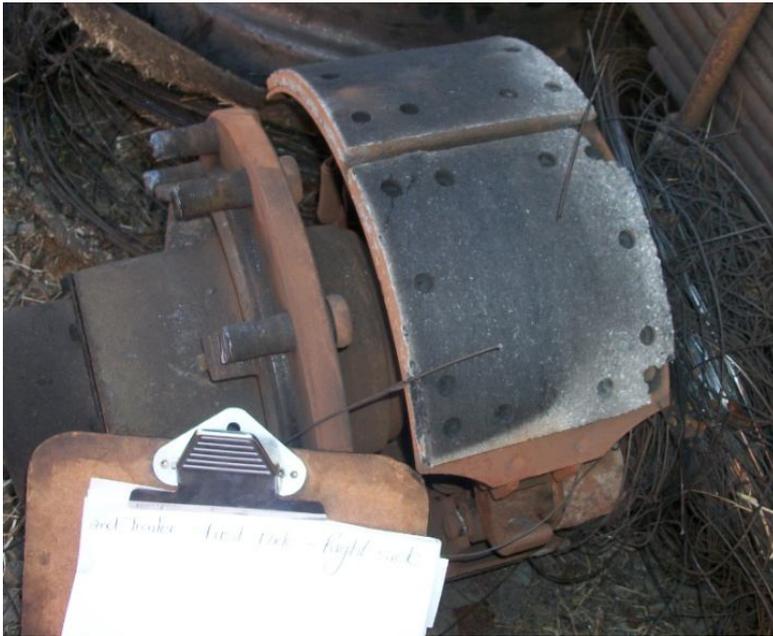
The brake of the right wheel on the first axle shows signs of operating efficiently until reaching its design capabilities, being close to the point of disintegration, Photo No.4 shows the fragments of the lining having broken off from the corners of the leading shoe.

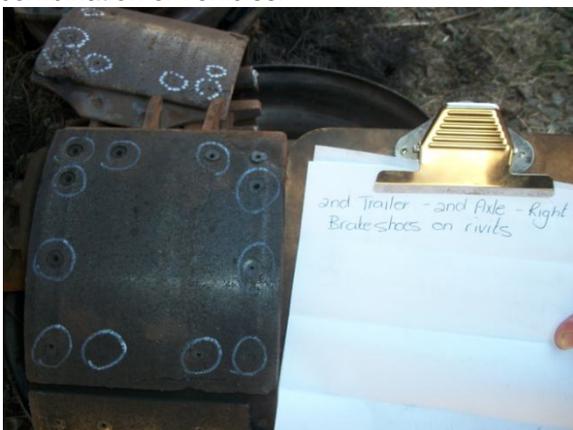
Photo no.5

Photo No.5 shows the extent to which the maintenance of this trailer has been neglected with respect to the safety critical task of the inspection and replacement of worn brake linings, the highest wearing part of the vehicle.

The reduction of brake effort caused by the rivets having worn down due to make contact with the brake drum, along with the glazed appearance of the shiny surface area of the lining and the partial disintegration of the lining have all been dealt with earlier in this report.

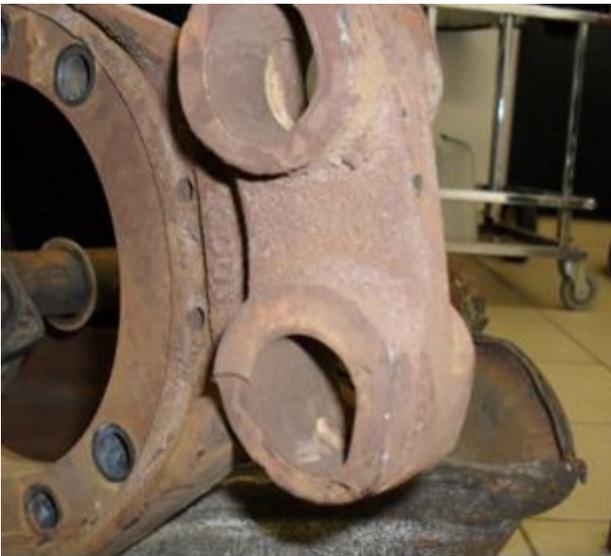
The holes are badly worn as can be seen here, note the flats on the right of the lower hole. This could not have happened in an impact with a brake drum present without severely damaging the drum also.

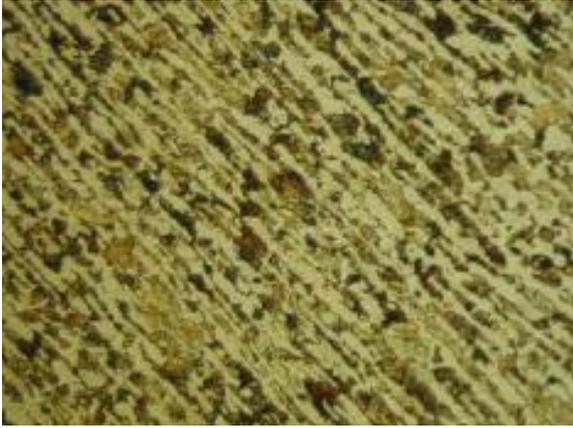
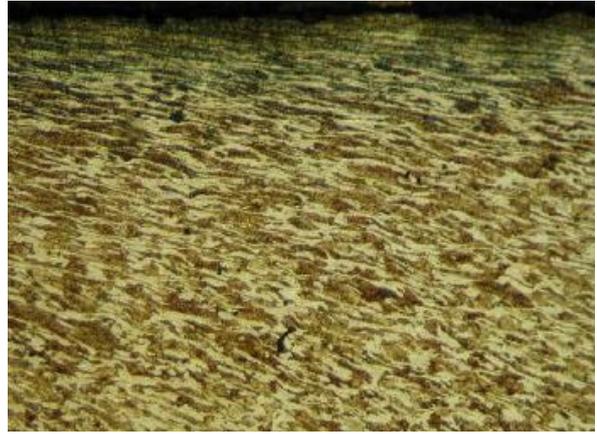
The picture on the left is of the normal molecular structure near the edge of the "S" of the camshaft. The molecules on the outer edge can be seen to be undisturbed and consistent with the molecules further in the centre of the sample.

The deformation of the molecules of the outer edge of the picture on the right is evident. The report clearly states that this is due to mechanical wear.

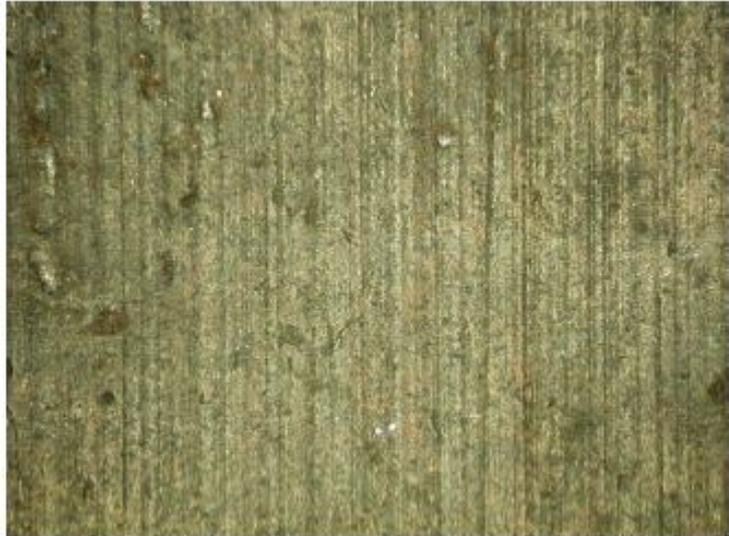
Sample 66 16G brake surface revealed a gray relative smooth surface with some evidence of abrasive wear illustrated by the "grooves"

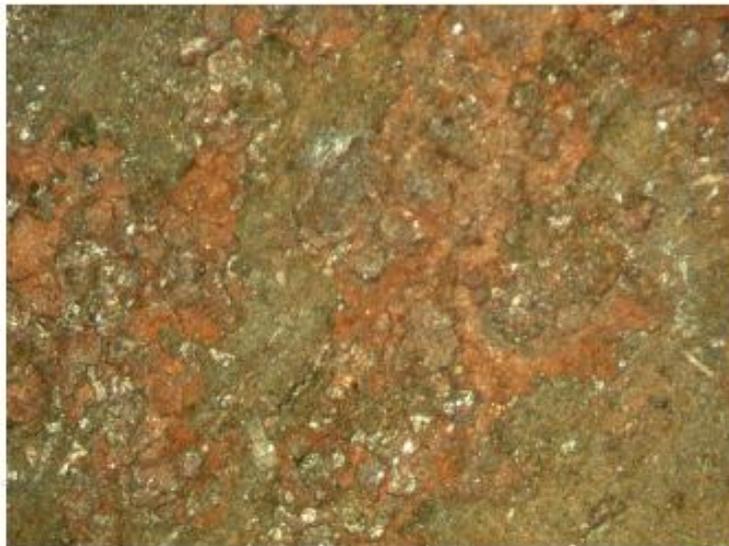
Sample 66 16B brake surface revealed evidence of corrosion as illustrated in the photomicrograph

No "smooth surface" could be observed on the sample examined.

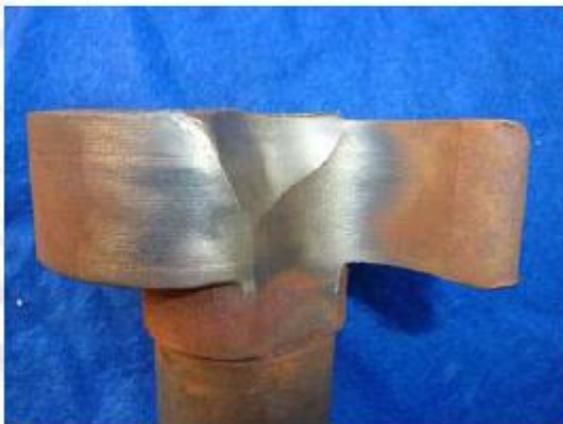
After rust removal the "5 camshaft" revealed several smooth worn regions as indicated by the enclosed photomicrographs.

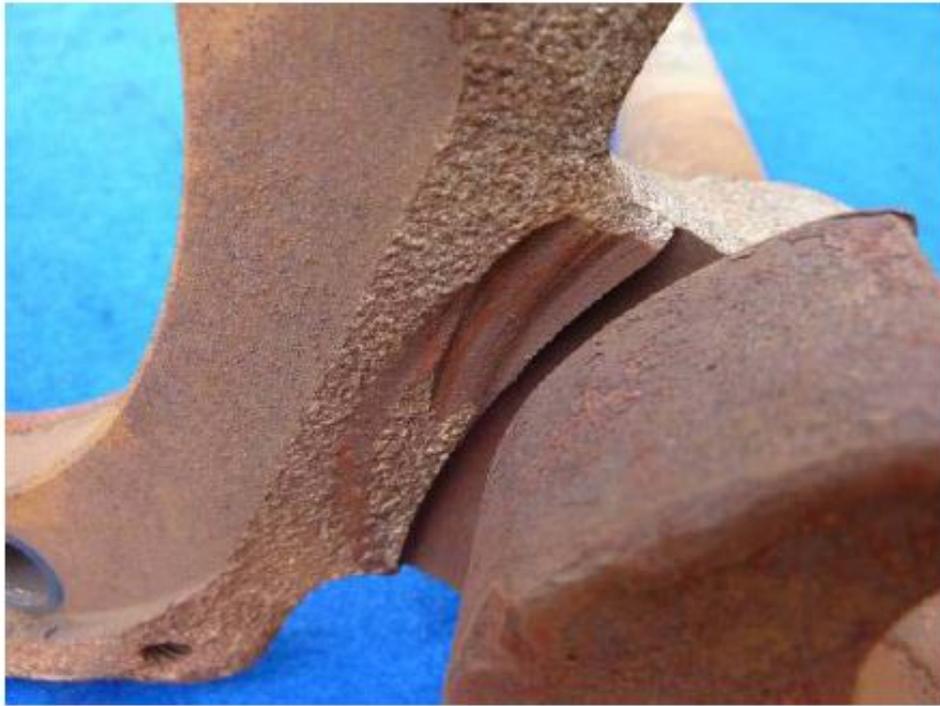
Examinations of the damage area's with the aid of a low power stereoscopic microscope revealed no extensive plastic deformation refer the photo macrograph.

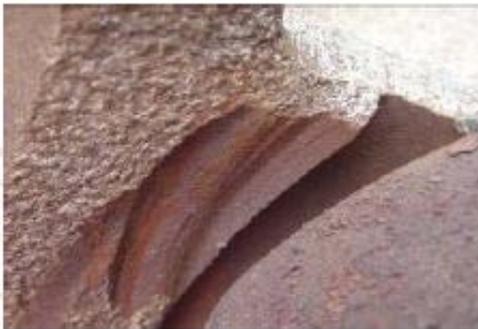
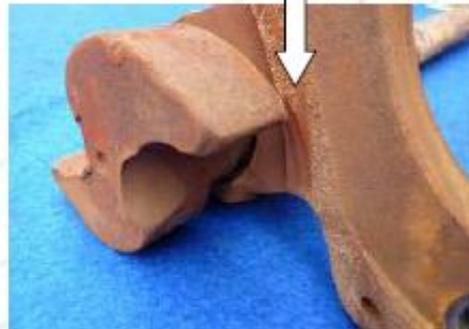
Examination of the spider surface indicated that the damage region coincided with the tip of the "S Cam" resulting in severe wear of the spider as indicated at photo-macrographs.

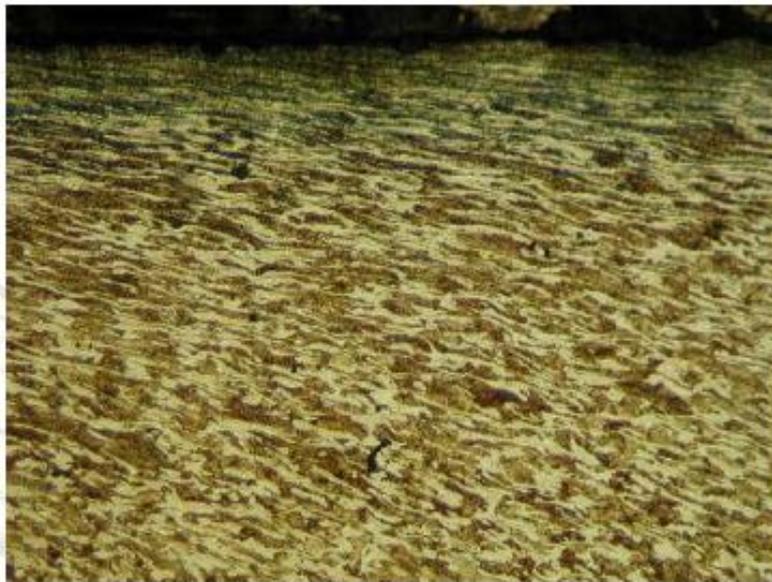
*Section of at the worn part of the " S Camshaft" surface
Mag 225x 2%Nital. The grain deformation was approximately 40 micron in depth.*
