TECHNICAL REPORT

VEHICLE MAKE:	Mercedes Benz	REPORT DATE:	12 th December 2011
REG No:	XXXXXXXX	LOCATION:	XXXXXXXX
INSURED:	XXXXXXXX	CLAIM No:	XXXXXXXX
INSURER:	XXXXXXXX	CONTACT	XXXXXXXX

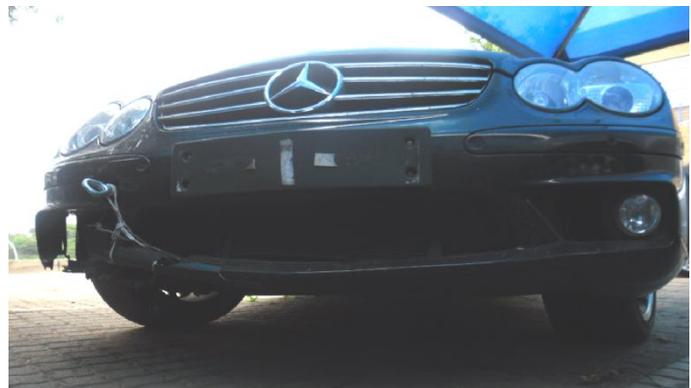
As can be seen from the picture on the right above, the vehicle has collision damage to the front right hand side which includes the front bumper, supports, trims and stiffeners, the radiator, the oil cooler, the air conditioning evaporator, front right fog lamp and various ancillaries relating to these components.

The damage seen is consistent with a collision as described by the Insured, which is that he claims to have hit a truck tyre carcass that was in the road. The quotation from XXXXXXXX for the repairs to

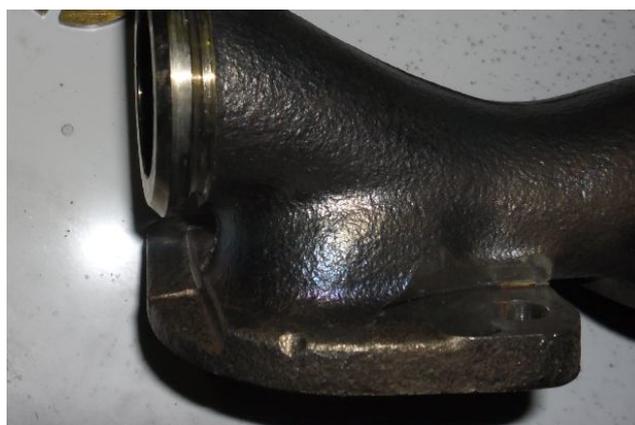
The first sign that the engine had experienced a catastrophic failure was the discolouration of the exhaust manifolds.

The straw / blue heat discolouration evident here is typical of a component having been exposed to extreme temperatures.

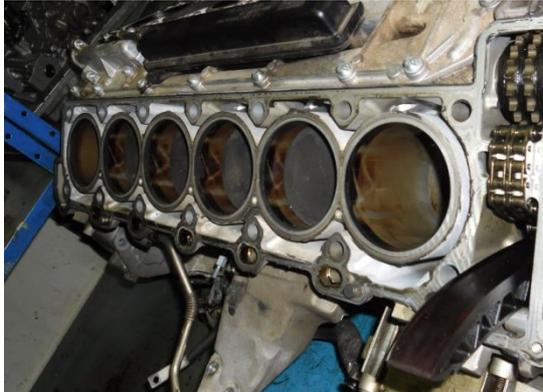
The right bank of cylinders has experienced four point thermal seizures in all six cylinders

These seizures occur when the coolant temperature is allowed to exceed the operating range of the vehicle or the coolant level becomes lower than is required to allow the cooling system to cool the vehicle.

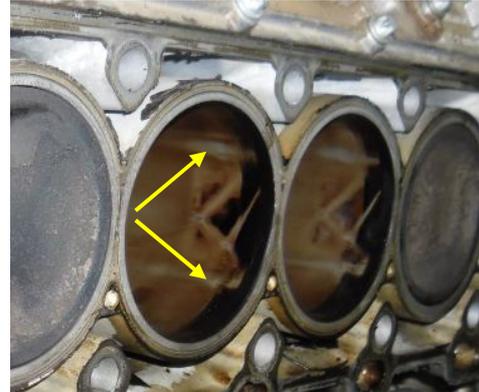
The left bank also has the marks of similar thermal seizures.

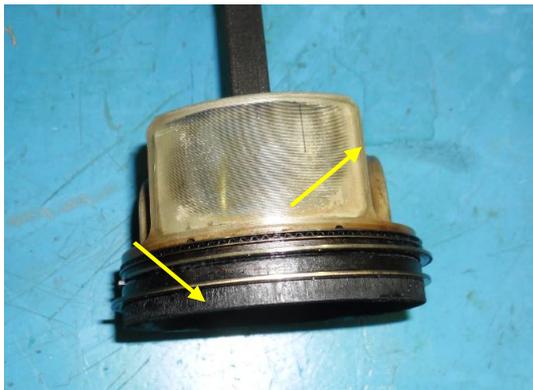
The piston from number three cylinder on the left bank.

As would be expected in a high performance engine such as this one, the piston skirts are of a low contact design, hence the unusual seizure marks in the cylinder bores. In the picture above on the left, the scoring on the piston skirt edge and more importantly, the seizure marks of the piston crown are clearly visible, confirming a thermal level above designed limits.

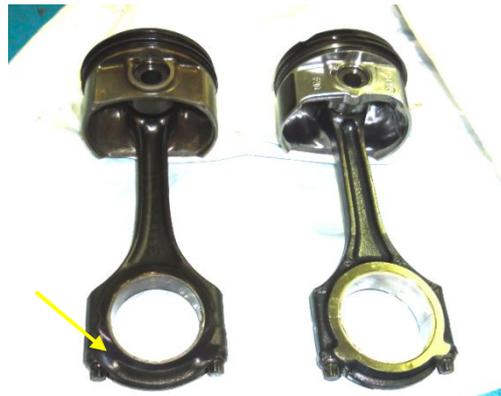
The piston / connecting rod assembly from our engine in comparison with a new similar assembly.

The extent of the heat that the piston / connecting rod assemblies had been exposed to can be seen when an assembly from our engine is compared with a new assembly. The arrow indicates the blue thermal oxidization on the side surfaces of our assembly. These colours indicate that the connecting rods in the engine reached temperatures exceeding 600 degrees Celsius. This component would not normally be expected to be exposed to temperatures exceeding 165 degrees Celsius.

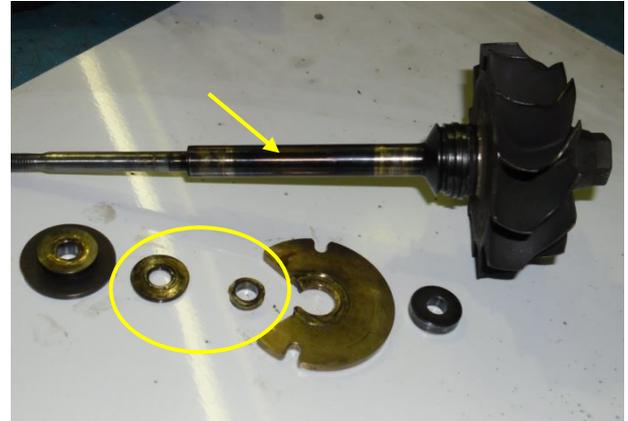
The turbine shaft and bearings of the left bank turbo charger.

The photo on the right above shows the now common “blue-ing” of the steel shaft and the complete disintegration of the compressor side radial / thrust bearing. The two items within the yellow circle are actually supposed to be one part.

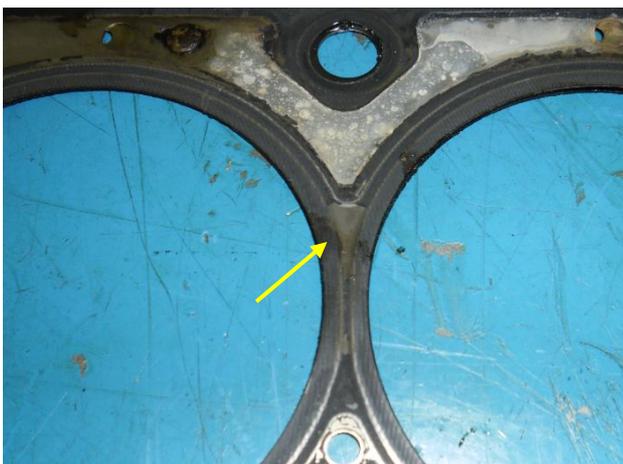
Evidence of inter cylinder leakage.

The cylinder heads exhibit signs of overheating in the form clear signs of cylinder head gasket failure causing inter cylinder leakage of compression – hence the inability of the vehicle to start for the XXXXXXX technicians. The formation of a white-ish grey deposit on the intake valves of each of the inner cylinders indicates that the vehicle was driven whilst inducting engine coolant from the leaking head gaskets.

Both cylinder heads are badly warped and are most likely scrap.

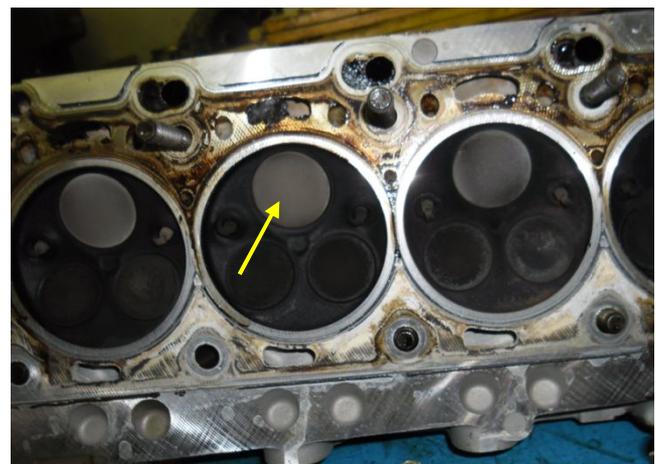
Typical view of the combustion chambers.

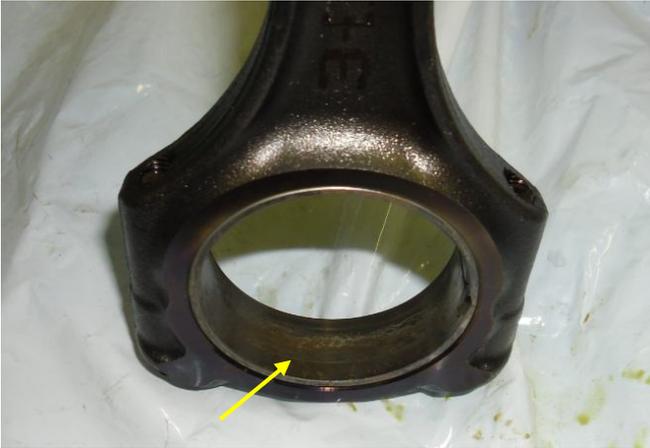
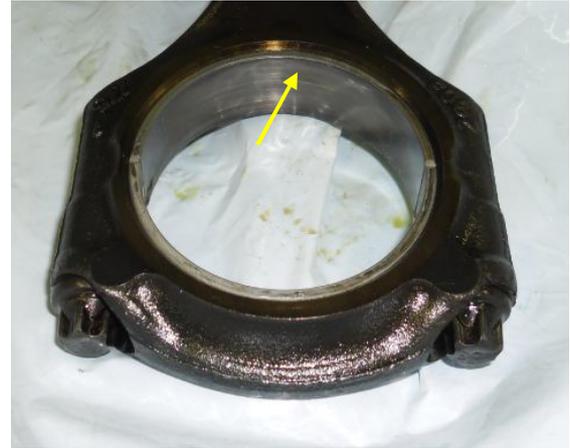
Big end bearings have lubrication failure damage

The bearings on the big end of the connecting rods have failed and were about to seize. This engine was driven long after every limit of temperature and lubrication had been exceeded.

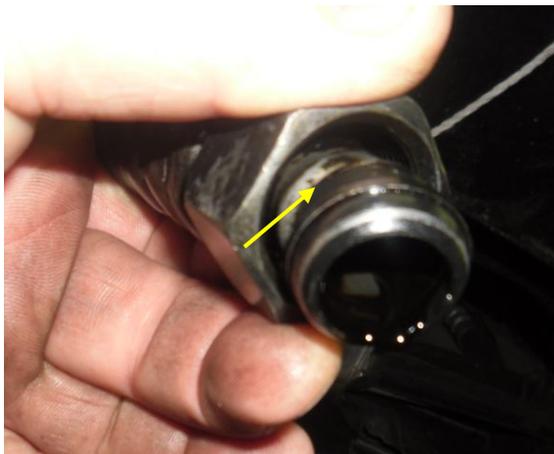
Oil leakage occurred from this joint

The connecting pipe at the front of the engine oil cooler had suffered impact damage causing an oil leak in that area. The oil pipe was leaking both at the swaged joint as well as the seal between the pipe connector and the cooler inlet have been compromised.

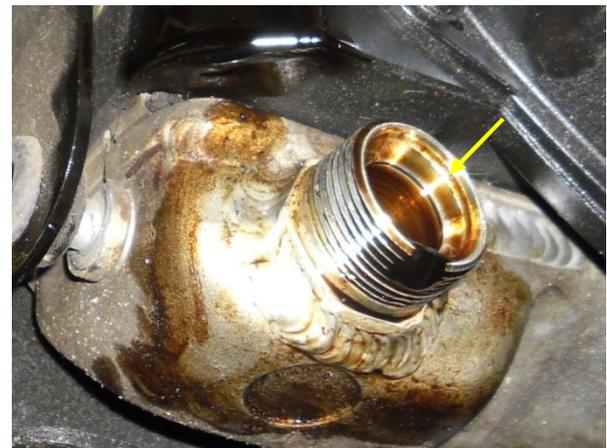
This sealing surface is damaged.

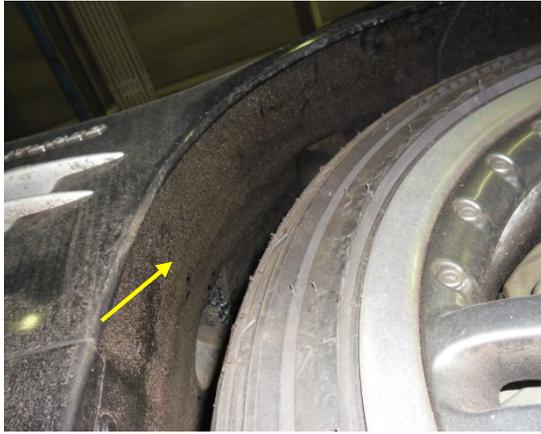
Oil in the right hand wheel arch.

The oil leaking from the oil cooler was dropped / sprayed right on to the front left wheel and was dispersed around the wheel arch and along the right underside of the car.

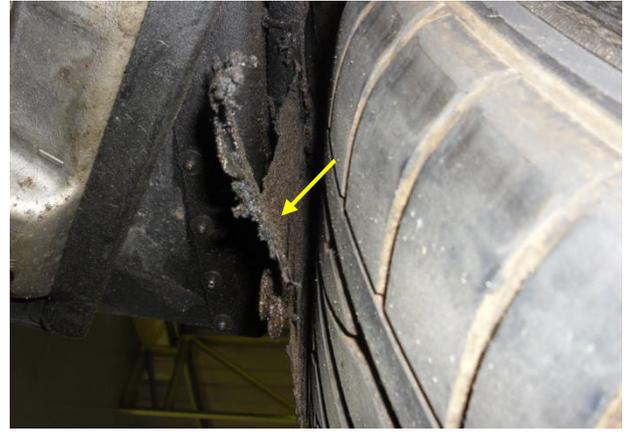
The front wheel inner cover has been worn away.

The car had been driven for a considerable time following the collision; witness to this is the extent of the wear to the right front inner wheel cover, which has worn away against the tyre.
