# BANBURY

## ACCIDENT REPORT

### PASSENGER VEHICLE

<b>INCIDENT DATE:</b>	16 <sup>th</sup> June 2010	<b>LOCATION:</b>	Setters way / R300
<b>VEHICLE 1:</b>	Mercedes Benz C180K	<b>REG. No:</b>	XXXXXX
<b>VEHICLE 2:</b>	Toyota Yaris 1.3	<b>REG. No:</b>	XXXXXX
<b>DRIVER 1:</b>	XXXXXX	<b>DRIVER 2:</b>	XXXXXX

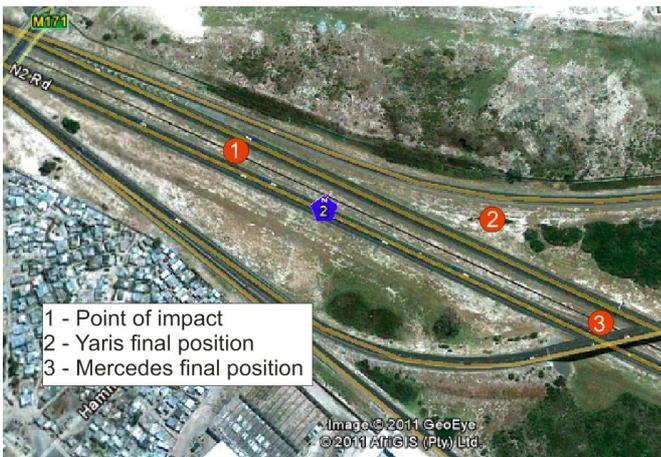
The Mercedes collided with the Toyota at point 1.

The impact caused the Toyota to leave the road and travel down the small embankment where it is spun in the wet grass and rolled at least once ending up on its wheels behind some bushes.

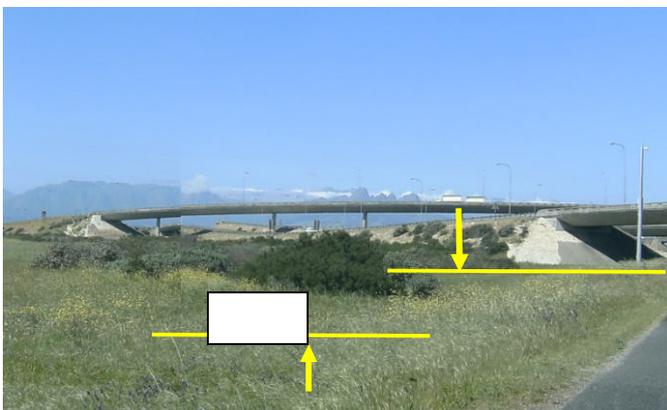
The height from the road surface to the bottom of the small embankment is approximately 2.5 metres.

The final position of the Toyota, shown here as the white rectangle is below the road surface and behind the large bush if viewed from the final position of the Mercedes.

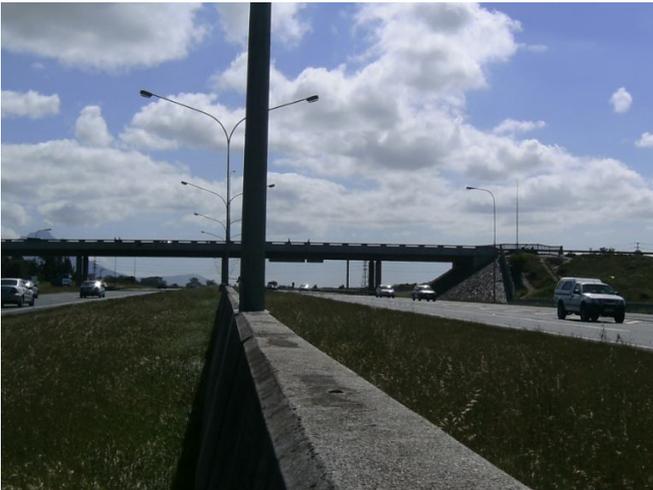
The view from the final position of the Mercedes shows that even in daylight the final position of the Toyota is out of the line of sight due to the drop in elevation and the bushes.

At night, the Toyota would have been totally obscured to XXXXXX as would the view of the Mercedes from the final position of the Toyota.

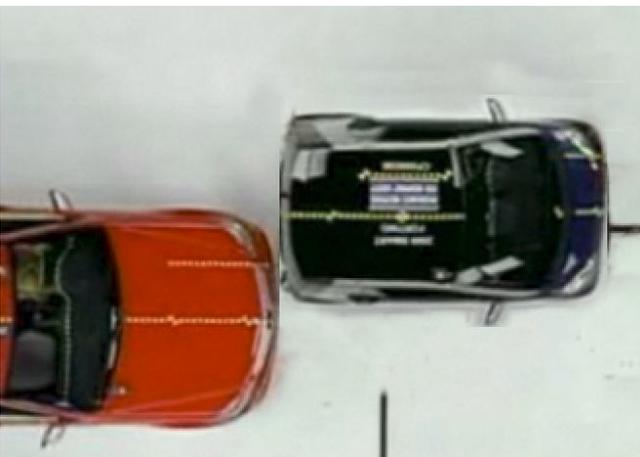
The picture on the left illustrates approximately the type of partial impact that the two vehicles endured.

The impact zone covers approximately 30% of the front of the Mercedes on the left side.

The impact zone on the rear of the Yaris also covers approximately 30% of the width of the vehicle but obviously is on the rear right hand side.

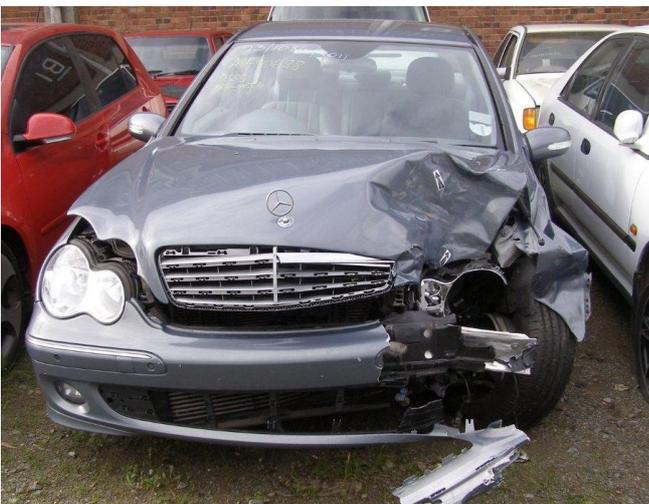
### Mercedes Benz C180K

The Mercedes has acquired moderate superficial damage to crumple zone components such as bumper, bonnet, headlamp and inner mudguard.

The right hand side of the vehicle shows little signs of the impact, notable is that the windscreen is in place and that there is no distortion of the windscreen aperture.

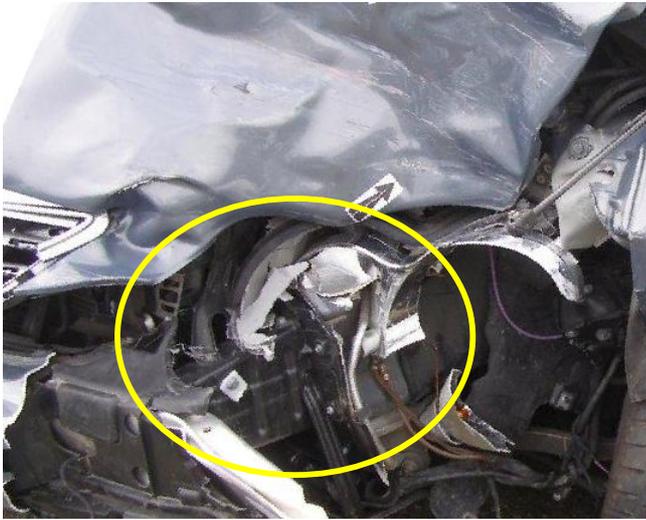
The left side impact absorber, bumper support and front chassis leg extension are in place and intact.

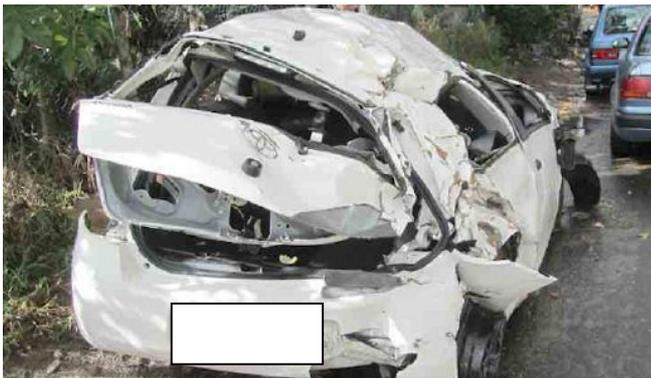
### Toyota Yaris

The initial impact damage caused to the Toyota was limited to the right hand side of the bumper, lower right hand side of the rear hatchback, right rear fender and possibly the right left tyre and wheel.

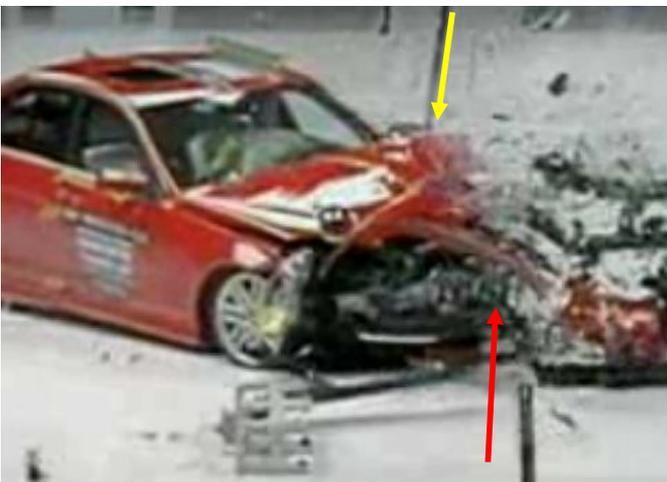
The physical evidence shows that difference in speed between the two vehicles was considerably less than 50 km/h, the impact speed was most probably closer to 30 km/h.

The clip on the right shows the severity of the damage caused to the same type of Mercedes vehicle as being driven by XXXXXX 100 milliseconds after the 30 mph (50 km/h) partial impact as shown in the earlier picture.

Note the windscreen separating and the complete destruction of the front of the vehicle.

The yellow arrow shows the direction of travel of the Mercedes prior to impact. The red is that of the smaller car

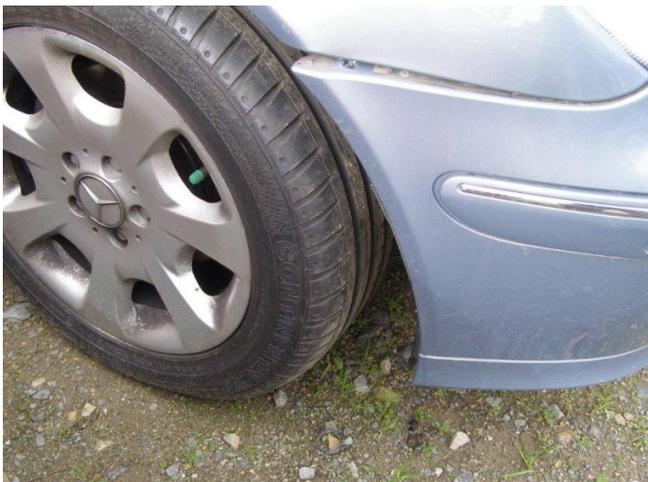
The right side of the Mercedes remained unscathed with the only sign of damage being the bumper which due to its left side impact, dislodged from its clips.

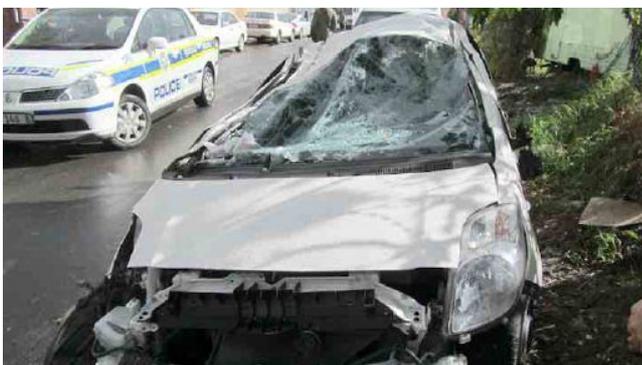
It is clear that the Toyota left the road and entered the central reservation between the off ramp to the R300 and the N2, which as shown earlier is considerably lower than the surface of the road. In doing so, the tragedy is that it rolled over at least once.

When considering the relatively light damage to the Mercedes Benz as well as the matching initial impact damage to the rear of the Toyota Yaris, it is clear that the consequential damages to the passenger cell in the ensuing roll over were the only reasons for the casualties that its occupants received.
