**Residential Recon Home Inspection Company**

# Inspection Table of Contents

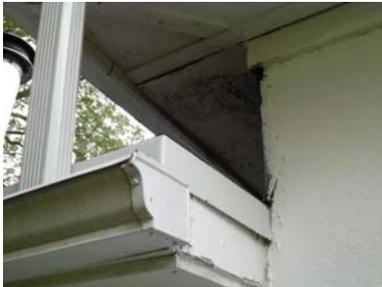
There is rotted wood soffits in the rear where the shed roof and the hip roof connect. Buyer should consider hiring a licensed contractor to repair the rotted sections of wood soffit.

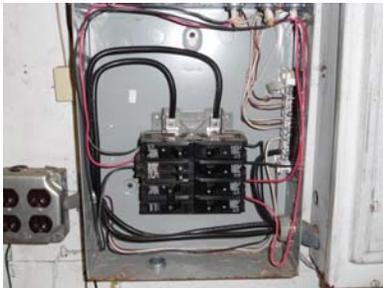
The sub panel has only one Neutral/Ground service equipment bar. The ground and Neutral should each have their own individual service equipment bar. In your case it is possible that the ground could carry current throughout the whole house. The ground should only carry current in the case of an emergency. It is recommended that you hire an electrical contractor to either add a service equipment bar for your ground wires, or replace the panel completely.

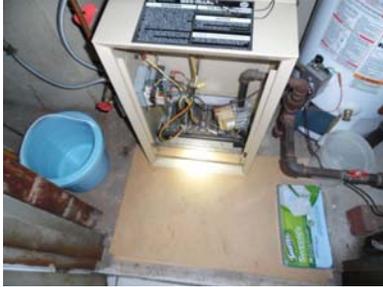
The heating system has no "Field Service Card". Oil fired heating systems require annual servicing. In the absence of a field service record within the past 12 months, recommend the heating system be serviced and cleaned by a licensed heating contractor.

At the time of the inspection the boiler would not completely fire up. This could be because of many different reasons that is outside the scope of the inspection. It is recommended that you hire a plumber or heating professional to service your unit.

It is recommended that you have your boiler serviced every year. There is a lot more to the system than the boiler, such as pumps, gas burners, igniters, and combustion air. Staying on top of a heating system extends the life of a heating system and will save you money over the long run.

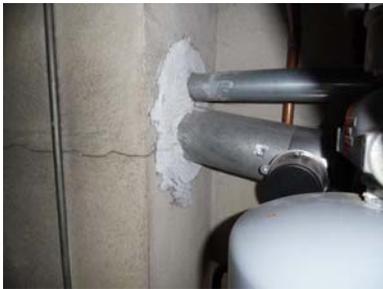
No Service Shutdown Switch was found in the home. This is a safety hazard and should be addressed by a licensed electrician.

Chimney connection appears to be coming loose and could become a safety hazard. This could allow poisonous toxins such as carbon monoxide to enter the home. It is recommended that you hire a heating professional to seal the joints and add a proper thimble to the chimney/vent connector.

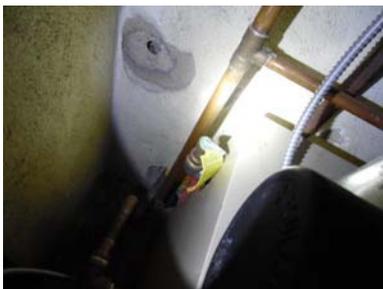
Pressure relief valve has no pipe leading to atleast 6 inches from the ground.

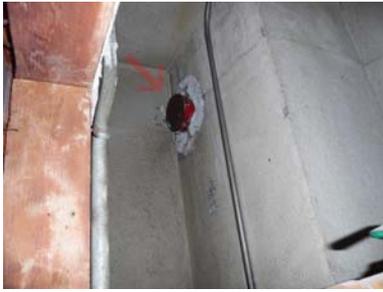
Although there is no fire place there is a second flue that is unused and is improperly sealed. There is a coffee can covering the hole for the unused flue. It is possible for particle of combustion to sneak through one flue and into the other and could re-enter the home through the space covered by the coffee. It is recommended that the gap is properly cemented over by a masonry professional.

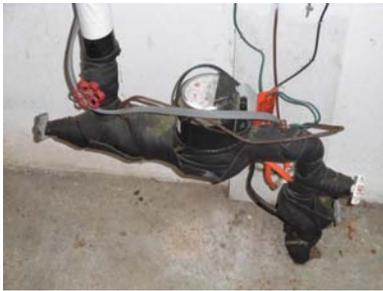
Be advised that the incoming water main was wrapped with heat tape. This is due to the water main entering the garage space below the home that is unheated. In extreme cold temperatures it is possible that the pipes freeze and potentially burst. During winter months it is advised that you monitor the pipes and utilize the heat tape that is installed.

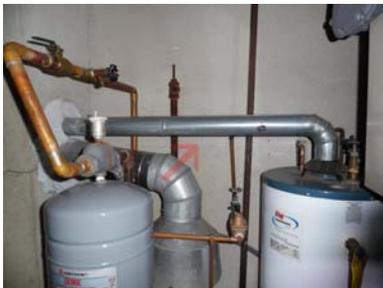
The flue for the water heater has no rise. It is recommended that the horizontal portion of the pipe rise not less than one-quarter inch to the linear foot, to insure a good draft. It is recommended that you hire a heating professional to increase the slop of your flue pipe.

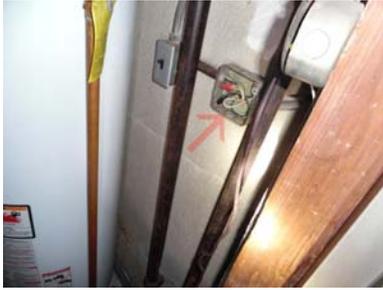
Poor - There is an open pig tail in the closet that the water heater/ boiler is located. This connection

should be properly enclosed in a junction box. It is recommended that a licensed electrician installs a junction box for the connections.

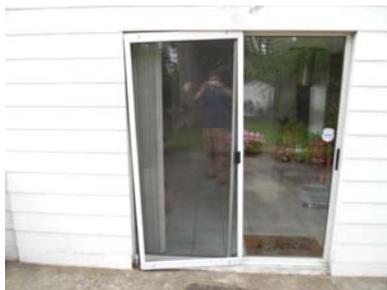
Metal - Marginal - The rear metal slider door screen has fallen out of the hinges/ The seat of the slider sits very close to the ground. This can lead to water intrusion in the winter months when the snow accumulates over the winter months. Make sure to keep the snow away from the slider.

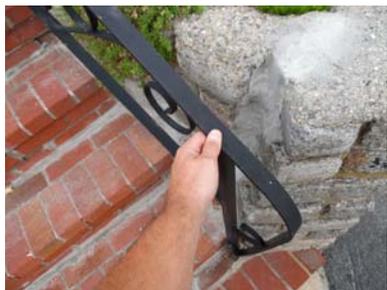
Steel Railing for brick stairway leading to home is "wobbly" and will get worse over time. I recommend that buyer budgets to replace in near future.

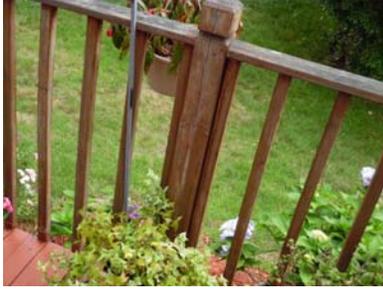
The railing posts on the rear deck are "wobbly" due to kerf cut posts. It is recommended that you hire a contractor to install new posts that continue thru the bottom of the deck and are properly bolted to the rim joist.

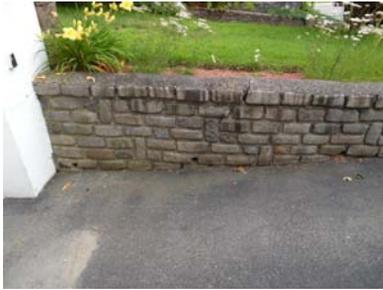
Front retaining walls and driveway retaining walls are bowing and cracking due to hydrostatic pressure. It appears that the retaining walls were cored to create weep holes to help with drainage, however, the weep holes appear to be non-professional work. You should monitor the movement of the walls and budget for potential repairs and additional weep holes to support with the drainage.

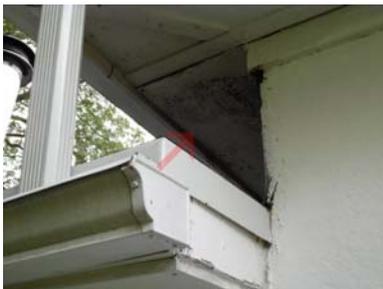
Yes - There is wood deterioration on the wooden soffits that lie just above the rubber membrane shed roof.

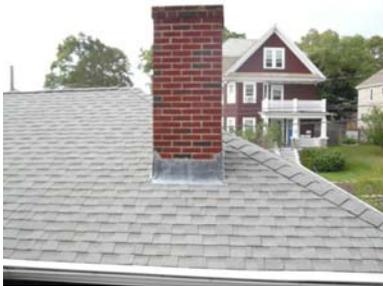
An uncapped chimney is a hole in the roof that readily admits rain, snow, ice, sleet, and wildlife. Rain water may appear in the fireplace, in a connector pipe from the furnace or in a cleanout door at the base of the chimney. A proper stainless steel cap, incorporating a spark screen, can reduce flue fire damage. by containing pieces of hot, flaming creosote attempting to spew from the chimney and ignite everything it touches. Also, almost all costly chimney restoration projects are the result of water getting inside where it doesn't belong and helping acids eat away the chimney material. **In short, good chimney caps enhance safety while they are saving money.**

Recommendation: A chimney sweep, clean the chimney, and examine the interior of the chimney and flue.

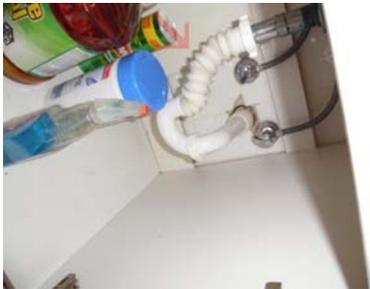
The flexible drain pipe below the sink can clog more easily due to the uneven surface on the interior of the drain

pipe. Recommend replacement of the flex drain pipes in the future with solid ABS or PVC.

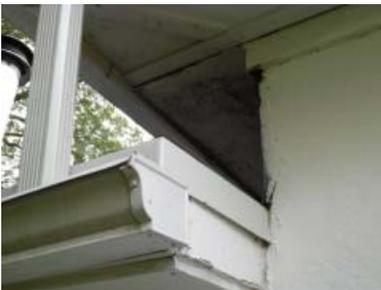
There is rotted wood soffits in the rear where the shed roof and the hip roof connect. Buyer should consider hiring a licensed contractor to repair the rotted sections of wood soffit.

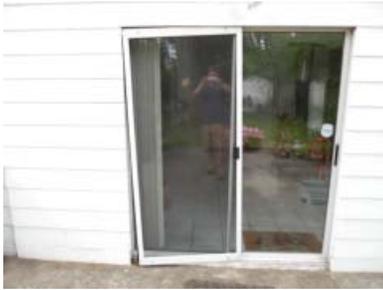
Metal - Marginal - The rear metal slider door screen has fallen out of the hinges/ The seat of the slider sits very close to the ground. This can lead to water intrusion in the winter months when the snow accumulates over the winter months. Make sure to keep the snow away from the slider.

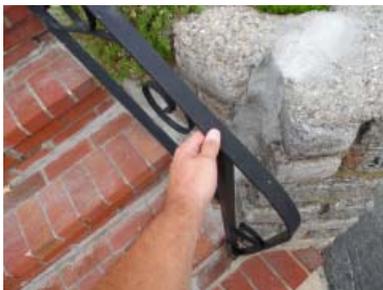
Steel Railing for brick stairway leading to home is "wobbly" and will get worse over time. I recommend that buyer budgets to replace in near future.

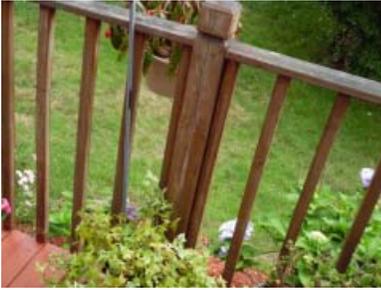
The railing posts on the rear deck are "wobbly" due to kerf cut posts. It is recommended that you hire a contractor to install new posts that continue thru the bottom of the deck and are properly bolted to the rim joist.

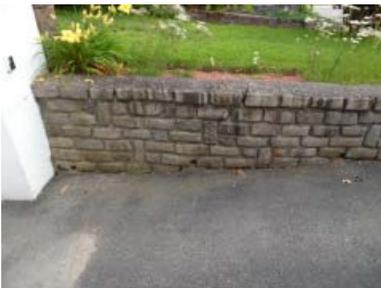
Front retaining walls and driveway retaining walls are bowing and cracking due to hydrostatic pressure. It appears that the retaining walls were cored to create weep holes to help with drainage, however, the weep holes appear to be non-professional work. You should monitor the movement of the walls and budget for potential repairs and additional weep holes to support with the drainage.

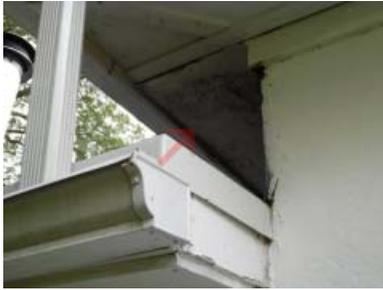
Yes - There is wood deterioration on the wooden soffits that lie just above the rubber membrane shed roof.

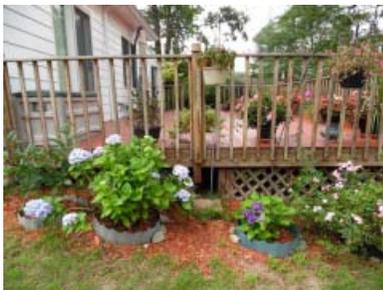
At time of inspection, lattice/fencing enclosed the deck. As a result, not all structural members of the deck were **readily accessible and observable**. Their true condition has not been determined and hidden defects may exist. You should ask the homeowner to remove the lattice work/fencing from around the deck and re-inspect the structural members under the deck prior to closing. If unreported defects arise, please call this office for further consultation or optional return visit.

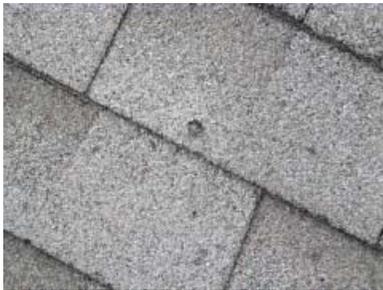
**Observation:** DE-ICING CABLES ON ROOF ON ROOF- Electrical heating cables , known as de-icing cables, were observed on the roof near its edges or valleys.

**Analysis:** A de-icing cable is typically installed on top of the roof shingles to melt snow and ice near the eaves and thereby prevent ice dam formation. For shock protection, the cable should be connected to a GFCI protected outlet. Be advised that the operational condition of the de-icing cable is undetermined.

**Recommendation:** Ask the owner to demonstrate the use of the de-icing system. **Be sure to ask about its needed frequency of use and about any past history of ice dam problems.**

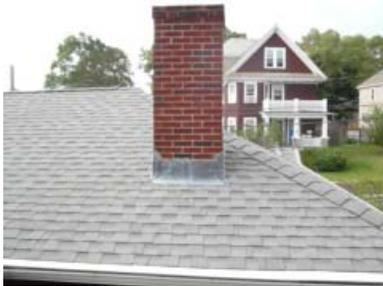
An uncapped chimney is a hole in the roof that readily admits rain, snow, ice, sleet, and wildlife. Rain water may appear in the fireplace, in a connector pipe from the furnace or in a cleanout door at the base of the chimney. A proper stainless steel cap, incorporating a spark screen, can reduce flue fire damage. by containing pieces of hot, flaming creosote attempting to spew from the chimney and ignite everything it touches. Also, almost all costly chimney restoration projects are the result of water getting inside where it doesn't belong and helping acids eat away the chimney material. **In short, good chimney caps enhance safety while they are saving money.**

Recommendation: A chimney sweep, clean the chimney, and examine the interior of the chimney and flue.

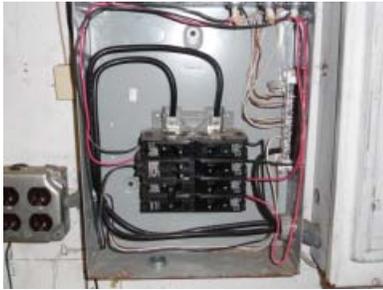
The sub panel has only one Neutral/Ground service equipment bar. The ground and Neutral should each have there own individual service equipment bar. In your case it is possible that the ground could carry current throughout the whole house. The ground should only carry current the case of an emergency. It is recommended that you hire and electrical contractor to either add a service equipment bar for your ground wires, or replace the panel completely.

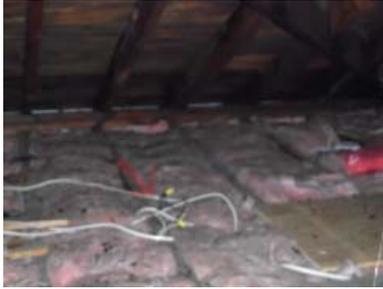
There is a branch circuit located in the attic that has an exposed pigtail. It is recommended that you hire an electrician to install a junction box for the pig tail, so that the open connection is properly protected from combustible hazards.

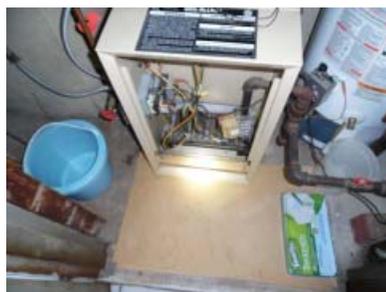
It is recommended that you have your boiler serviced every year. There is a lot more to the system than the boiler, such as pumps, gas burners, igniters, and combustion air. Staying on top of a heating system extends the life of a heating system and will save you money over the long run.

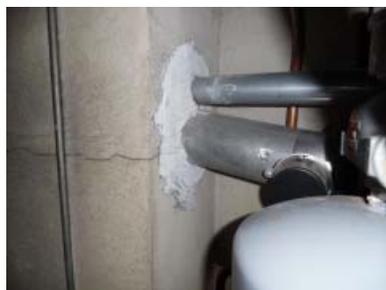
Chimney connection appears to be coming loose and could become a safety hazard. This could allow poisonous toxins such as carbon monoxide to enter the home. It is recommended that you hire a heating professional to seal the joints and add a proper thimble to the chimney/vent connector.

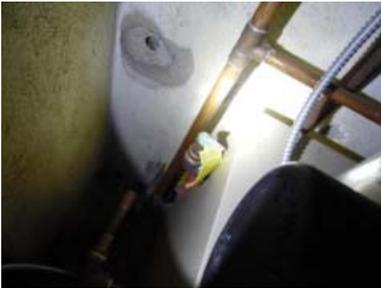
Pressure relief valve has no pipe leading to atleast 6 inches from the ground.

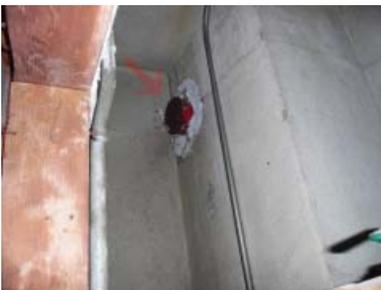
Although there is no fire place there is a second flue that is unused and is improperly sealed. There is a coffee can covering the hole for the unused flue. It is possible for particle of combustion to sneak through one flue and into the other and could re-enter the home through the space covered by the coffee can. It is recommended that the gap is properly cemented over by a masonry professional.

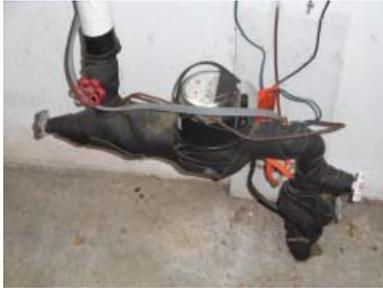
Be advised that the incoming water main was wrapped with heat tape. This is due to the water main entering the garage space below the home that is unheated. In extreme cold temperatures it is possible that the pipes freeze and potentially burst. During winter months it is advised that you monitor the pipes and utilize the heat tape that is installed.

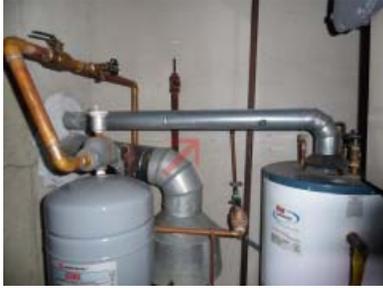
The flue for the water heater has no rise. It is recommended that the horizontal portion of the pipe rise not less than one-quarter inch to the linear foot, to insure a good draft. It is recommended that you hire a heating professional to increase the slop of your flue pipe.

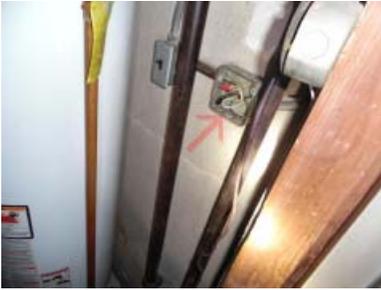
Poor - There is an open pig tail in the closet that the water heater/ boiler is located. This connection should be properly enclosed in a junction box. It is recommended that a licensed electrician installs a junction box for the connections.

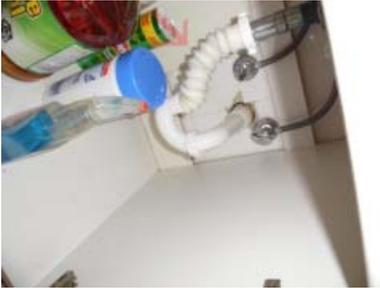
**Condition:**  
The flexible drain pipe below the sink can clog more easily due to the uneven surface on the interior of the drain pipe. Recommend replacement of the flex drain pipes in the future with solid ABS or PVC.
