# Your Inspection Report

1234 My Street  
Boise, ID 83702

**INSPECTION DATE:**  
Thursday, October 22, 2015

RE: Report No. 1006  
1234 My Street  
Boise, ID  
83702

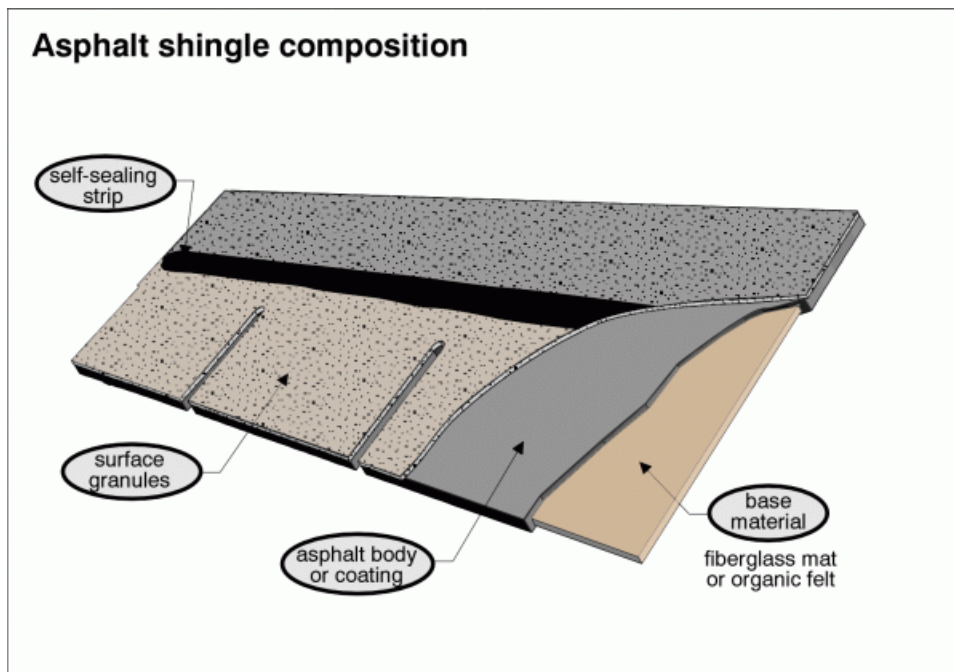
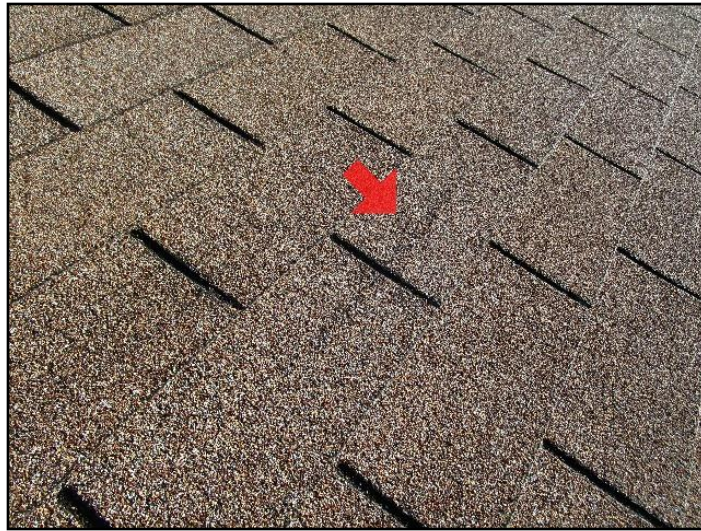
**1. Condition:** • [Granule loss](#)

**Implication(s):** Chance of water damage to contents, finishes and/or structure

**Location:** Throughout Roof

Granule loss

**Task:** Monitor

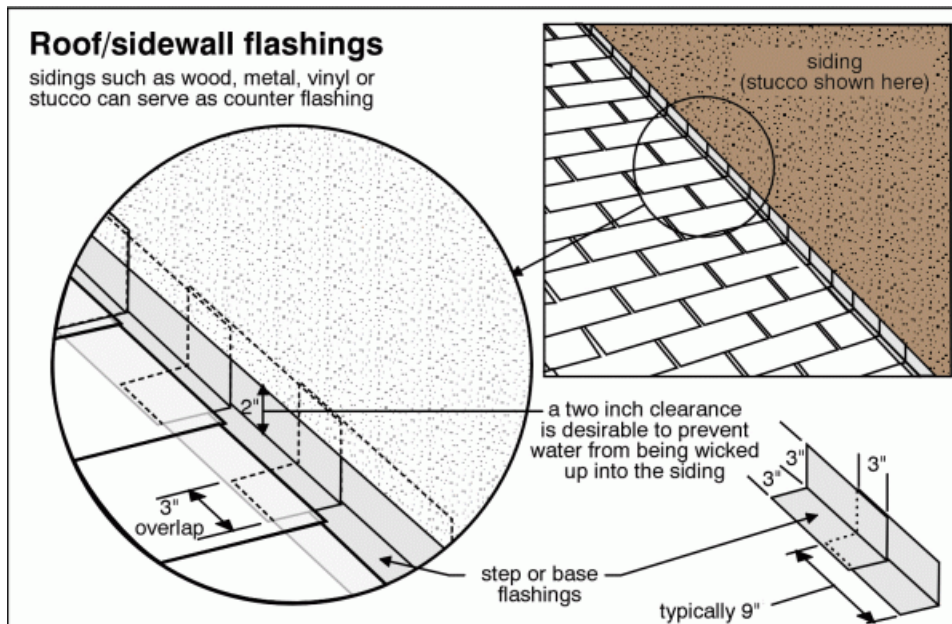
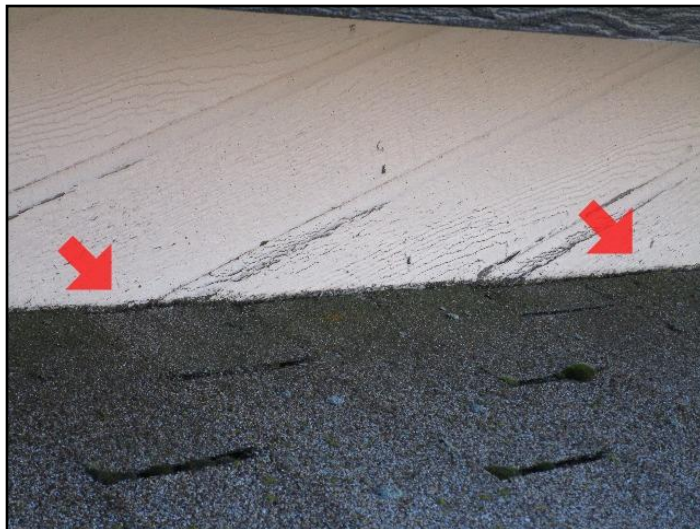
2. Condition: • [Siding not cut back](#)

Implication(s): Chance of water damage to contents, finishes and/or structure

Location: Front Roof

*Siding not cut back*

Task: Repair

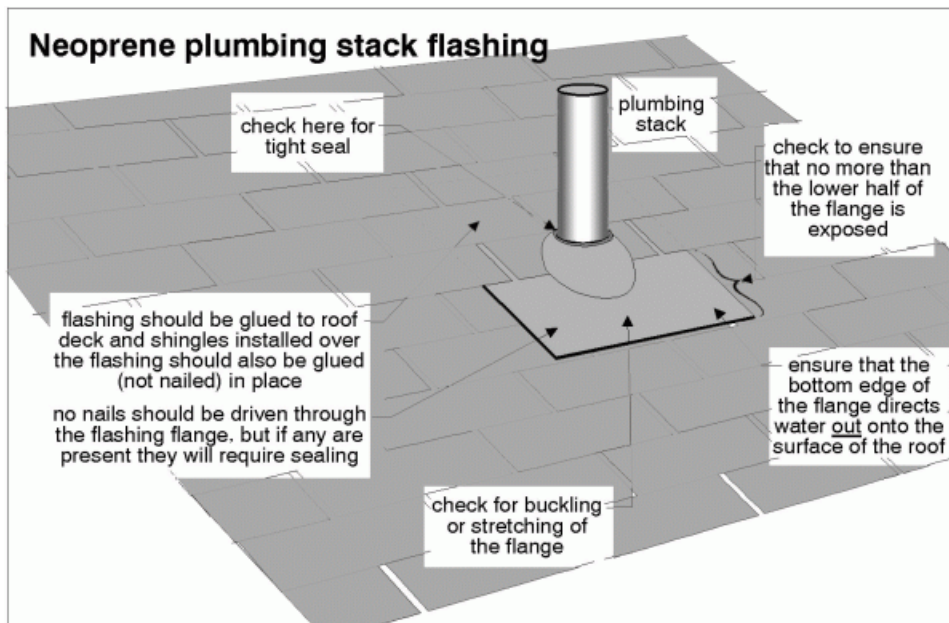
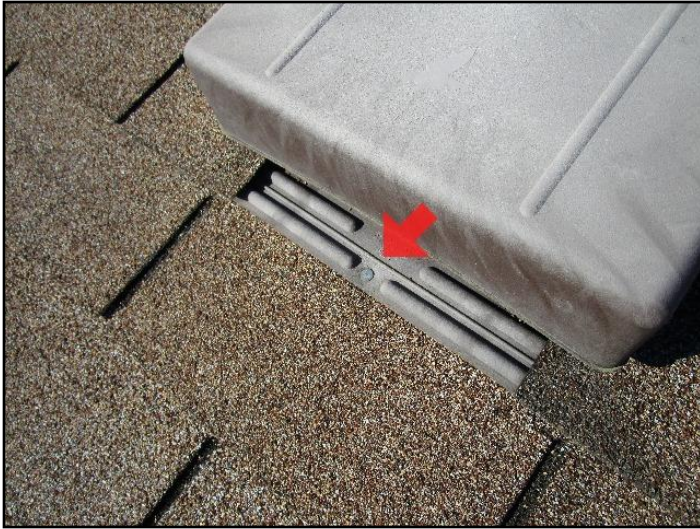
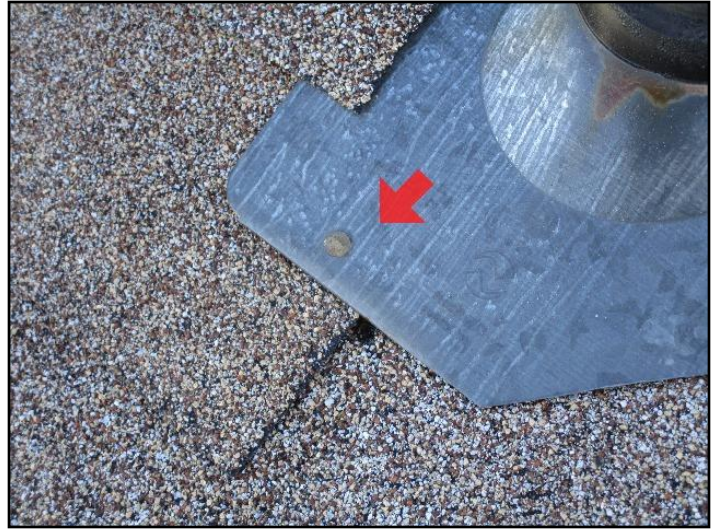
3. Condition: • [Exposed, missing fasteners](#)

Implication(s): Chance of water damage to contents, finishes and/or structure

Location: Throughout Roof

*Exposed, missing fasteners*

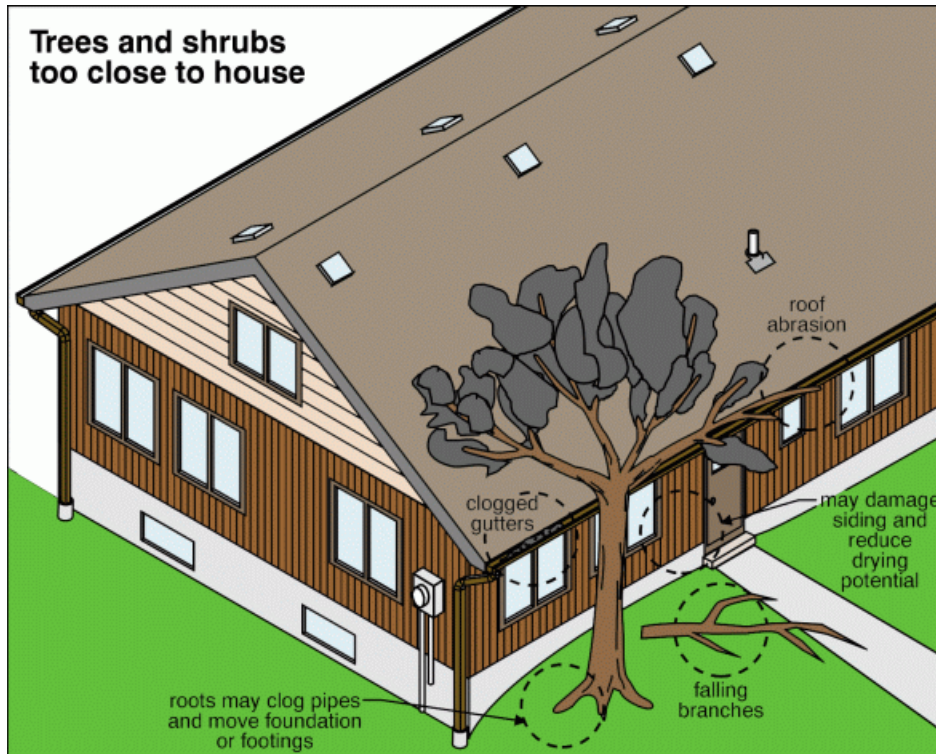
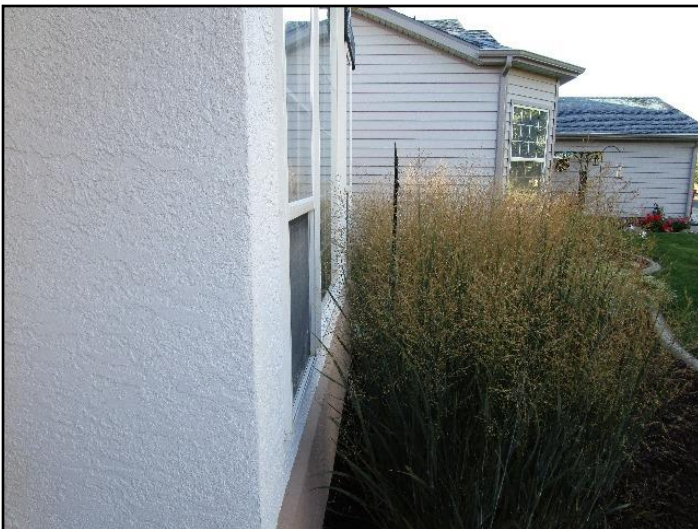
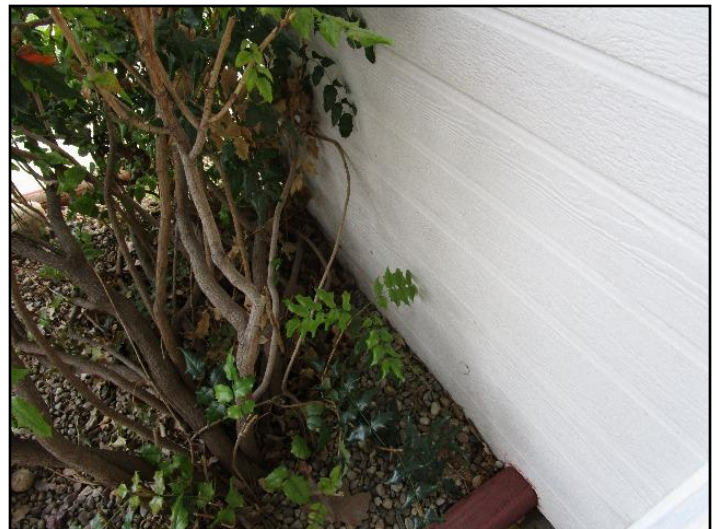
**6. Condition:** • [Trees or shrubs too close to building](#)

**Implication(s):** Chance of water damage to contents, finishes and/or structure | Chance of pests entering building | Material deterioration

**Location:** Front

*Trees or shrubs too close to building*

**Task:** Improve

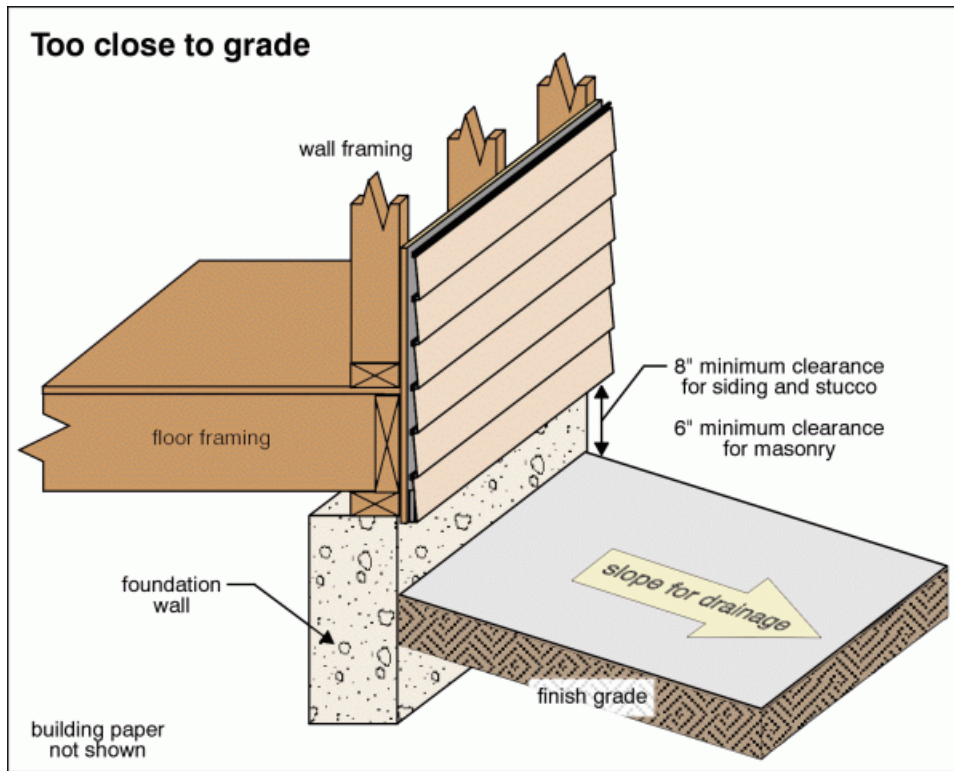
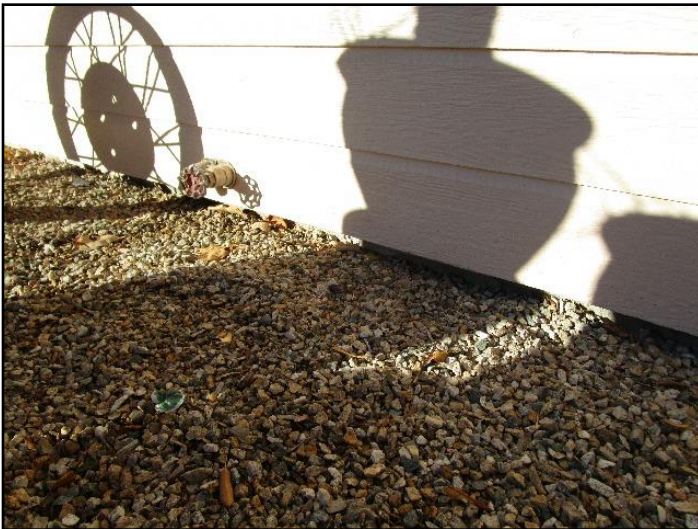
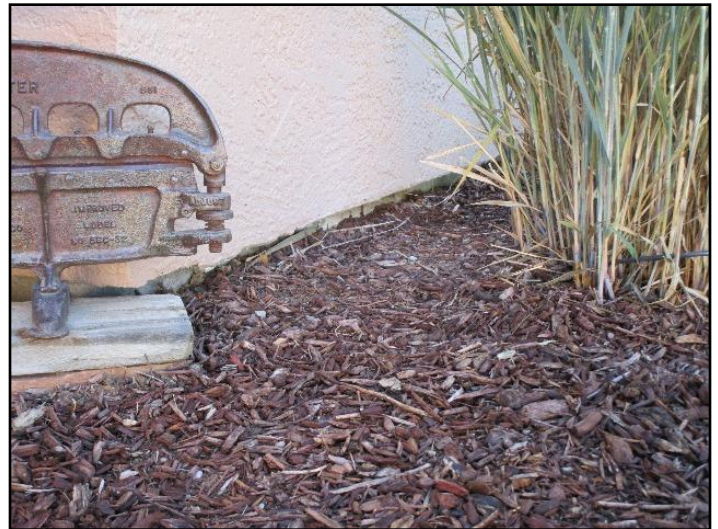
**7. Condition:** • [Siding too close to grade](#)

**Implication(s):** Chance of water entering building | Weakened structure | Rot | Insect damage

**Location:** Throughout Exterior

*Siding too close to grade*

**Task:** Improve

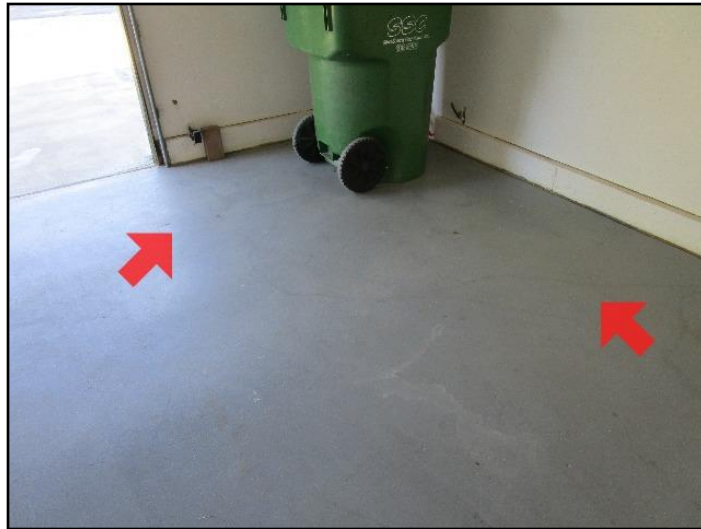
**8. Condition:** • [Improper slope](#)

**Implication(s):** Loss of proper slope for drainage

**Location:** Northwest Garage

*Improper slope*

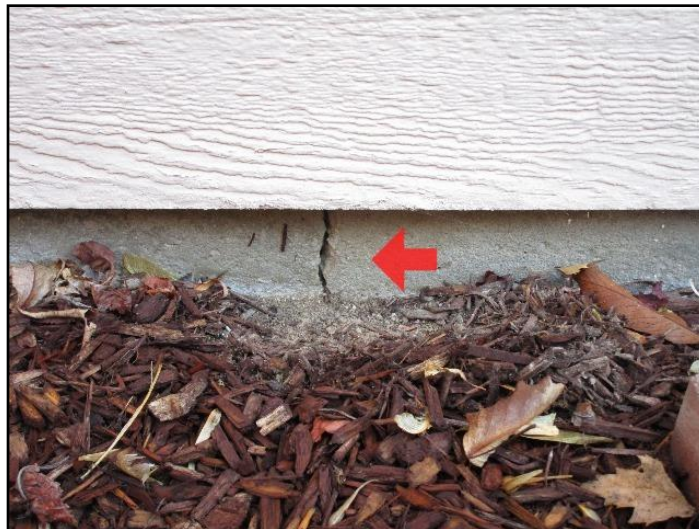
**Condition:** • [Cracked](#)

**Implication(s):** Chance of water damage to contents, finishes and/or structure | Weakened structure

**10. Condition:** • [Cracked](#)

**Location:** South

*Cracked*

**Task:** Repair Monitor

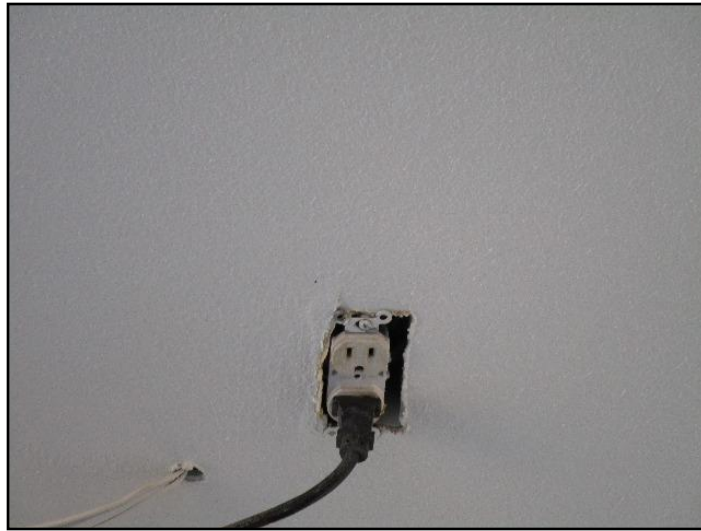
**11. Condition:** • [Missing](#)  
**Implication(s):** Electric shock  
**Location:** Garage  
**Task:** Repair or replace

*Missing*

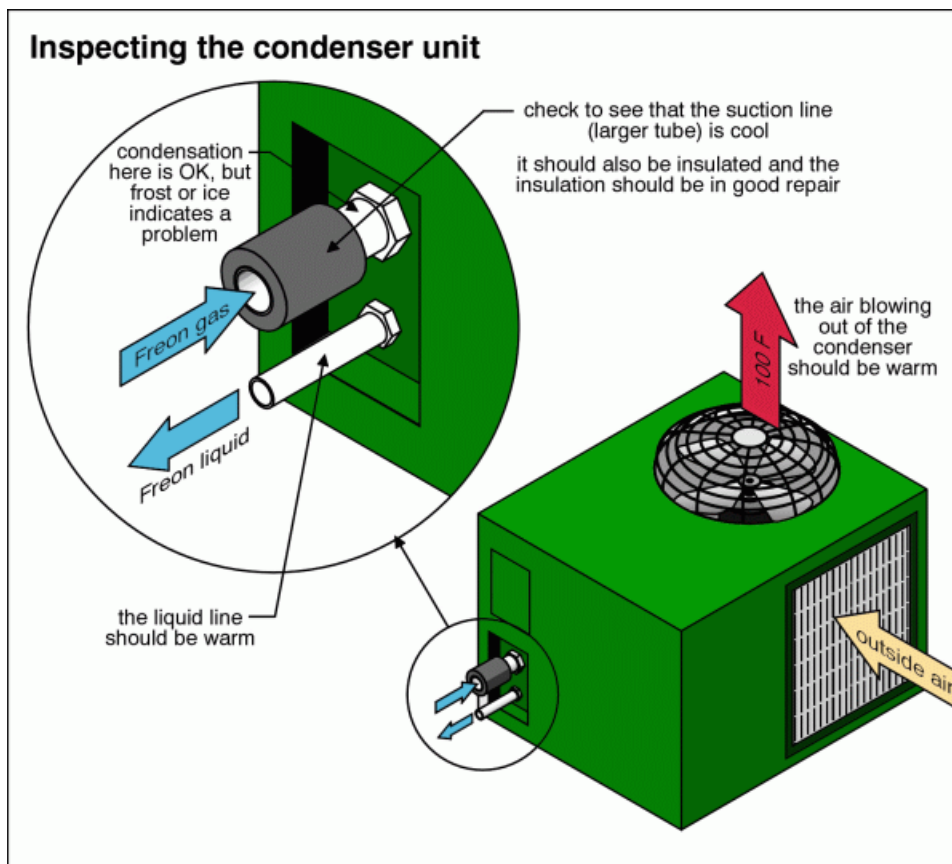
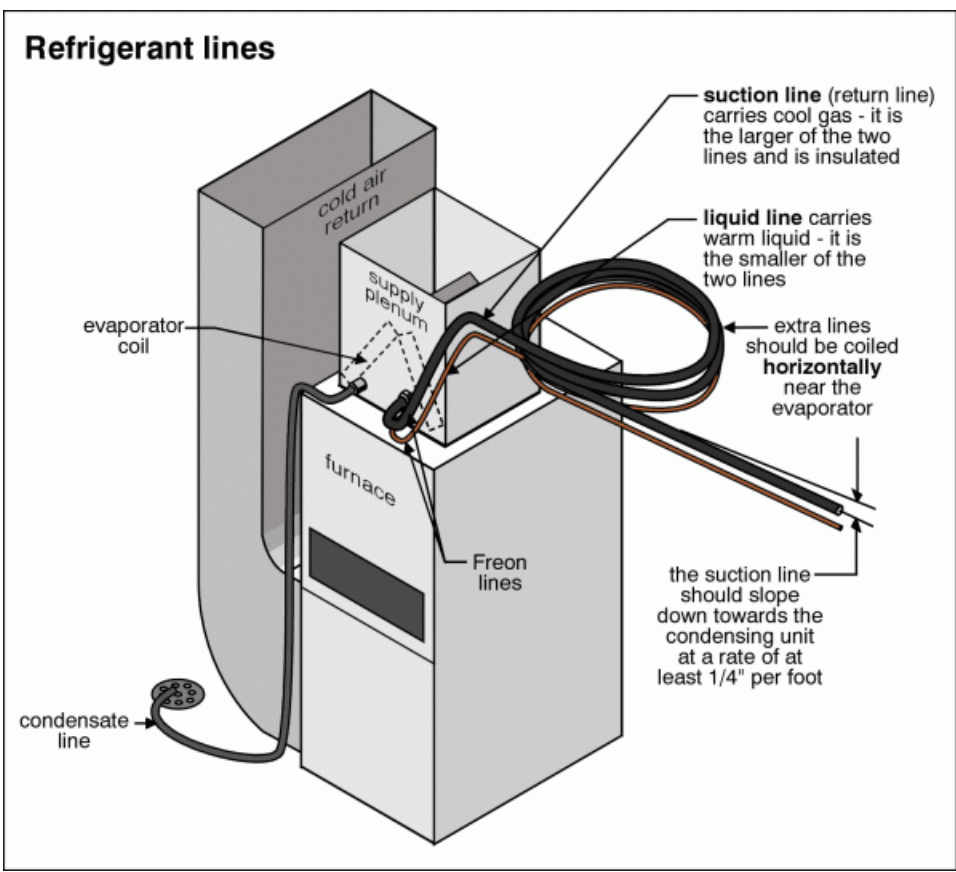
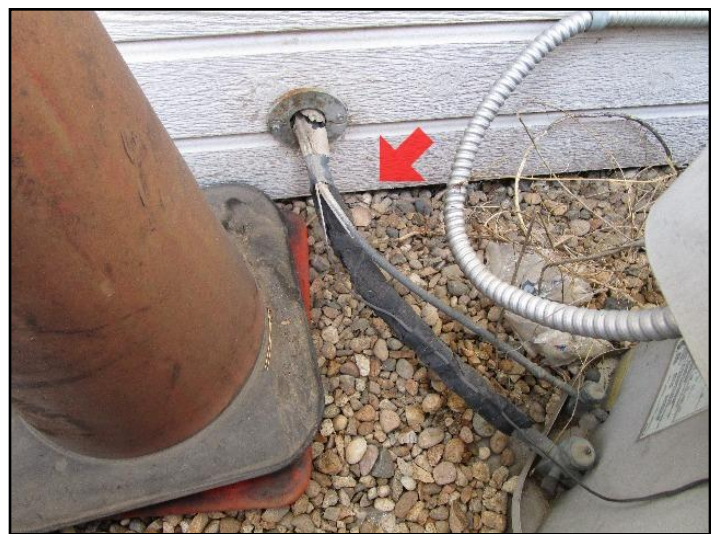
**13. Condition:** • [Missing insulation](#)

**Implication(s):** Reduced system life expectancy | Increased cooling costs | Reduced comfort

**Location:** Exterior

*Missing insulation*

**Task:** Repair or replace

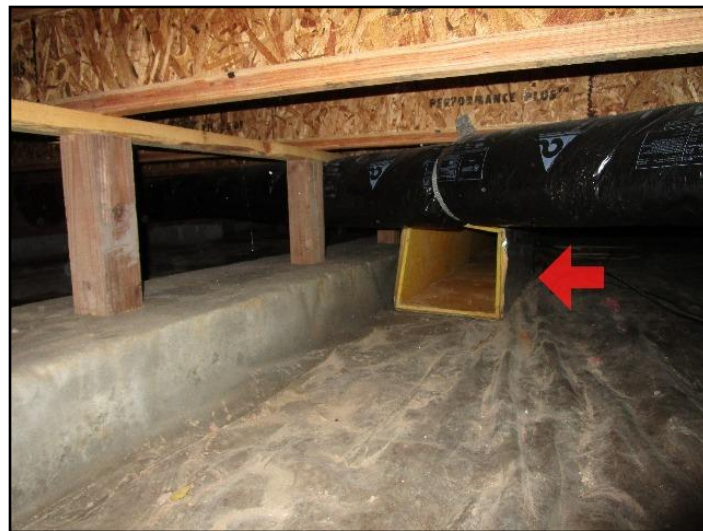
- 14. Condition:** • Debris in crawl space
- Location:** Throughout Crawl Space
- Task:** Remove

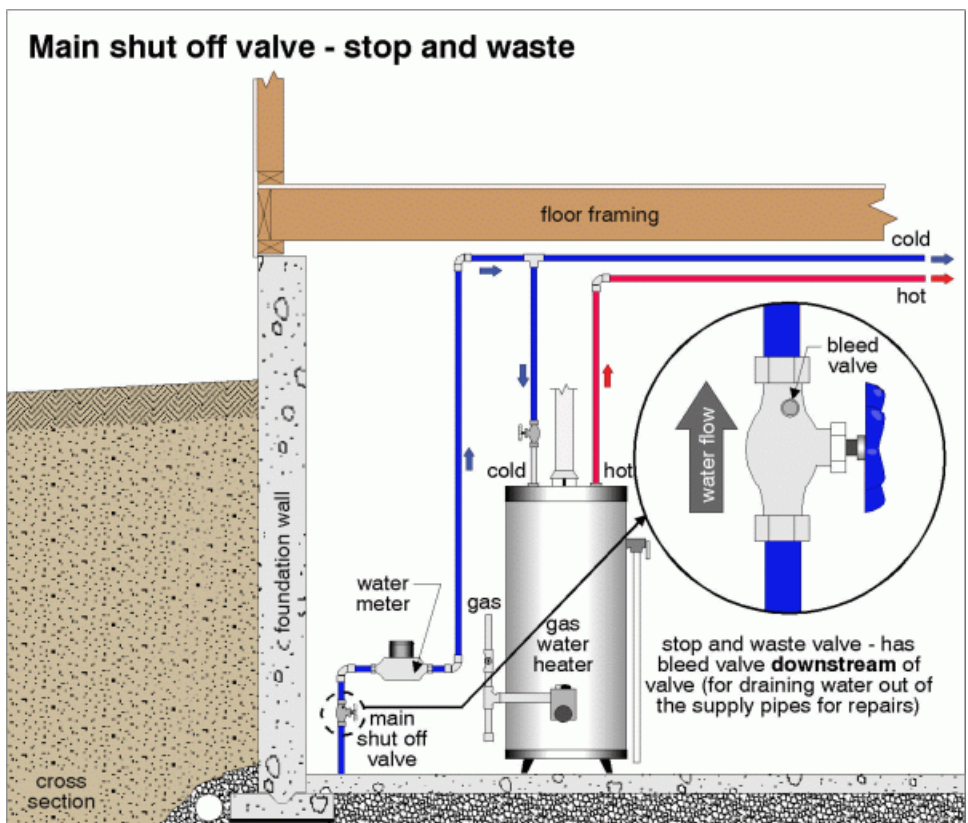
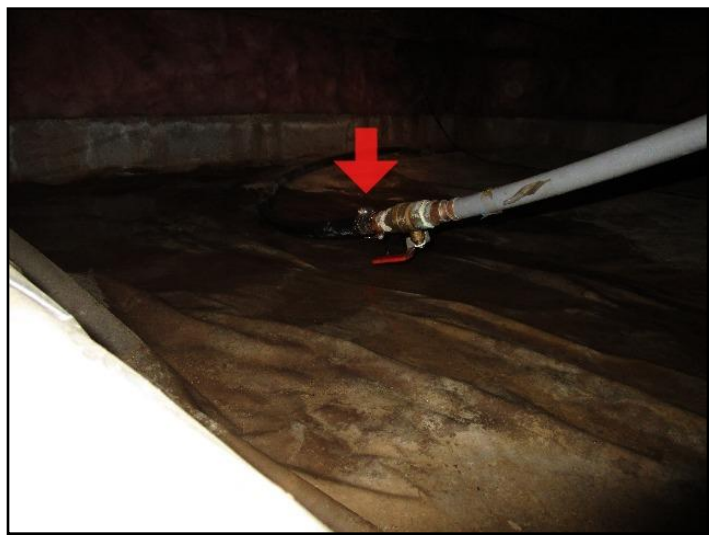
**Condition:** • [Leak](#)

**Implication(s):** Chance of water damage to contents, finishes and/or structure | No water

**Location:** Southwest Crawl Space

**15. Condition:** • [Leak](#)

Leak

**Task:** Repair

**Time:** Immediate

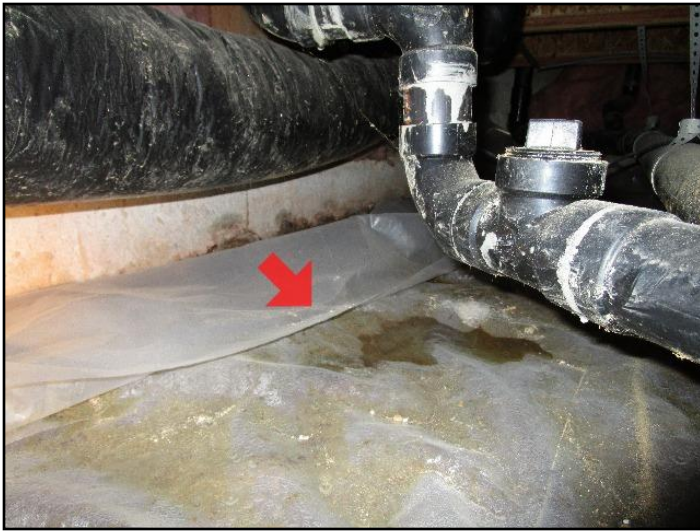
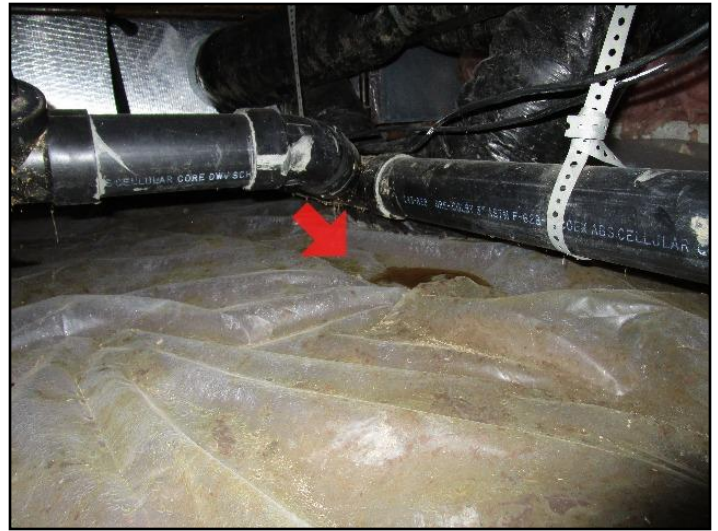
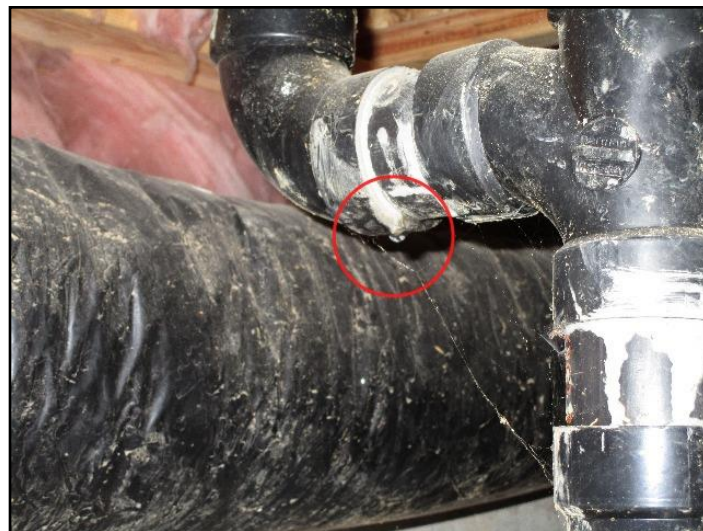
**Condition:** • [Leak](#)

**Implication(s):** Sewage entering the building

**Location:** Crawl Space

16. Condition: • [Leak](#)

Implication(s): Sewage entering the building

Location: Crawl Space

Leak

Task: Repair

Time: Immediate

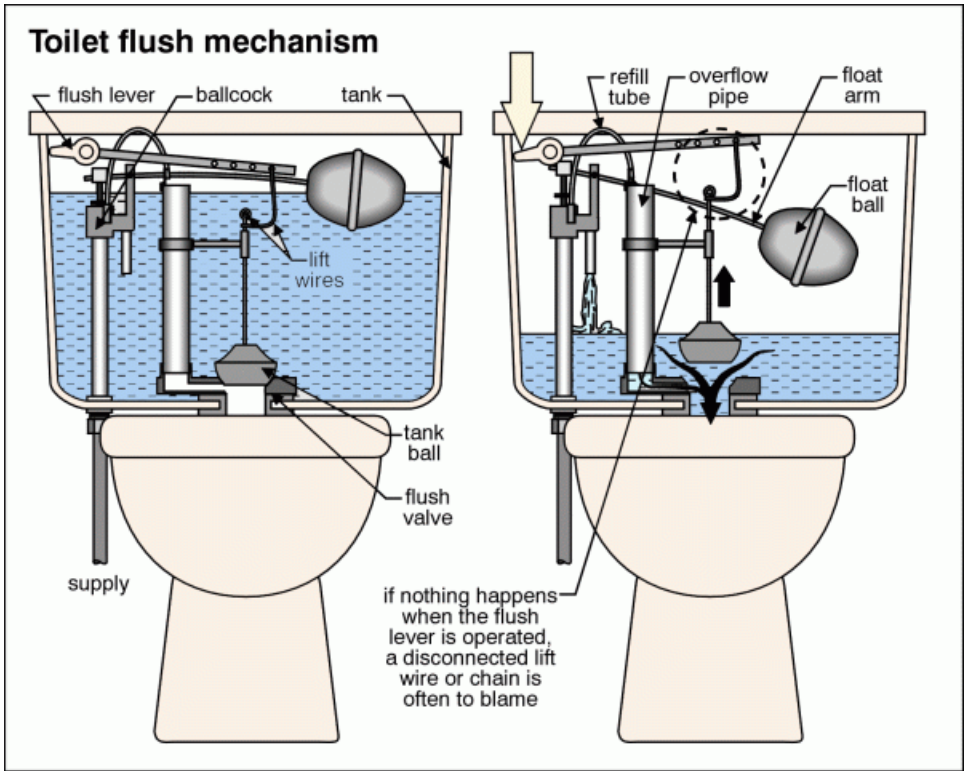
**17. Condition:** • [Running continuously](#)

**Implication(s):** Chance of condensation damage to finishes and/or structure | Increased water consumption

**Location:** Hallway Bathroom

**Task:** Repair

**Time:** Immediate
