Right Angle Inspections, LLC

Property Inspection Report

123 Any St, Everytown, CO 80123
Inspection prepared for: Will Buy
Real Estate Agent: Goode Sell - ABC Real Estate

Date of Inspection: 11/7/2015 Time: 11:00
Age of Home: 1979 Size: 1850'
Weather: Sunny

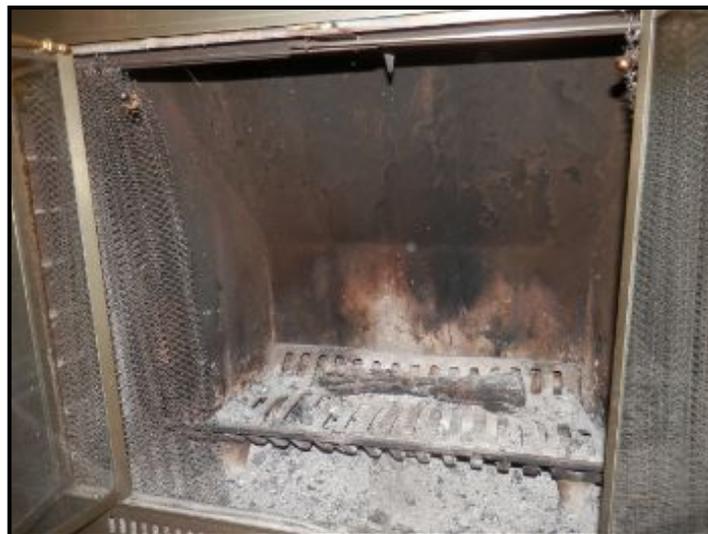
Interior Areas Fireplace

- Damper is difficult to operate.
- The burn chamber and flue are dirty.
- Professional cleaning and adjustments are recommended prior to further use.

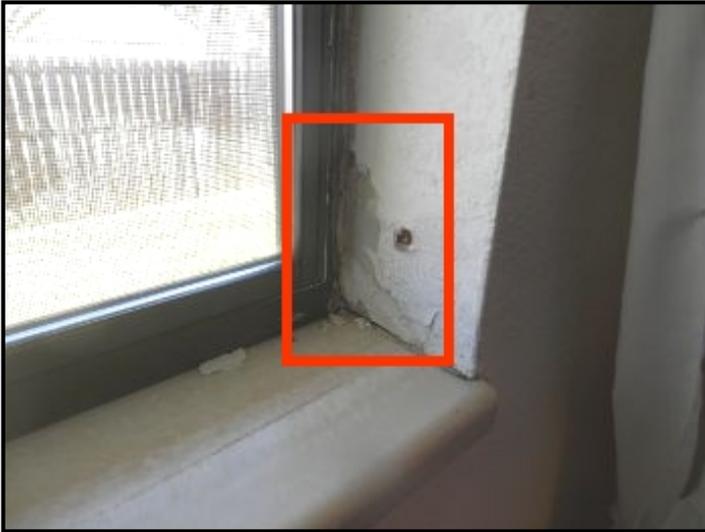
- Caulking between the window and frame is recommended at many of the windows.
- There are many windows that need service work. Some of the main house windows do not latch correctly. Many sunroom windows do not open a close correctly. I recommend a qualified window service person to thoroughly further evaluate ALL windows throughout to determine the extent of repairs and cost. When multiple problems are found; I report as a grouping, reporting every single maintenance issue and/or defect at precise locations is outside the scope of this inspection in this situation.

Caulk and paint

Page 3 Item: 4	Window Condition	<ul style="list-style-type: none"> • There are many windows that need service work. Some of the main house windows do not latch correctly. Many sunroom windows do not open a close correctly. I recommend a qualified window service person to thoroughly further evaluate ALL windows throughout to determine the extent of repairs and cost. When multiple problems are found; I report as a grouping, reporting every single maintenance issue and/or defect at precise locations is outside the scope of this inspection in this situation.
Kitchen		
Page 4 Item: 3	GFCI	<ul style="list-style-type: none"> • No GFCI in the kitchen. Ground fault circuit interruption protection should installed at all outlets near water sources and exterior including garages. Required locations have continually been added to safety standards over the years as the protection these devices provide have saved lives and prevents injury. Upgrading an older structure to be in compliance with current standards is highly recommend but not required. Bringing certain circuits to current standards is typically the responsibility of the purchaser but is subject to negotiation due to the safety aspect of these devices. Consult a competent and licensed electrician to install these devices at the appropriate locations.

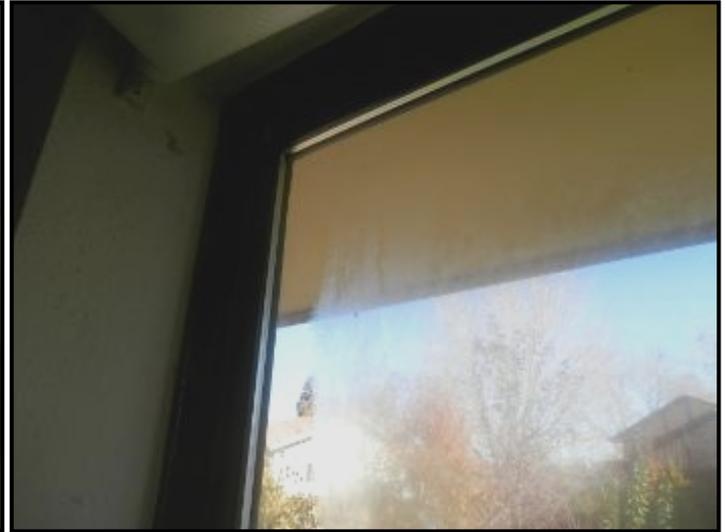
Bad thermal seal

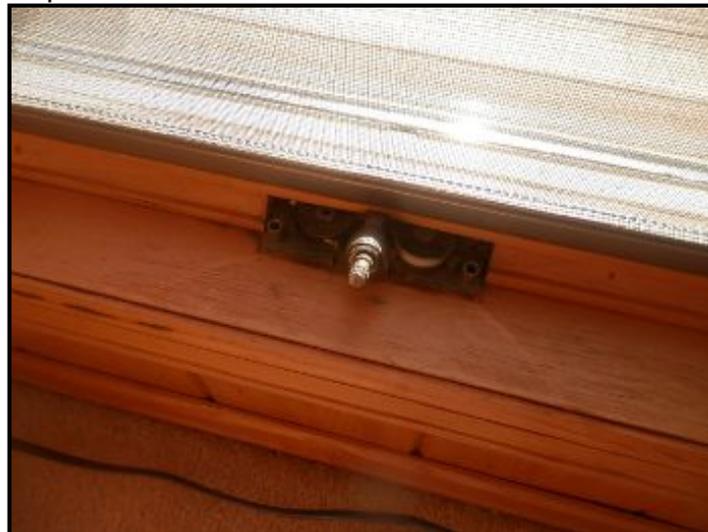
Missing/dammaged hardware

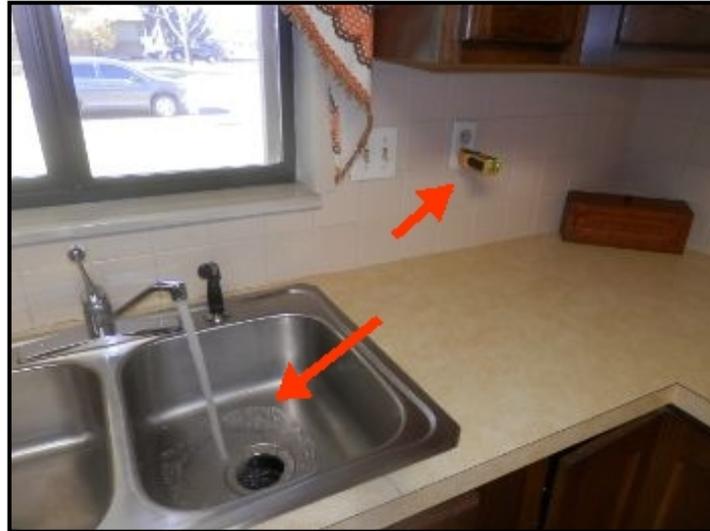
- **No GFCI in the kitchen.** Ground fault circuit interruption protection should be installed at all outlets near water sources and exterior including garages. Required locations have continually been added to safety standards over the years as the protection these devices provide have saved lives and prevented injury. Upgrading an older structure to be in compliance with current standards is highly recommended but not required. Bringing certain circuits to current standards is typically the responsibility of the purchaser but is subject to negotiation due to the safety aspect of these devices. Consult a competent and licensed electrician to install these devices at the appropriate locations.

No GFCI

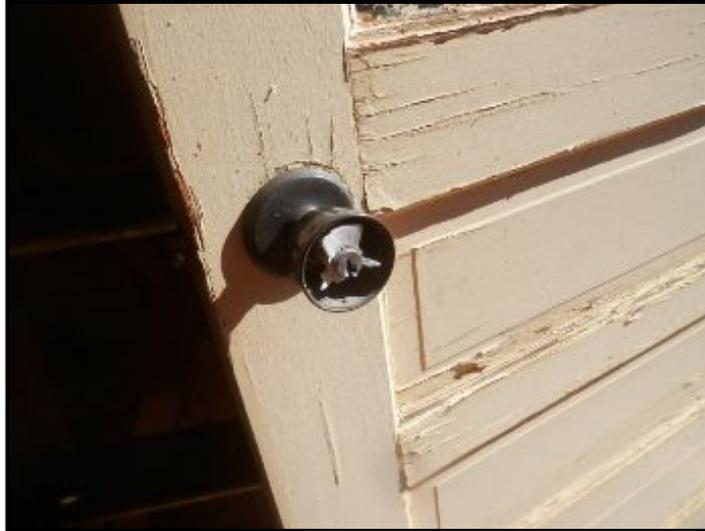
Garage Exterior Door

- Old door knob deteriorated on the exterior. Older, not very secure, locking mechanism. Recommend upgrading to newer and more secure hardware.

Garage		
Page 8 Item: 1	Exterior Door	<ul style="list-style-type: none"> • Old door knob deteriorated on the exterior. Older, not very secure, locking mechanism. Recommend upgrading to newer and more secure hardware.

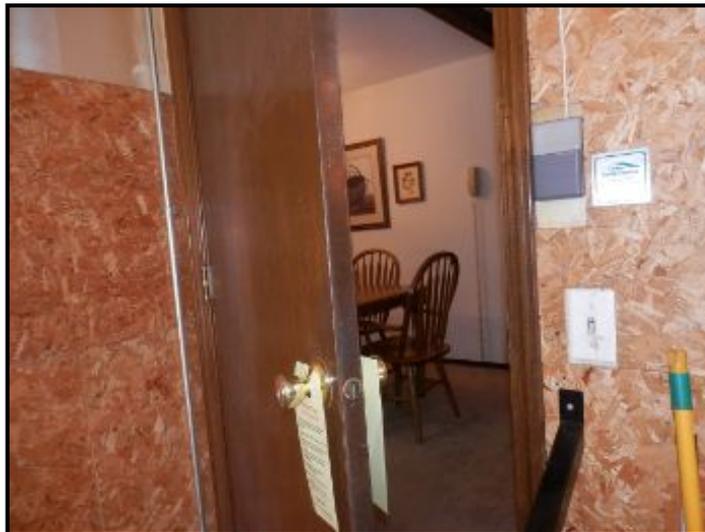
- Garage-house door does not close automatically. This is to act as a fire stop, and keeps exhaust fumes out. Self-closing devices, such as spring loaded hinges, on garage access doors into the living space should be installed for adequate fire safety protection.

Page 8 Item: 2	Fire Door	<ul style="list-style-type: none"> • Garage-house door does not close automatically. This is to act as a fire stop, and keeps exhaust fumes out. Self-closing devices, such as spring loaded hinges, on garage access doors into the living space should be installed for adequate fire safety protection.
Roof		
Page 11 Item: 1	Roof Condition	<ul style="list-style-type: none"> • Roof surface material has more wear then normal for the age. Long term dependability is questionable. • Note that experts recommend that any roof over 10 years old receive a roof certification by a local roofing specialist. • A licensed and competent roofing contractor should be called to make further evaluation and perform repairs as needed.
Page 12 Item: 3	Gutter	<ul style="list-style-type: none"> • The gutters are older and corroding. Some areas need reattaching and/or sloping. System components are deteriorating, may have a limited life. A qualified service technician should perform further evaluation and make repairs as needed.

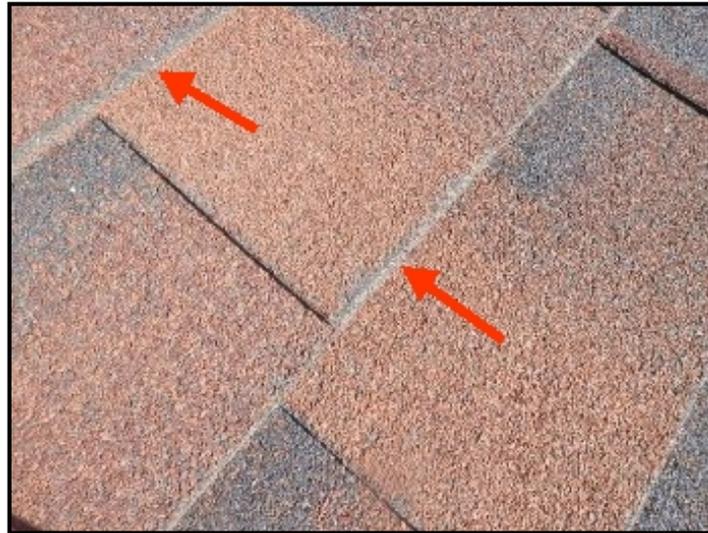
- Roof surface material has more wear than normal for the age. Long term dependability is questionable.
- Note that experts recommend that any roof over 10 years old receive a roof certification by a local roofing specialist.
- A licensed and competent roofing contractor should be called to make further evaluation and perform repairs as needed.

Wear noted

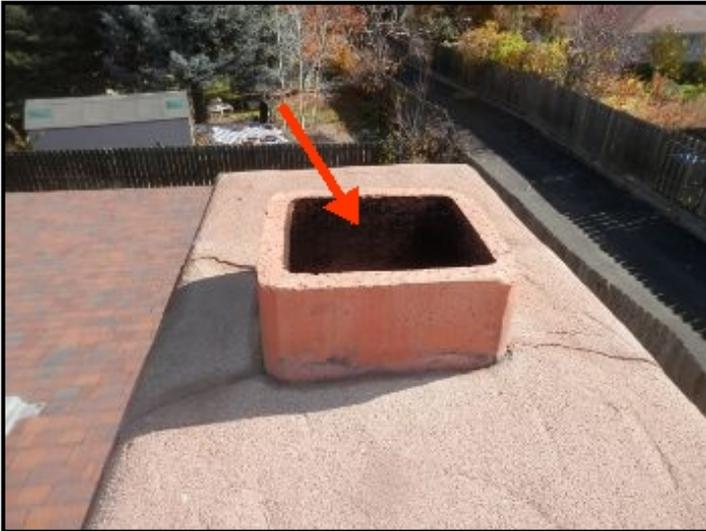
- No chimney cap or spark arrestor noted. Recommend installation to prevent premature weathering, water intrusion, and nesting of wildlife.
- Case cap (chimney crown) is cracked and should be caulked to reduce opportunity for water infiltration and damage. This is a common maintenance item that is often neglected by homeowners; you should make a crown inspection part of your routine seasonal maintenance checklist.

No spark arrestor

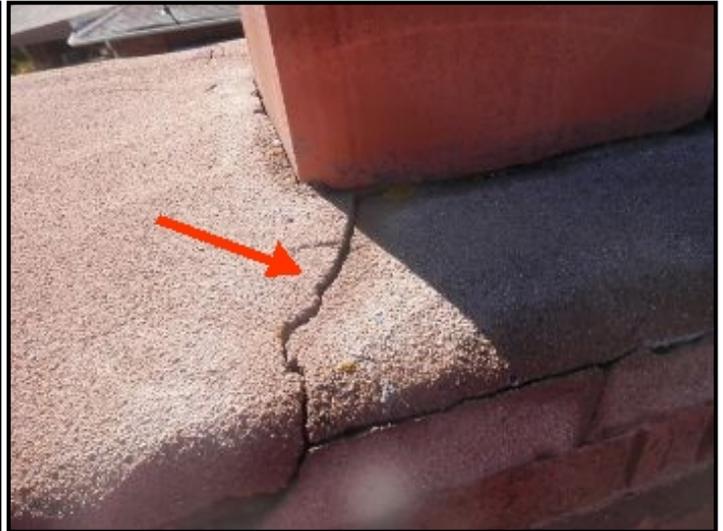
Crack in the cover

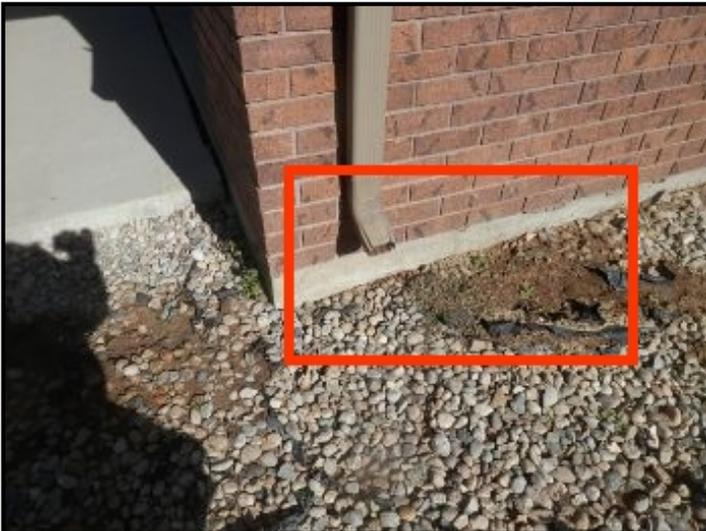
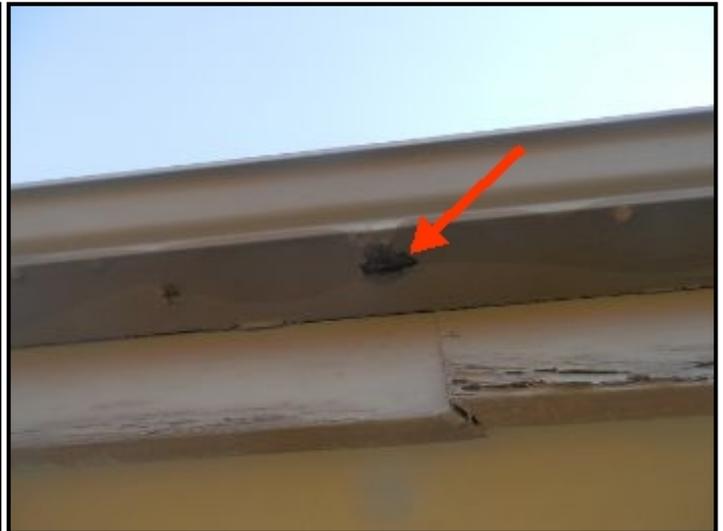
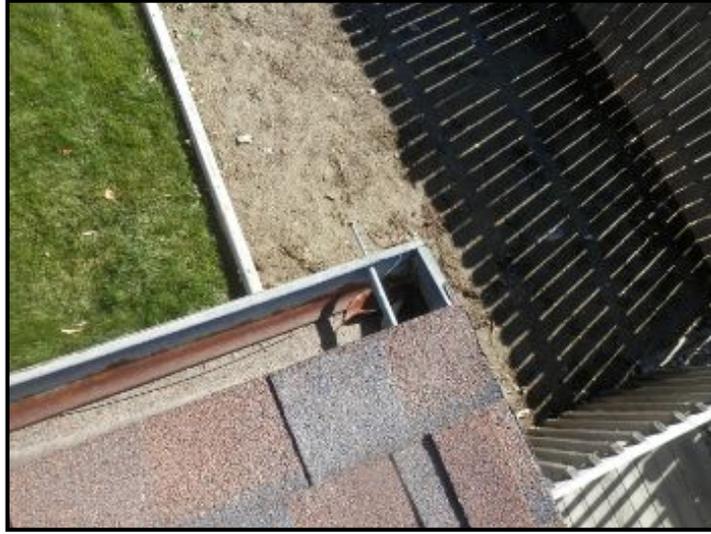
- Downspout extensions are missing or insufficient: Install to divert water at least 4 to 6 feet away from the foundation.
- The gutters are older and corroding. Some areas need reattaching and/or sloping. System components are deteriorating, may have a limited life. A qualified service technician should perform further evaluation and make repairs as needed.

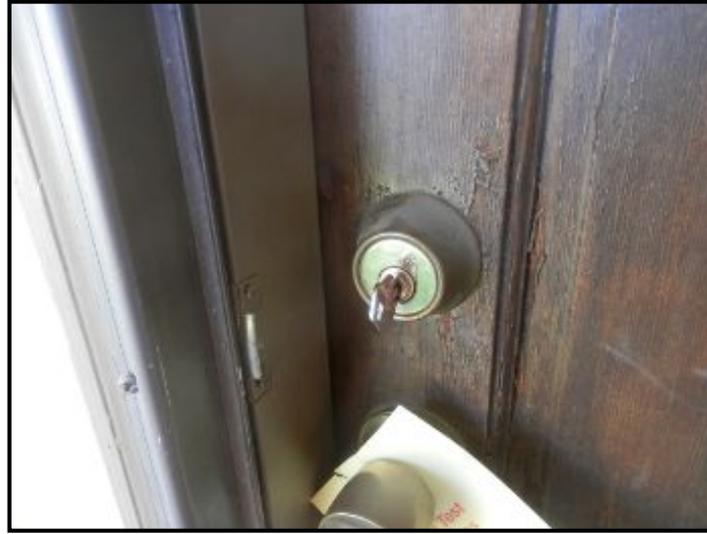
- Front Door - Dead bolt is hard to operate. Minor adjustments are needed to restore proper operation. Recommend further evaluation and repairs made by an experienced locksmith.

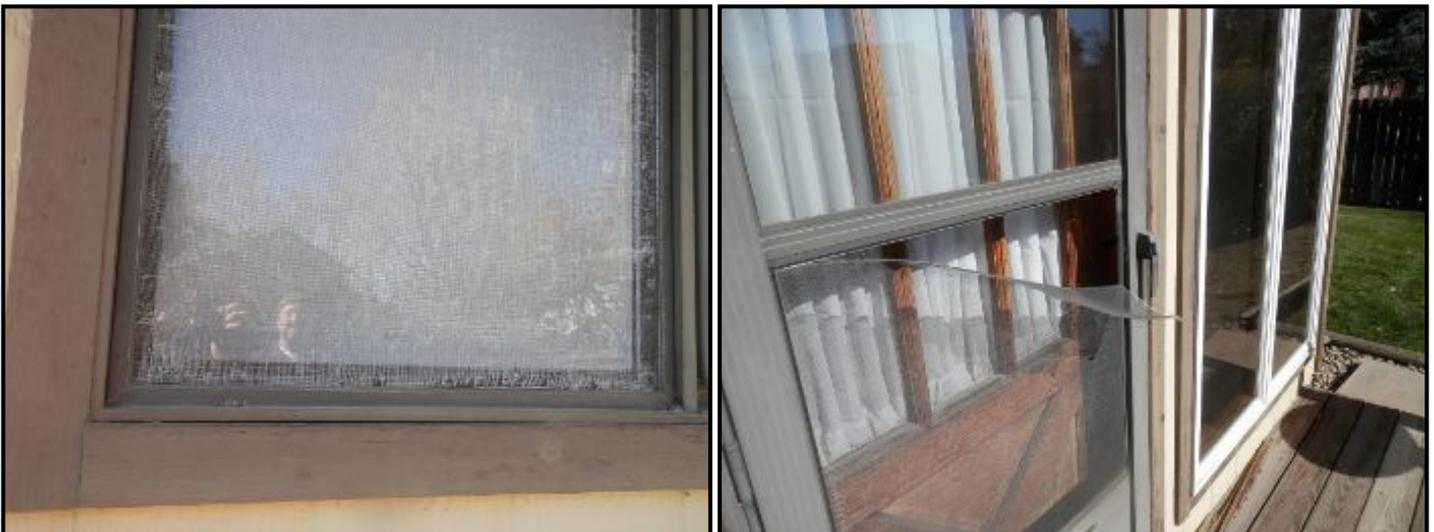
- The screens of several windows in the home are damaged.

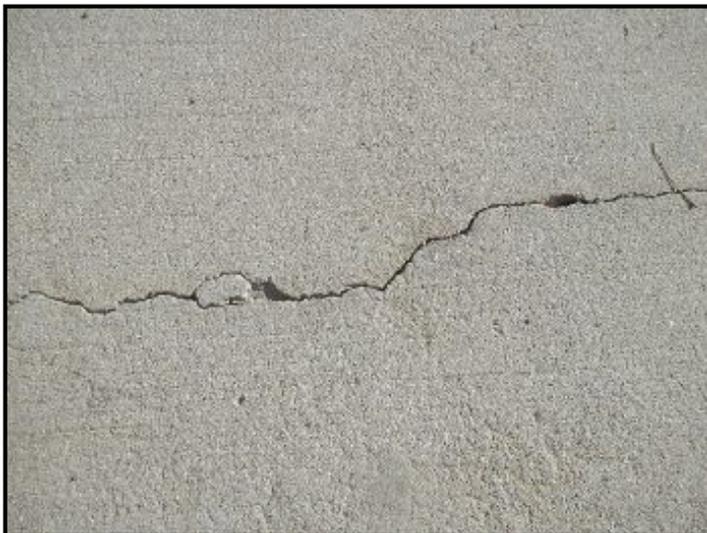
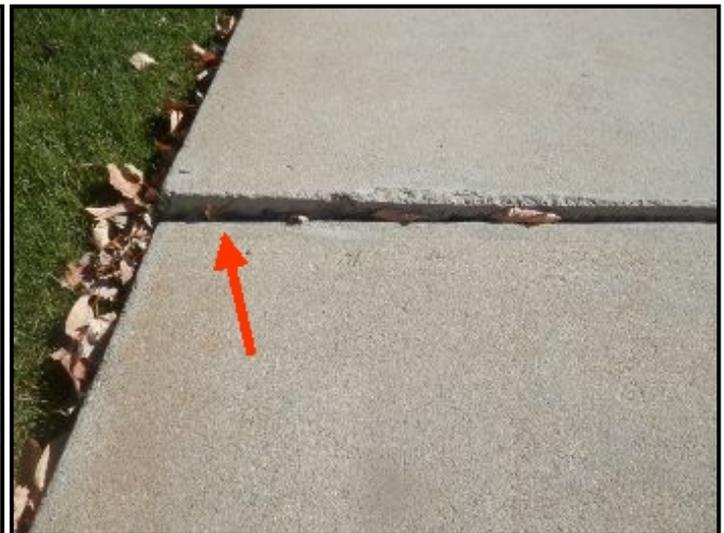
Grounds Driveway and Walkway Condition

• Typical cracking was observed at the concrete surfaces. Further deterioration will occur as water expands and contracts from freeze and thaw cycles. Recommend sealing the cracks to prolong the life of the concrete.

• **Uneven slabs at the driveway. This is a potential tripping hazard. Recommend repair and or replacement of the displaced walks.**

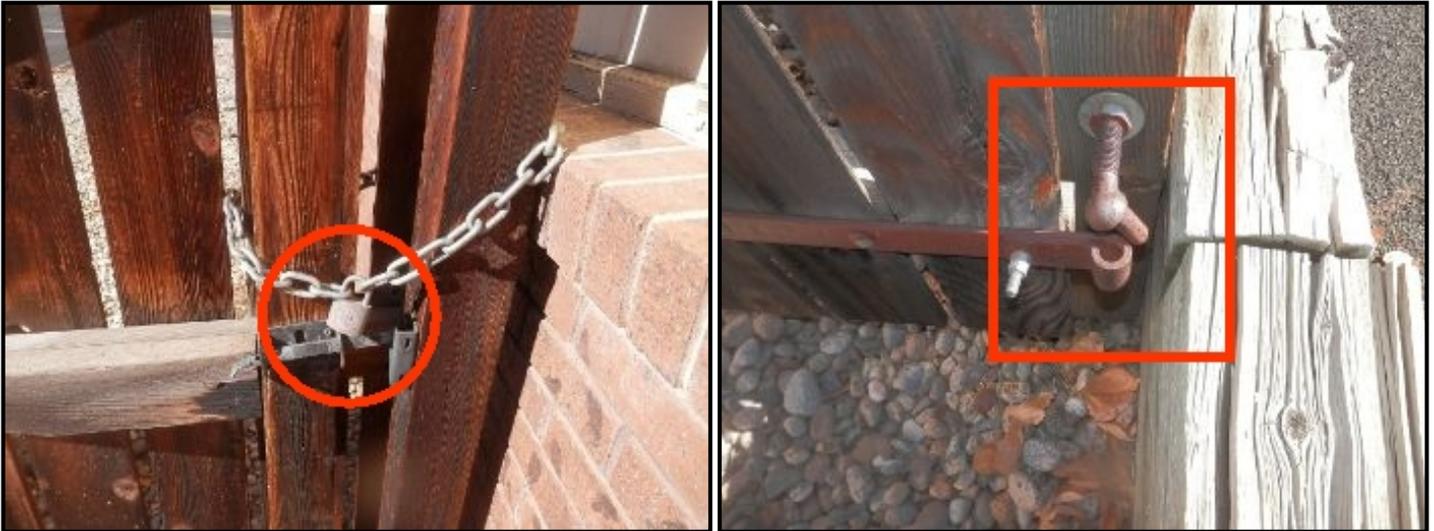
Grounds Gate Condition

• Gates were locked at the time of inspection, did not operate.

• **Gate hinges are in need of minor repairs and/or adjustments in order to restore proper operation.**

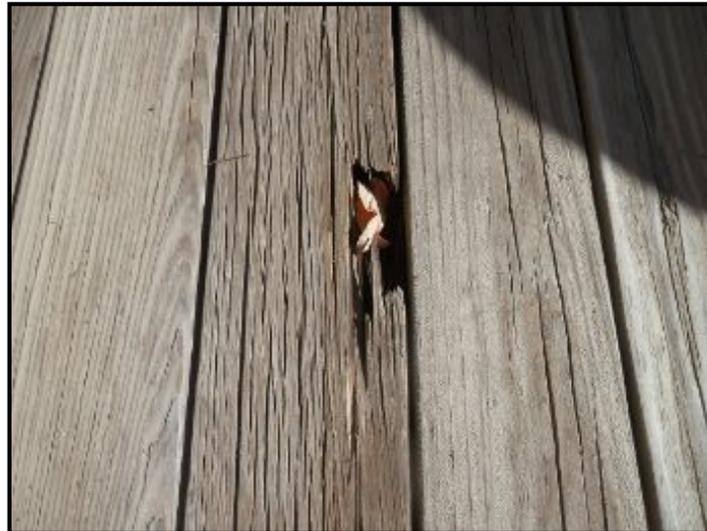
- Rotted wood board(s) noted.
- There is major weathering at the deck surface materials, should be painted or have finish sealant applied to preserve the materials. Maintenance should not be delayed, weather damage is noted but salvageable, will worsen if not quickly addressed. A licensed contractor should be called for estimates where maintenance and sealant are desired.

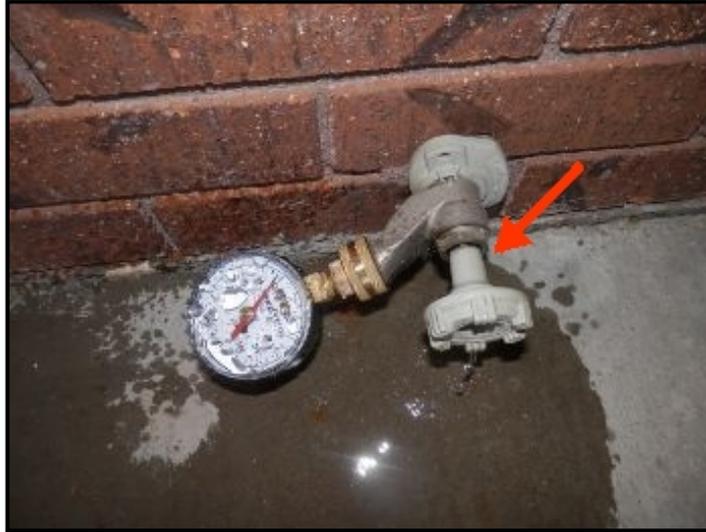
- Leak observed at valve stem, this leak is prevalent when a restriction is placed on the water flow. If no restriction is on the faucet the leak is not always detectable. Repairs that are needed are considered normal maintenance and upkeep.
- Freeze proof hose faucets are noted. Be sure to disconnect all hoses and attachments before seasonal freezing occurs.

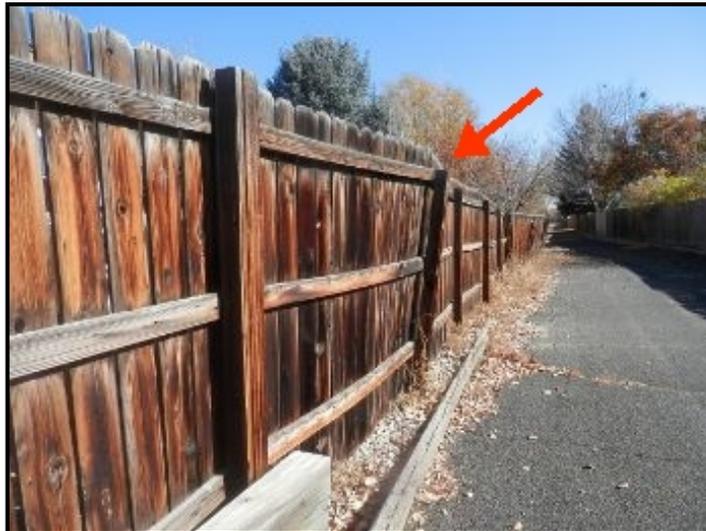
Grounds Fence Condition

- The fence is leaning, rebuilding areas of the fencing should be considered.

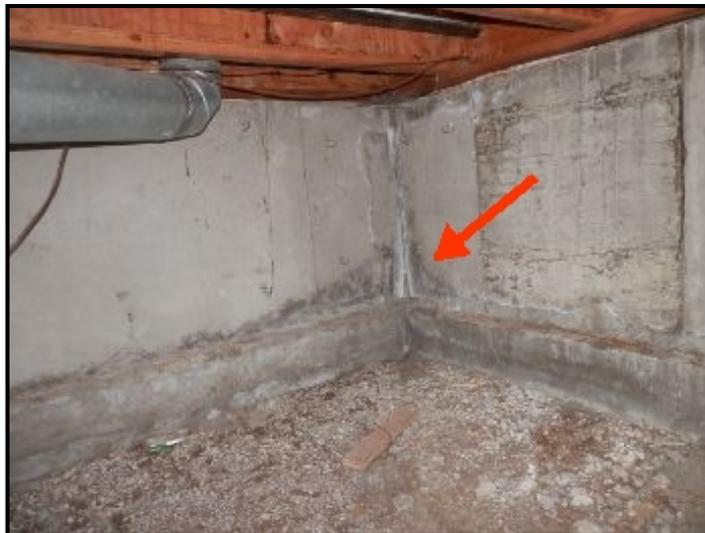
- Efflorescence observed; this is a mineral deposit left behind from previous exterior water infiltration.

Efflorescence

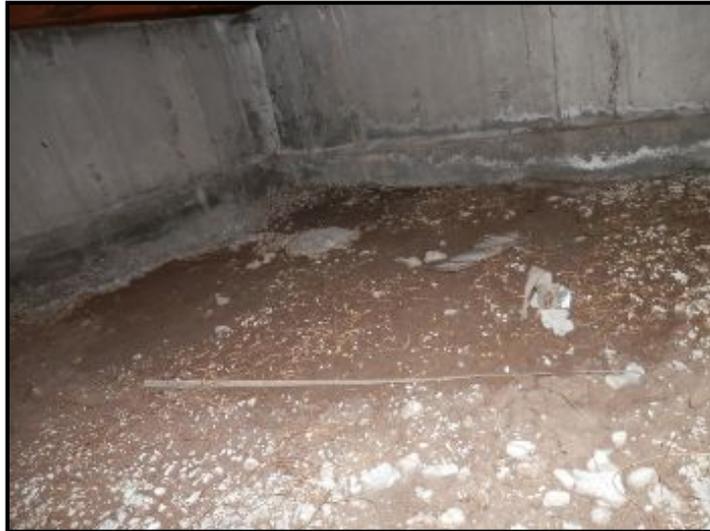
- Moisture at the corners in the crawl space is found. Typical of poor downspout drainage. The best defense against water seepage is good drainage of soils away from the foundation wall. The observed conditions are not alarming, however monitoring for future water penetration is necessary. I advise consulting appropriate persons for further evaluation and performing repairs if the condition continues to worsen.

Wet area

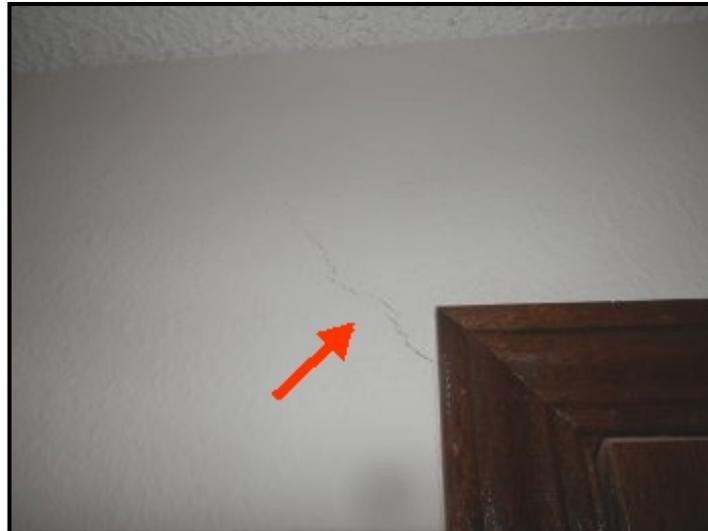
Master Bedroom Wall Condition

- Moderate cracks are found in the walls. Typical for the age.

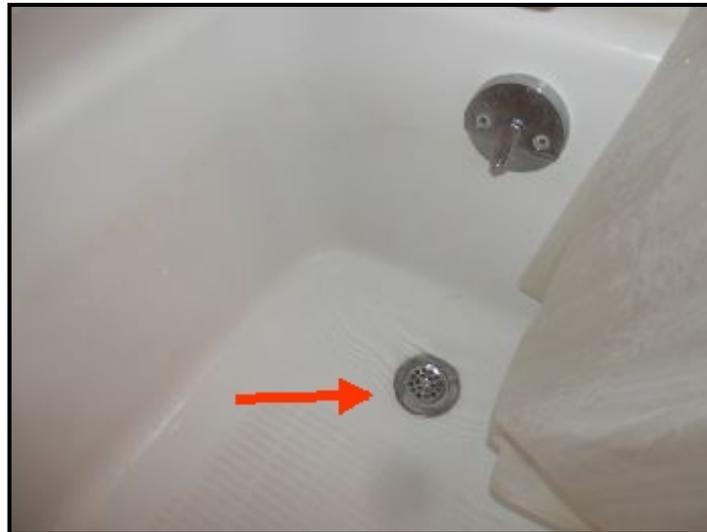
- Tub stop does not operate properly. Tub will not hold water. A qualified plumber should make repairs.
