Inspection Report

Property Address:

12345 Anywhere, USA

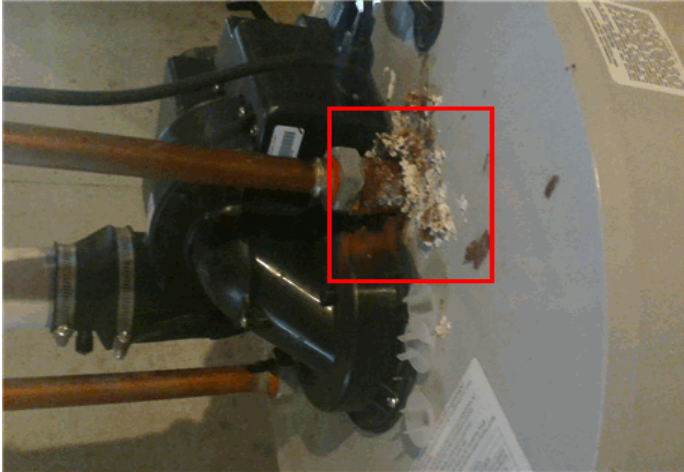
40) Water Heater Conditions

R

SUPPLY LINE LEAKING AND CARODED. It is suggested that a "Licensed Plumbing Contractor" be contacted for further evaluation and repair.

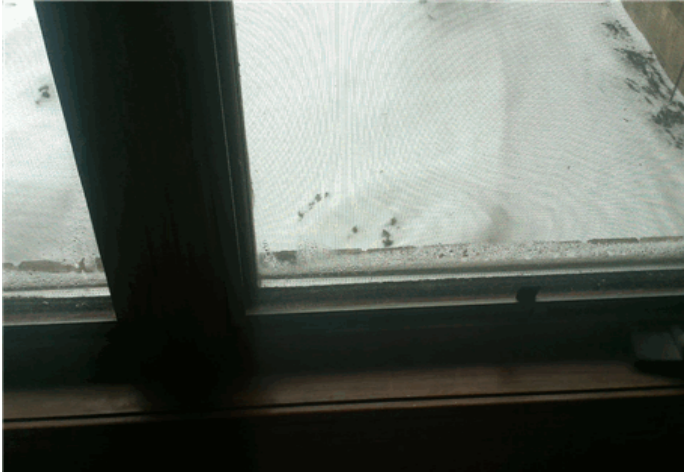
45) Interior Window Conditions

R

The thermal pane window(s) at appear to have lost its / their thermal seal. Moisture, fogging, and hazing are common signs of this condition. While mostly cosmetic, this condition is generally not repairable. Correction would require replacement of the window(s) or window pane(s). It is suggested that a "Licensed General Contractor" be contacted for further evaluation and repair.

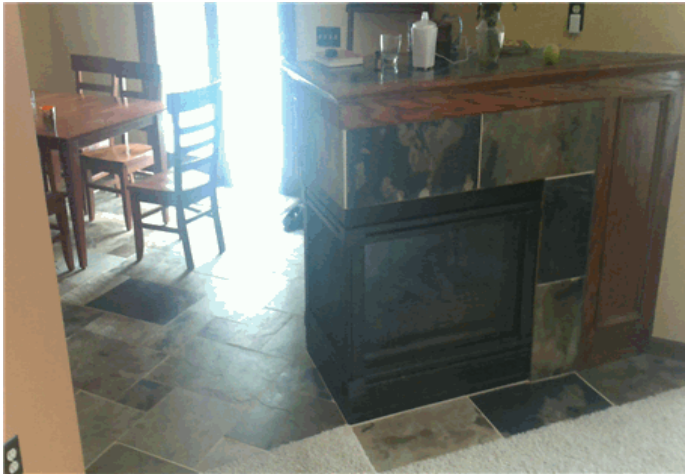
51) Fireplace Conditions

AS

The fireplace is gas fired and was operable at the time of inspection. No flue was observed at this unit. Depending on the type and manufacturer, some of these units burn cleanly and do not require a flue. Client is advised to obtain information from the manufacturer regarding use, maintenance, and carbon monoxide risks, if any.

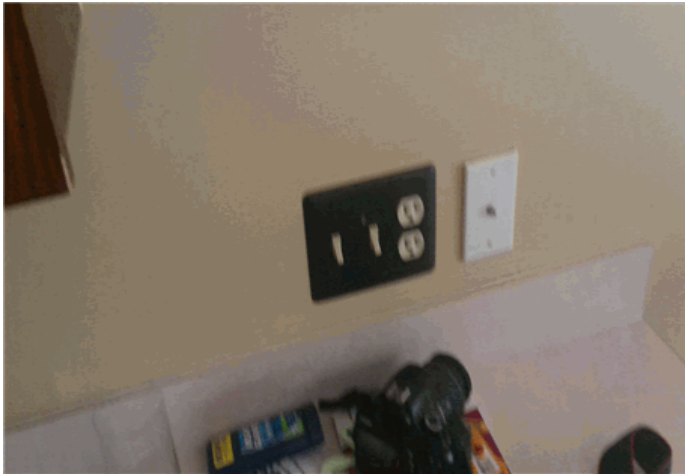
58) Electrical Conditions

R

RECEPTICLE ADJACENT TO SINK SHOULD BE GFCI. It is suggested that a "Licensed Electrical Contractor" be contacted for further evaluation and repair.

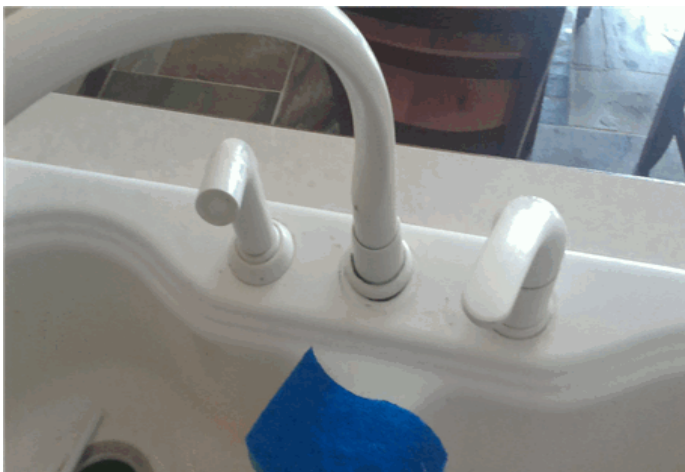
63) Sink Plumbing Conditions

R

The faucet leaked / dripped at the time of the inspection. Repair is recommended. It is suggested that a "Licensed Plumbing Contractor" be contacted for further evaluation and repair.
