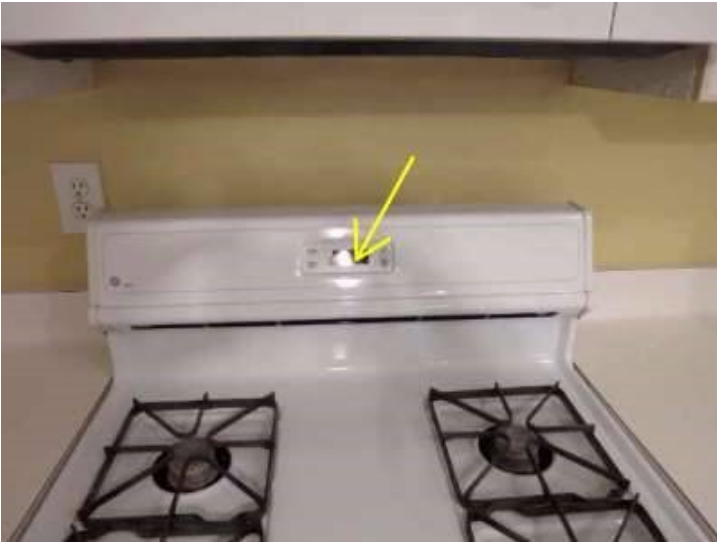
The natural gas service was turned on during the inspection. The inspector operates only "normal" controls such as thermostats, stove burner knobs, and on/off switches, and does not operate gas shut-off valves or activate pilot lights. As a result, items such as but not limited to the gas supply system, gas-fired water heater(s), gas-fired forced air furnace(s), gas fireplace(s), stove(s), and range(s) were fully evaluated. The inspector was able to test for gas leaks. Any problems that are found after this evaluation should be repaired by a qualified contractor.

Photo 3-1
 Display not functional
 Recommend that a qualified person repair as necessary!

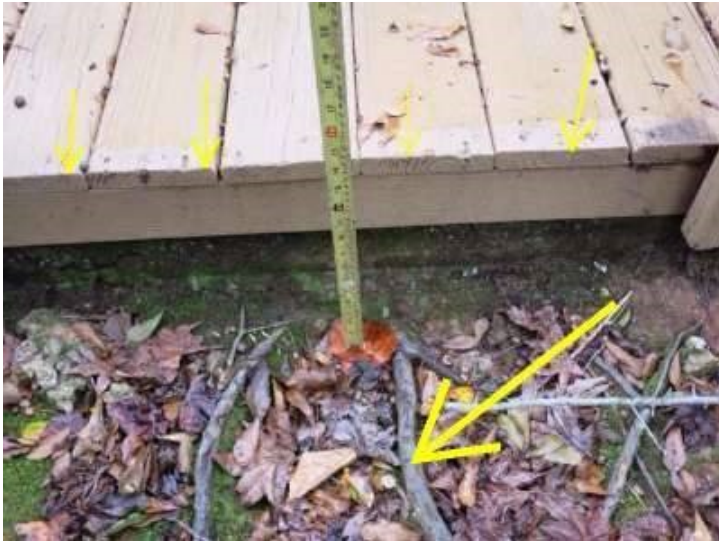
Photo 5-1
Needed repairs noted in this report should be brought to the attention of the contractor!

Risers for stairs at one or more locations were higher than 7 3/4 inches and posed a fall or trip hazard. Risers should be 7 3/4 inches or shorter. At a minimum, be aware of this hazard, especially when guests who are not familiar with the stairs are present. Recommend that a qualified contractor repair per standard building practices.

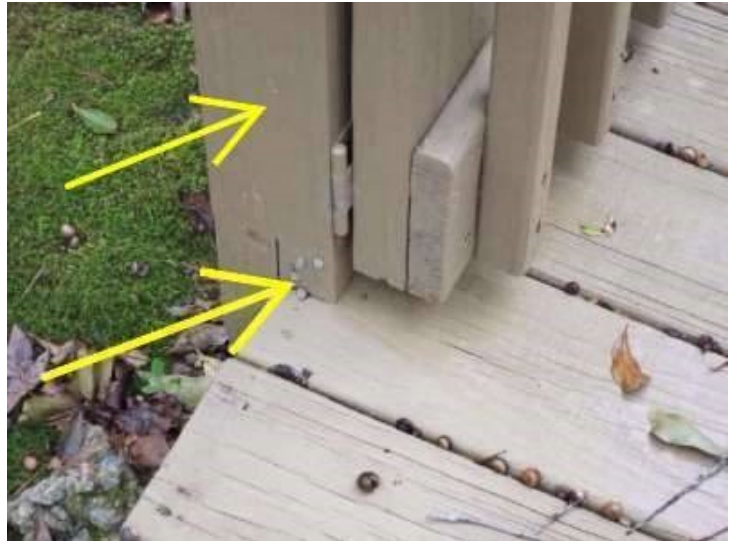
Photo 5-2
Rail loose needs to be repaired
Recommend that a qualified person repair as necessary

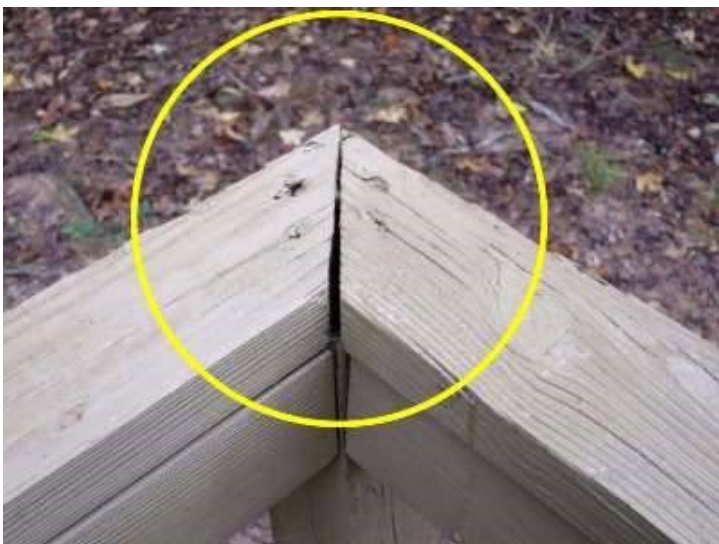
Photo 6-1

Guardrails at one or more locations with drop-offs higher than 30 inches were loose, wobbly and/or damaged, and pose a fall hazard. Recommend that a qualified person repair guardrails as necessary.

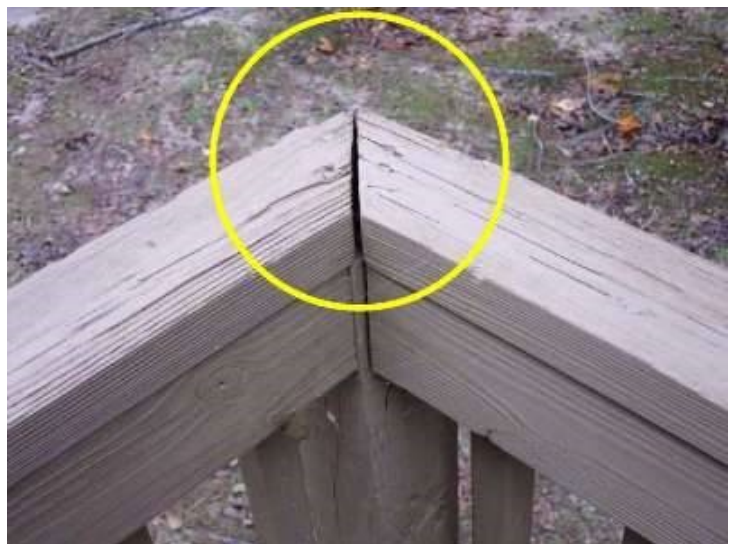
Photo 6-2
Need repair!

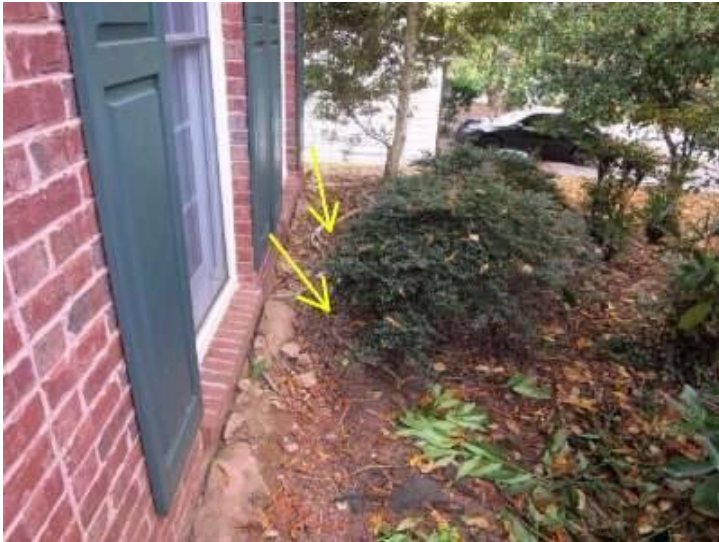
Photo 7-1

One or more large trees were very close to the foundation. Tree roots can cause significant structural damage to foundations, or may have already caused damage (see other comments in this report). Recommend that a qualified tree service contractor or certified arborist remove trees as necessary to prevent damage to foundations.

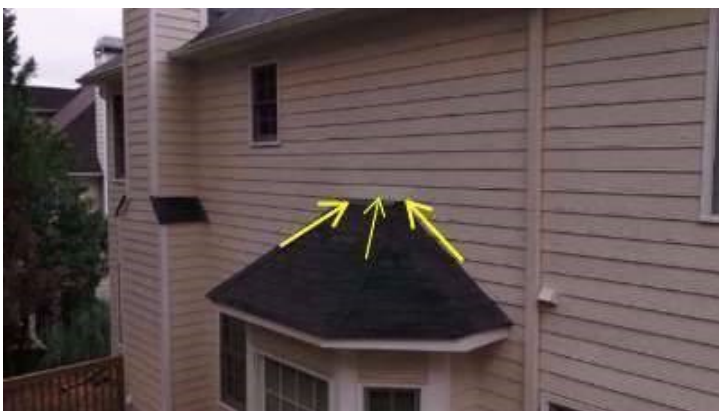
Photo 8-1

Some nail heads at the composition wood siding were protruding from the wood, or had been nailed in so as to break the surface of the siding, and caulk was missing. Most manufacturers of composition wood siding specify that nail heads should be flush with the surface, and that the surface of the siding should not be broken. If broken, then caulk should be applied to the nail heads to prevent water penetration and subsequent deterioration of the siding. Recommend that a qualified person repair per the siding manufacturer's specifications.

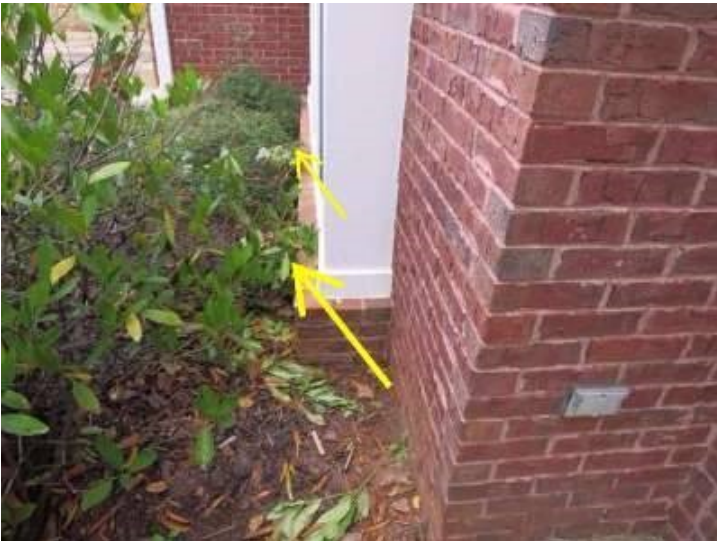
Photo 9-1

Vegetation such as trees, shrubs and/or vines was in contact with or close to the building exterior. Vegetation can serve as a pathway for wood-destroying insects and can retain moisture against the exterior after it rains. This is a conducive condition for wood-destroying organisms. Recommend pruning, moving or removing vegetation as necessary to maintain at least 6 inches of space between it and the building exterior. A 1-foot clearance is better.

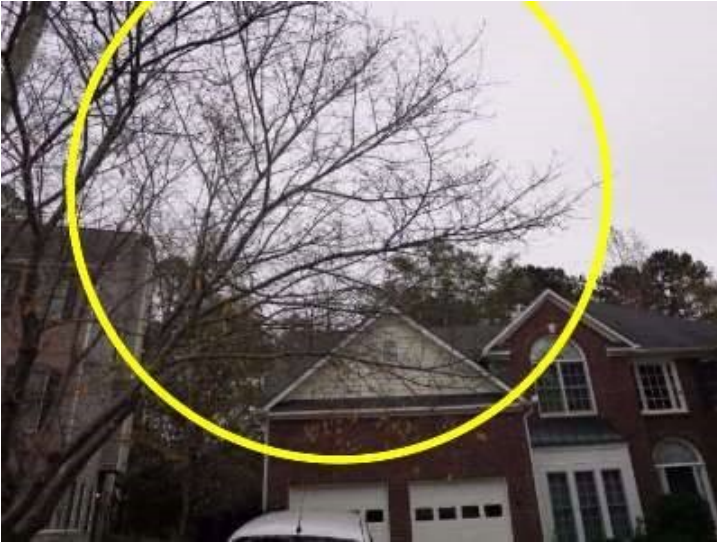
Photo 10-1

Trees were in contact with or were close to the building at one or more locations. Damage to the building can occur, especially during high winds, or may have already occurred (see other comments in this report). Recommend that a qualified tree service contractor or certified arborist remove trees as necessary to prevent damage to the building exterior.

Hanging over drive way needed repairs noted in this report should be brought to the attention of the contractor .

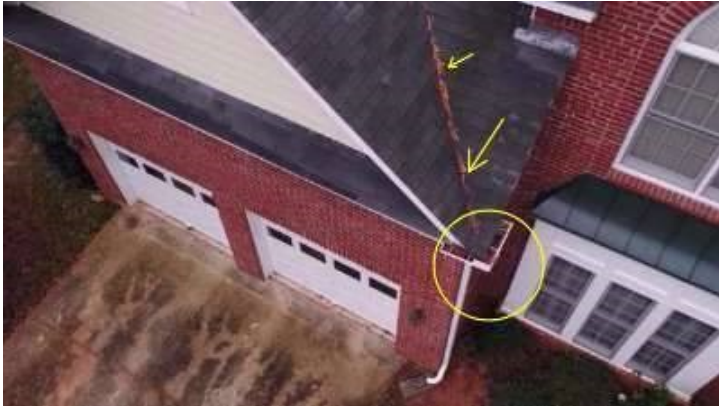
Photo 12-1

Significant amounts of debris have accumulated in one or more gutters or downspouts. Gutters can overflow and cause water to come in contact with the building exterior, or water can accumulate around the foundation. This is a conducive condition for wood-destroying organisms. Recommend cleaning gutters and downspouts now and as necessary in the future.

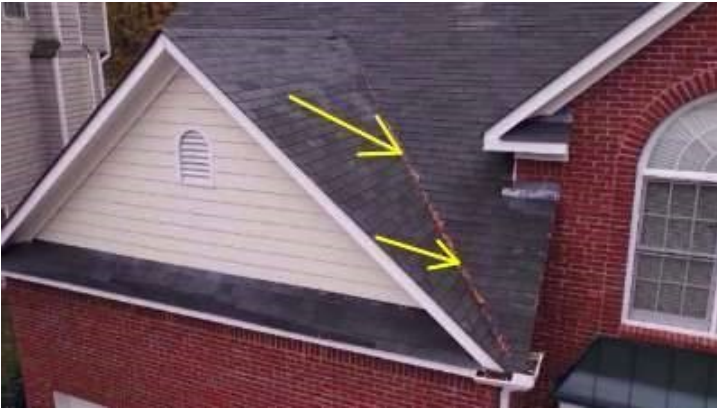
Photo 13-1

Significant amounts of debris such as leaves, needles, seeds, etc. have accumulated on the roof surface. Water may not flow easily off the roof, and can enter gaps in the roof surface. Leaks can occur as a result. This is a conducive condition for wood-destroying organisms. Recommend cleaning debris from the roof surface now and as necessary in the future.

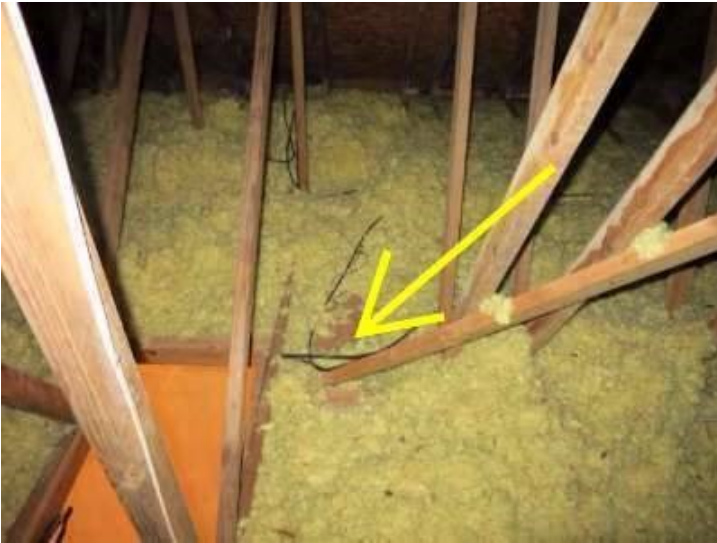
Photo 17-1

The ceiling insulation installed in the attic was substandard and appeared to have an R rating that's significantly less than current standards (R-38). Heating and cooling costs will likely be higher due to poor energy efficiency. Recommend that a qualified contractor install insulation for better energy efficiency and per standard building practices.

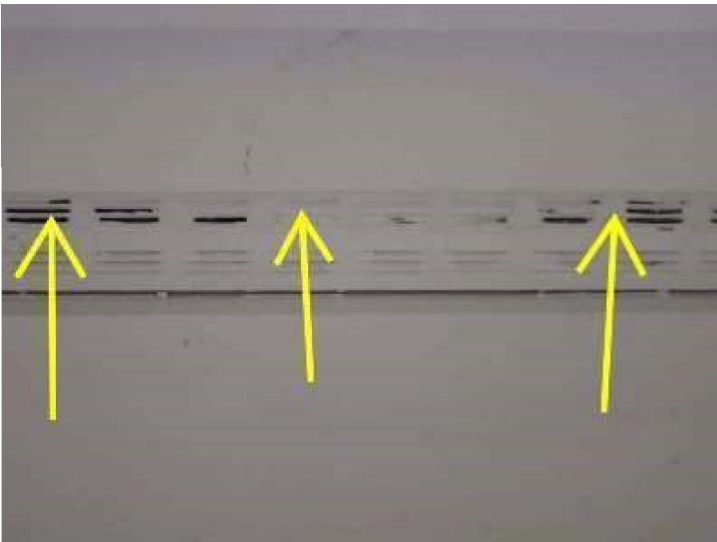
Photo 18-1

One or more attic or roof vent screens were clogged with paint. This can reduce air flow through the roof structure or attic and result in reduced service life for the roof surface materials because of high temperatures. Moisture from condensation is also likely to accumulate in the roof structure and/or attic. Recommend that a qualified person repair as necessary so air flows freely through all vents. For example, by cleaning screens or replacing screens with 1/8-inch to 1/4-inch wire mesh.

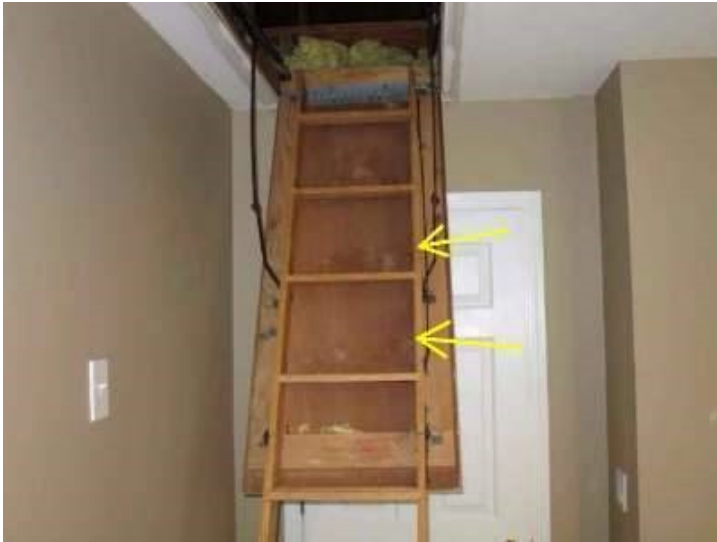
Photo 19-1

One or more attic access hatches or doors were not insulated, or had substandard insulation. Recommend installing insulation as necessary and per current standards at hatches or doors for better energy efficiency. For more information, visit:

Attic access hatches does not seal properly

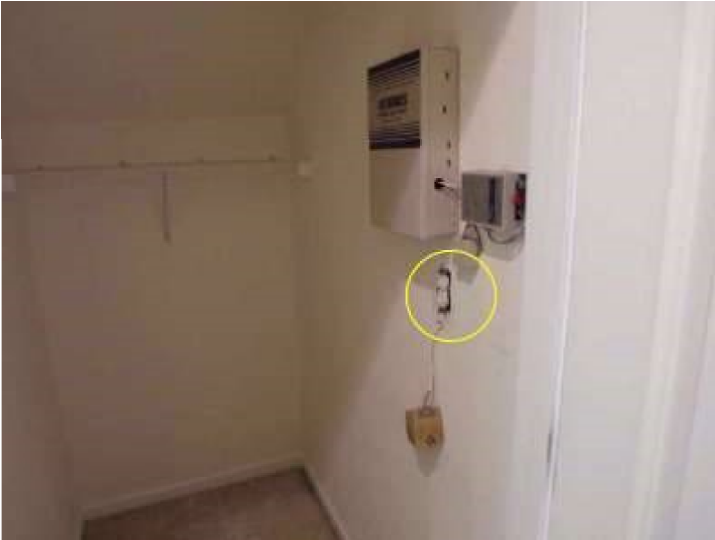
One or more receptacles were broken or damaged. This is a potential shock or fire hazard. Recommend that a qualified electrician replace such receptacles as necessary.

Photo 22-1
Cover Needed

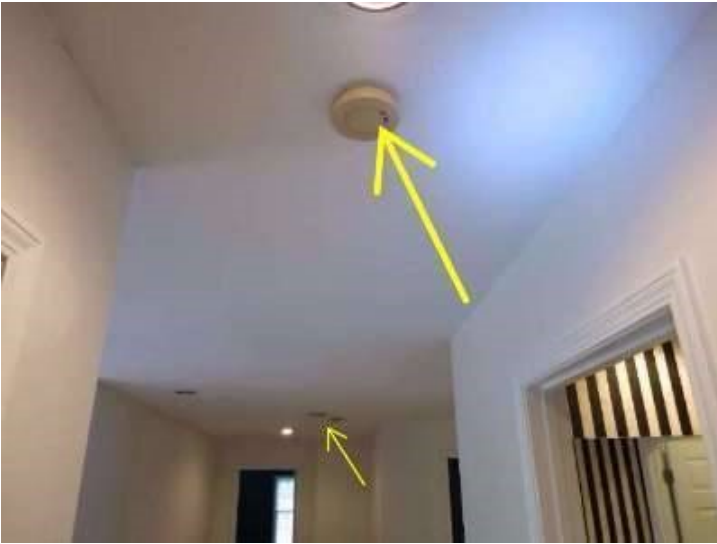
Photo 25-1

For home buyers, batteries in all the smoke alarms should be replaced after taking occupancy. Batteries should be replaced annually in the future. "Chirping" noises emitted from smoke alarms typically indicate that batteries need replacing. For more information, visit:
<http://www.reporthost.com/?SMKALRM>

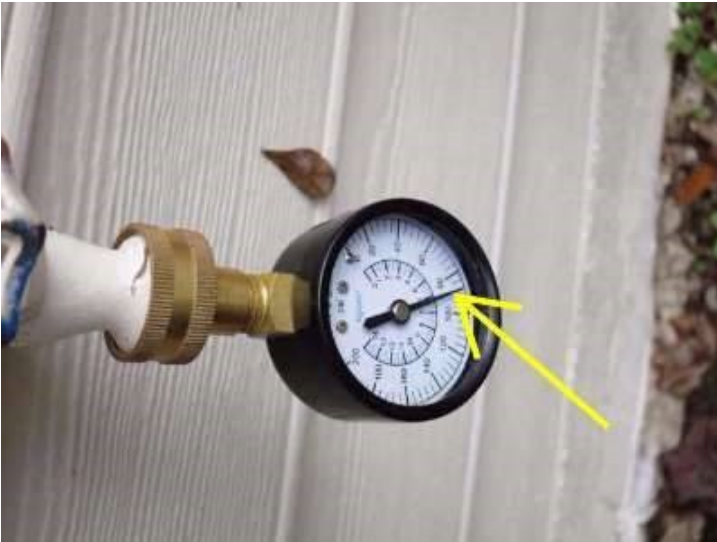
Photo 27-1

The water supply pressure was greater than 80 pounds per square inch (PSI). Pressures above 80 PSI may void warranties for some appliances such as water heaters or washing machines. Flexible supply lines to washing machines are likely to burst with higher pressures. 40-80 PSI is considered the normal range for water pressure in a home, and most plumbers recommend 50-60 PSI. Typically, the pressure cannot be regulated at the water meter. Recommend that a qualified plumber evaluate and make modifications to reduce the pressure to below 80 PSI. Installing a pressure reducing valve on the main service pipe is a common solution to this problem. If one exists, then it should be adjusted, repaired or replaced as necessary to maintain lower pressures. Note that installing a pressure reducing valve creates a "closed system," which may require installing an expansion tank at the water heater if one is not already installed.

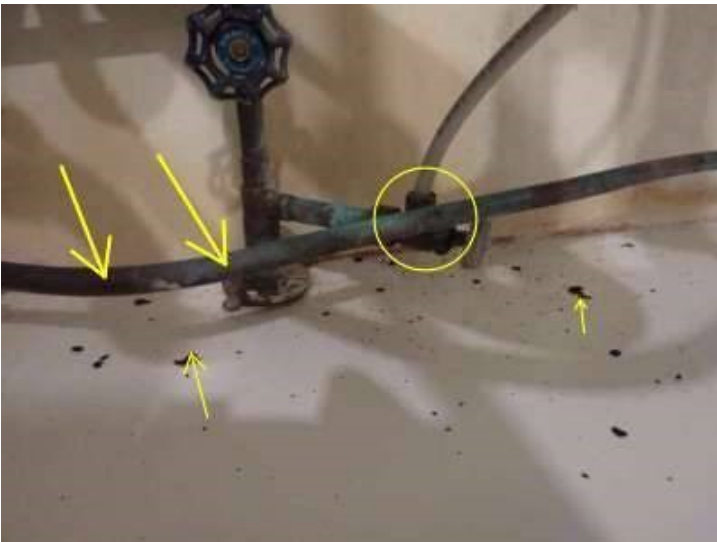
Photo 28-1

Significant corrosion was found in some water supply pipes or fittings. Leaks can occur as a result. Recommend that a qualified plumber evaluate and replace components as necessary.

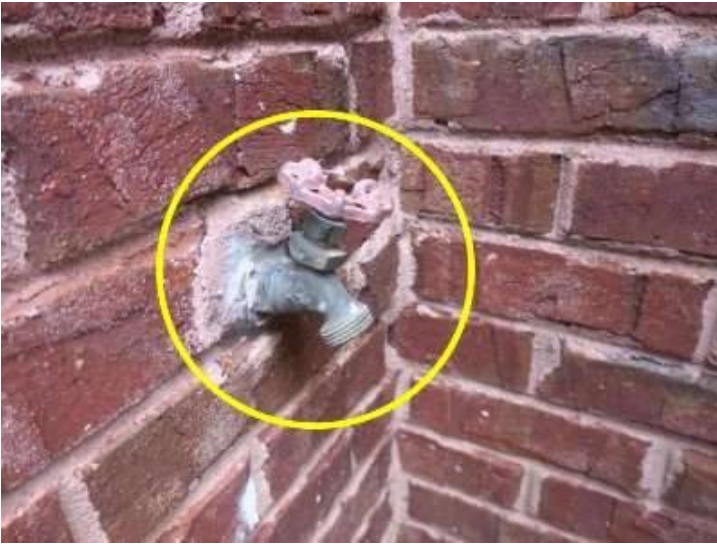
**Photo 29-1**

One or more hose bibs appeared to be inoperable. No water flowed from the bib(s) when turned on. This may be due to a shut-off valve being turned off. Note that the inspector does not operate shut-off valves. Recommend consulting with the property owner about inoperable hose bibs, and if necessary have a qualified plumber make repairs.

Main front left of front door!

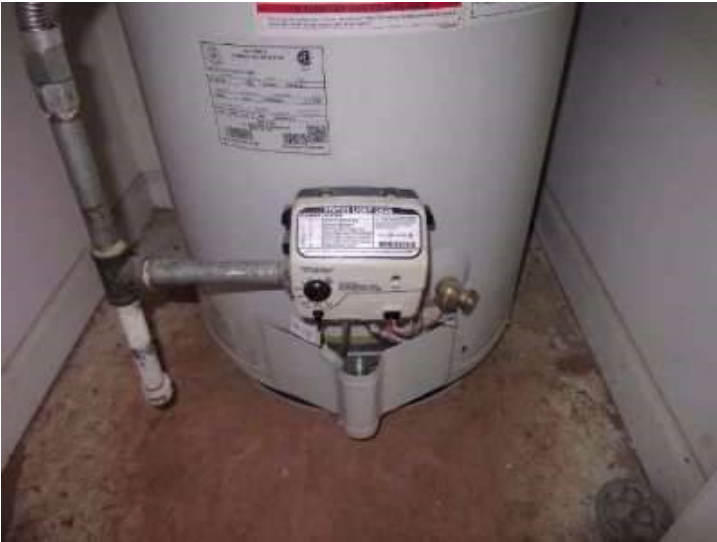
Photo 32-1

The estimated useful life for most water heaters is 8-12 years. This water heater appeared to be this age and/or its useful lifespan and may need replacing at any time. Recommend budgeting for a replacement in the near future, or considering replacement now before any leaks occur. The client should be aware that significant flooding can occur if the water heater fails. If not replaced now, consider having a qualified person install a catch pan and drain or a water alarm to help prevent damage if water does leak.

Built 08/08/2012

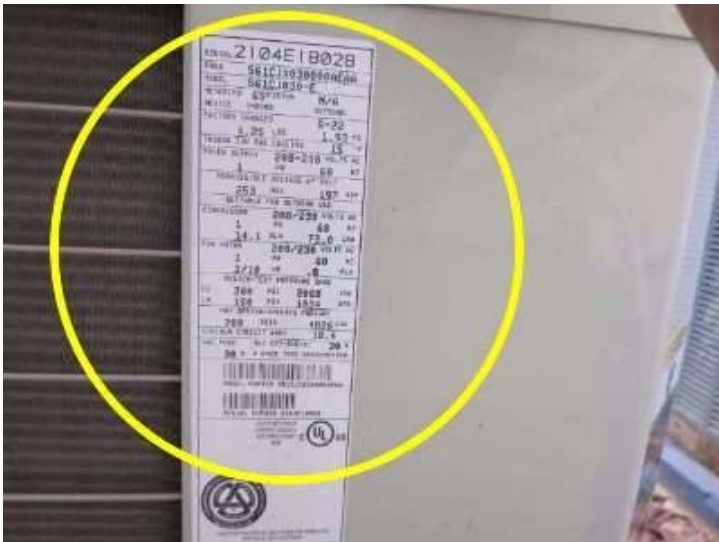
Photo 33-1

The last service date of the forced air heating/cooling system appeared to be more than 1 year ago, or the inspector was unable to determine the last service date. Ask the property owner when it was last serviced. If unable to determine the last service date, or if this system was serviced more than 1 year ago, recommend that a qualified HVAC contractor service this system and make repairs if necessary. Because this system has a compressor and refrigerant system, this servicing should be performed annually in the future. Any needed repairs noted in this report should be brought to the attention of the contractor when it's serviced.

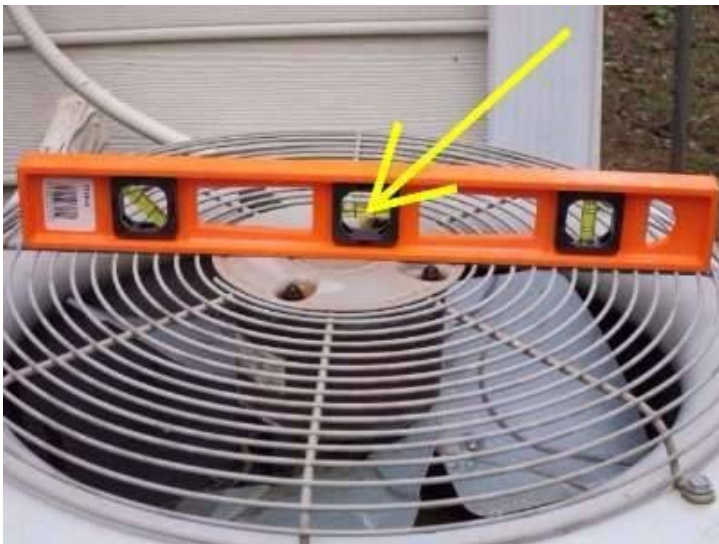
Photo 33-3

Not level
 needed repairs noted in this report should be brought to the attention of the contractor when it's serviced.

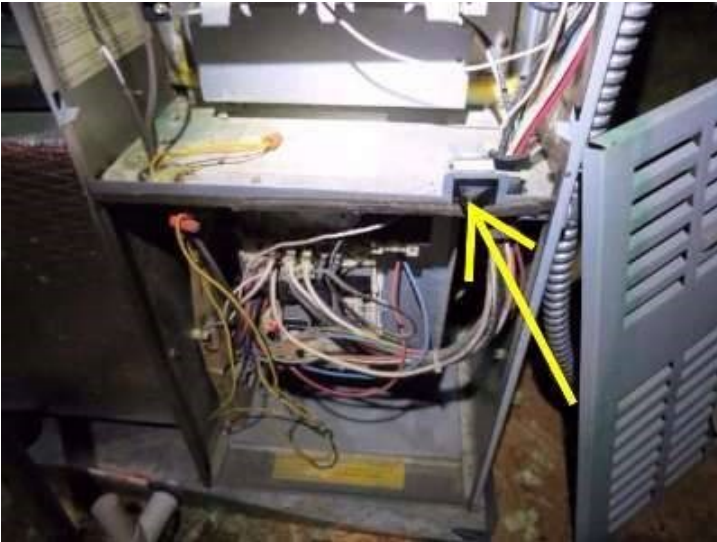
Photo 33-5
service switch need repairs !
needed repairs noted in this report should be brought to the attention
of the contractor when it's serviced.

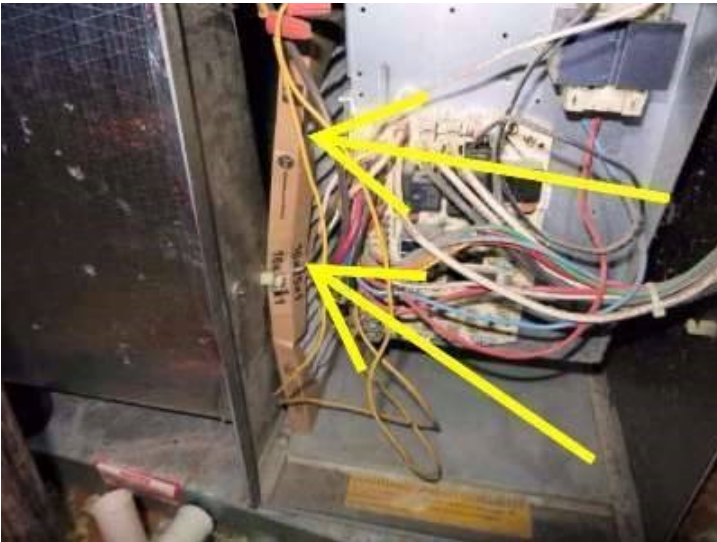
Photo 34-1

Recommend that home buyers replace or clean HVAC filters upon taking occupancy depending on the type of filters installed. Regardless of the type, recommend checking filters monthly in the future and replacing or cleaning them as necessary. How frequently they need replacing or cleaning depends on the type and quality of the filter, how the system is configured (e.g. always on vs. "Auto"), and on environmental factors (e.g. pets, smoking, frequency of house cleaning, number of occupants, the season).

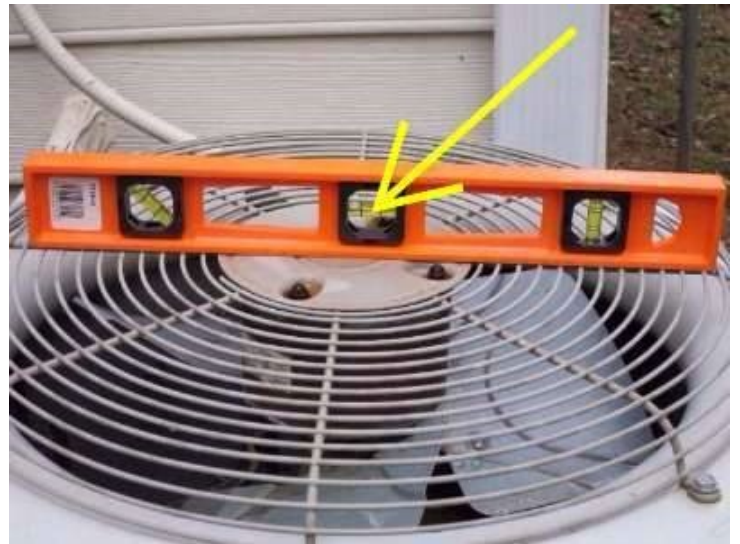
Photo 35-4
Not level
needed repairs noted in this report should be brought to the attention of the contractor when it's serviced.

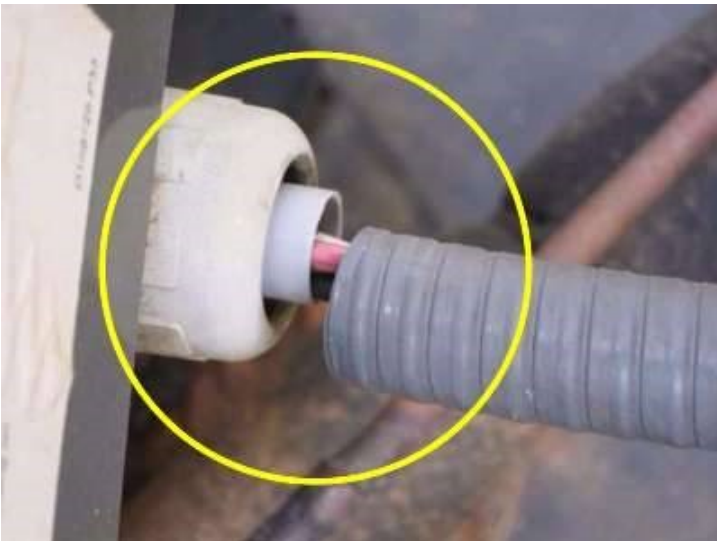
Photo 35-7

LOOSE CONDUCT needed repairs noted in this report should be brought to the attention of the contractor when it's serviced. Recommend that a qualified person repair as necessary

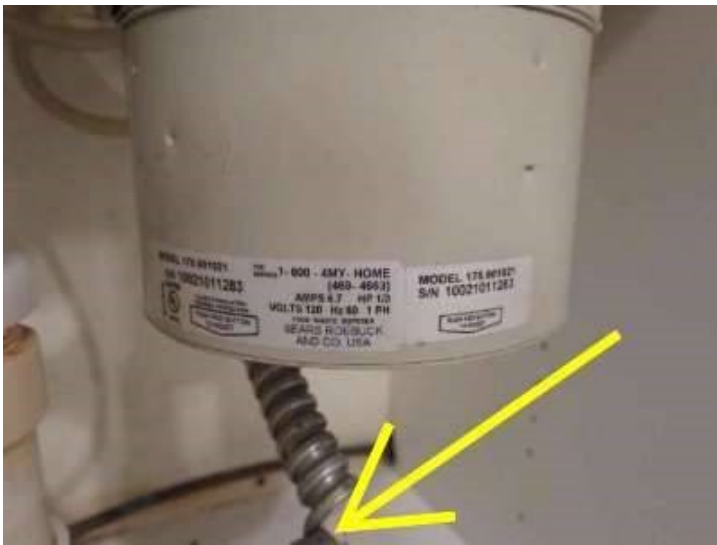
Photo 38-1

38) 🛠️⚡ Electrical wiring for the under-sink food disposal was substandard. Non-metallic sheathed wiring was exposed and subject to damage. The wiring can be damaged by repeated bending or contact with sharp objects. BX-armored conduit should be installed to protect wiring, or a flexible appliance cable should be installed. This is a potential shock hazard. Recommend that a qualified contractor repair per standard building practices.

Recommend that a qualified person repair as necessary

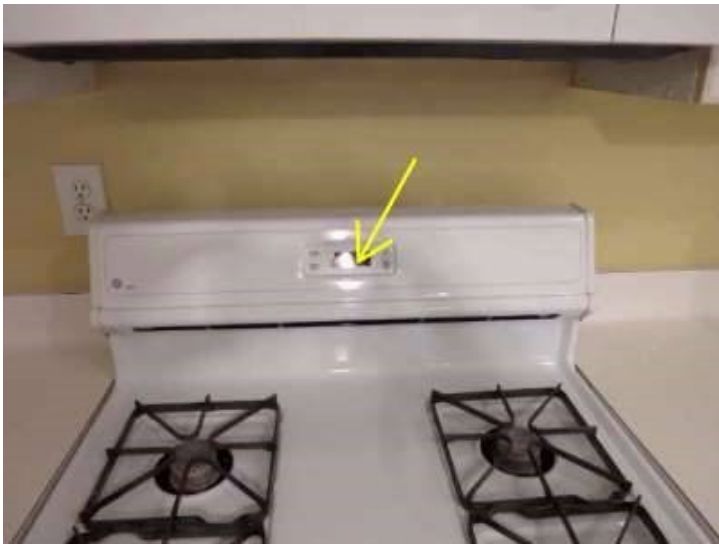
Photo 42-1

The oven bake function appeared to be inoperable. Consult with the property owner. If necessary, a qualified person should repair.

Display not functional
Recommend that a qualified person repair as necessary!

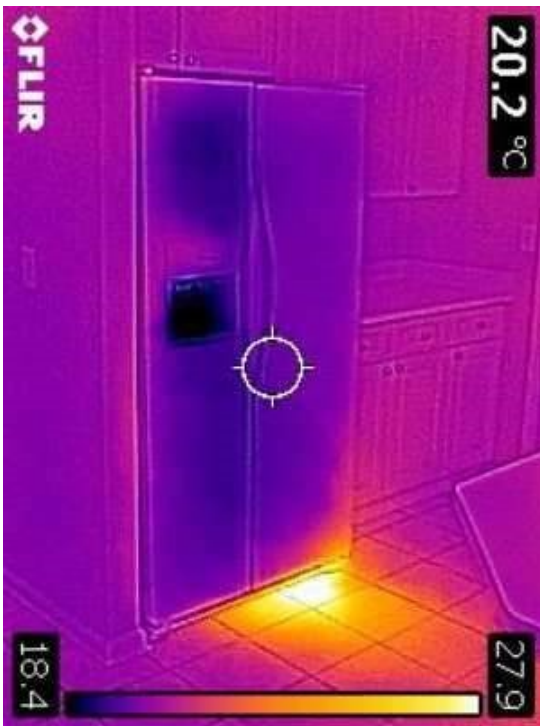
Photo 43-1

Clean the coils may be needed
Recommend that a qualified person repair as necessary.

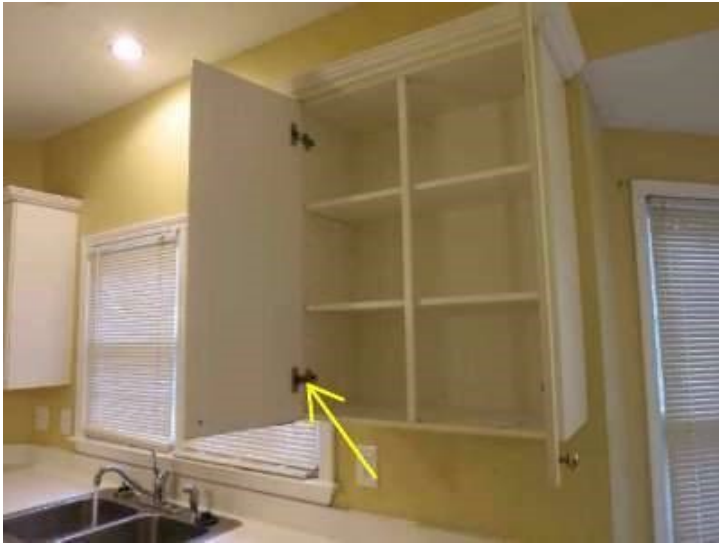
Photo 44-1

44) One or more cabinets were loose, or were secured with too few or substandard fasteners. An adequate number of appropriate fasteners should be used. For wall-hung cabinets, inadequate fasteners can pose a safety hazard if cabinets fall. Recommend that a qualified person repair as necessary.

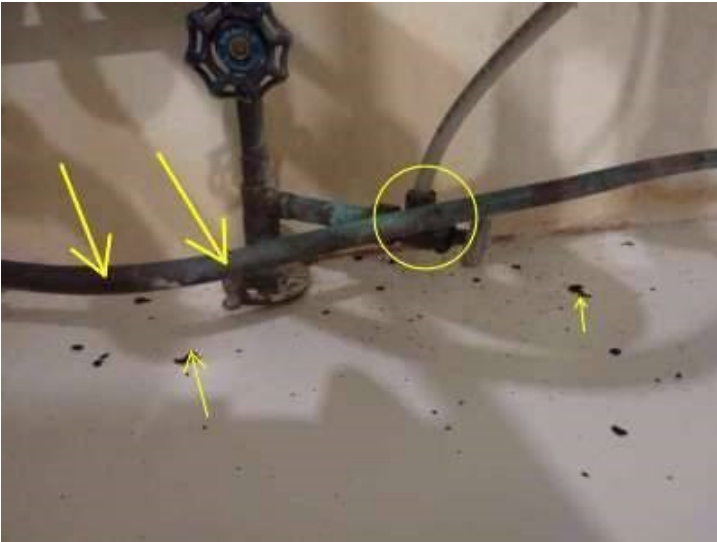
Photo 45-1

Stains were found in the shelving or cabinets below the sink. Plumbing leaks may have occurred in the past. Consult with the property owner about this, and if necessary a qualified person evaluate and repair.

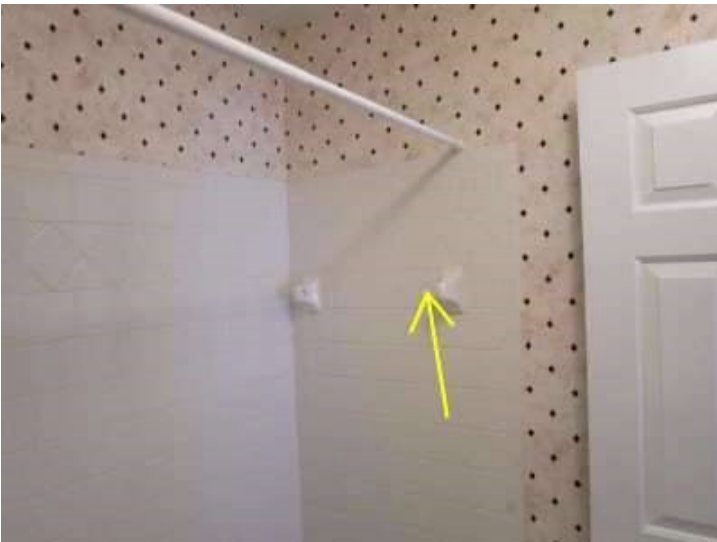
Photo 46-1

Cabinet hardware such as hinges, latches, closers, magnets or pulls at location(s) #A were loose, missing or damaged at one or more cabinet drawers, doors or turntables. Recommend that a qualified person repair as necessary.

Missing bar

Recommend that a qualified person repair as necessary

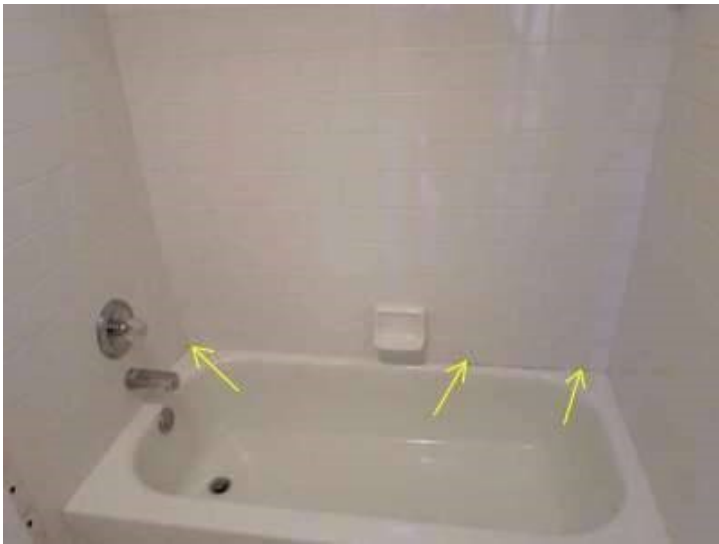
Photo 47-1

Gaps, no caulk, or substandard caulking were found between the bathtub and the at location(s) #A. Water may penetrate these areas and cause damage. Recommend that a qualified person re-caulk or install caulking as necessary.

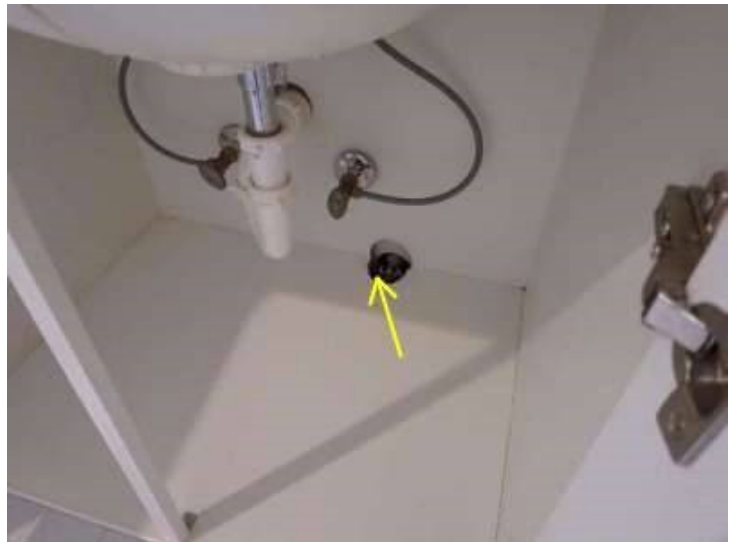
Photo 48-2

Stains were found in the shelving or cabinets below the sink at location(s) #B. Plumbing leaks may have occurred in the past. Consult with the property owner about this, and if necessary that a qualified person evaluate and repair.

Under master bath sink
Recommend that a qualified person repair as necessary

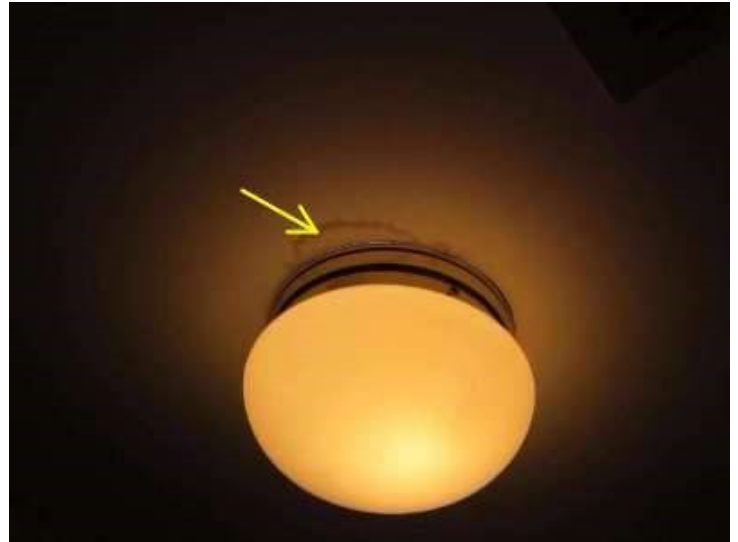
Photo 48-4

Master bath no active leak but needs repair!!

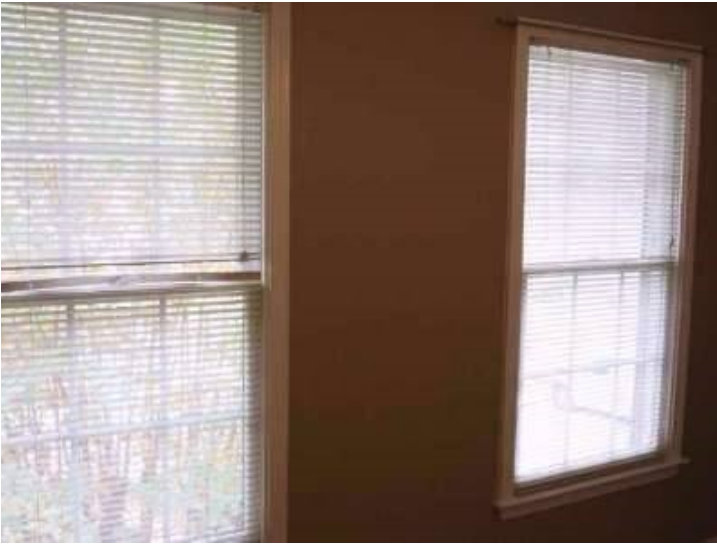
Photo 50-1

One or more bedrooms had windows that wouldn't open or were stuck shut. Unless a bedroom has an exterior entry door, at least one window requires adequate egress in the event of a fire or emergency to allow escape or to allow access by emergency personnel. Recommend that a qualified contractor repair or make modifications per standard building practices. For more information, visit:

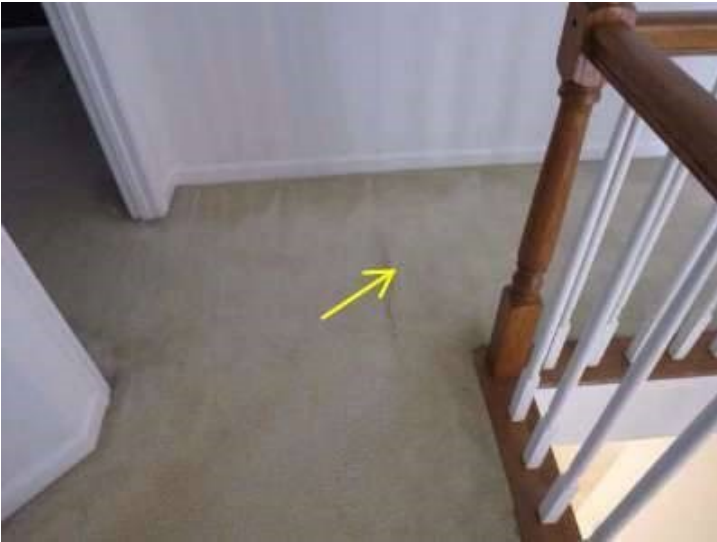
Photo 51-1

51) 🛠️🔪 Carpeting in one or more areas was loose and posed a trip hazard. Recommend that a qualified contractor repair as necessary. For example, by stretching or replacing carpeting.

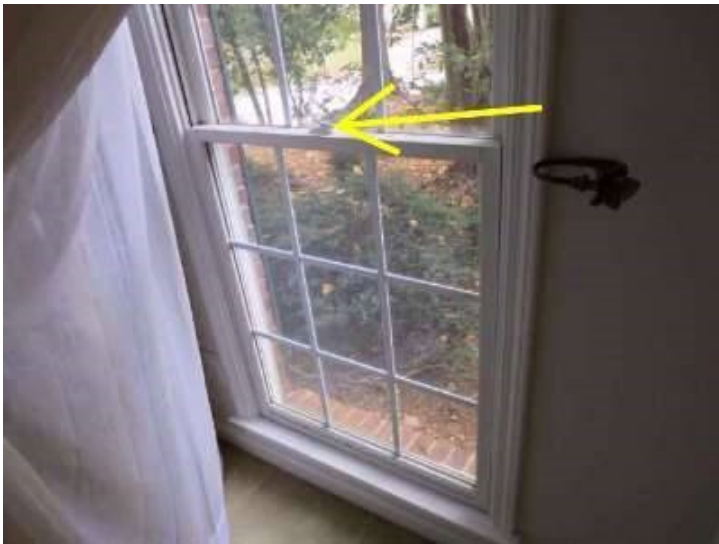
Photo 52-1

52) 🛠️🔑🔍 One or more windows that were designed to open and close were stuck shut. Recommend that a qualified person repair windows as necessary so they open and close easily.

All windows on 1st and 2nd floor need to be checked

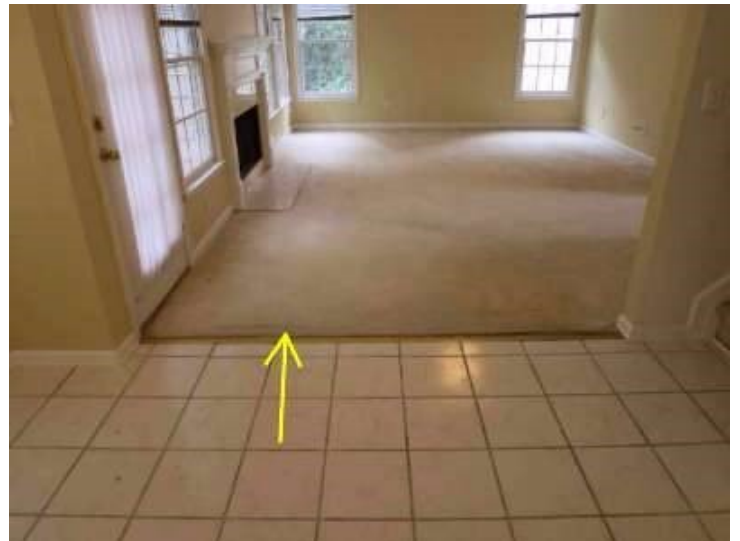
Photo 52-4
Trip hazard
Recommend that a qualified person repair as necessary

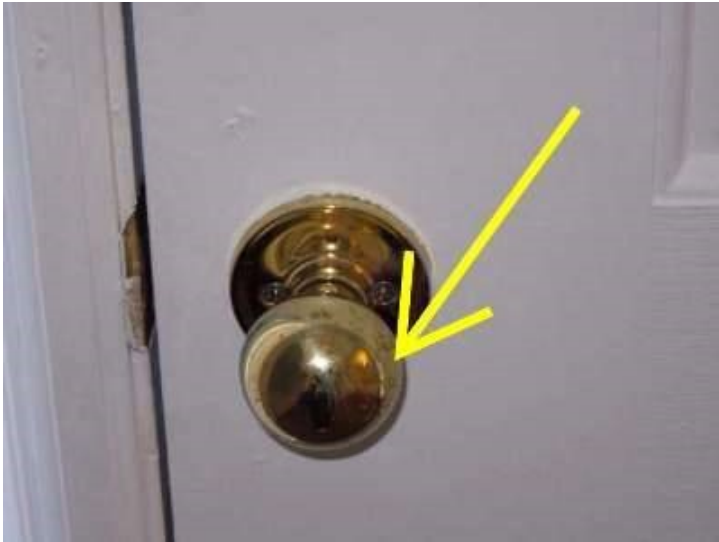
One or more entry doors wouldn't latch when closed. This is a security concern if no deadbolt is installed. A qualified person should repair as necessary.

Photo 53-1
Loose hardware

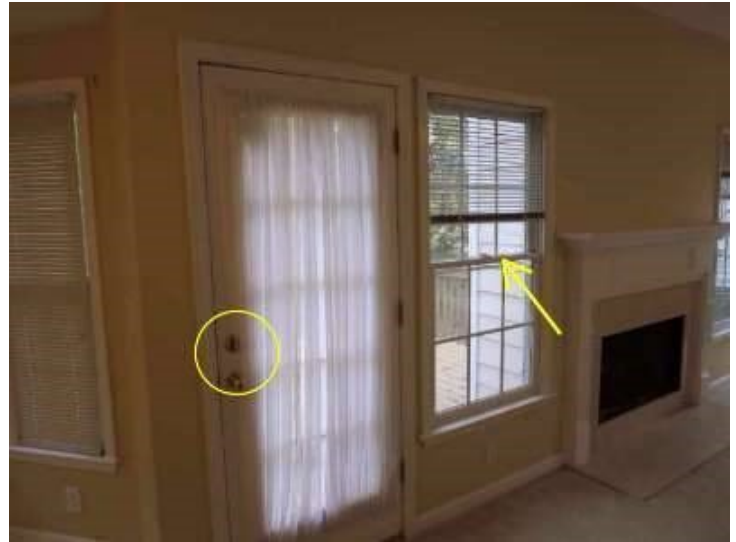
Photo 53-2
Dead bolt not latching, Window does not open freely

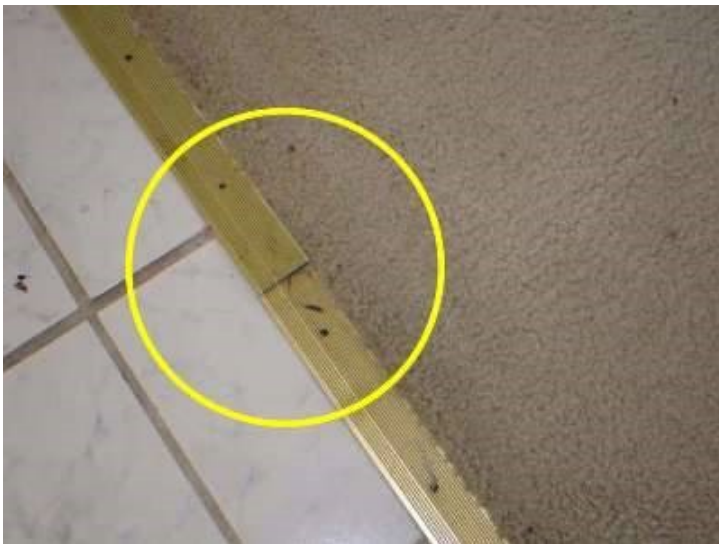
Carpeting in one or more areas was loose. Recommend that a qualified contractor repair as necessary. For example, by stretching or replacing carpeting.

Photo 54-1
Kitchen living-room entryway

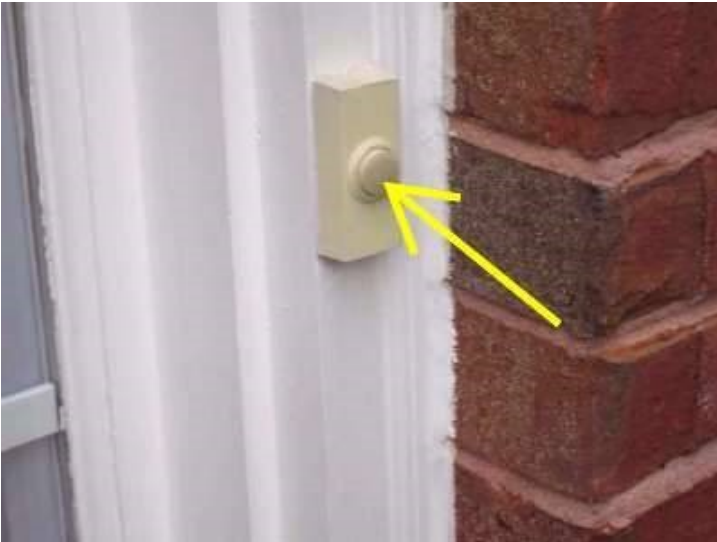
Photo X-11
Door bell is inoperable
Recommend that a qualified person repair as necessary
