# Pre-purchase Building Inspection Report

Complies with Australian Standards AS4349.1 - 2007

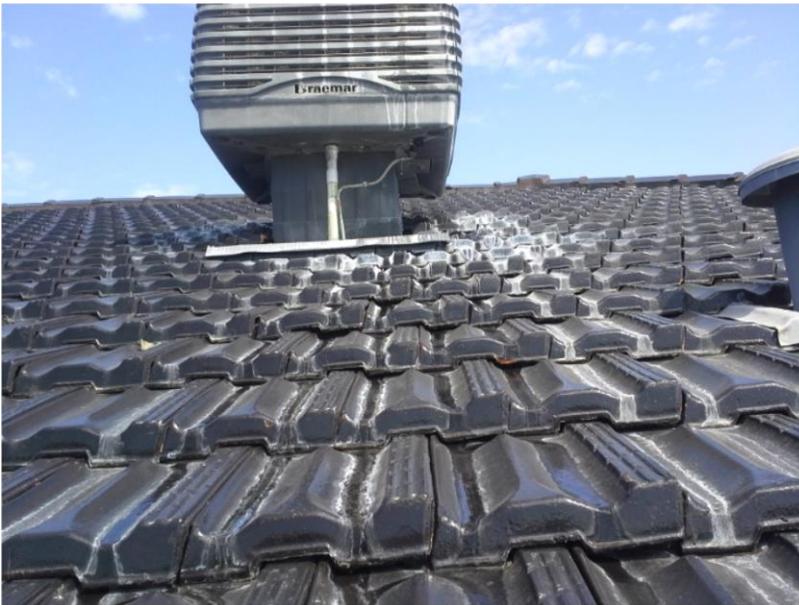
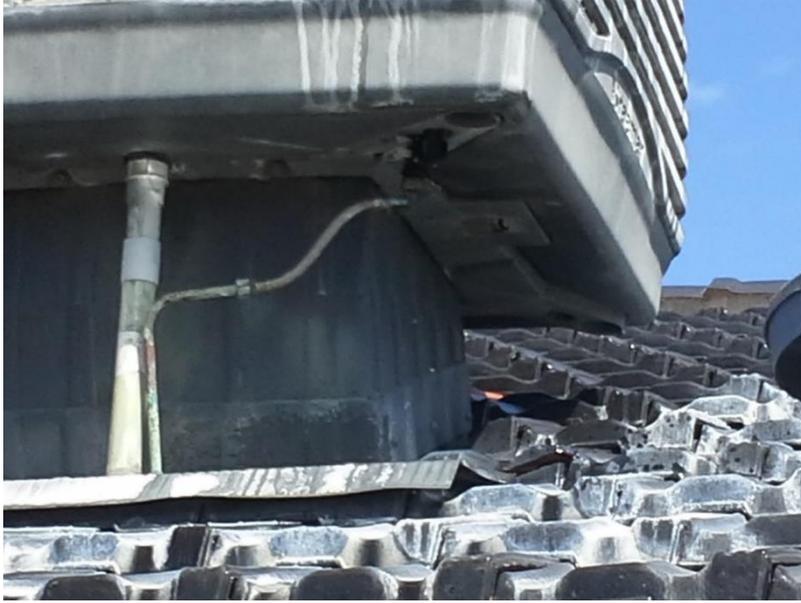
#### Item 1

Building:	Roof
Area:	All Sides
Findings:	Leakage was observed from Evaporative Cooler water outlet pipe and further leakage was observed from the eaves gutter.

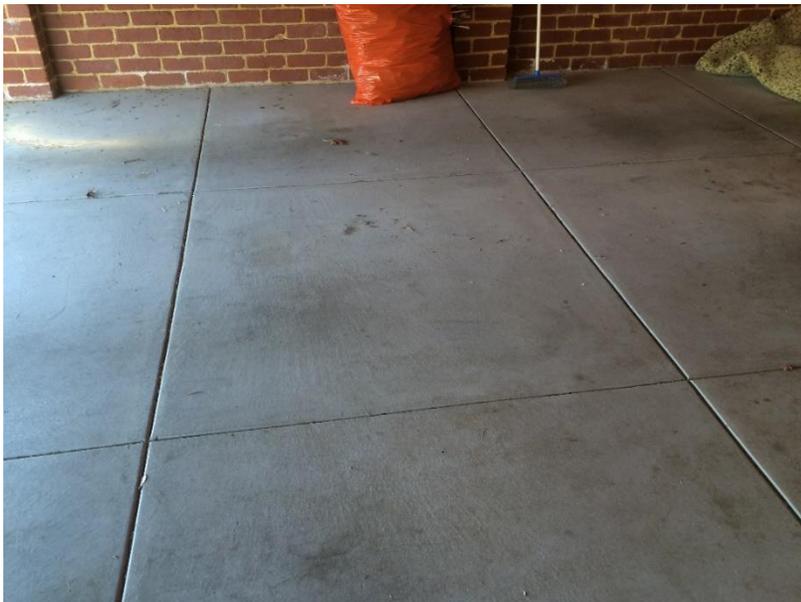
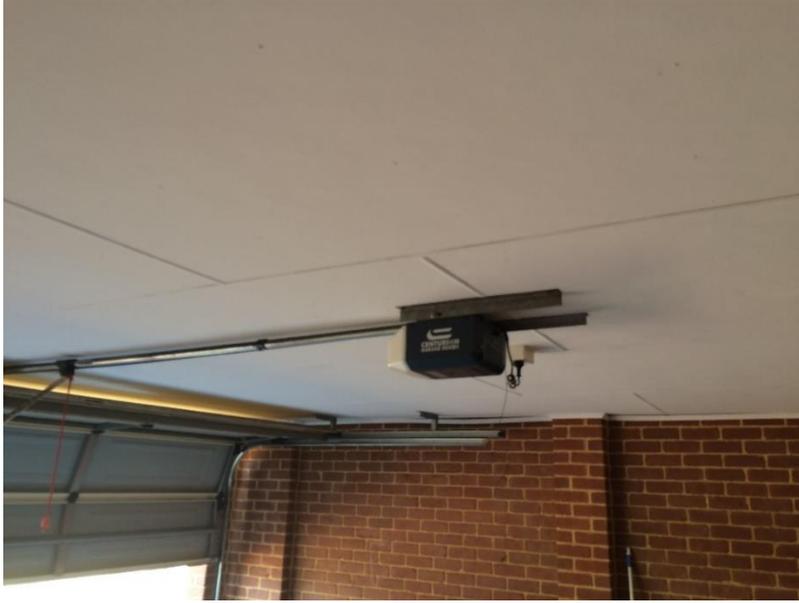
## Item 2

Building: Garage  
Location: Front  
Findings: Garage door operation was checked and found to be working order. The Garage remote was not in working order. Minor stains were found throughout the garage floor and may need general cleaning.

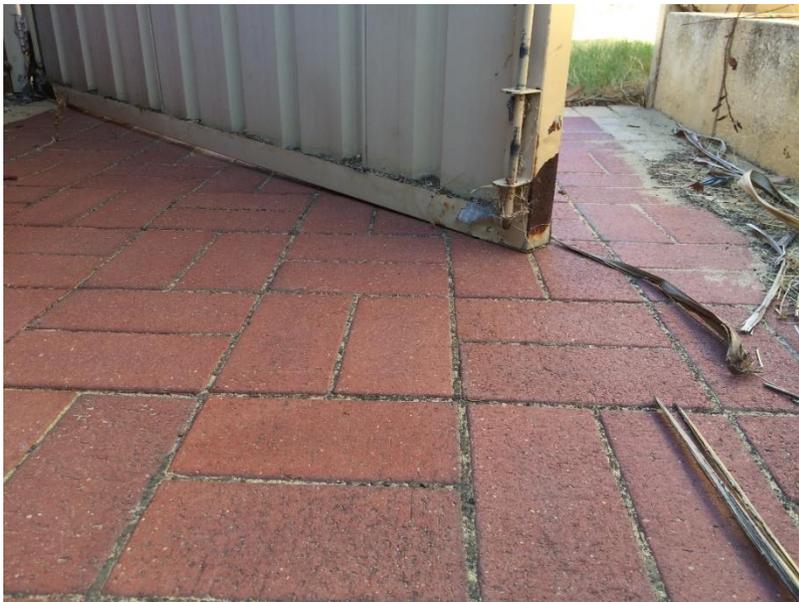
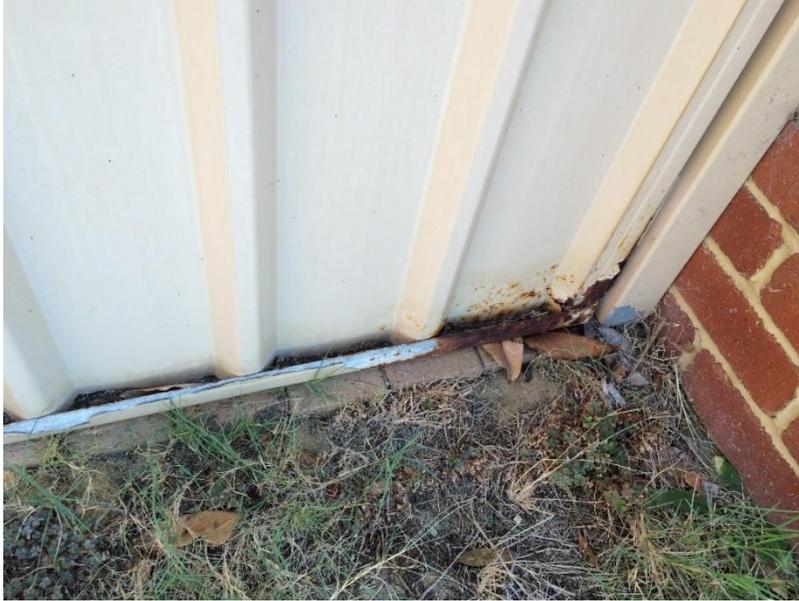
### Item 3

Building: Roof  
Location: All Sides  
Findings: Backyard entrance door was not found in working order. The door was only opening half way and is considered to be bent as shown by the clearance below the door in the photograph. Rusting was also observed on the door stud and door frame. It is recommended to re install the door with stronger or more hinges on the door with greater clearance from ground.

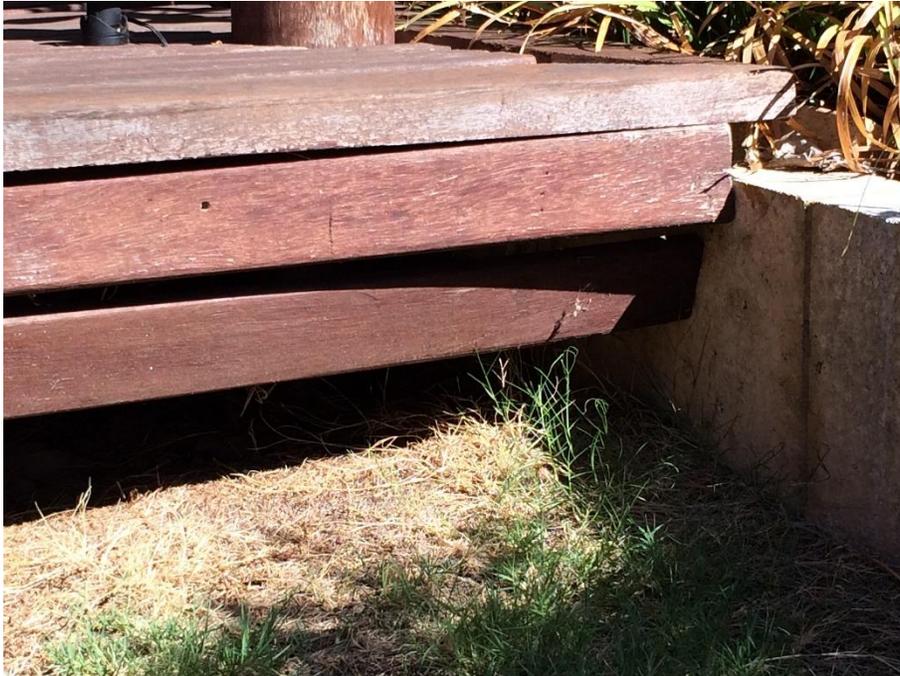
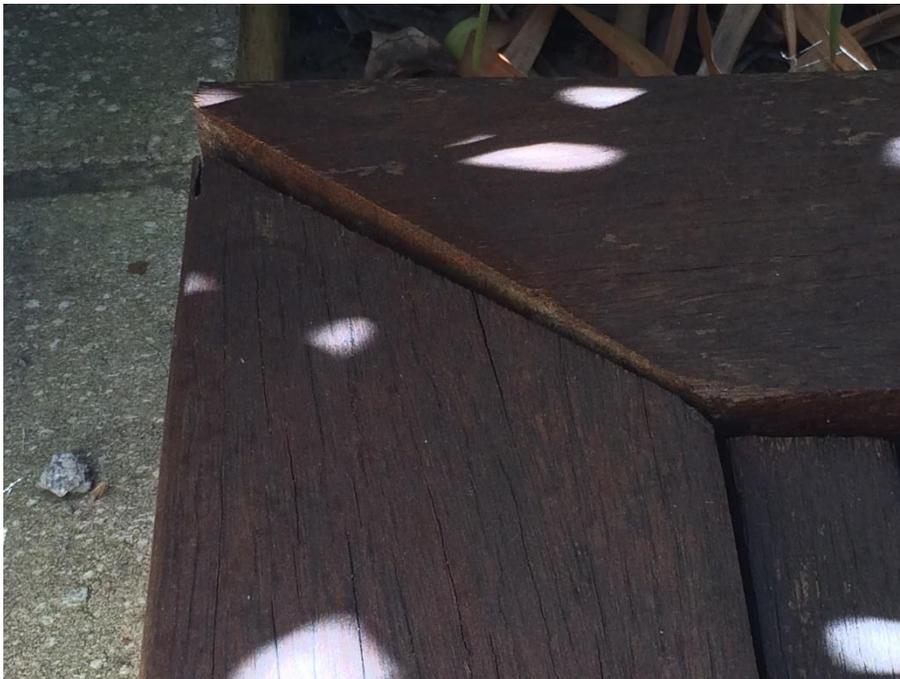
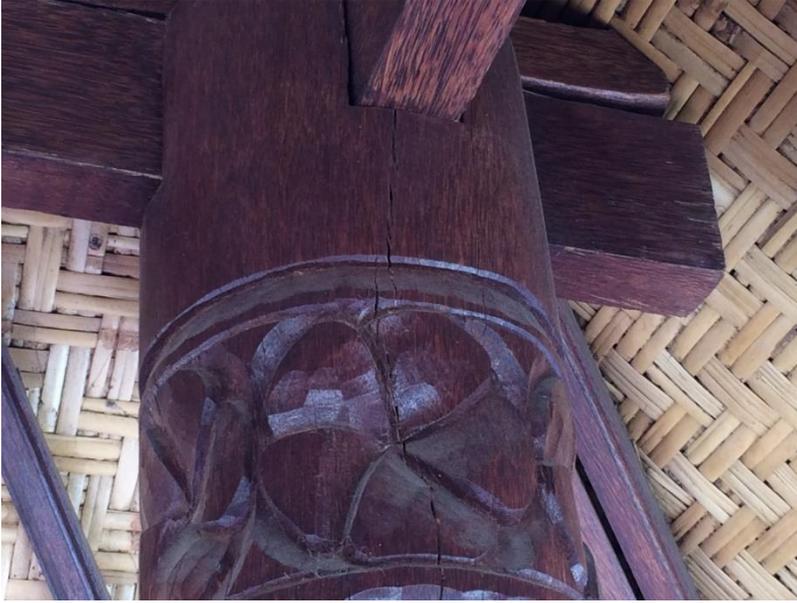
## Item 4

Building: Spa Patio

Location: Patio

Findings: Dislocation of timber slate due to clearance from the adjacent planter wall, considered non load bearing, however, it is recommended to be supported below by a brick to prevent any accidents. Splitting of pole was observed, however, the pole is considered to be in stable condition with no structural concerns. The crack can be sealed and re painted. If the crack opens further, it is recommended to get inspected from structural consultant. It is recommended to maintain the timber floor on level surface to prevent slips and trips. The entrance to patio was observed through loose tile pavers. Further, there is possibility of water ponding during rains, hence it is recommended to provide proper drainage to this area.

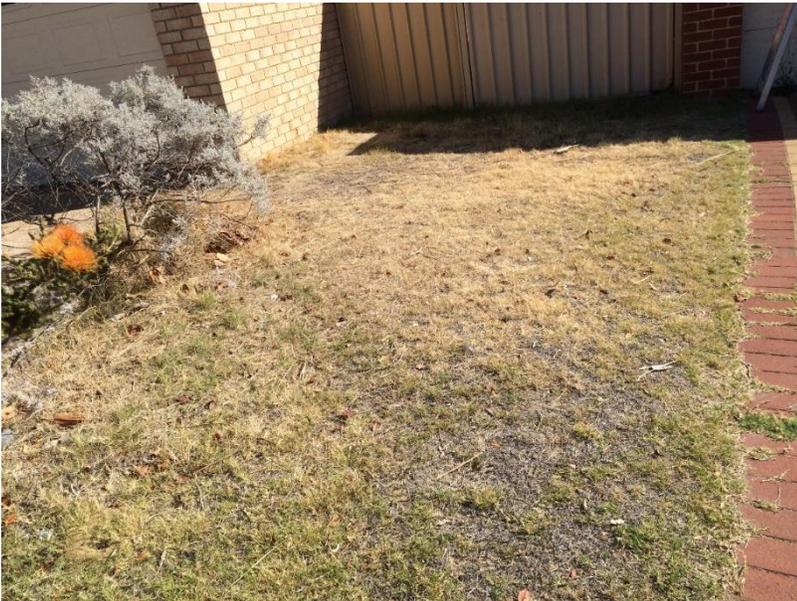
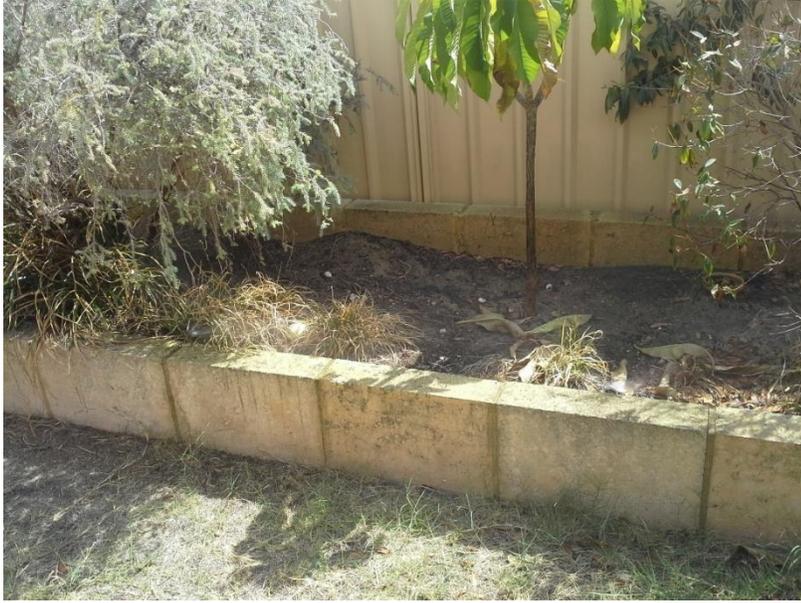
## Item 5

Building: Front Lawn  
Location: Front  
Findings: Needs weeding, seeding, re patching dead surface or re surfacing of the entire lawn area. Plants on outside planter have dried and may need re conditioning.

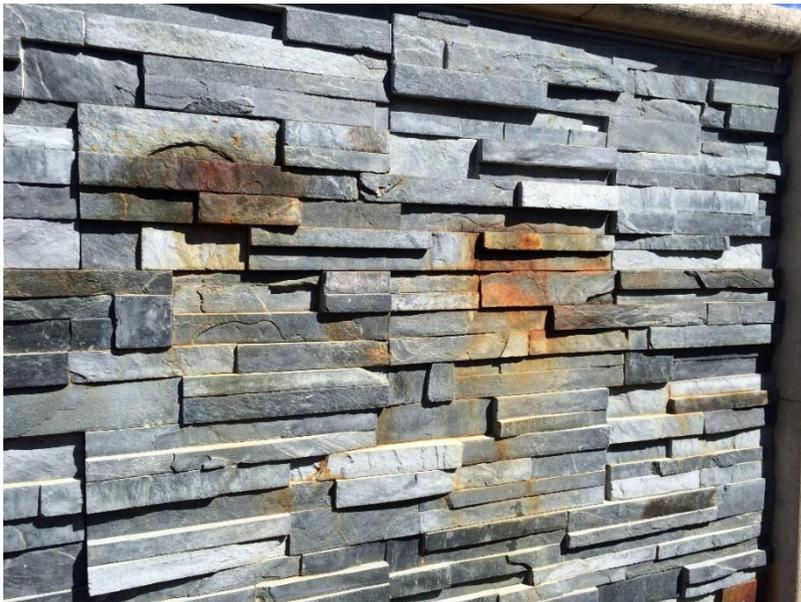
## Item 6

Building: Water Feature

Location: Side Corridor

Findings: Water Feature shows tile stains. pump was found to be in good operating condition.

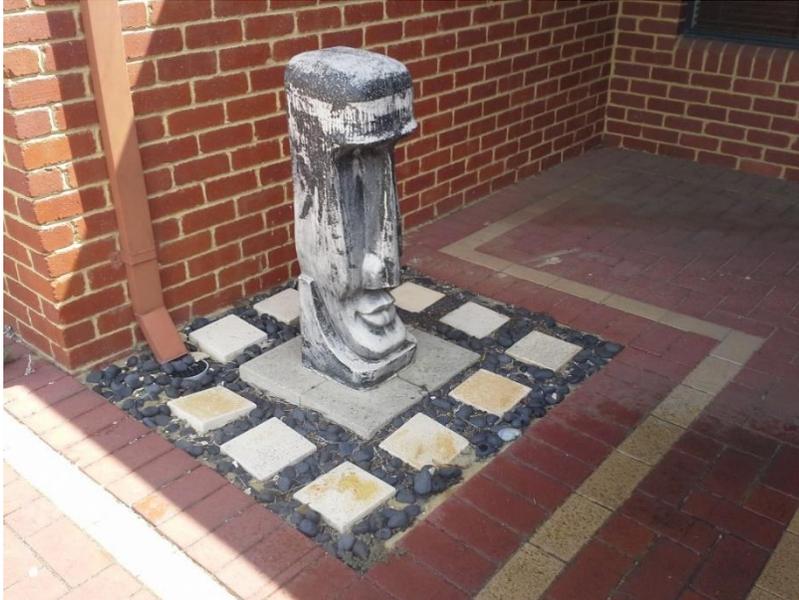
## Item 7

Building: Front Statue  
Location: Front  
Finding: Stain was found throughout the statue, may need general cleaning and re surfacing.

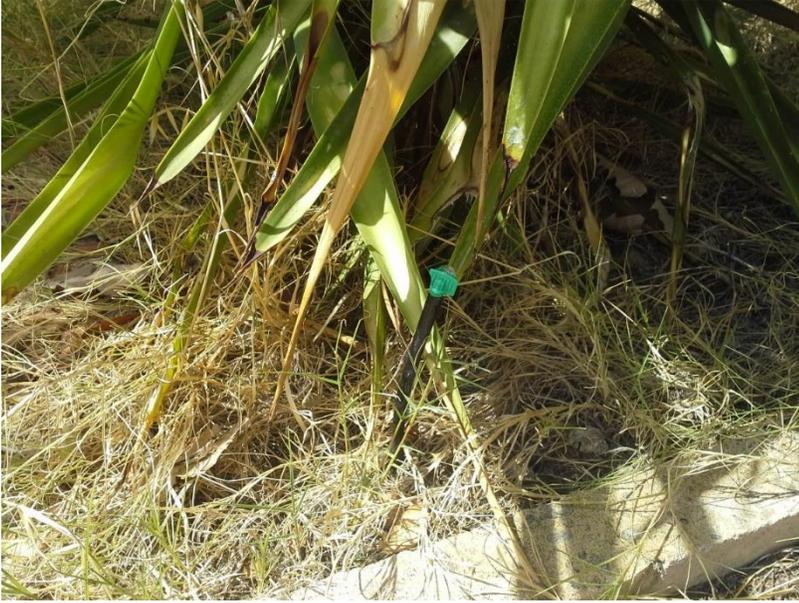
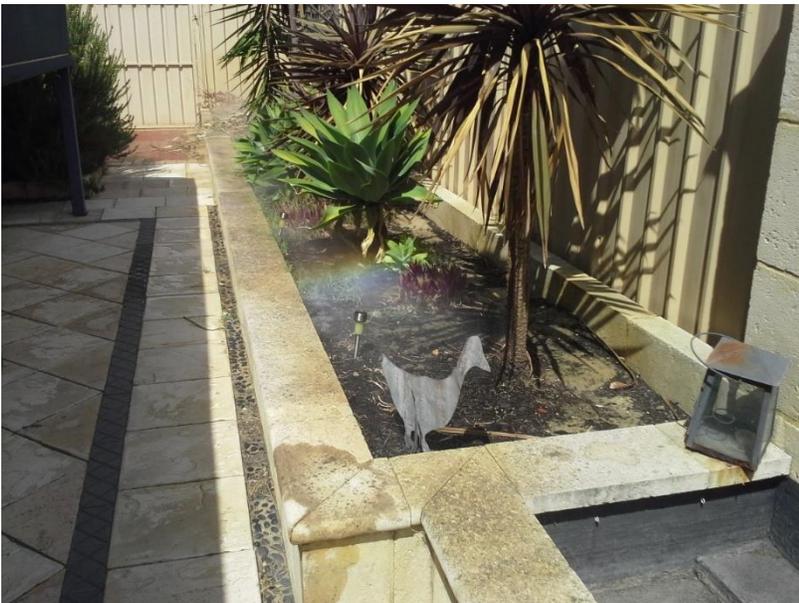
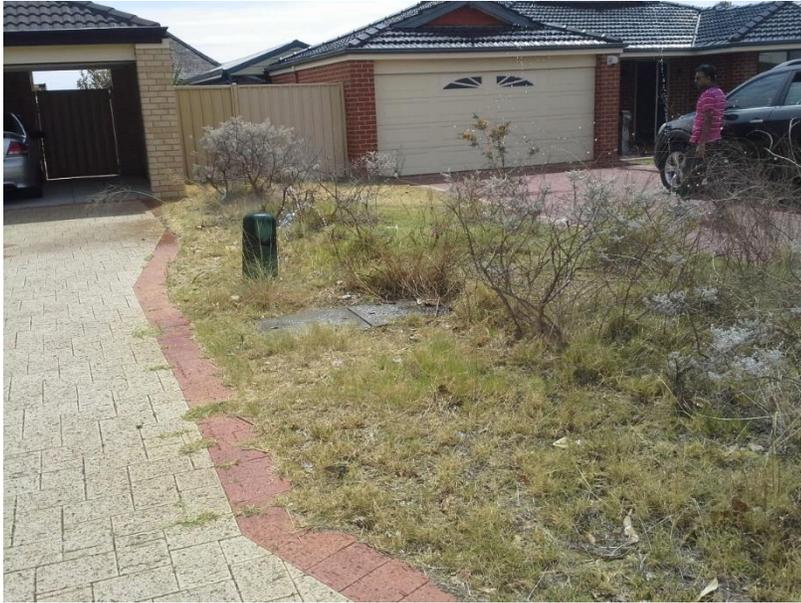
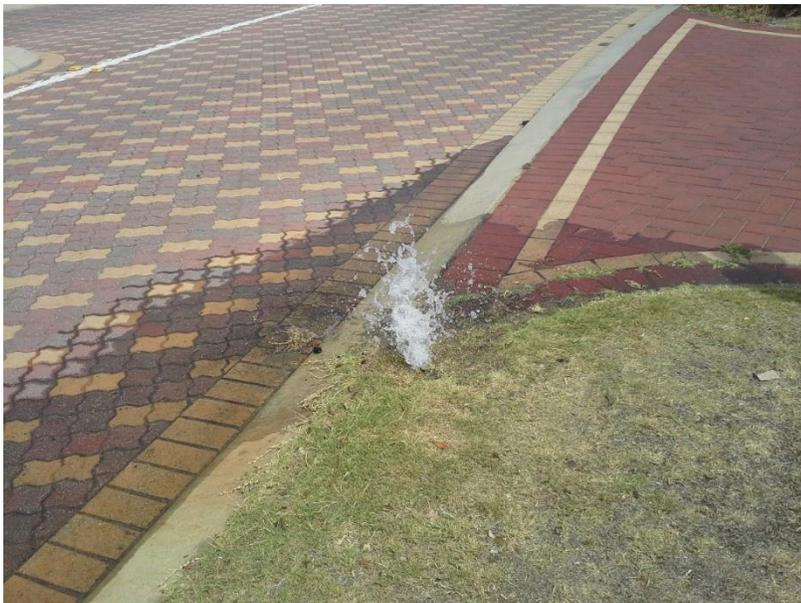
## Item 8

Building: Sprinklers  
Location: All areas  
Finding: Few internal sprinkler pipe on station 3 were found in blocked condition. One of the sprinkler on station 1 was not found in working order and may need replacement, similarly on station 2, two of the sprinkler were not found in working order and may need replacement.

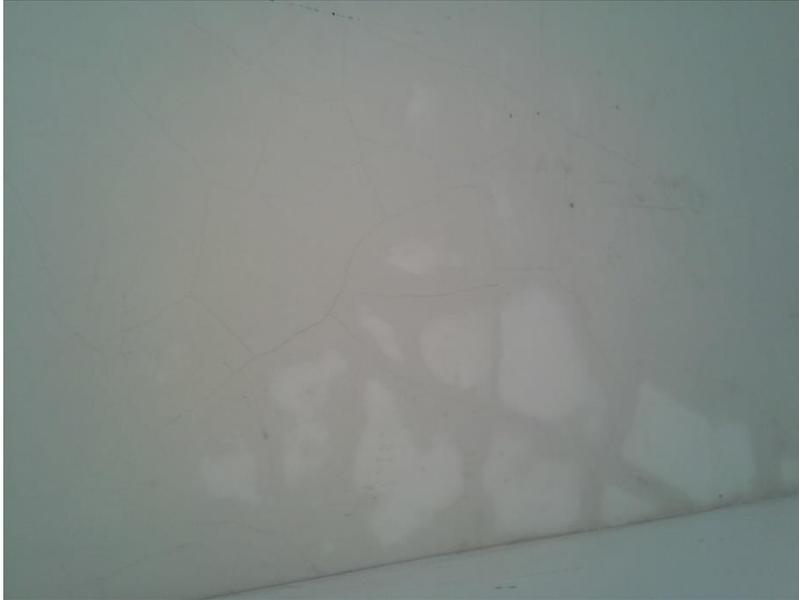
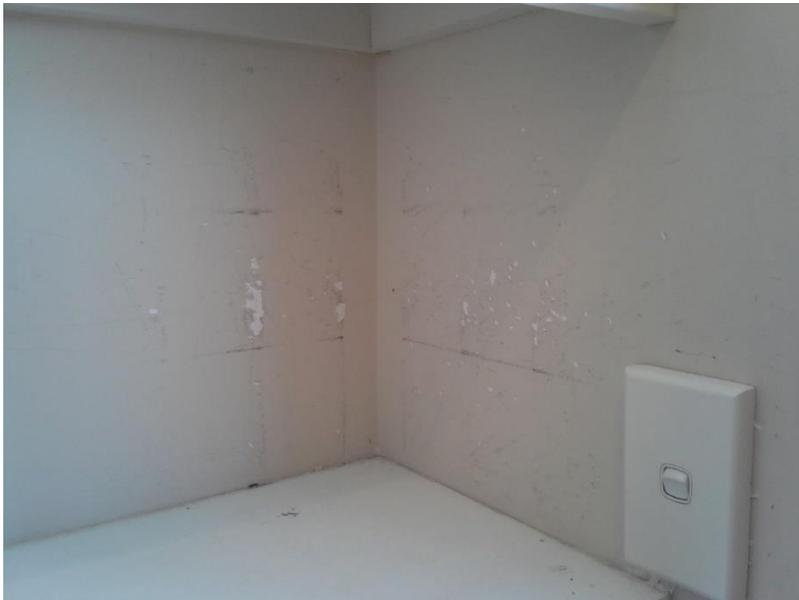
## Item 9

Building: Kitchen Area  
Location: Wardrobe  
Finding: Shrinkage cracks and peeling of paint surface

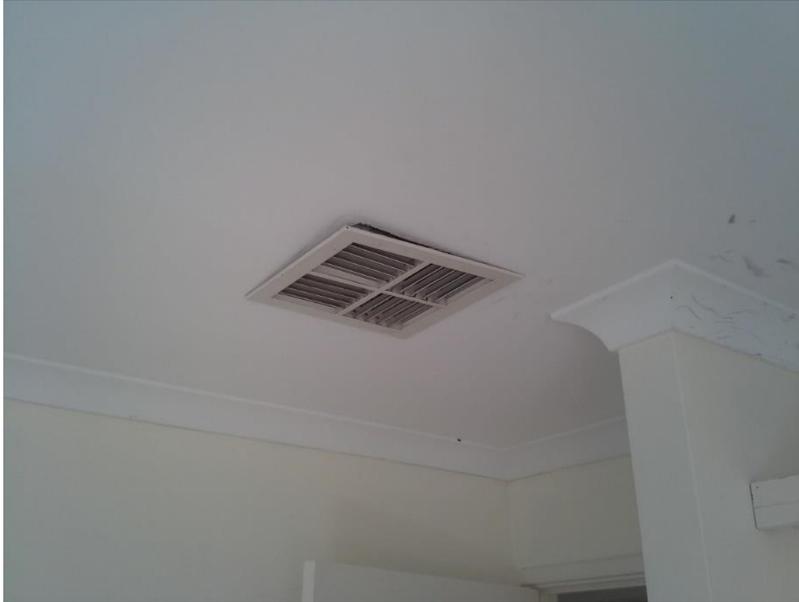
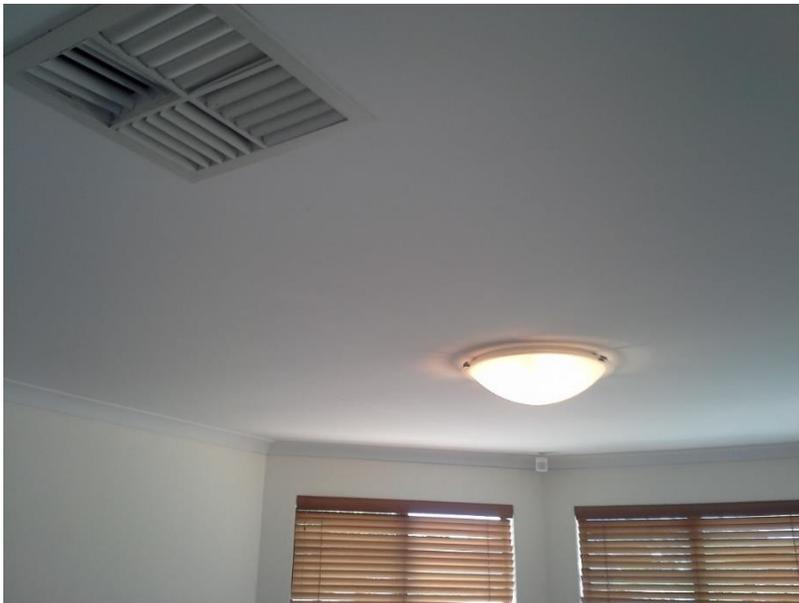
## Item 10

Building: Air Conditioning Louver  
Location: Ceiling  
Finding: Louver were observed to be detached from the ceiling and may require to be sealed back to the surface.

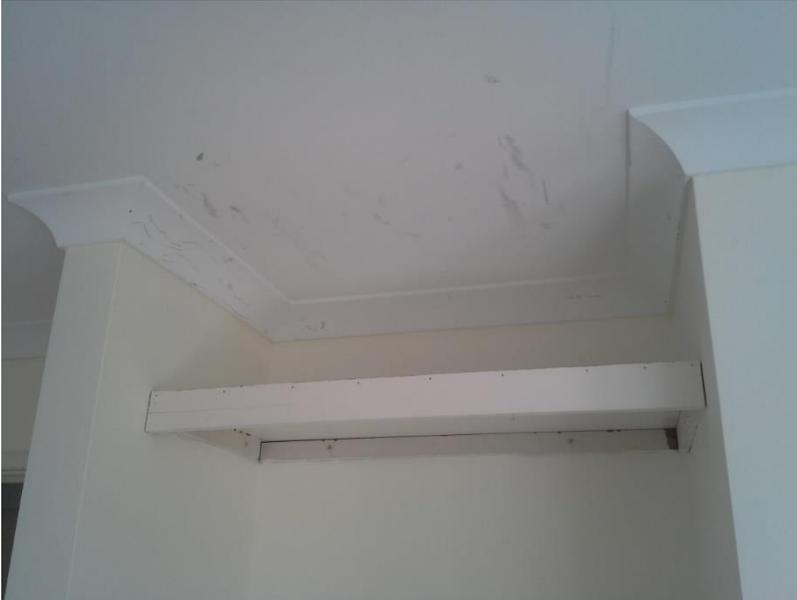
## Item 11

Building: Near wardrobe  
Location: Bedroom 1 near kitchen  
Finding: Paint peel off was observed and may require patching and re surfacing.

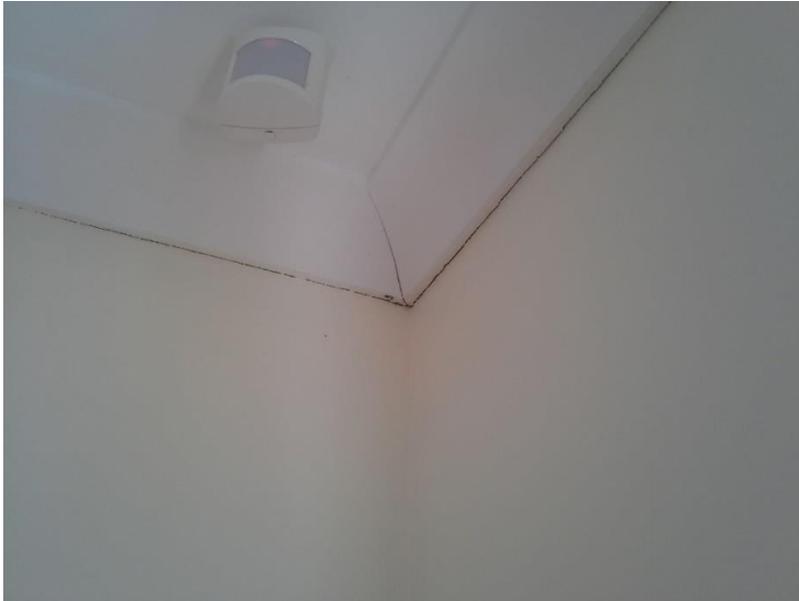
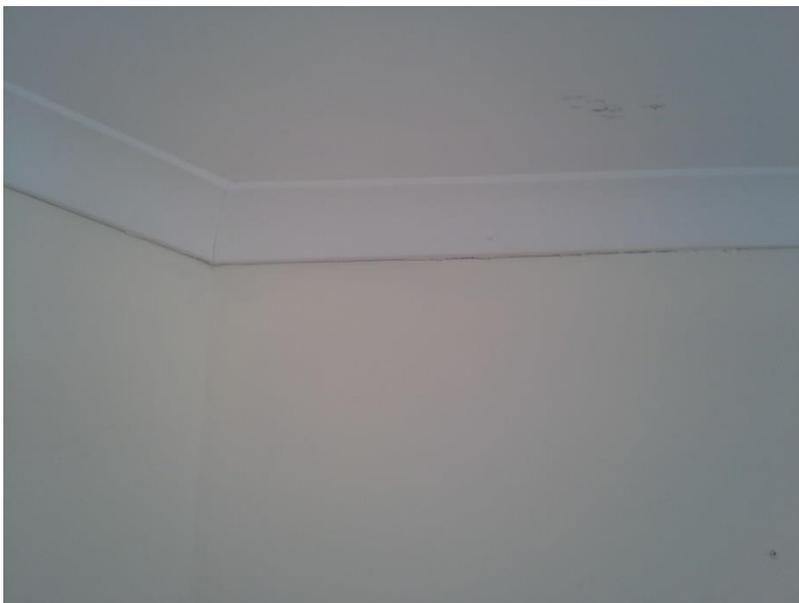
## Item 12

Building: Cornice  
Location: Multiple areas  
Finding: Corner of cornice and bonding to the wall was observed to be detached. It may require patching and re surfacing.

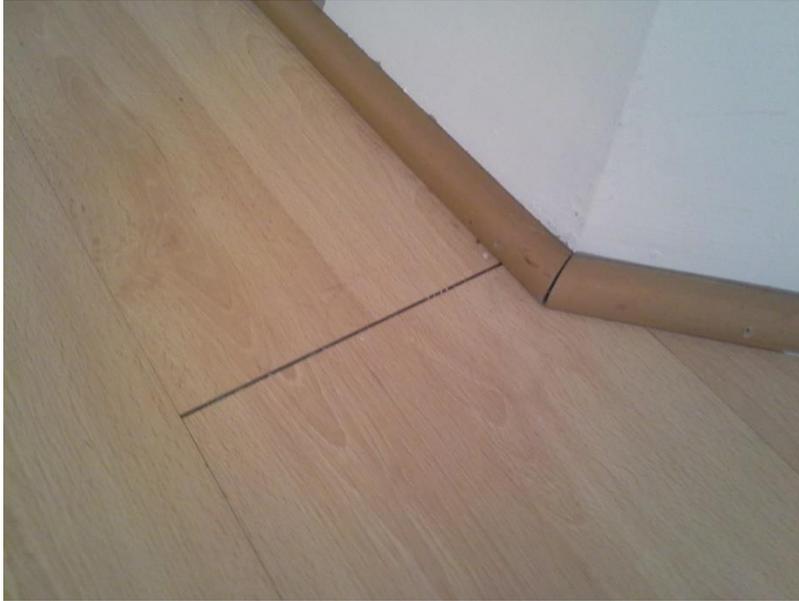
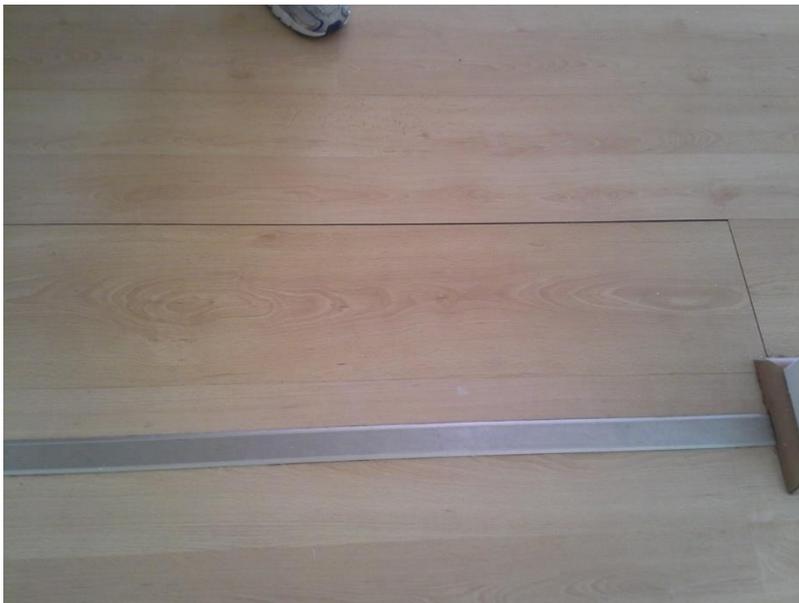
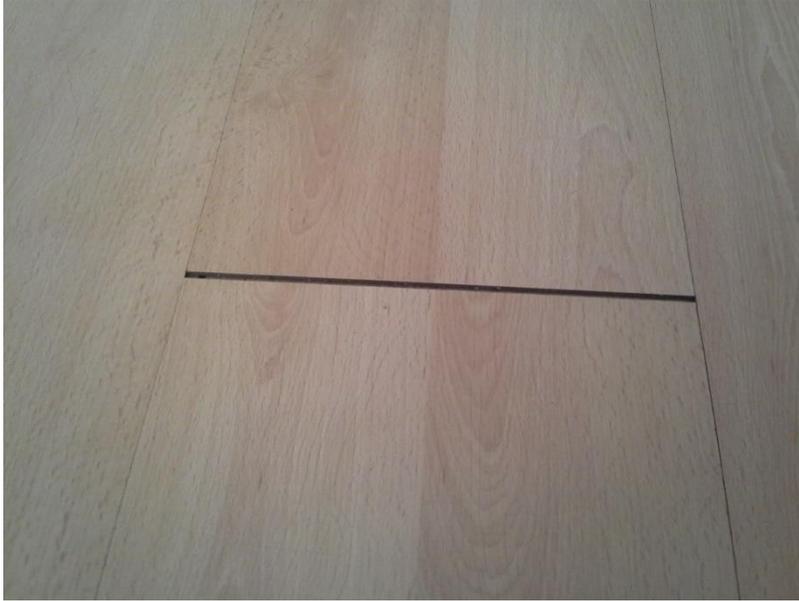
## Item 13

Building: Living area  
Location: Adjacent to kitchen  
Finding: Rejoining and sealing may be required of loose timber slate which were observed to be loose state.

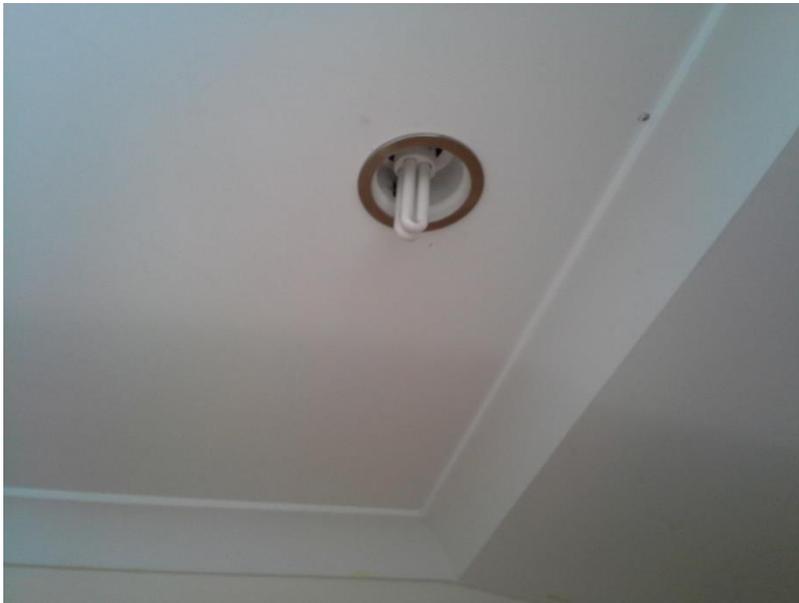
## Item 14

Building: Interior  
Location: Ceiling lamp and cover  
Finding: Ceiling lamp was found in exposed state and the cover was not present as seen in living area.

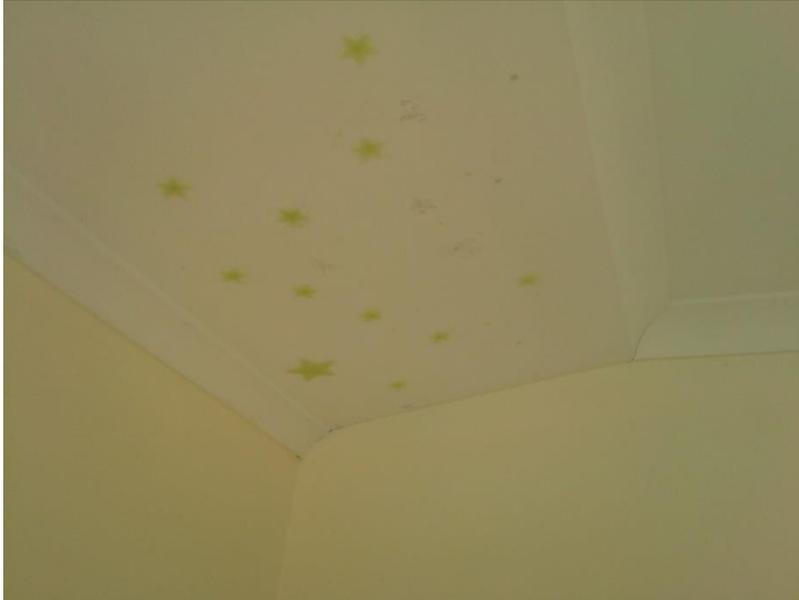
## Item 15

Building: Bedroom 3 and 4  
Location: ceiling  
Finding: Radium sticker were observed in random order which may require cleaning and re surfacing.

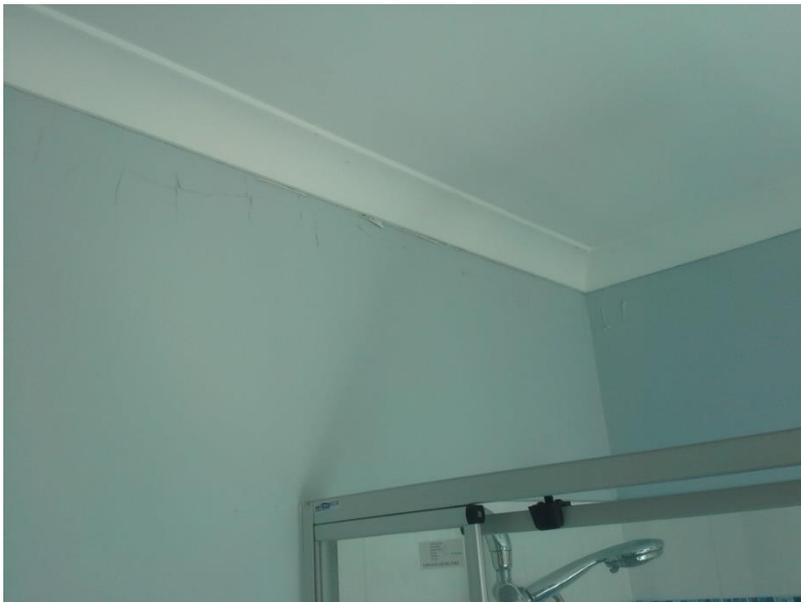
## Item 16

Building: Master Bedroom  
Location: Bathroom  
Finding: Peeling of paint surface, Sealants from basin were exposed and may require re Sealing.

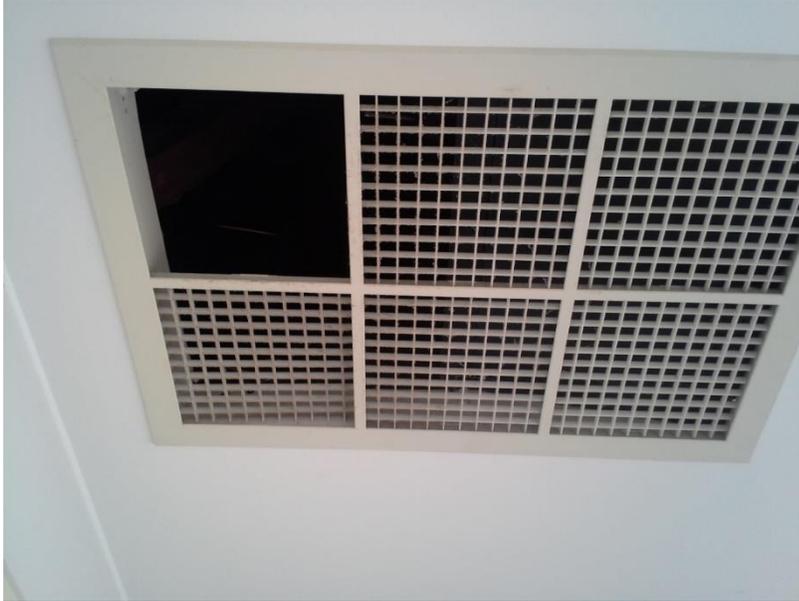
## Item 17

Building: Laundry Area  
Location: Air Condition Exhaust opening  
Finding: One of the square was found to be missing from the cover.

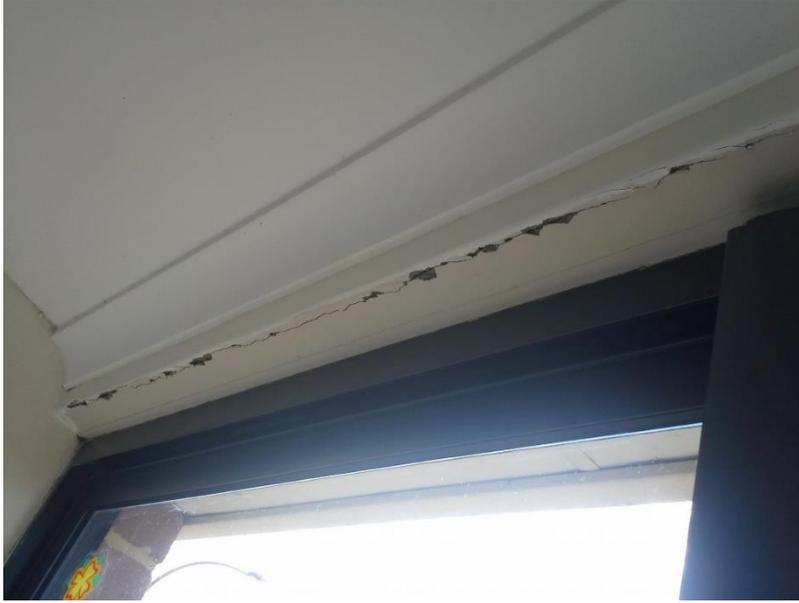
## Item 18

Building: Laundry  
Location: Wardrobe  
Finding: Peeling of paint surface

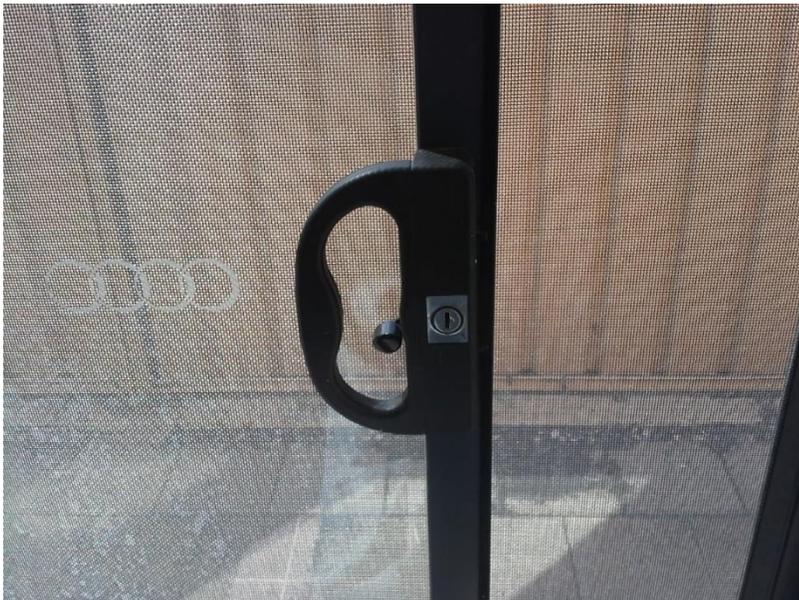
## Item 19

Building: Laundry Area  
Location: Glass Door  
Finding: Loose handle was noticed which may need to tighten to prevent further damage.

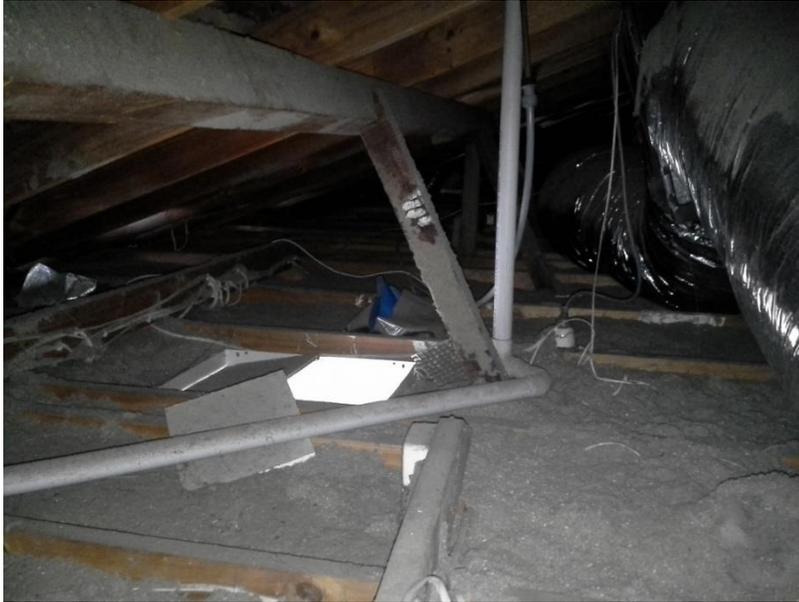
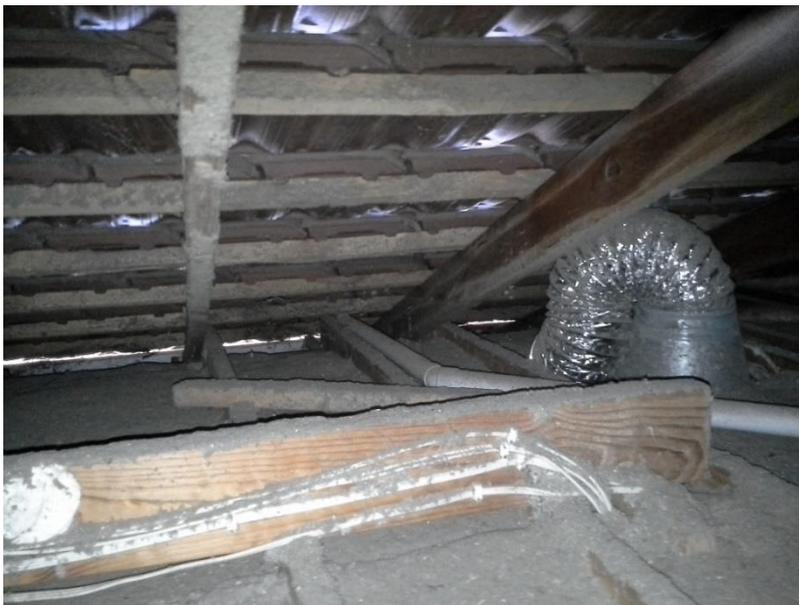
## Item 20

Building: Insulation  
Location: Ceiling  
Finding: Insulation is considered to be exposed to moisture and is considered to be significantly affected. Further specialist advise is recommended to reinstate the ceiling insulation and maintain energy efficiency.

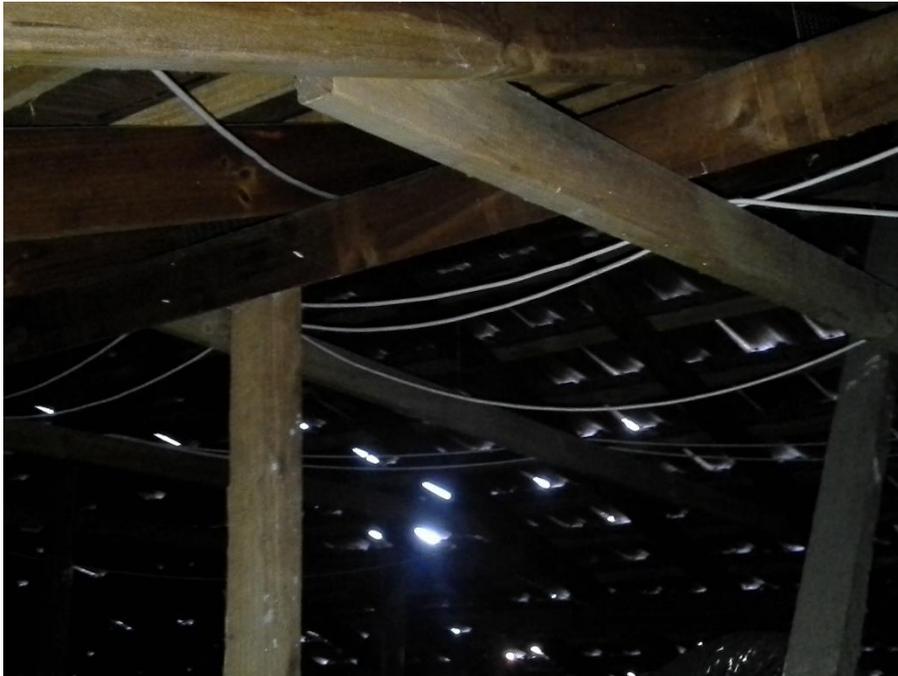
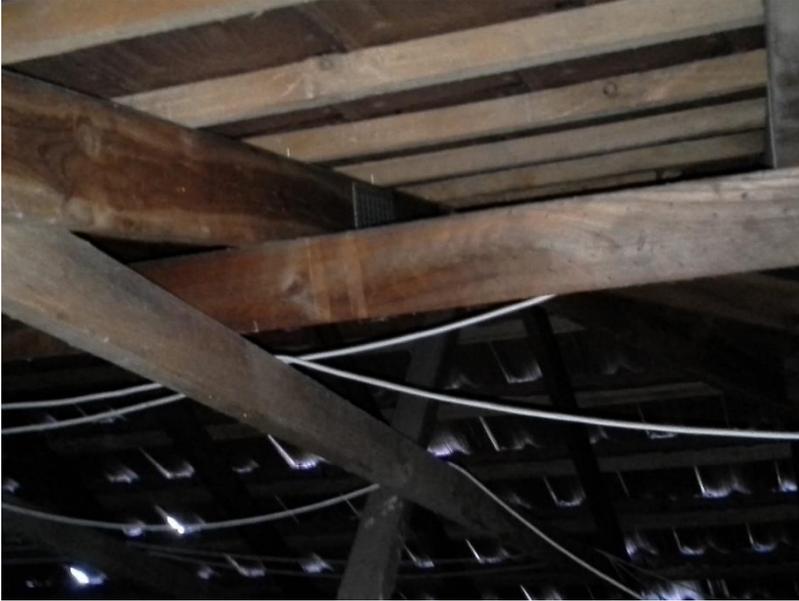
## Item 21

Building: Timber elements and Connections  
Location: Ceiling  
Finding: Minor moisture damage was observed on timber elements, no structural damage on timber members And connections was noticed, no termite conducive activity was noticed, hence deemed to be in good condition.

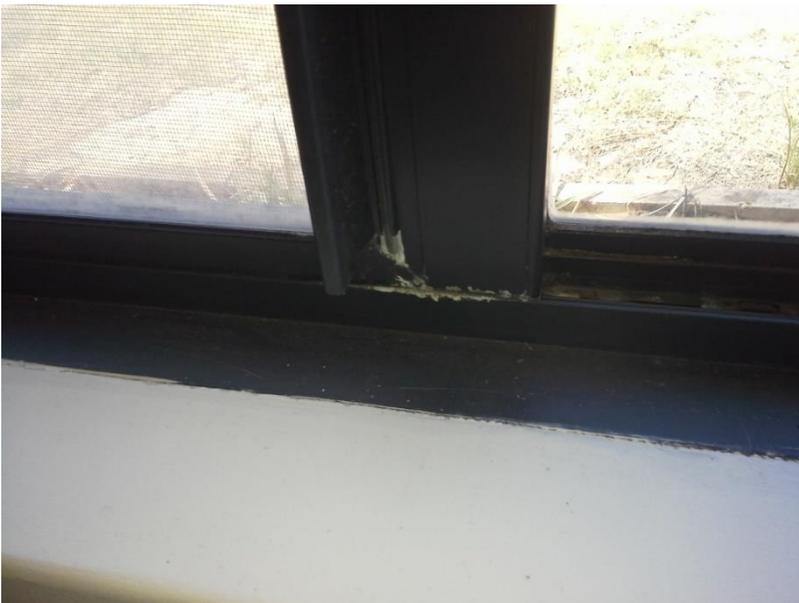
## Item 22

Building: Window Frame and screen  
Location: Frame and Screen  
Finding: Tear was noticed on the window screen and the paint peel was observed on the window frame.

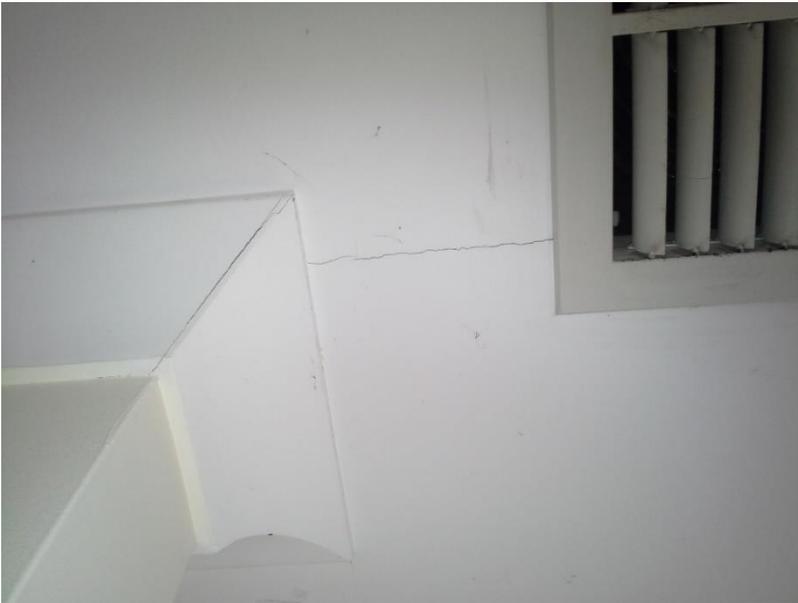
## Item 23

Building: Ceiling  
Location: Bedroom 1  
Finding: Minor crack was noticed on the ceiling which may be patched and painted. The crack may be due to minor movement or inadequate support of the air condition duct which may direct the load to ceiling. If the crack re appears after repainting, it is recommended to strengthen this area.

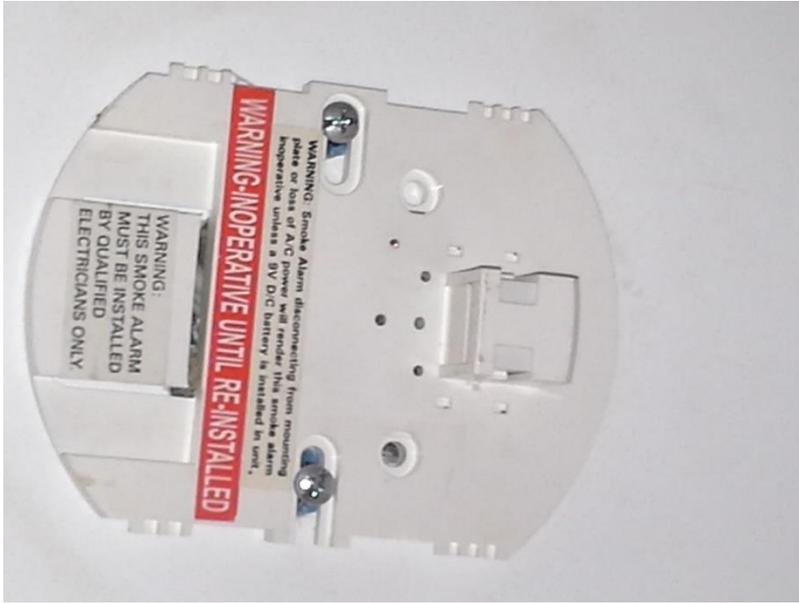
## Item 24

Building: Smoke Detector – 2 off  
Location: Interior  
Finding: Smoke unit was found detached from the point and was lying in kitchen wardrobe. Both the smoke detector were checked using one of the unit with battery inside and were found in working order. It is recommended to have the smoke detector installed at all the time to prevent any fire related hazard.

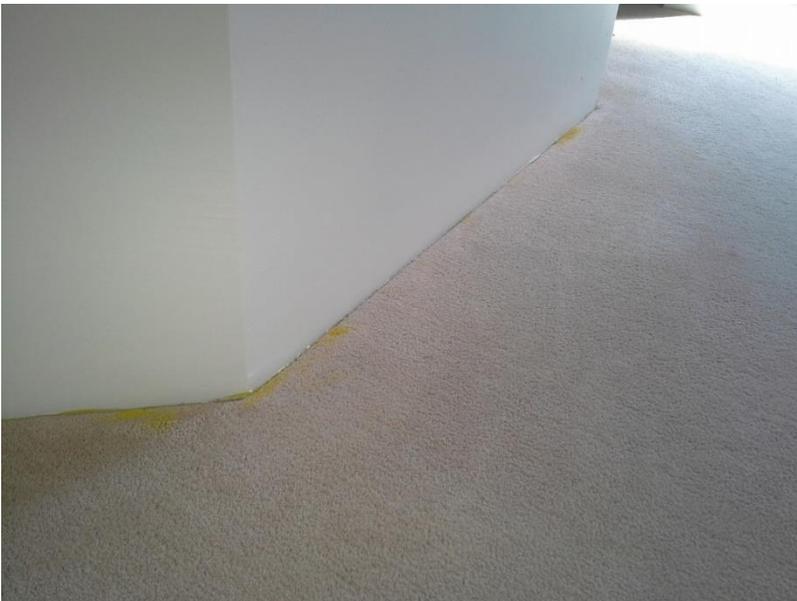
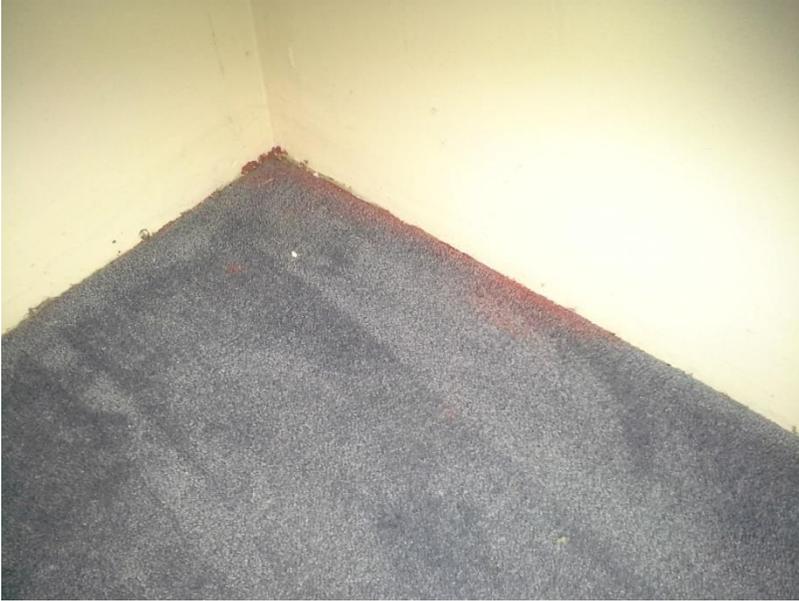
## Item 25

Building: Carpet  
Location: Bedrooms  
Finding: Stain, minor dents were found on all carpet which may need general cleaning and maintenance.

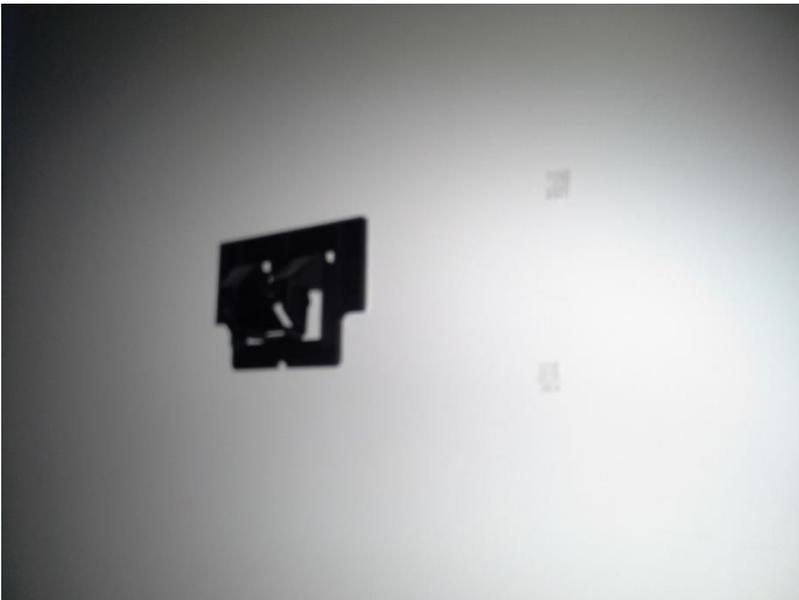
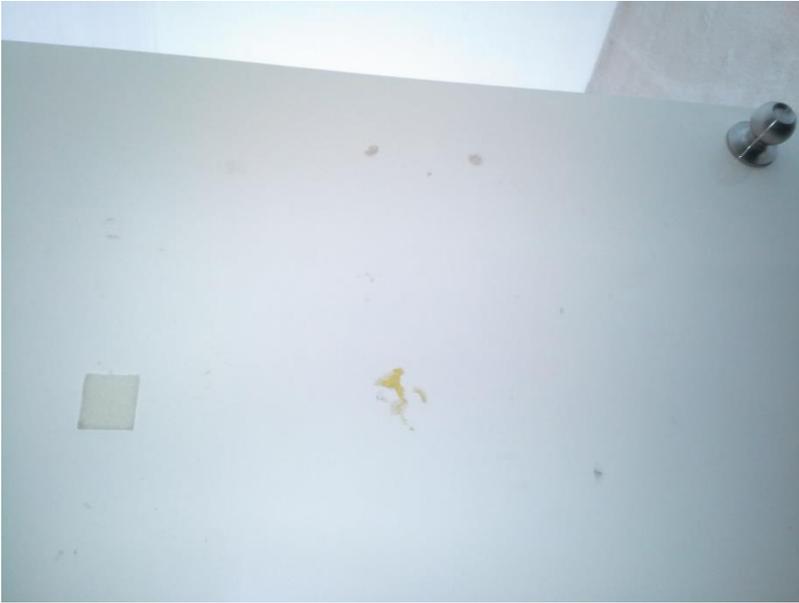
## Item 26

Building: Bedroom Doors  
Location: Bedrooms  
Finding: Bedroom hanger and stains were present on door.
