# Pre-purchase Building Inspection Report

Complies with Australian Standards AS4349.1 - 2007

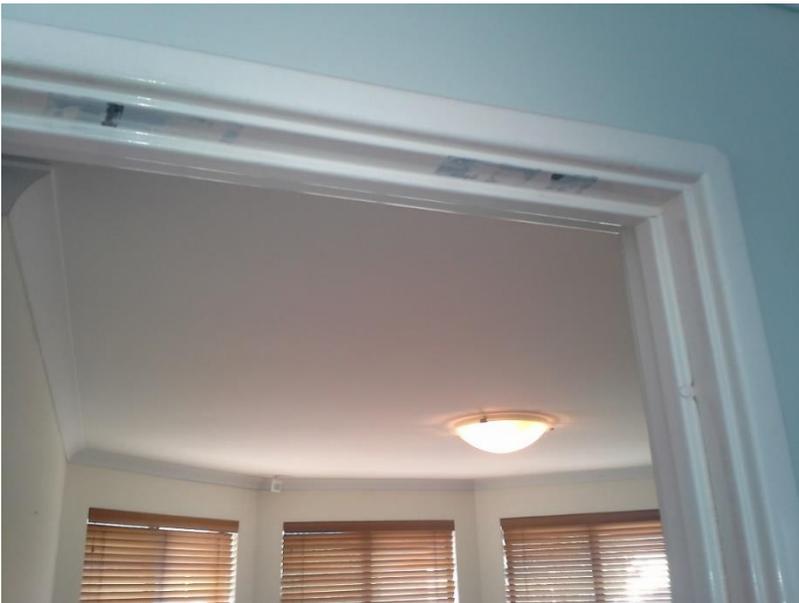
## Item 27

Building: Bedroom Door  
Location: Master Bedroom  
Finding: Bedroom hanger and stains were present in partial condition on door which may require removal, cleaning and resurfacing.

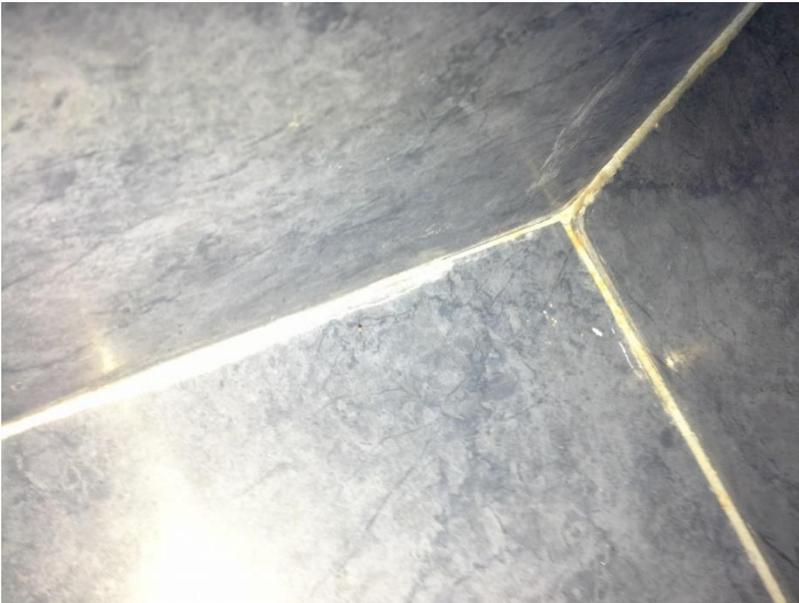
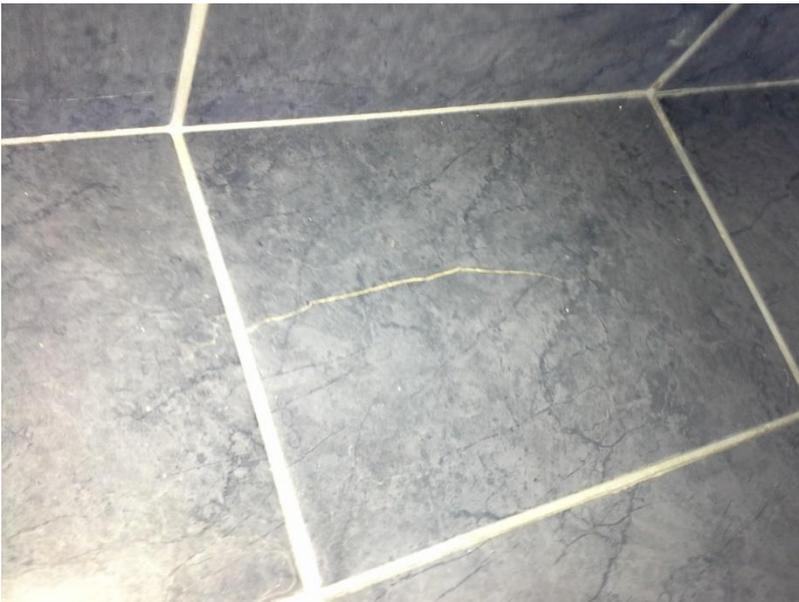
## Item 28

Building: Bathroom  
Location: Master Bedroom  
Finding: Bathroom tile was found in cracked order and re sealing may be required at the edges

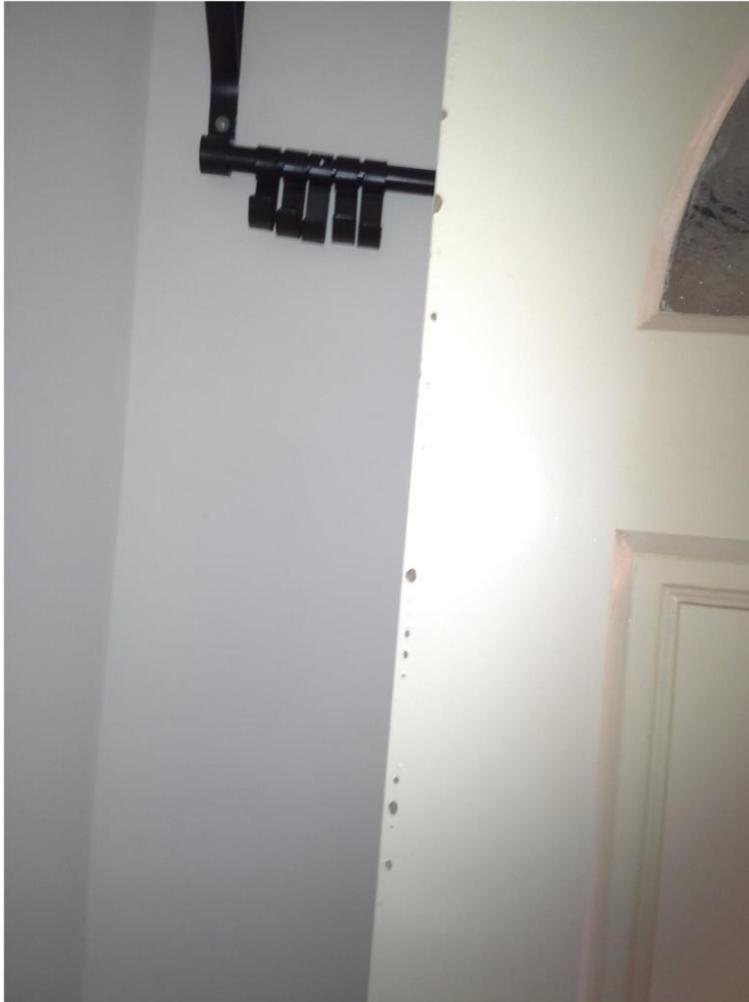
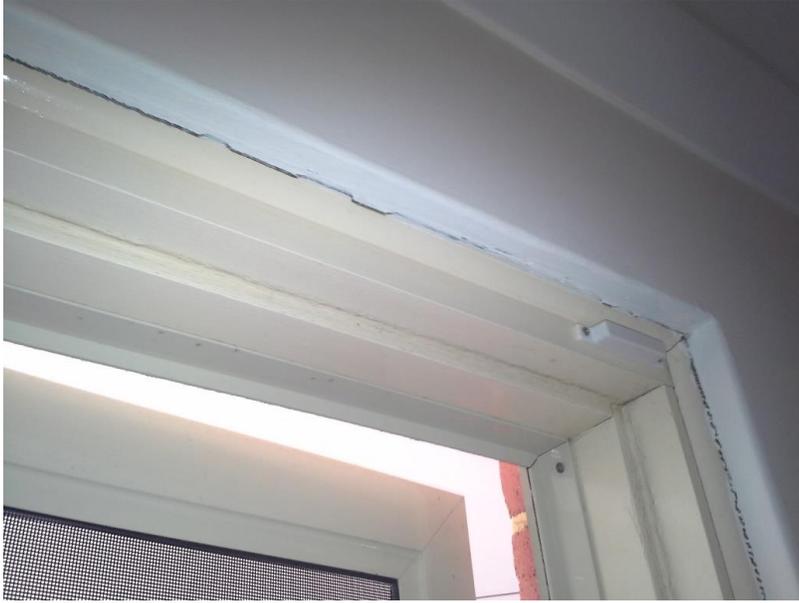
## Item 29

Building: Main entrance door  
Location: Entrance  
Finding: Paint Peel off, cracking from header was noticed and may need minor repair and resurfacing.

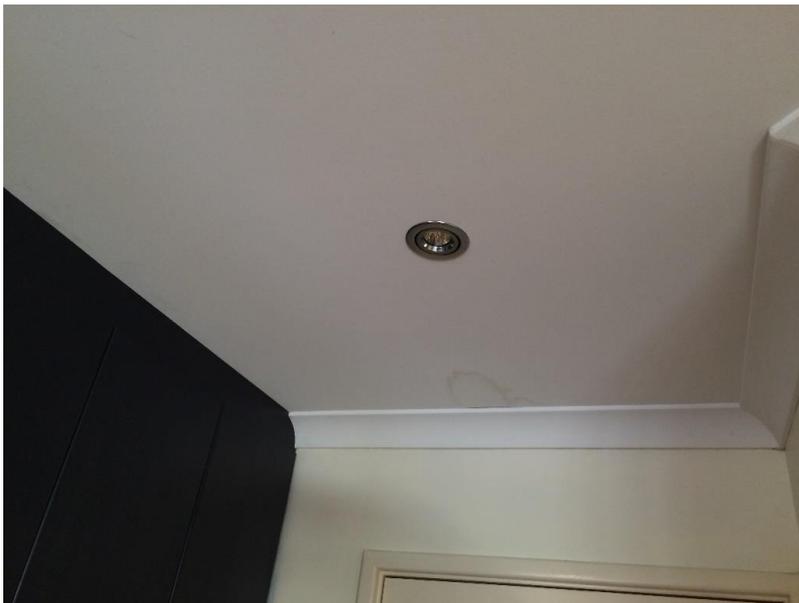
## Item 30

Building: Kitchen  
Location: Above Garage door  
Finding: Water stain was observed on ceiling which may be due to leakage from roof. Ceiling light located above the door was not found in working order

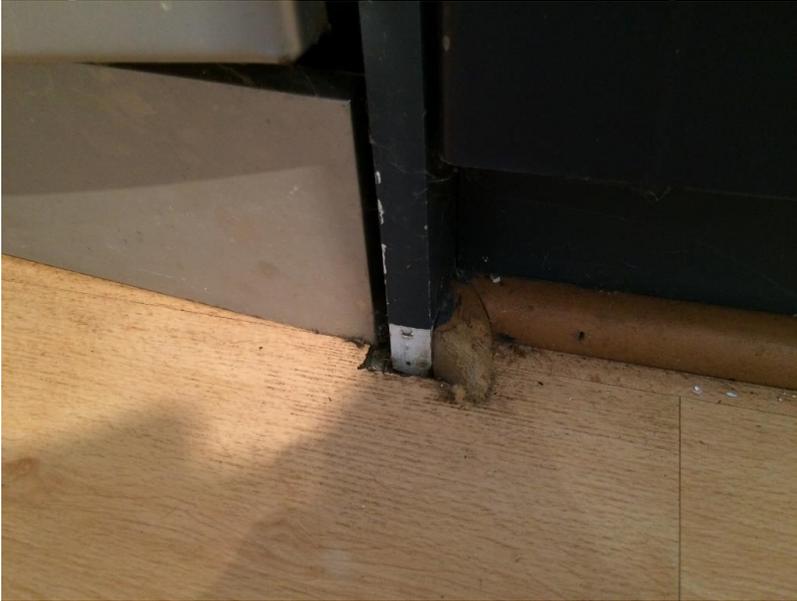
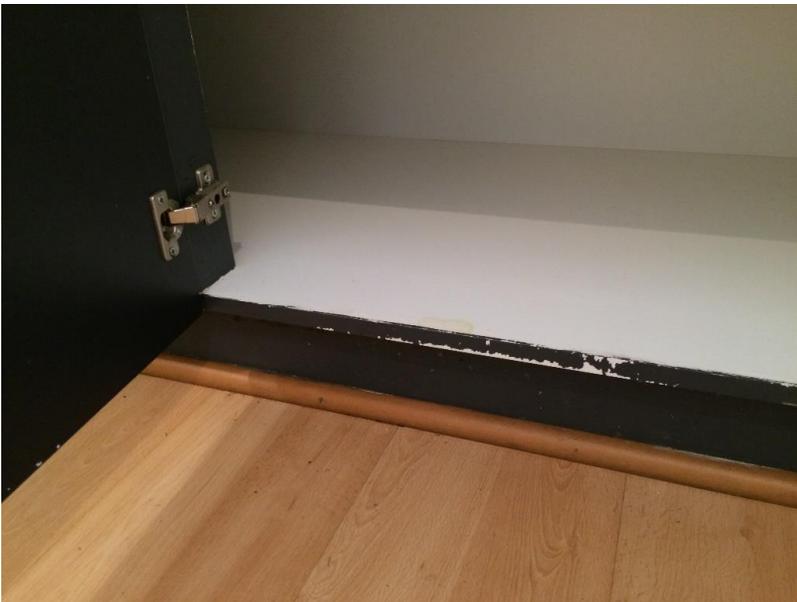
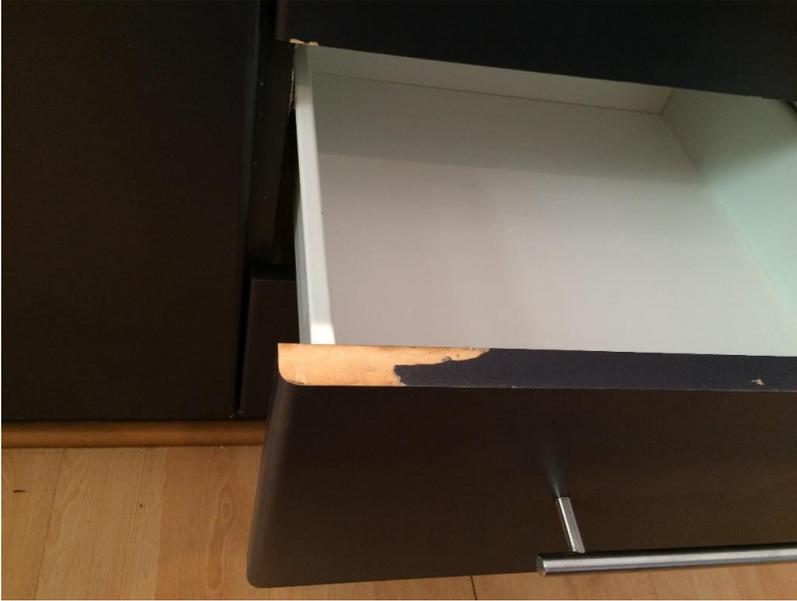
## Item 31

Building: Kitchen  
Location: Kitchen Cabinet  
Finding: Cabinet door shows laminate peeling off and moisture damage

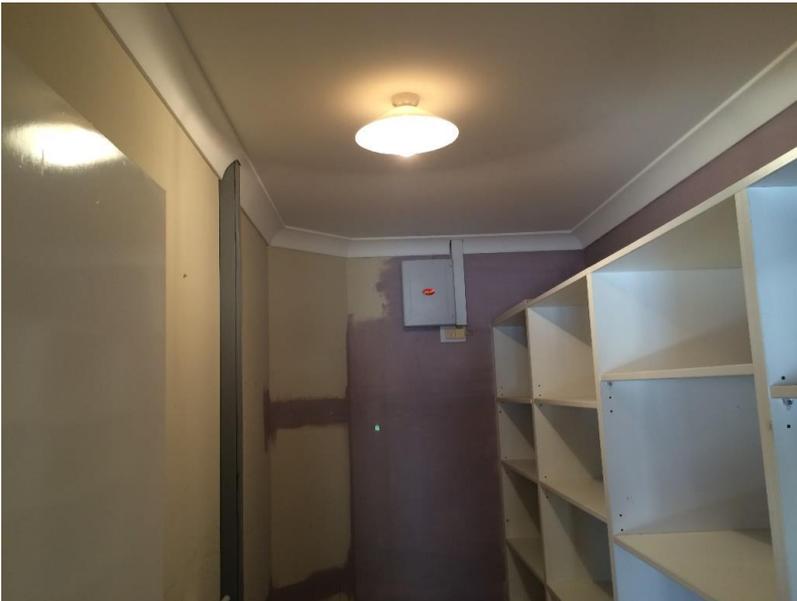
## Item 32

Building: Kitchen  
Location: Wardrobe  
Finding: Unfinished Paint work was observed on the wardrobe walls.

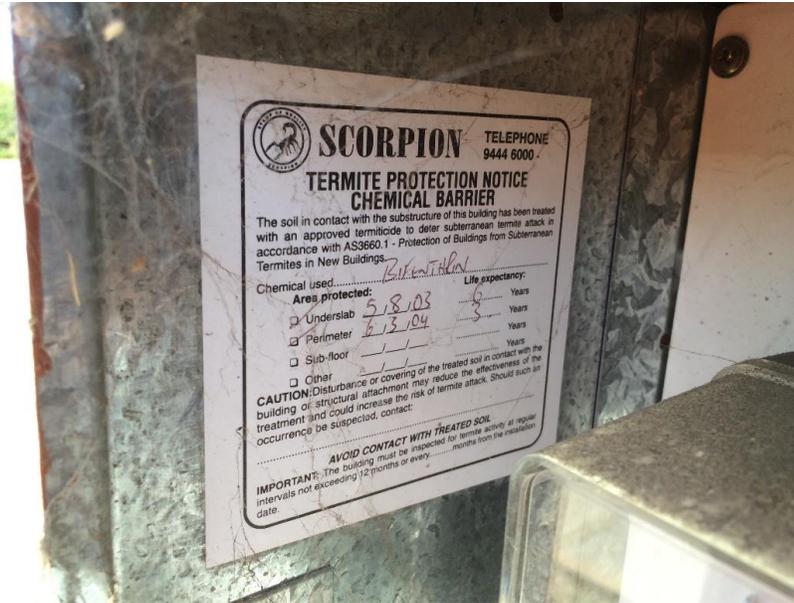
## Item 33

Building: Termite Protection  
Location: Switch Board  
Finding: Termite Barrier Protection has expired however, no activity conducive to termite damage was observed. It is recommended to get Termite Barrier Protection done to prevent any future damage.

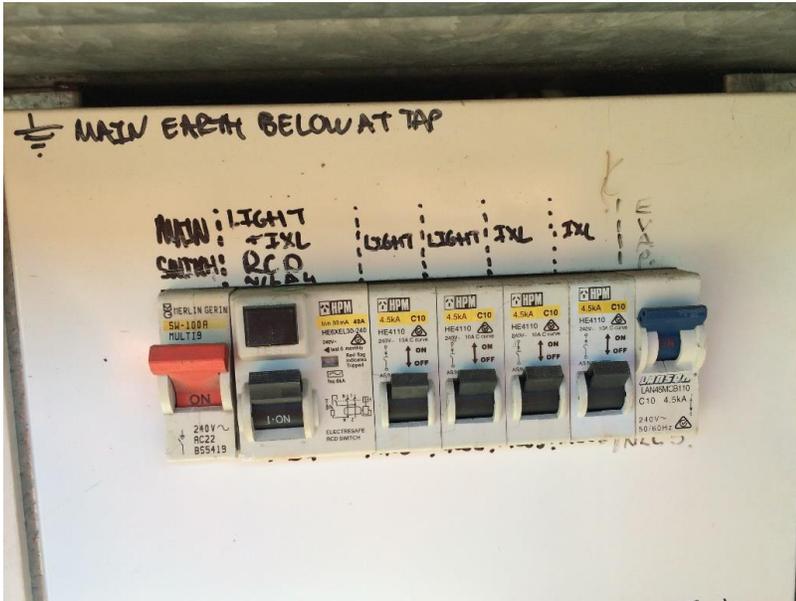
## Item 34

Building: Switchboard  
Location: RCD  
Finding: RCD were observed in working order.

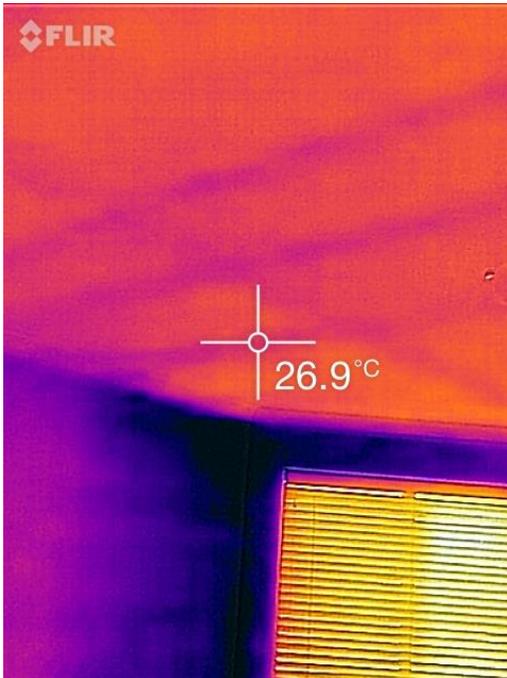
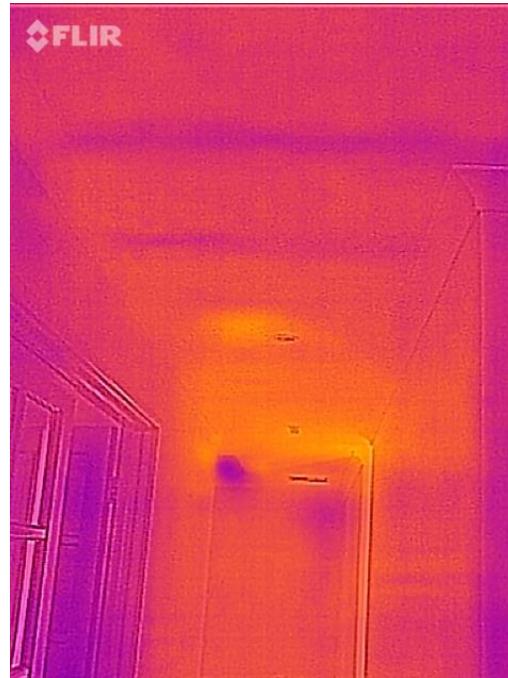
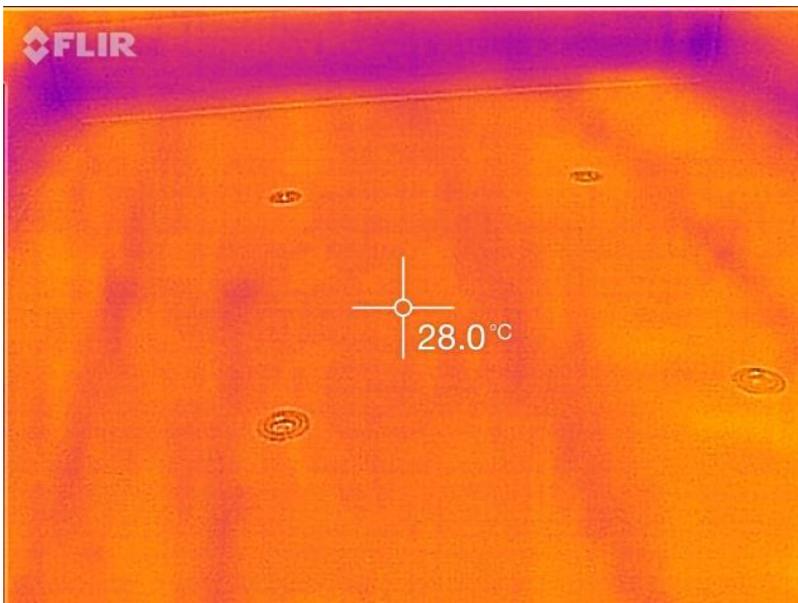
## Item 35

Building: Interior – Thermal Imaging  
Location: All Areas  
Finding: Thermal Imaging was done for interior of house to detect ceiling insulation as well termite activities. Uniform Insulation was observed below and no termite activity was observed on ceiling surface.

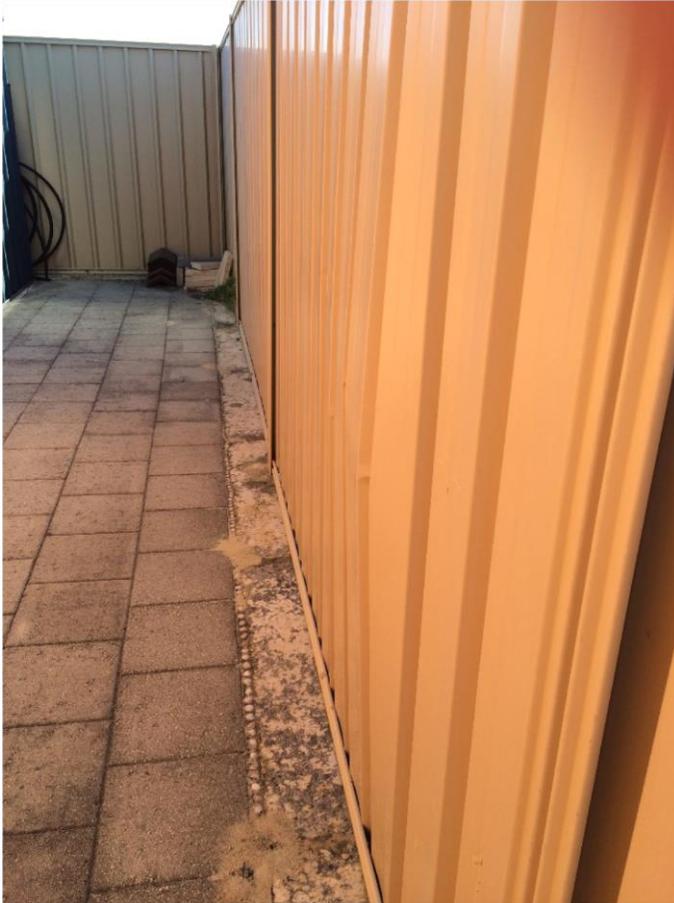
## Item 36

Building: Corridor Fence  
Location: East Side of the house  
Finding: Fence bulging out of plane was observed.

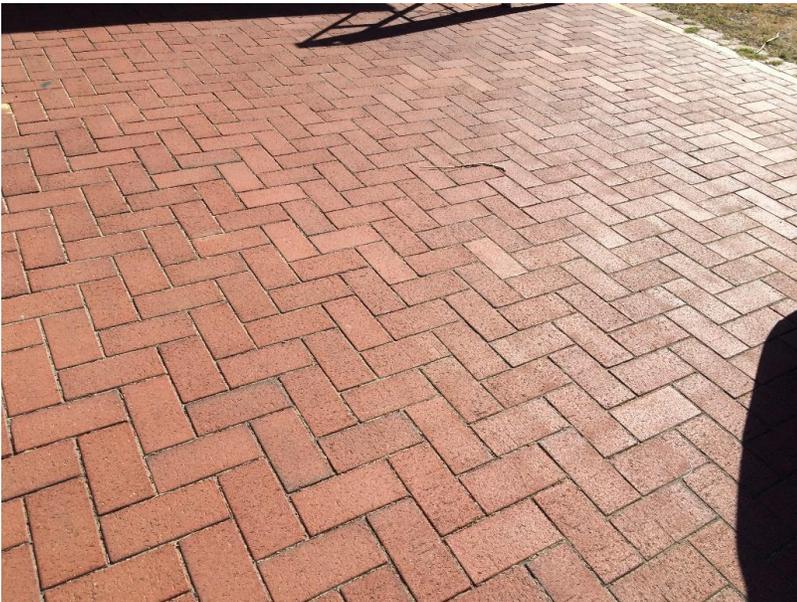
## Item 37

Building: Drive way  
Location: Front  
Finding: Pavers were observed in good order, general cleaning may be required to prevent growth of weeds.

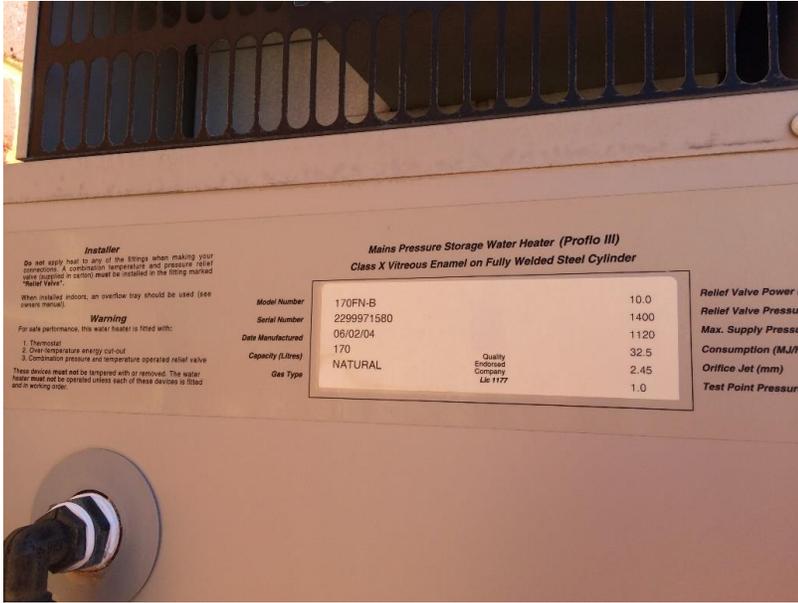
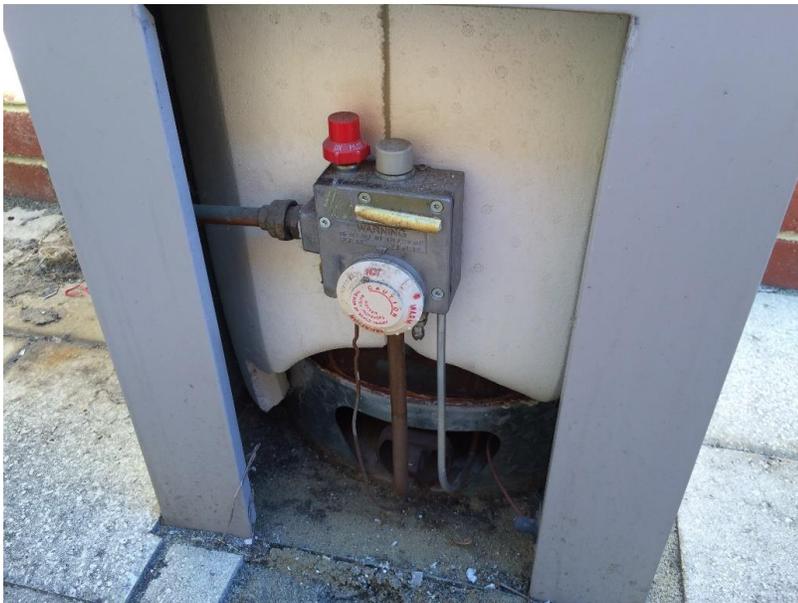
## Item 38

Building: Appliance  
Location: Heater  
Finding: Water Heater installation date was not observed on the equipment however, the manufacture date was noticed to be 2004. The useful life of water heater in general is considered to be 10 – 15 years with major maintenance every 5 year. The condition of the present heater was noticed to be rusted and may be at the end of its useful life. It is recommended to have the water heater inspected either for replacement or maintenance.

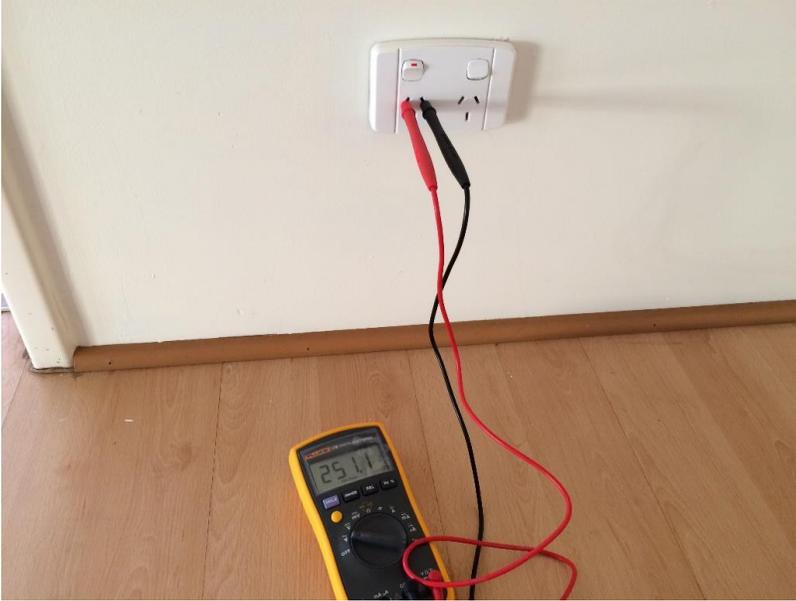
## Item 39

Building: Electric Point  
Location: Random check  
Finding: Random electric point was checked and was found in working order.

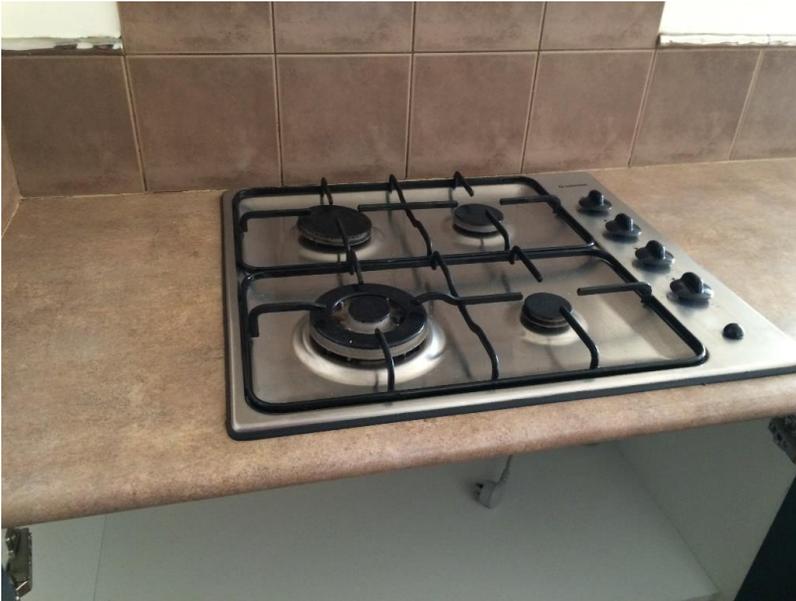
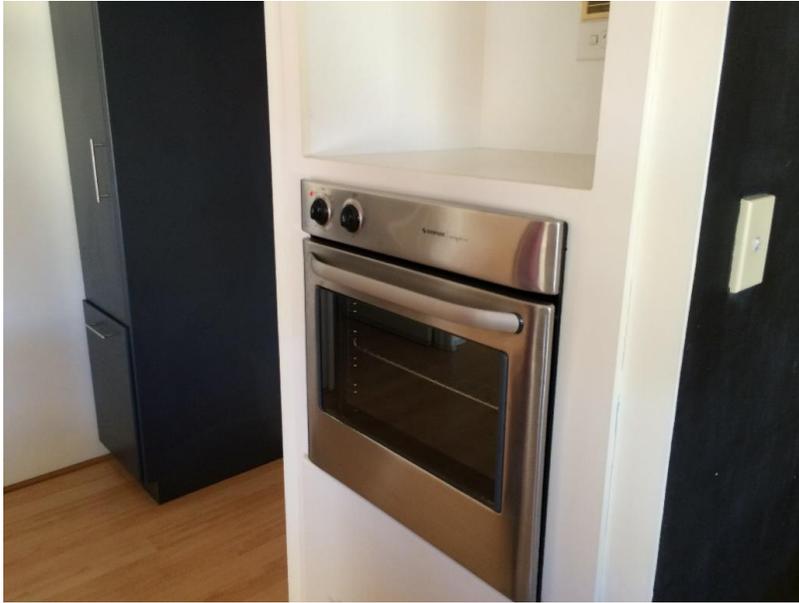
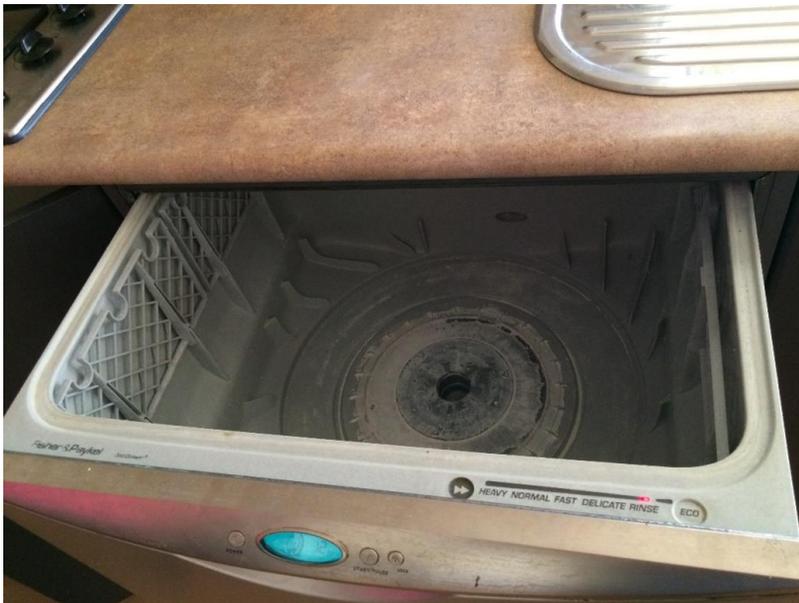
## Item 40

Building: Kitchen Appliance  
Location: Kitchen  
Finding: Stove lighter was not operational at the time of inspection, may need a battery replacement. Dishwasher and Oven was checked and found to be in working order. However, the useful life of dishwasher may be over and may need a replacement.

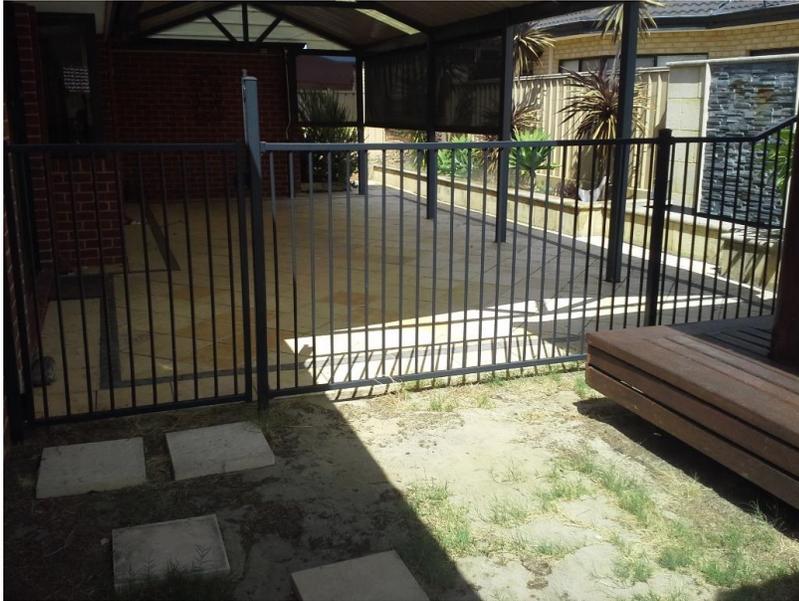
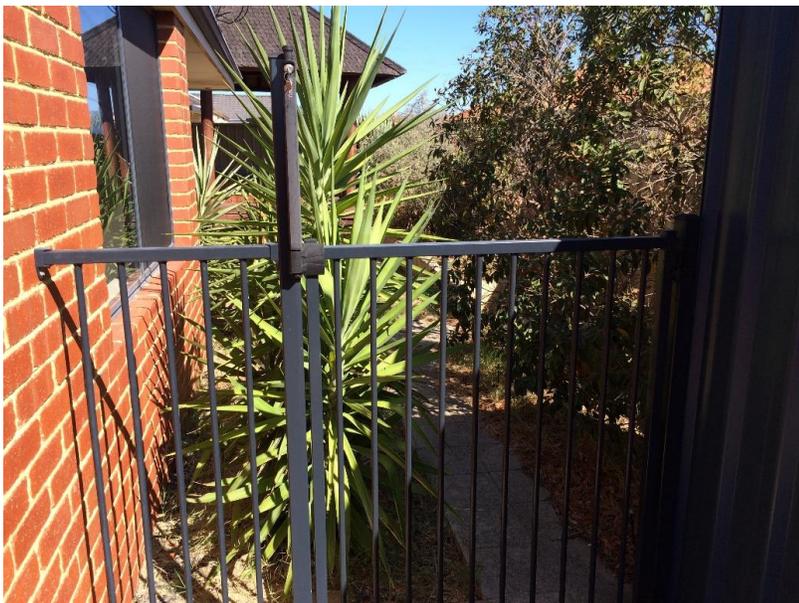
The Spa barrier fence is found to be safety compliant with the current regulations provided the planter from outside is cleared for minimum of 900mm. A warning and CPR sign is recommended on the fence.
