7225 Highview Rd Port Hardy, BC V0N2P0

Monday, March 14, 2016

Andrew Philliskirk AScT, CHIP

7225 Highview Rd, Port Hardy, BC March 14, 2016

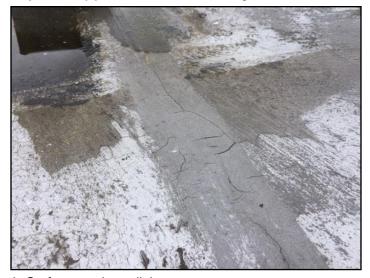
3. Condition: • Cracked

1. Surface cracks, splitting

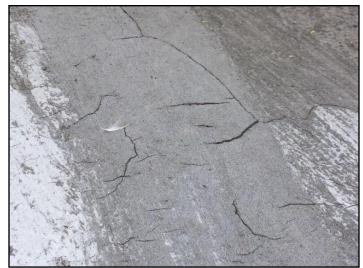
2. Surface cracks, splitting

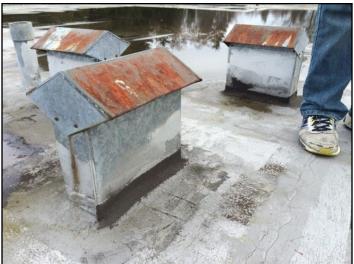
4. Condition: • Patched

3. Patched

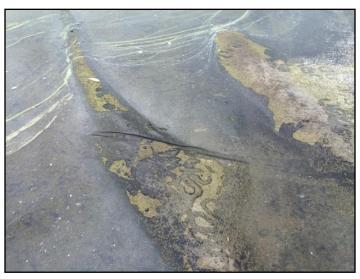
5. Condition: • No UV protection (paint, granules, etc.)

4. No UV Protection

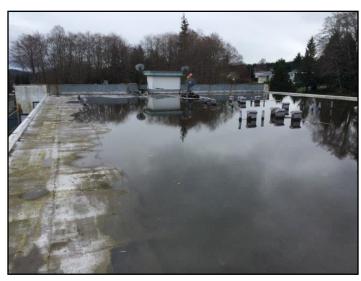
6. Condition: • Ponding

6. Ponding

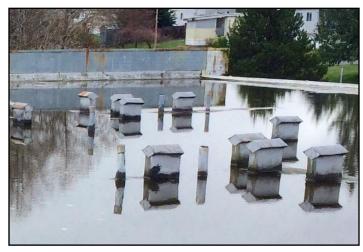
5. Ponding

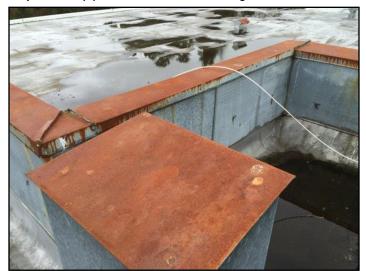
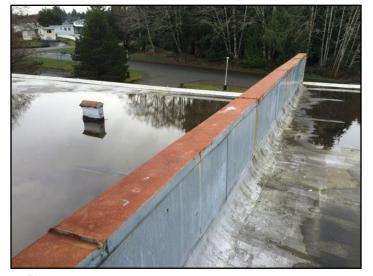
7. Condition: • Rust

7. Rust **8.** Rust

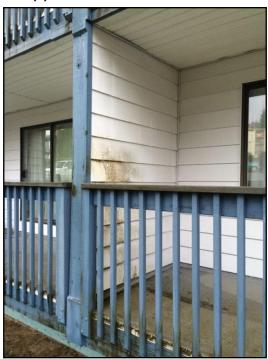
9. Condition: • <u>Discolored</u>Implication(s): Cosmetic defects

20. Discolored

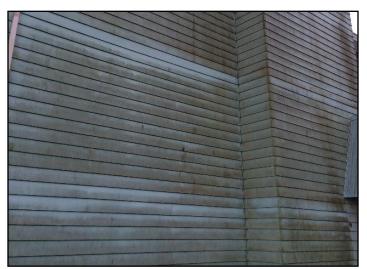
22. Discolored

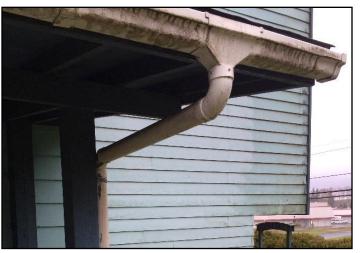
23. Discolored

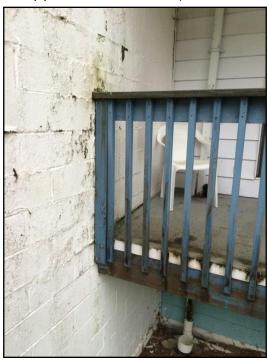
10. Condition: • Masonry deterioration

24. Missing, ineffective weep holes or flashings

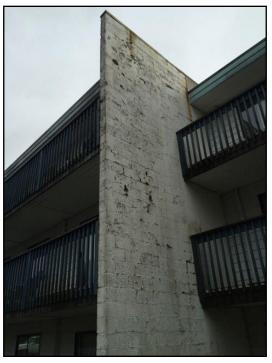
25. Masonry deterioration

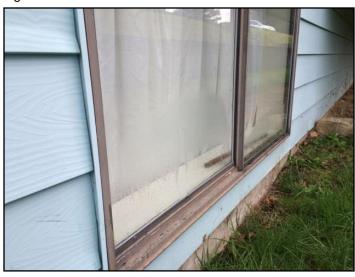
11. Condition: • Excess condensation

26. Excess condensation

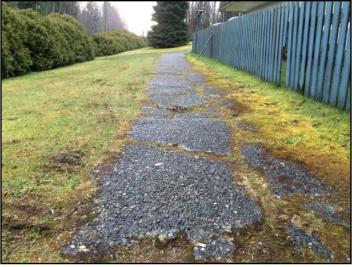
12. Condition: • Uneven (trip hazard)

27. Uneven (trip hazard)

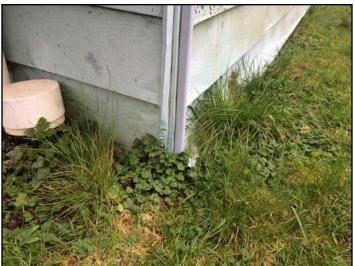
13. Condition: • Siding too close to grade

28. Siding too close to grade

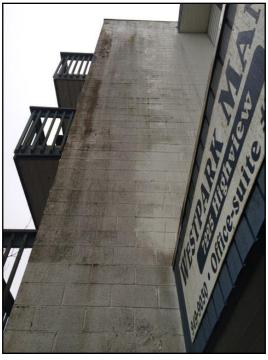
14. • The block walls have been subject to years of exposure to the weather. They have suffered from many wet-freeze cycles causing spalling. The deteriorated masonry poses a structural and possibly a safety hazard. It should be reviewed by a qualified stone mason to see if it is structurally sound. It may just need repointing, re-sealing (paint) and ensuring that adequate weep holes exist.

15. Condition: • Masonry deteriorating

29. Masonry deterioration

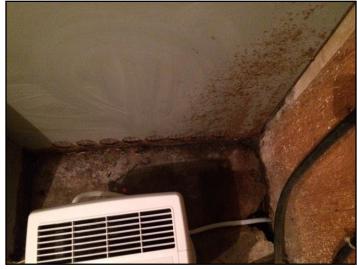
31.

18. • During the inspection it was raining outside. The electrical room had a steady flow of water running underneath the main cabinets causing the the metal cabinets to rust along the bottom. The water flowed into the room adjacent where a sump pump was set up to extract the water.

The perimeter drainage beside these panels needs to be looked at to see what is wrong. A drainage company should be brought in to review the performance of the perimeter drainage and figure out where the water is coming from and how to stop it. They could send a video camera down the drainage lines to look for problems like blockages.

Once the water ingress has been stopped a certified electrical professional should be brought in to assess these cabinets for safety.

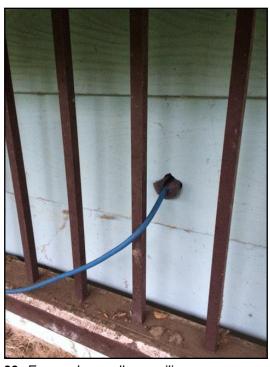
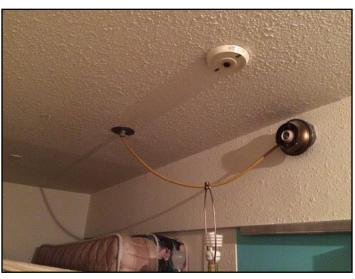
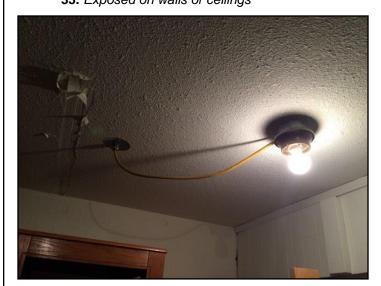
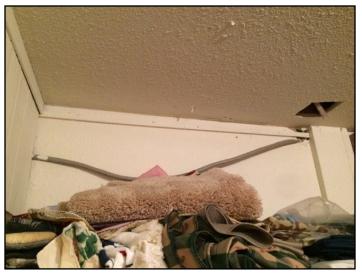
19. Condition: • Exposed on walls or ceilings

33. Exposed on walls or ceilings

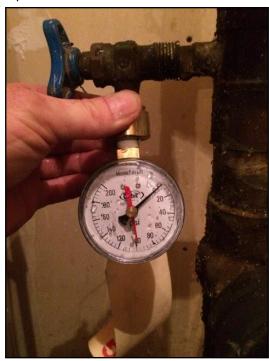
21. Condition: • Required due to high supply water presssure

There is no visible pressure regulator in the utility room. The water pressure was over 100psi and should be reduced to prevent possible leaks.

39. Required due to high supply water presssure

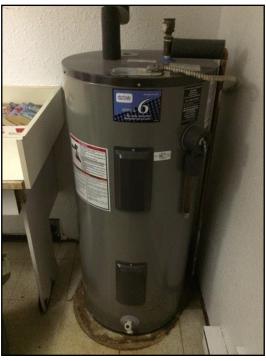
23. Condition: • Wobbly or not stable

This tank in the laundry room needs to be seismically restrained.

40. Wobbly or not stable

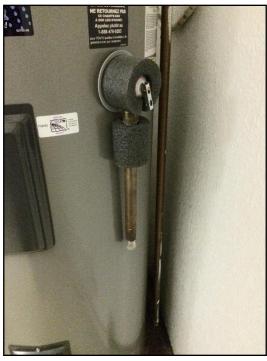
26. Condition: • Discharge tube too short

41. Discharge tube too short

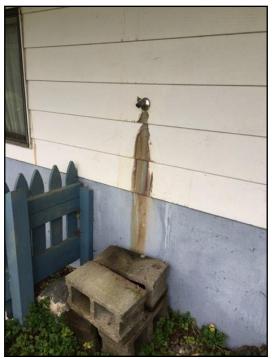
29. Condition: • Leak or drip

42. Leak or drip

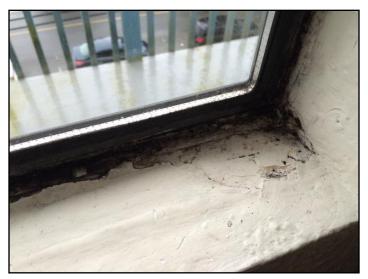
31. Condition: • Excess condensation

43. Excess condensation

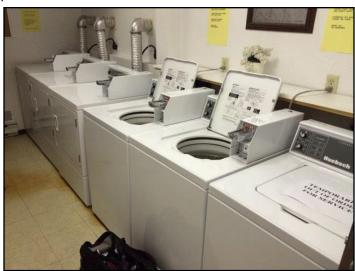
32. Condition: • Inoperative Two machines out of service.

44. Inoperative

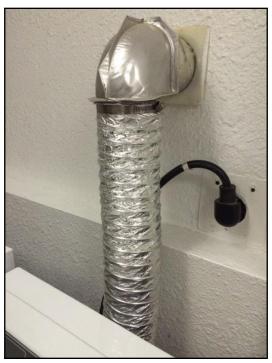
33. Condition: • Dryer vent material not smooth wall Implication(s): Equipment ineffective | Fire hazard

45. Dryer vent material not smooth wall

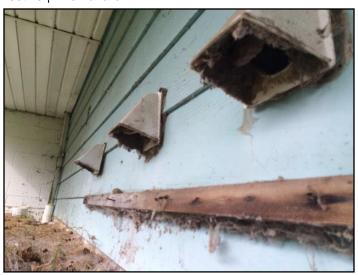
34. Condition: • Screen on vent termination Dryer vents stuck open. Entry point for vermin. Implication(s): Equipment ineffective | Fire hazard

46. Screen on vent termination
