Your Inspection Report

11554 136 Street
Surrey, BC V3R 3C2

Thursday, July 21, 2016

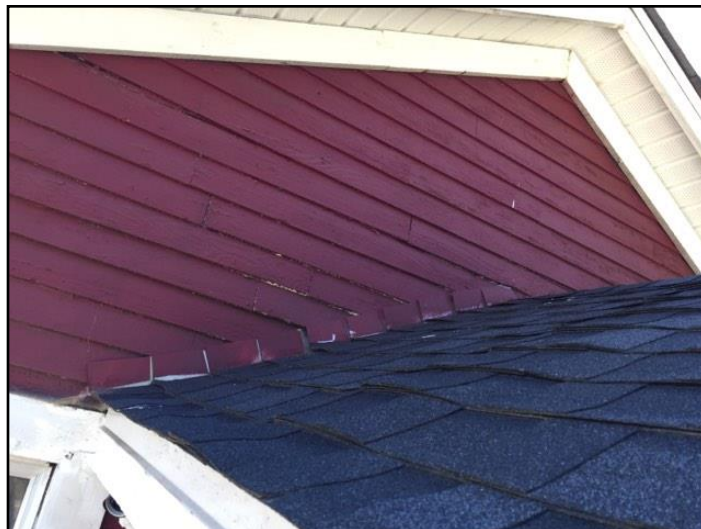
3. Metal Flashings

- High
- Side wall flashings need to be sealed.

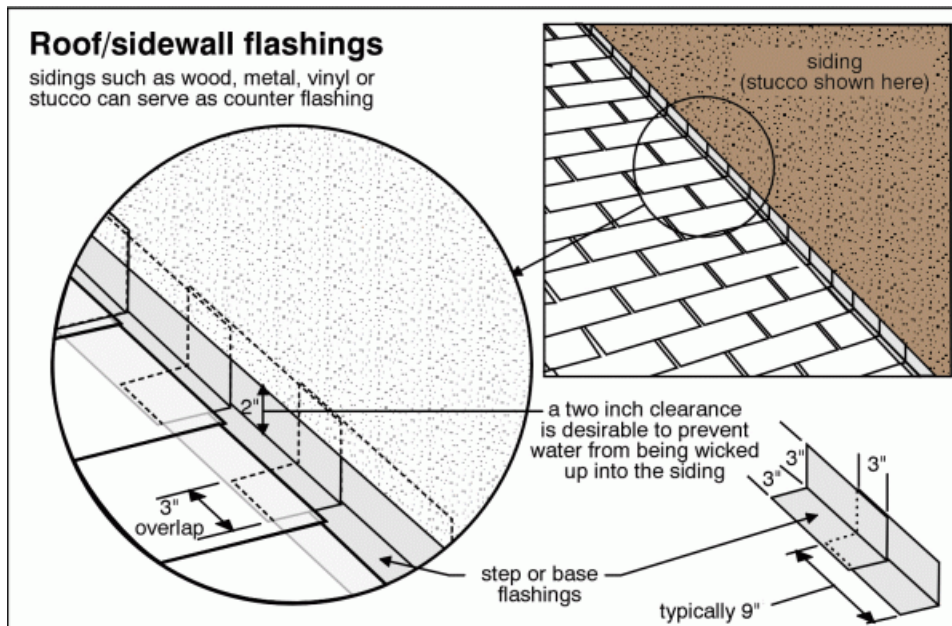
2. Condition: • [No step or counter flashings](#)

Implication(s): Chance of water damage to contents, finishes and/or structure

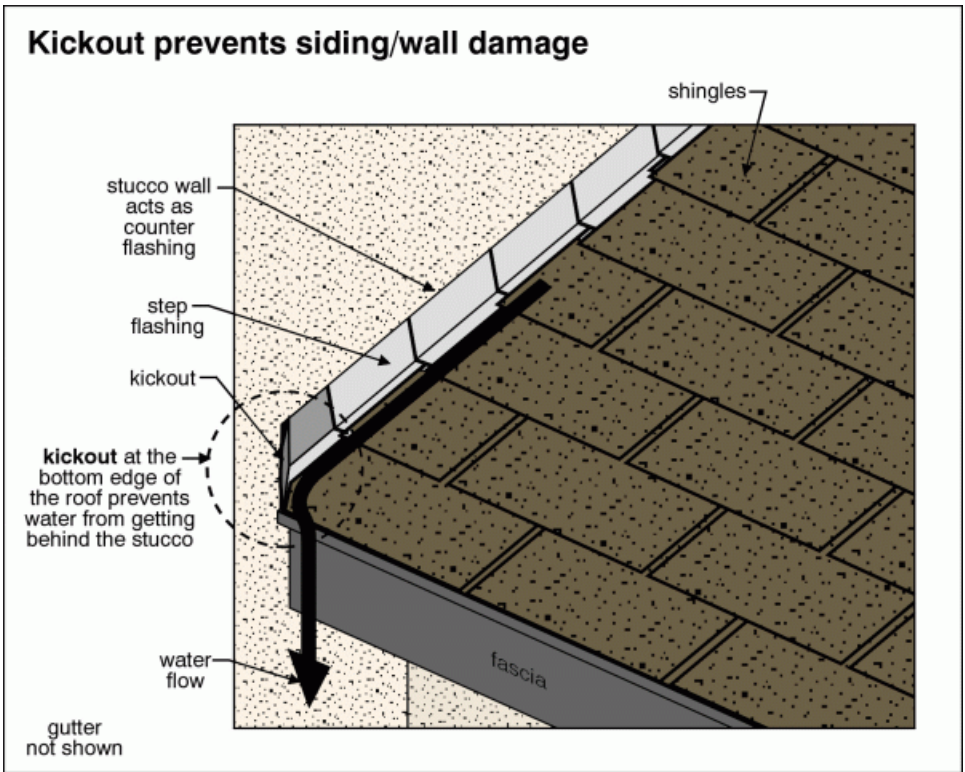
5. Condition: • [No kickout flashing](#)

Implication(s): Chance of water damage to contents, finishes and/or structure

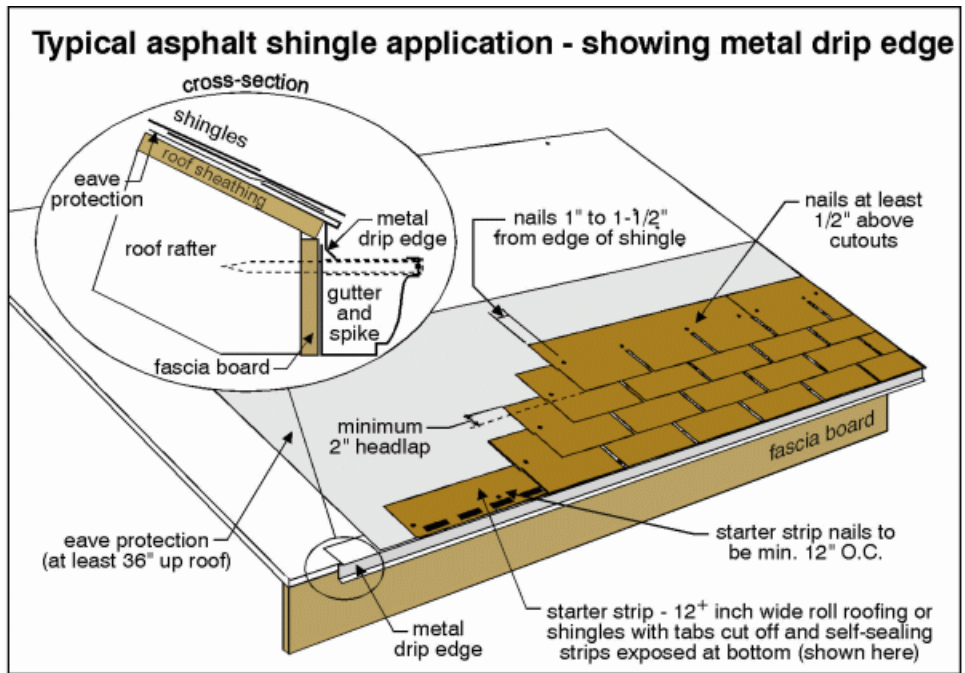
6. Condition: • [Missing](#)

Implication(s): Chance of water damage to contents, finishes and/or structure

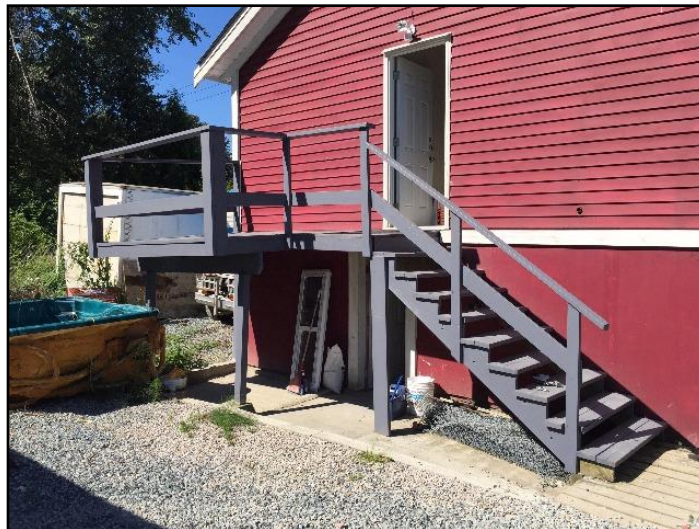
7. • The back deck has been poorly constructed. It is a safety hazard as it stands now and should not be used until made safe by a qualified carpenter or contractor. It has been attached to the house using only wood screws. The best way is to through-bolt the ledger to the rim joist of the house. The main beam has no bracing to prevent it from toppling over. The deck is tilting away from the house. The guardrails and banisters are missing pickets which pose a falling hazard. This is an unsafe arrangement that needs to be addressed. A carpenter or contractor should be brought in to fix these issues so this deck is safe to use. The siding has been patched together using at least four different materials. The vinyl siding is coming away from the building in areas. There needs to be some time spent installing appropriate drip flashings and caulking by a contractor.

17. Unsafe Deck - Do not Use.

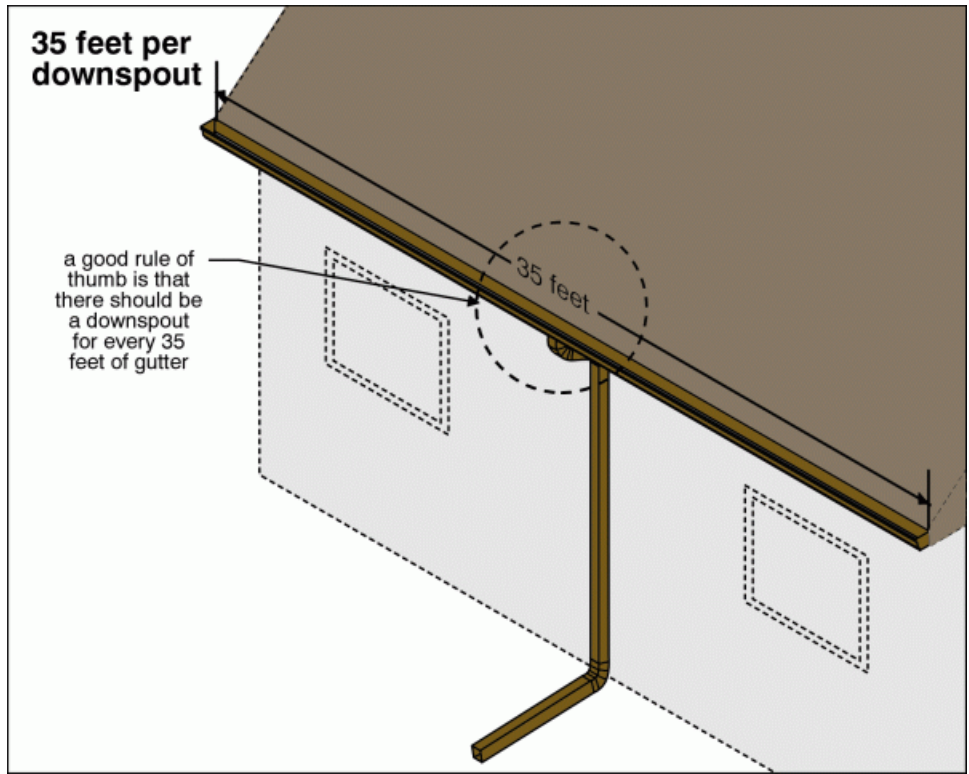
8. Condition: • [Missing](#)

Implication(s): Chance of water damage to contents, finishes and/or structure

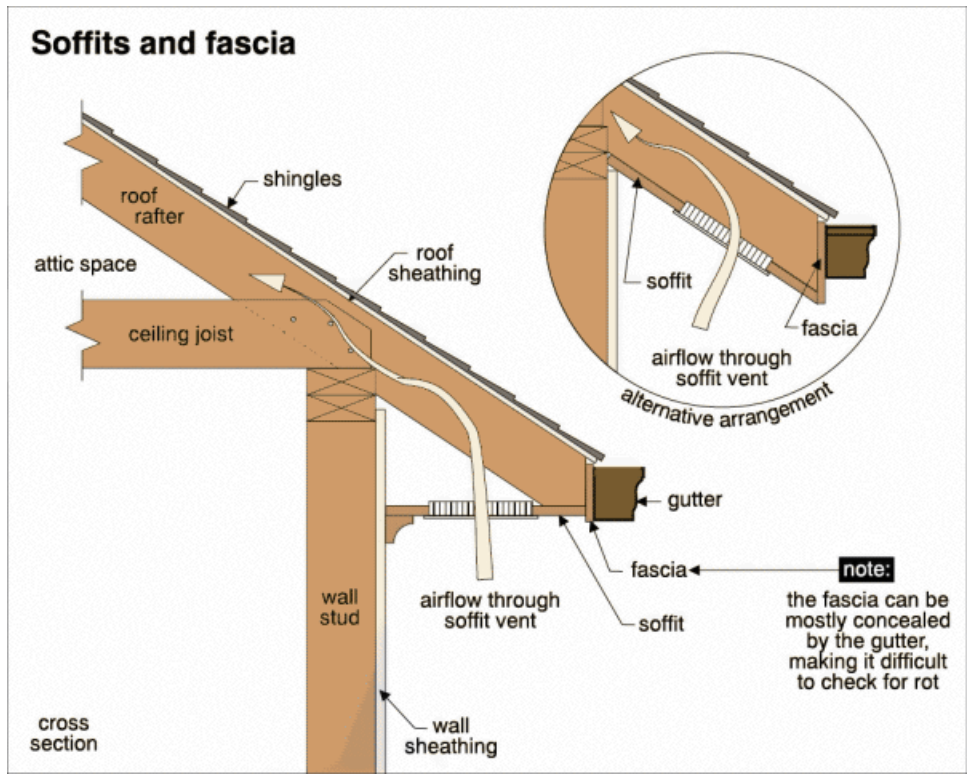
9. Condition: • [Vents missing, ineffective](#)

Implication(s): Chance of condensation damage to finishes and/or structure | Material deterioration

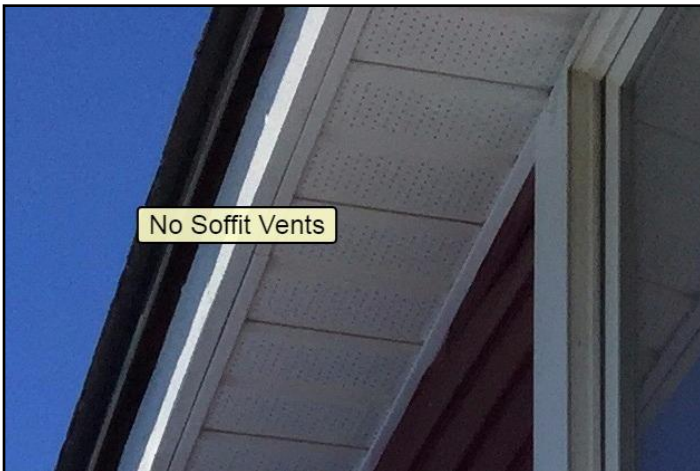
18. Missing Soffit Vents

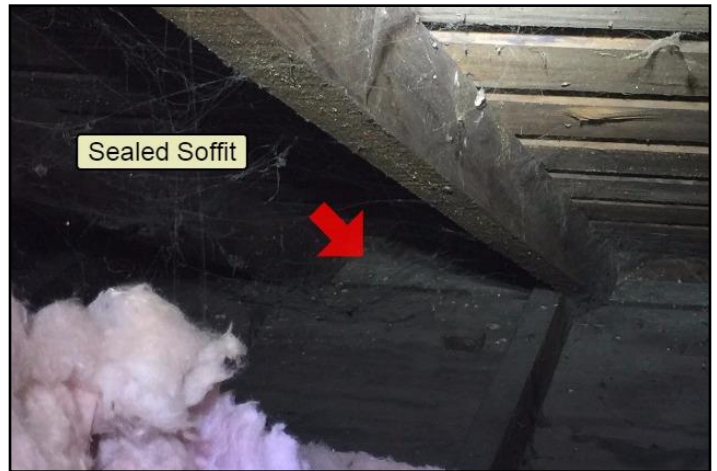
19. Missing Soffit Vents

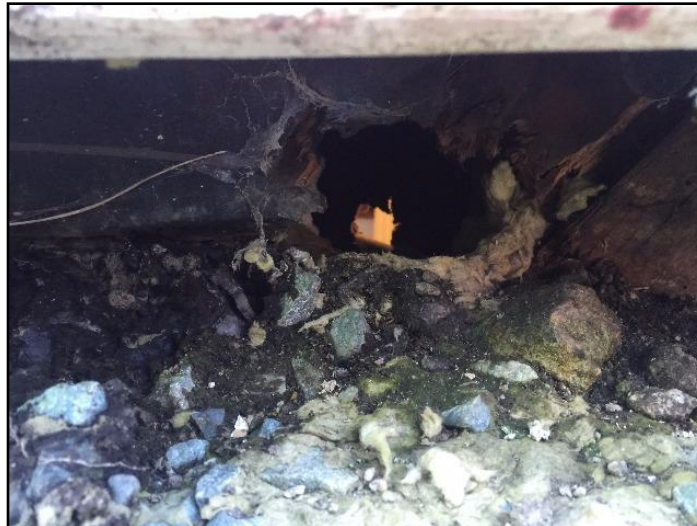
10. Condition: • The rodents have chewed right through both walls.

20. Rodent damage to wall

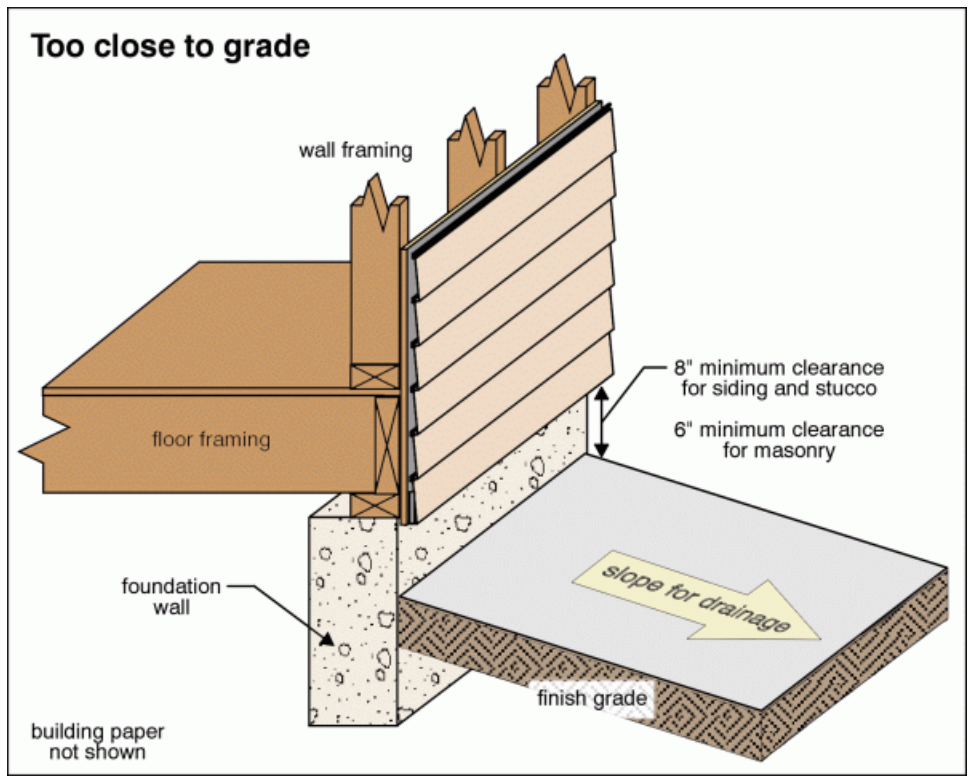
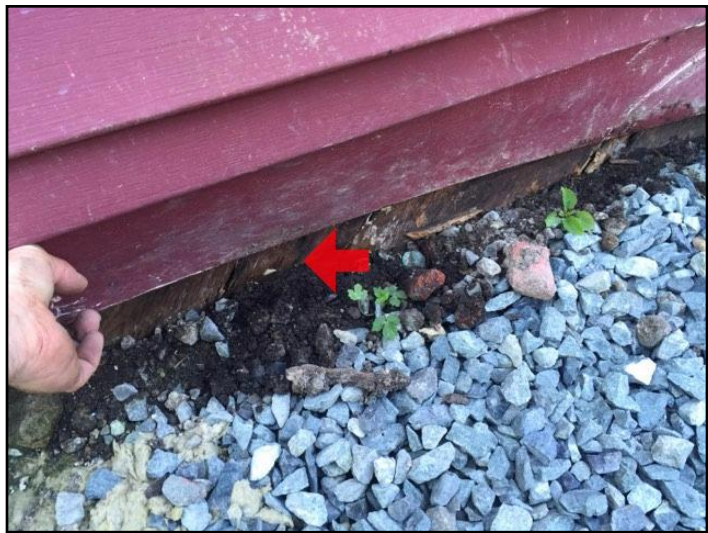
11. Condition: • [Too close to grade](#)

Implication(s): Chance of water damage to contents, finishes and/or structure | Material deterioration | Rot | Insect damage

21. Too close to grade

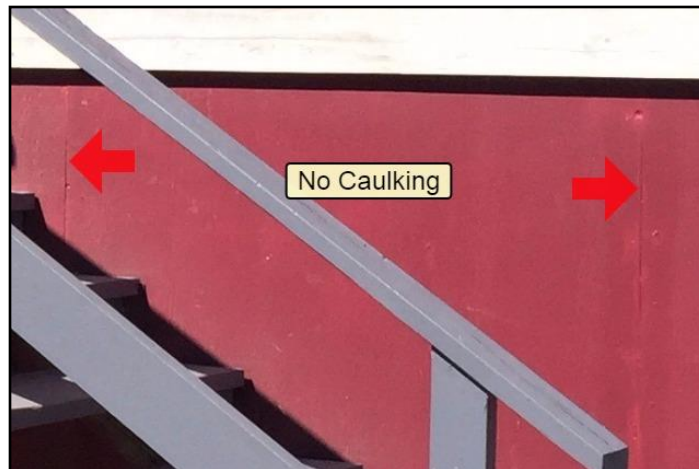
13. Condition: • [Missing paint or caulking](#)

23. Missing paint or caulking

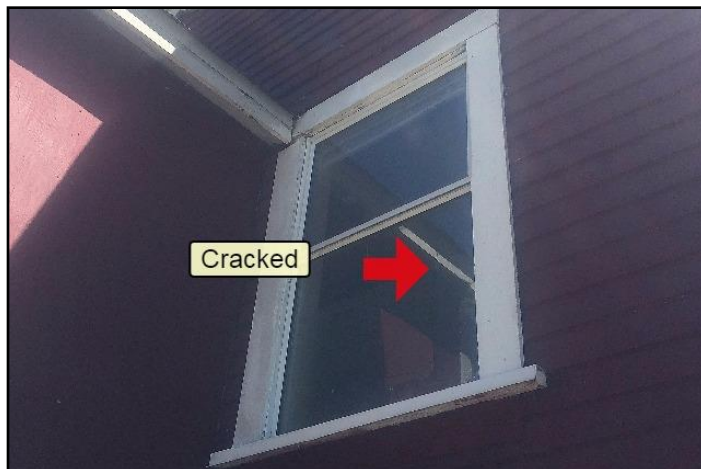
14. Condition: • [Cracked](#)

24. Cracked

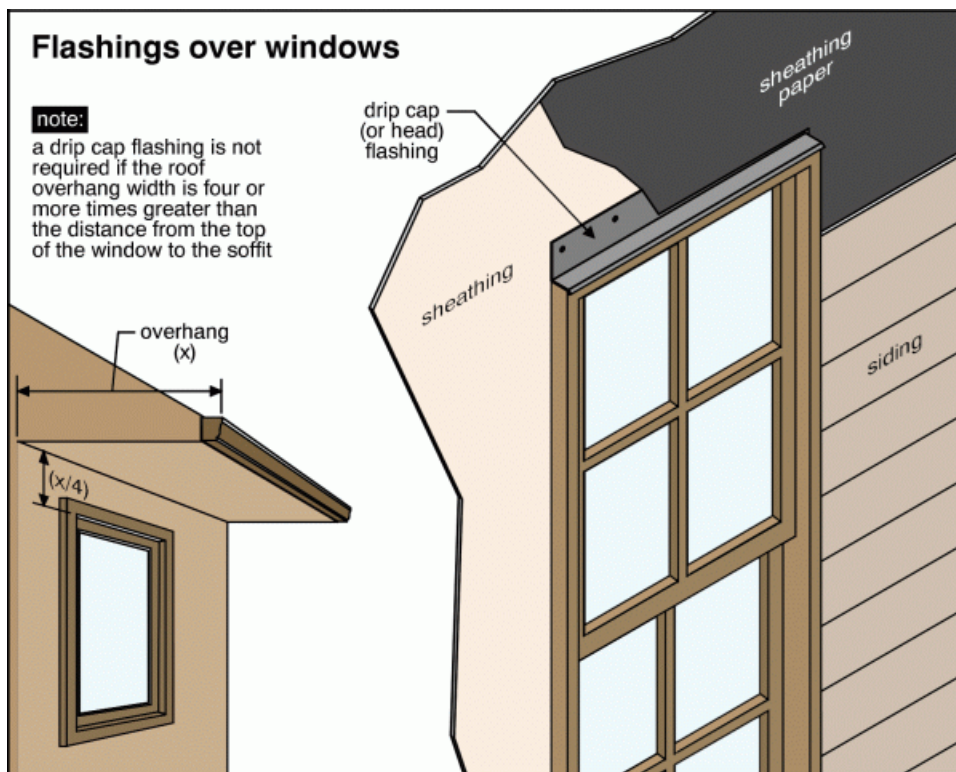
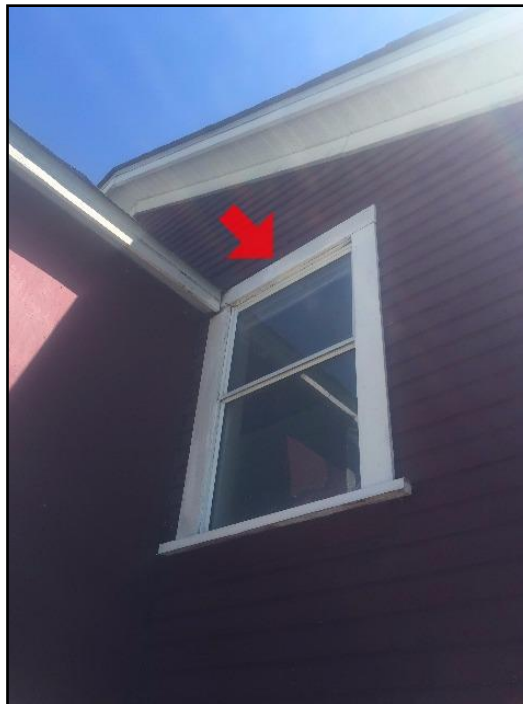
15. Condition: • [Missing](#)

25. Missing Drip Edge

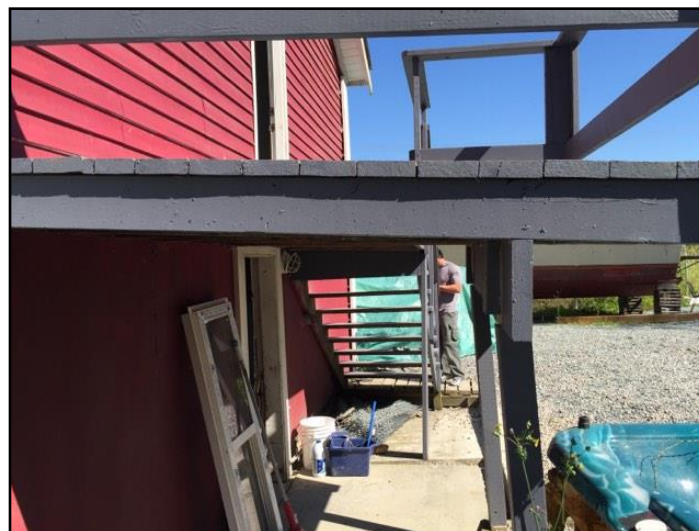
17. Condition: • [Leaning](#)

Implication(s): Weakened structure | Chance of movement

26. Leaning

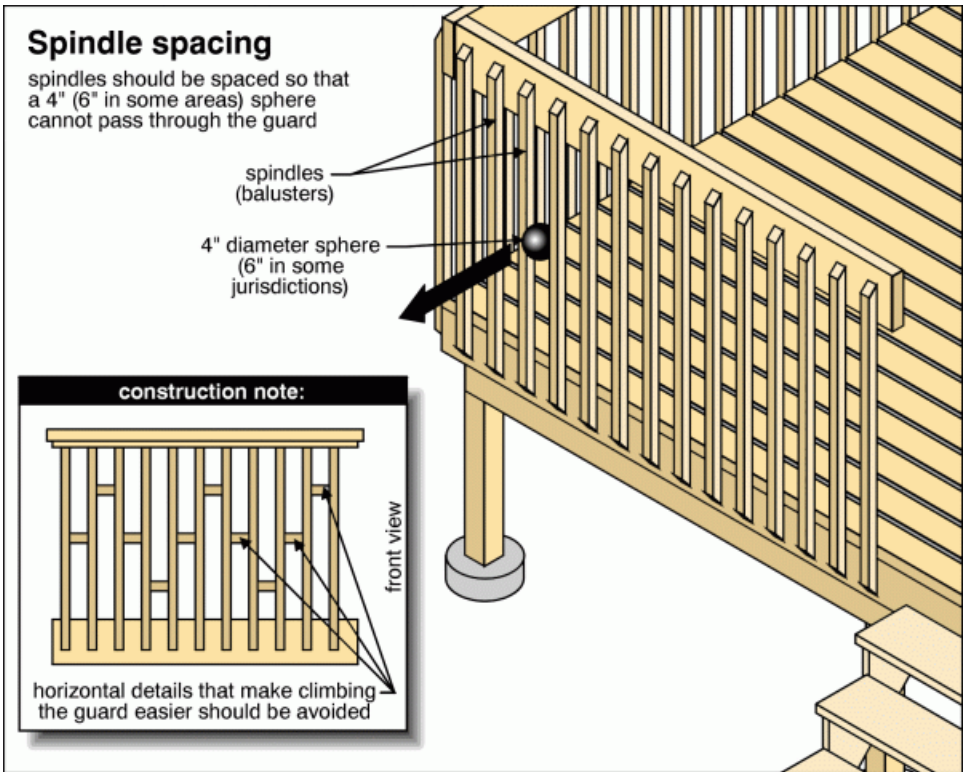
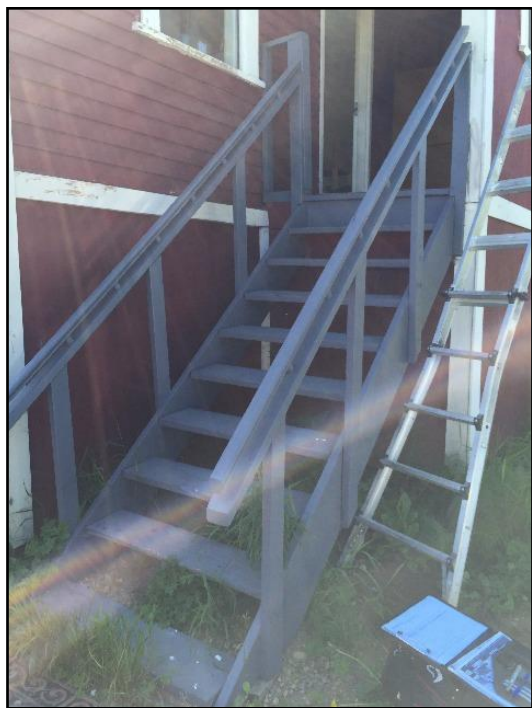
18. Condition: • [Spindles too far apart](#)

Implication(s): Fall hazard

27. Spindles too far apart

28. Spindles too far apart

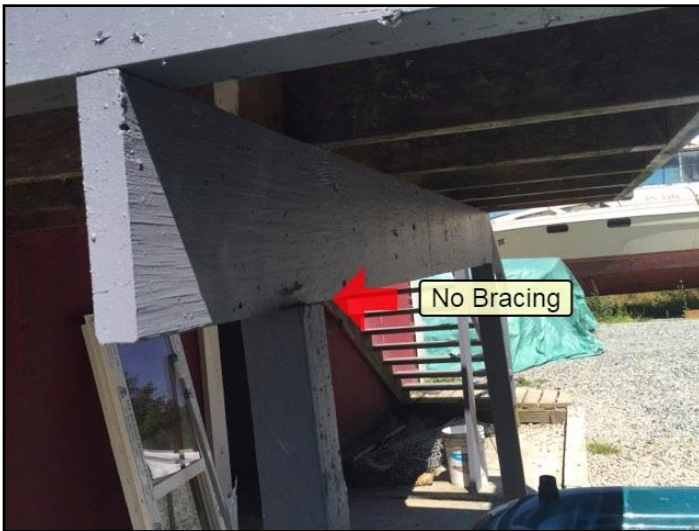
19. Condition: • Unsafe

29. Unsafe Beam

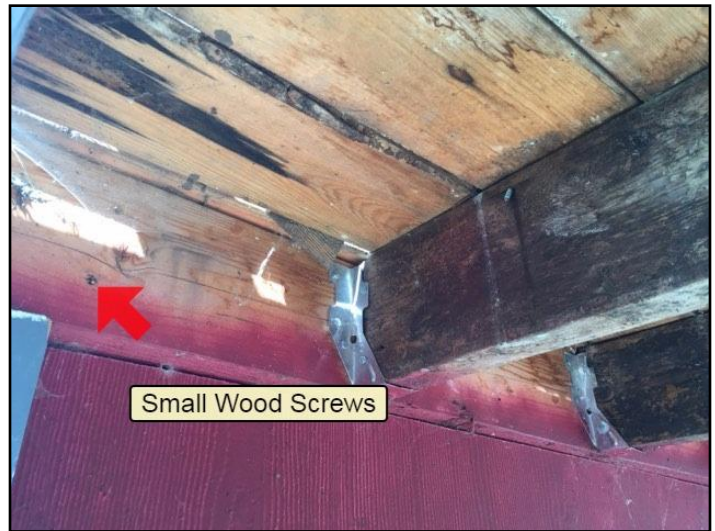
30. Screwed not bolted

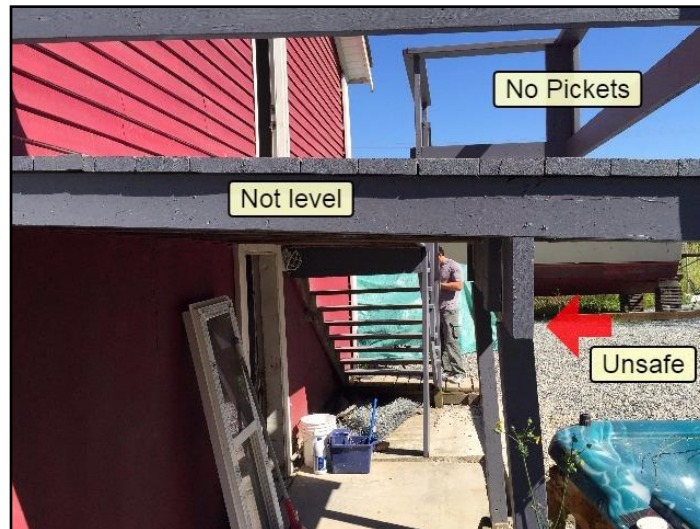
31. Unsafe

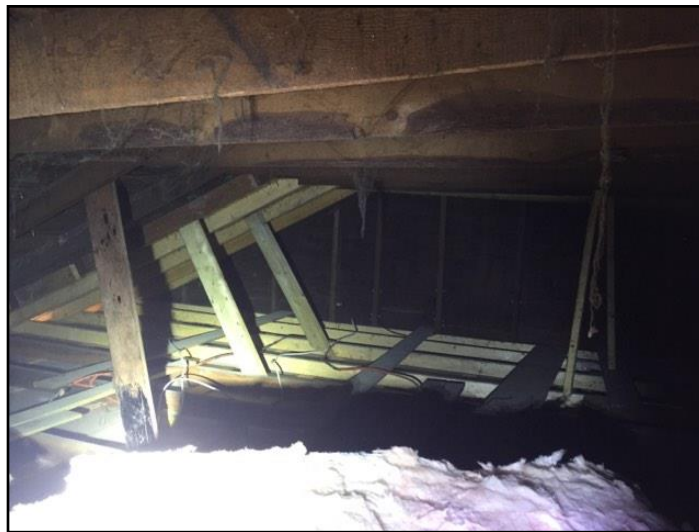
33. Roof extended

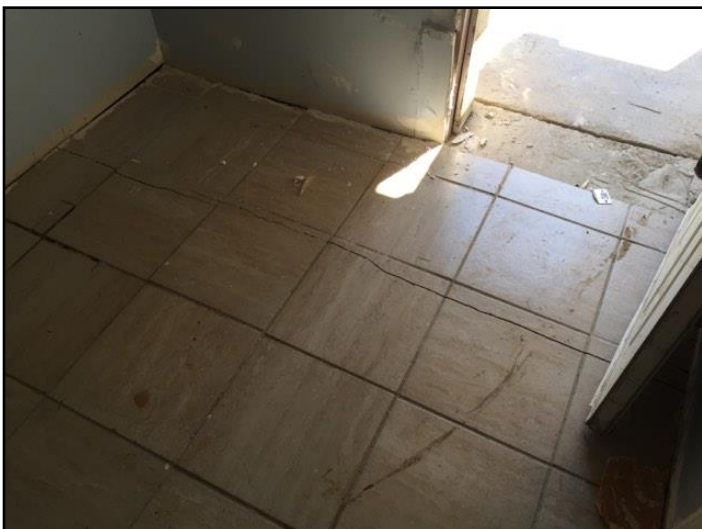
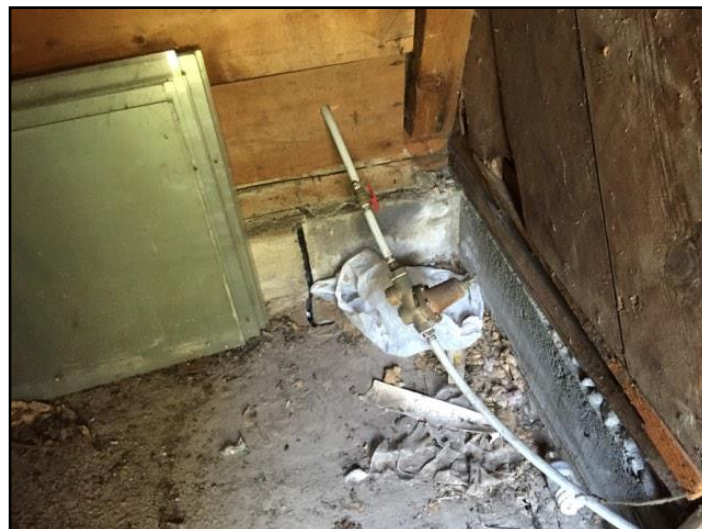
22. **Condition:** • [Settled](#)

Implication(s): Chance of structural movement

36. Settled

37. Settled

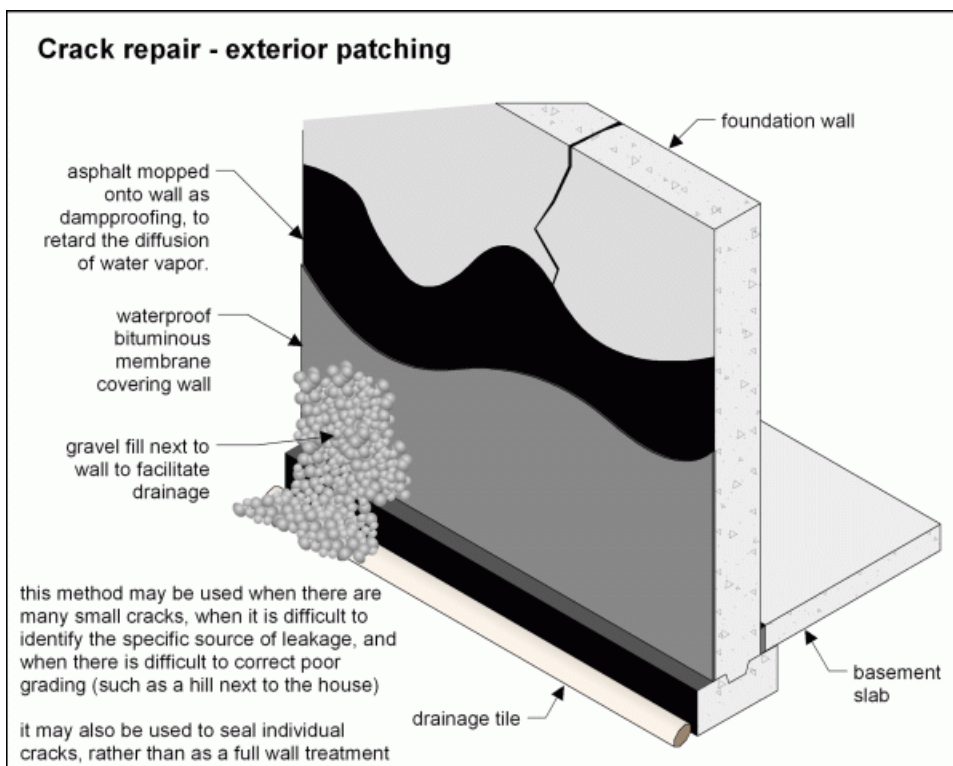
23. Condition: • Typical minor cracks

Implication(s): Chance of water entering building

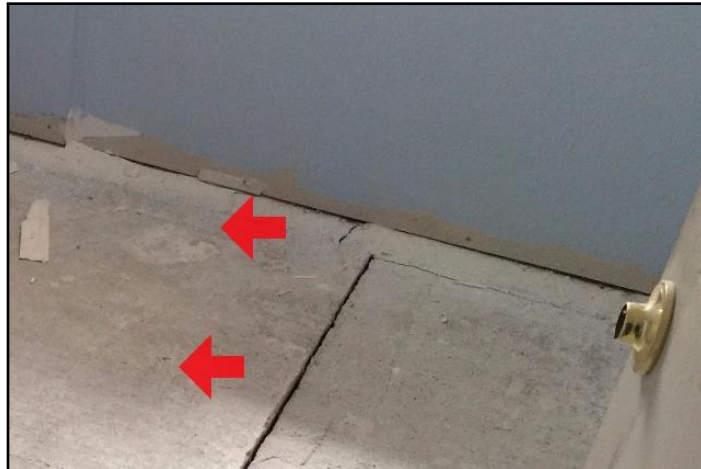
25. Condition: • [Lateral movement](#)

Implication(s): Weakened structure

38. Lateral movement

These cracks should be caulked, to prevent insects and rodents getting into the house, and monitored for further lateral movement.

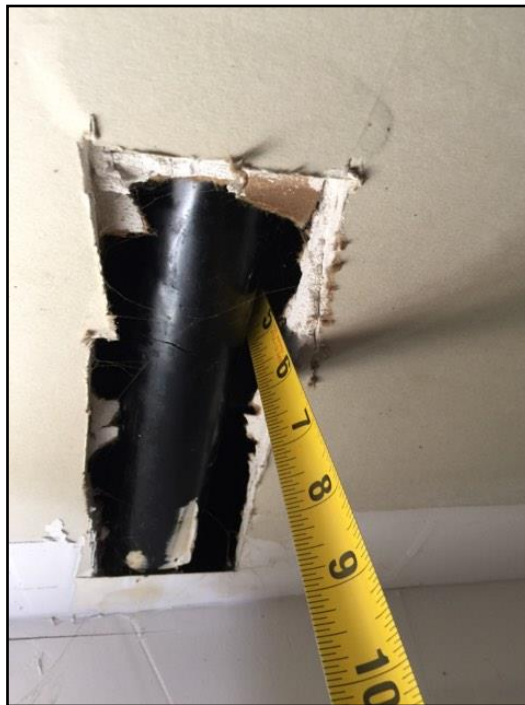
27. Condition: • Undersized floor joists are below today's minimum code.

39. Floor joists undersized

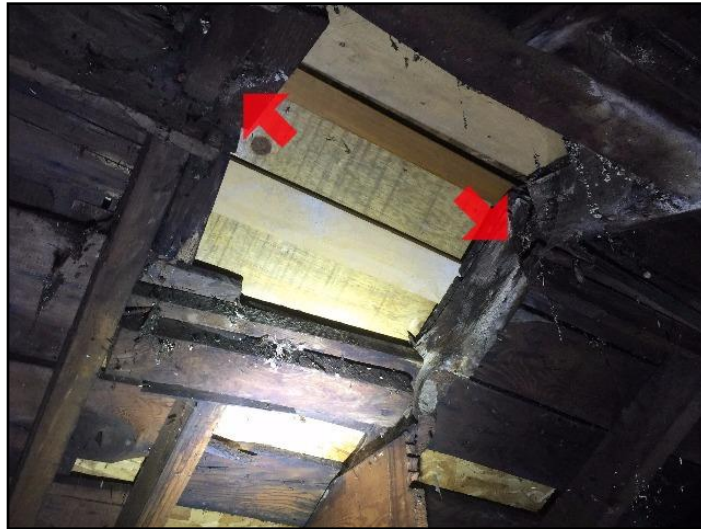
28. Condition: • [Rot, fire or insect damage](#)

Implication(s): Weakened structure | Chance of structural movement

40. Rot/fire damage to roofing

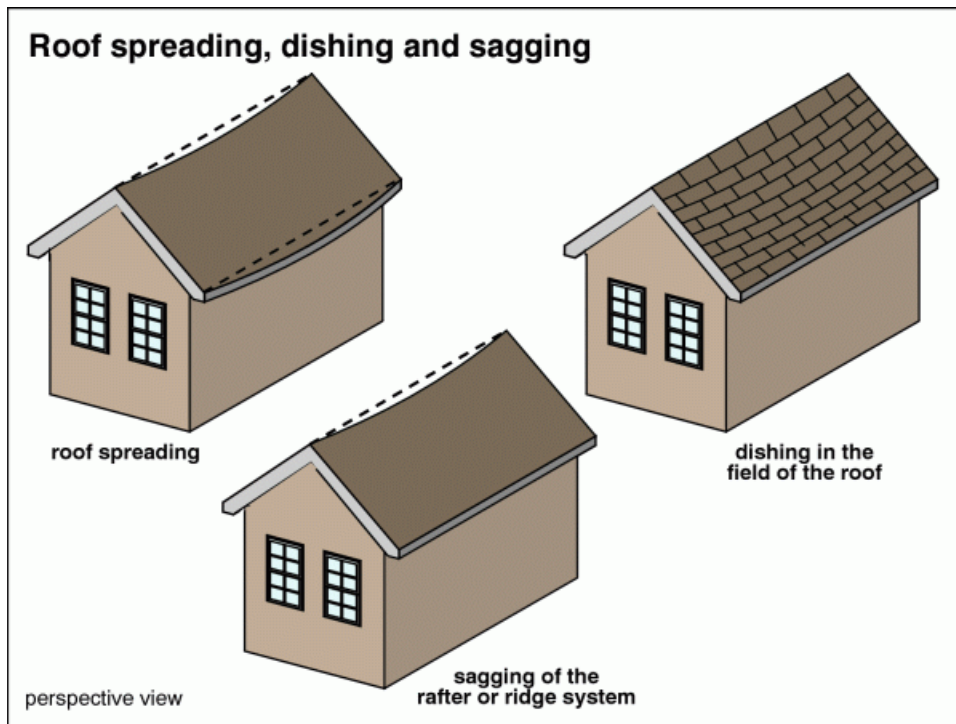
29. Condition: • [Ridge sagging](#)

Implication(s): Weakened structure | Chance of structural movement

41. Ridge sagging

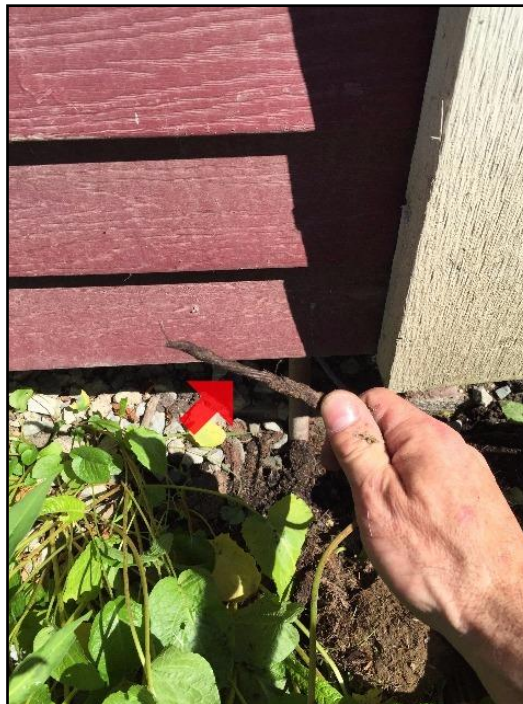
31. Condition: • [Corroded ground wire](#)

Implication(s): Electric shock

51. Ground wire corroded

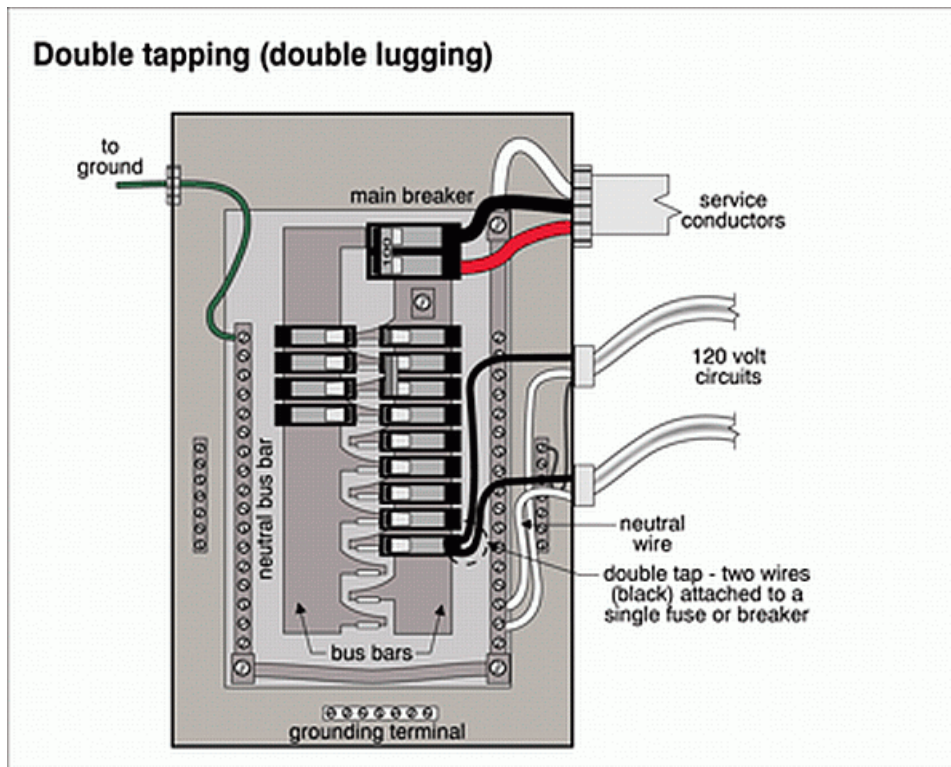
32. Condition: • [Double taps](#)

Implication(s): Fire hazard

52. Double taps

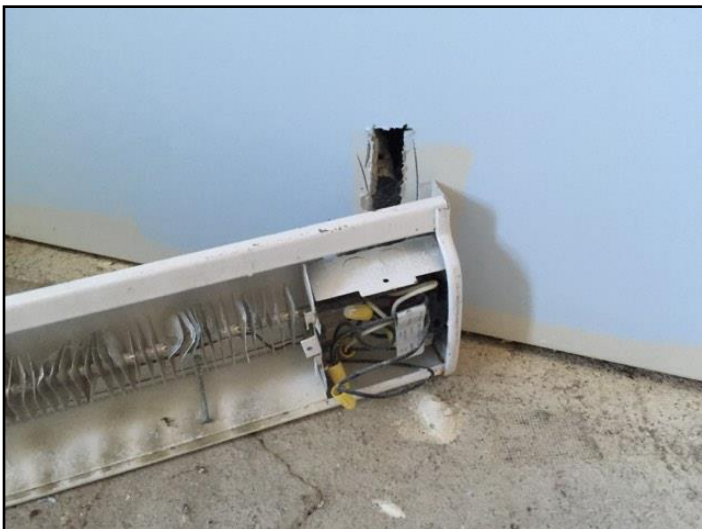
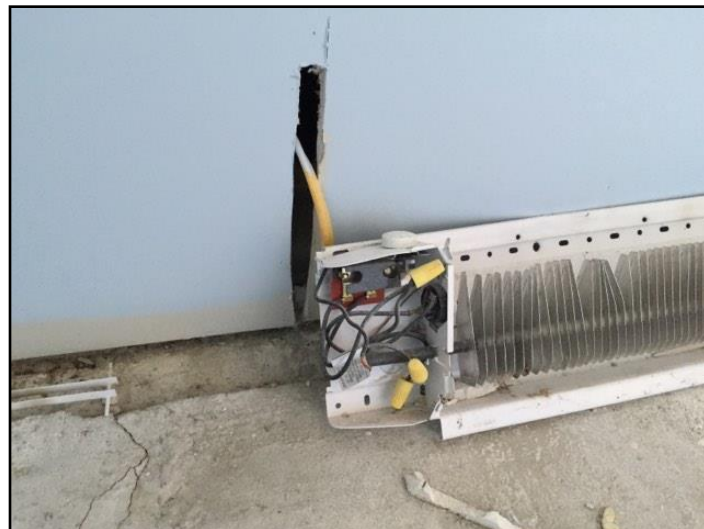
33. Condition: • [Exposed on walls or ceilings](#)

Implication(s): Electric shock

54. Exposed wiring

55. Exposed wiring

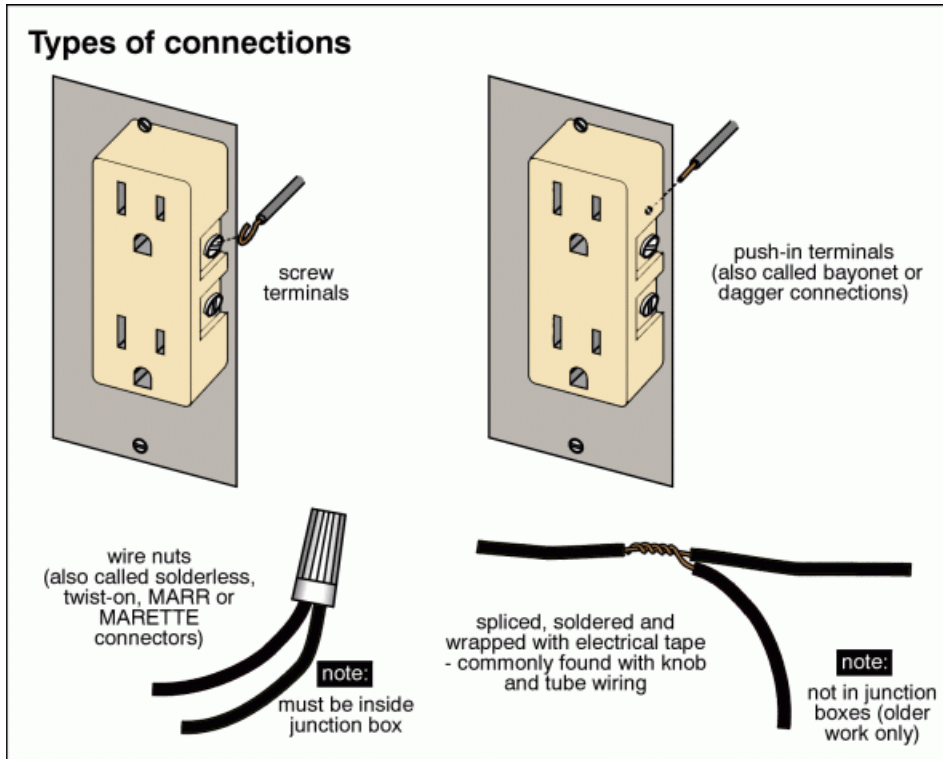
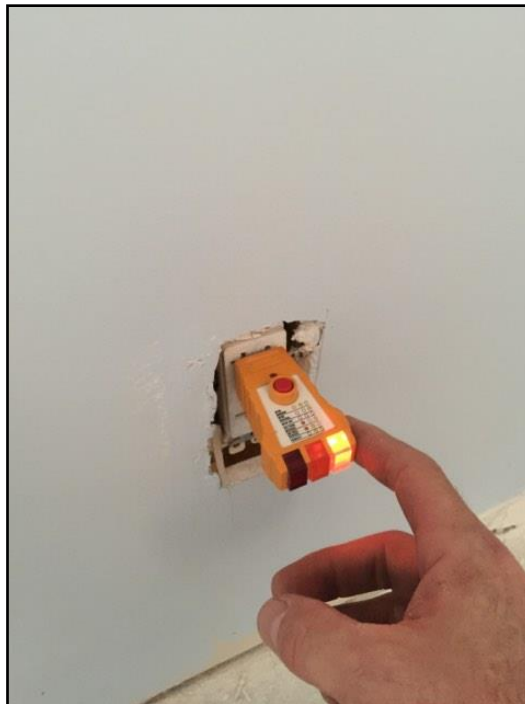
34. Condition: • [Loose connections](#)

Implication(s): Electric shock | Fire hazard | Interruption of electrical service

57. Loose connections

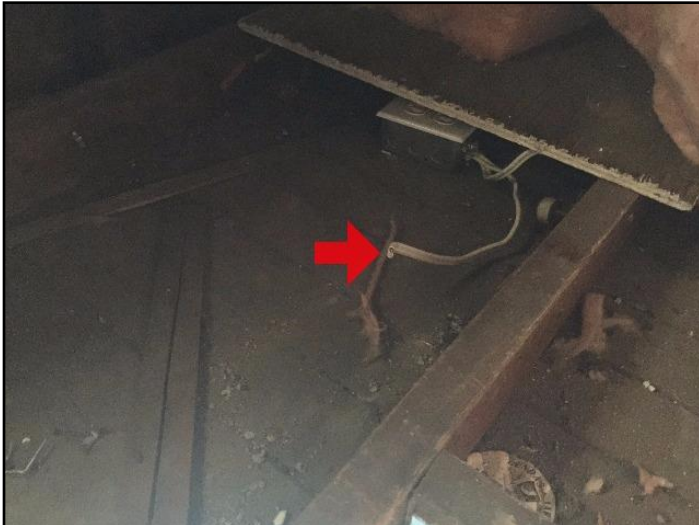
35. Condition: • [Abandoned wire](#)

Implication(s): Electric shock

58. Abandoned wire

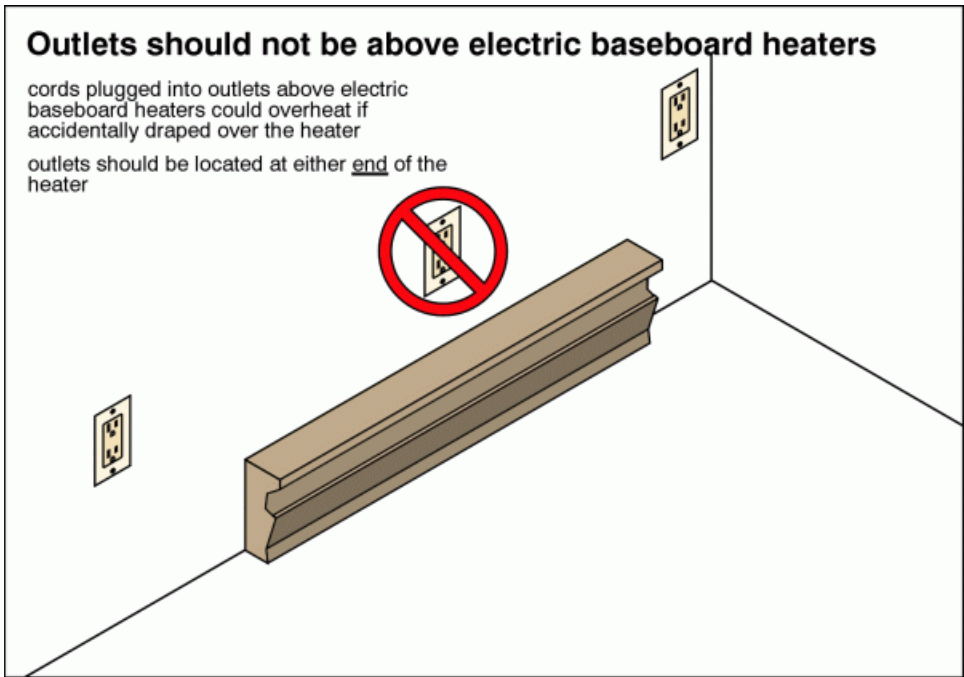
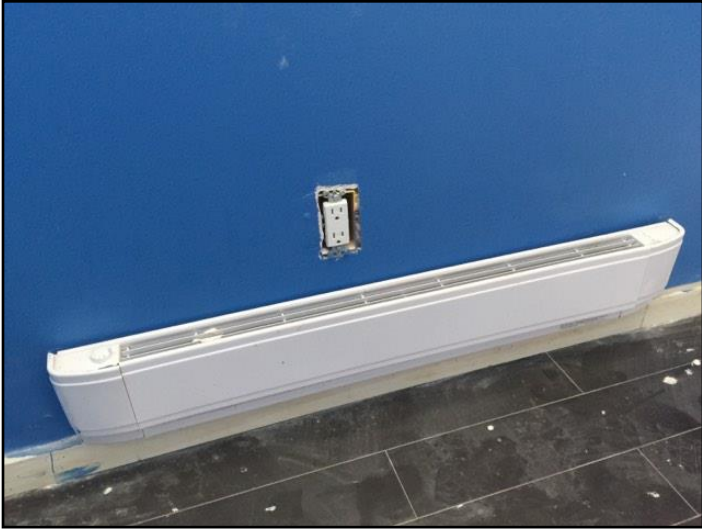
37. Condition: • [Above electric baseboard heaters](#)

Implication(s): Increased fire hazard

60. Above electric baseboard heaters

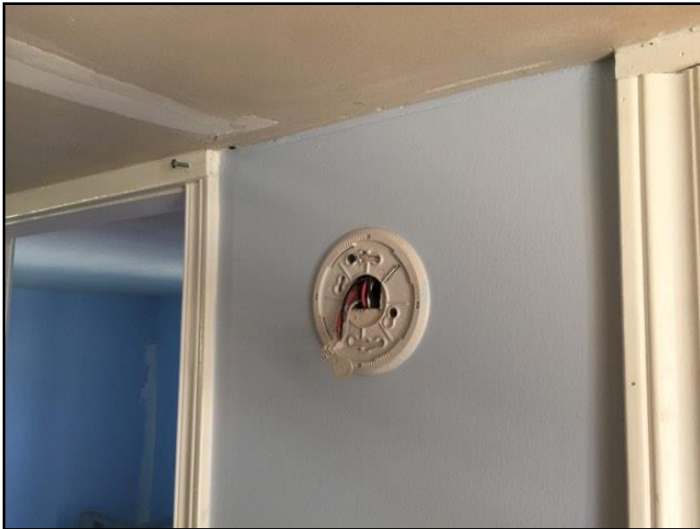
38. Condition: • Missing
Implication(s): Fire hazard

61. *Removed smoke detector*

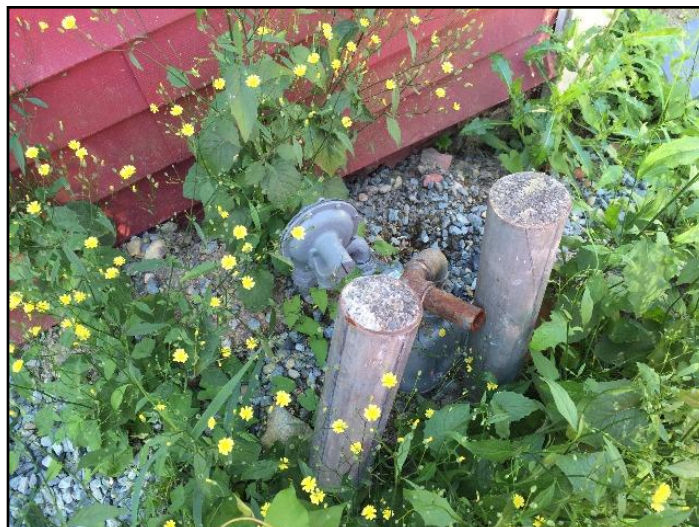
64. Abandoned Gas Service

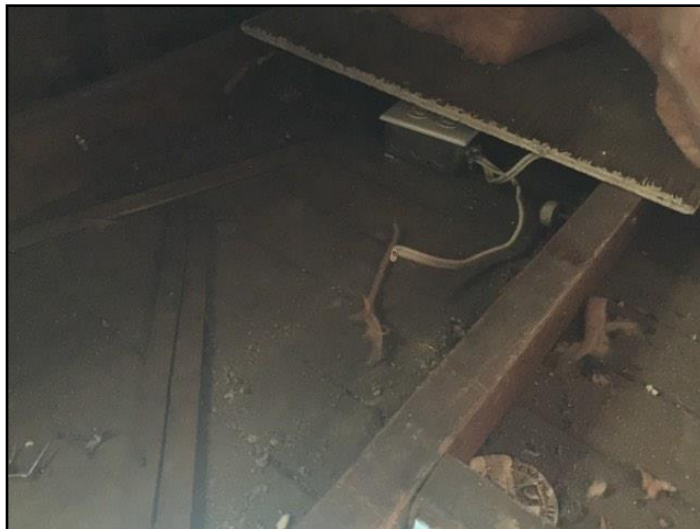
Attic/roof ventilation: • [None found](#)

66. None found

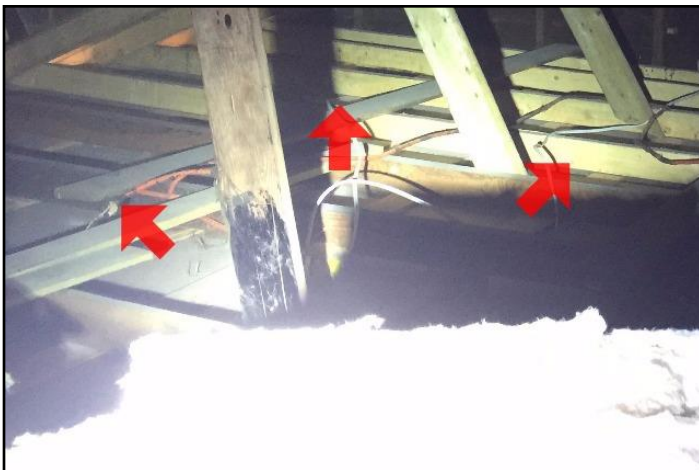
41. Condition: • [Gaps or voids](#)

Implication(s): Increased heating and cooling costs | Reduced comfort

67. Gaps or voids

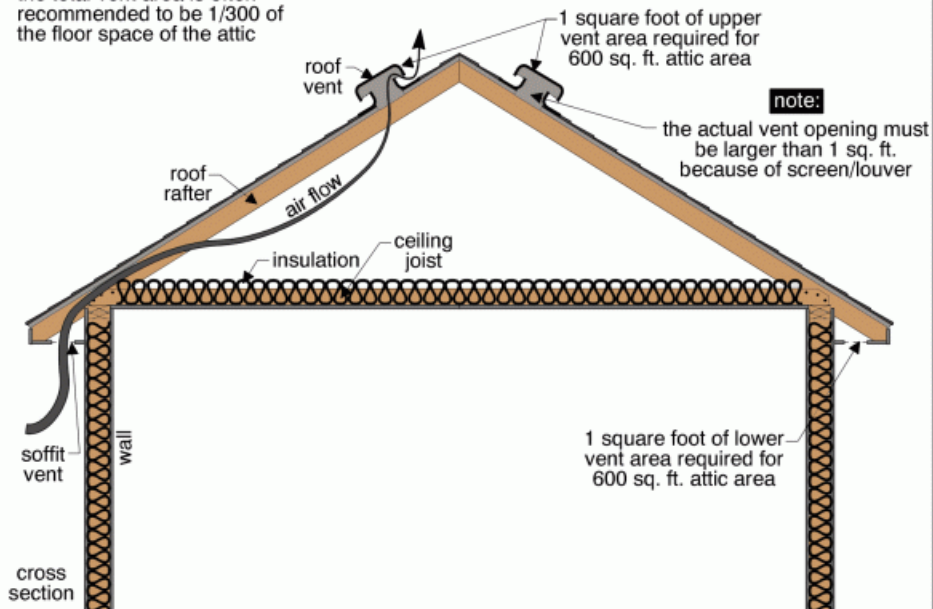
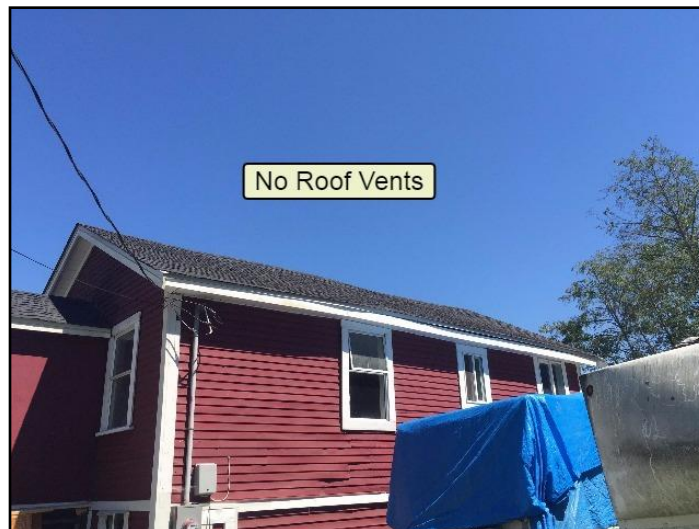
42. Condition: • [Missing](#)

Implication(s): Chance of condensation damage to finishes and/or structure

69. Missing Roof Vents

the total vent area is often recommended to be 1/300 of the floor space of the attic

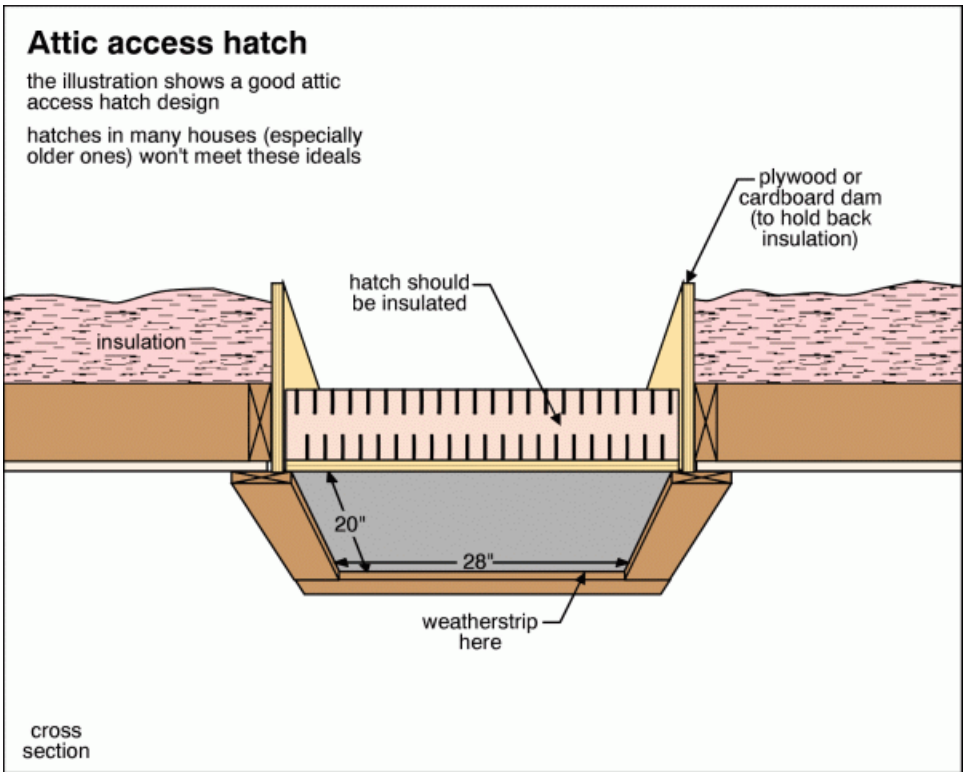
43. Condition: • [Not insulated and not weatherstripped](#)

Implication(s): Chance of condensation damage to finishes and/or structure | Increased heating and cooling costs | Reduced comfort
