Your Inspection Report

11554 136 Street
Surrey, BC V3R 3C2

Thursday, July 21, 2016

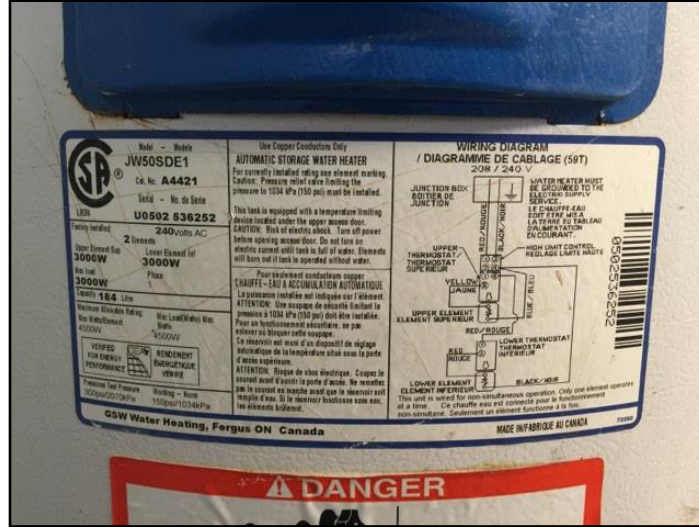
73. Water Heater Specs

Water heater failure probability: • [High](#)

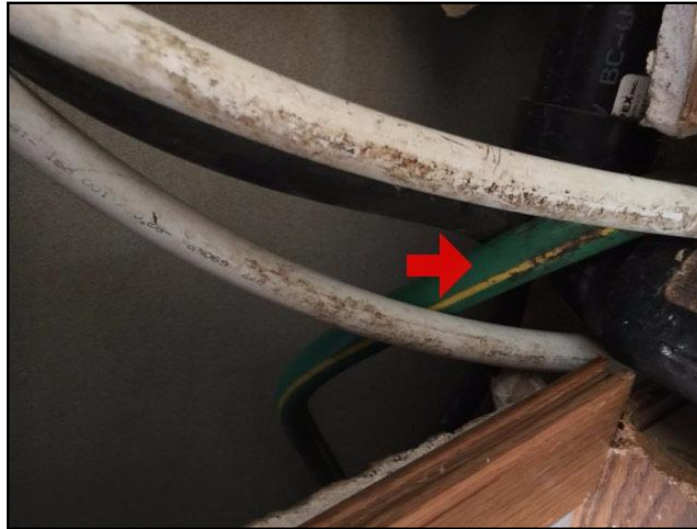
45. Condition: • [Non-standard material](#)

Implication(s): Chance of water damage to contents, finishes and/or structure | Reduced system life expectancy | No water

74. Non-standard material

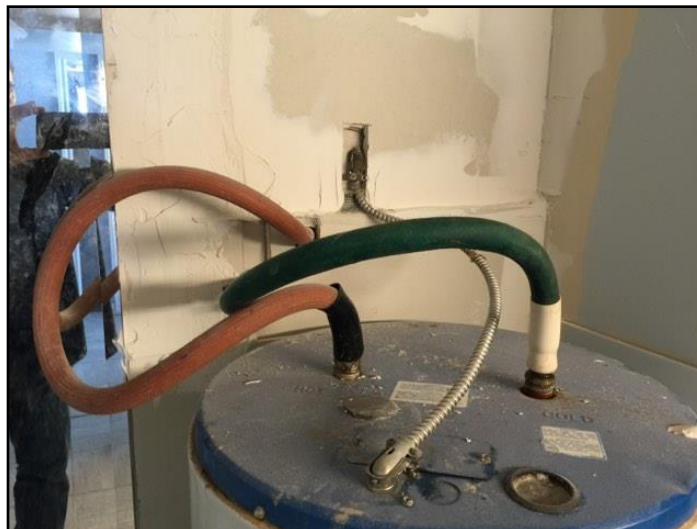
75.

46. Condition: • Garden hose used for hot water tank.

Implication(s): These hoses are not designed for continuous pressure and high heat applications. There is risk of bursting and flooding. The hoses themselves may leach harmful heavy metals into the drinking water. They should be replaced with rated potable water lines.

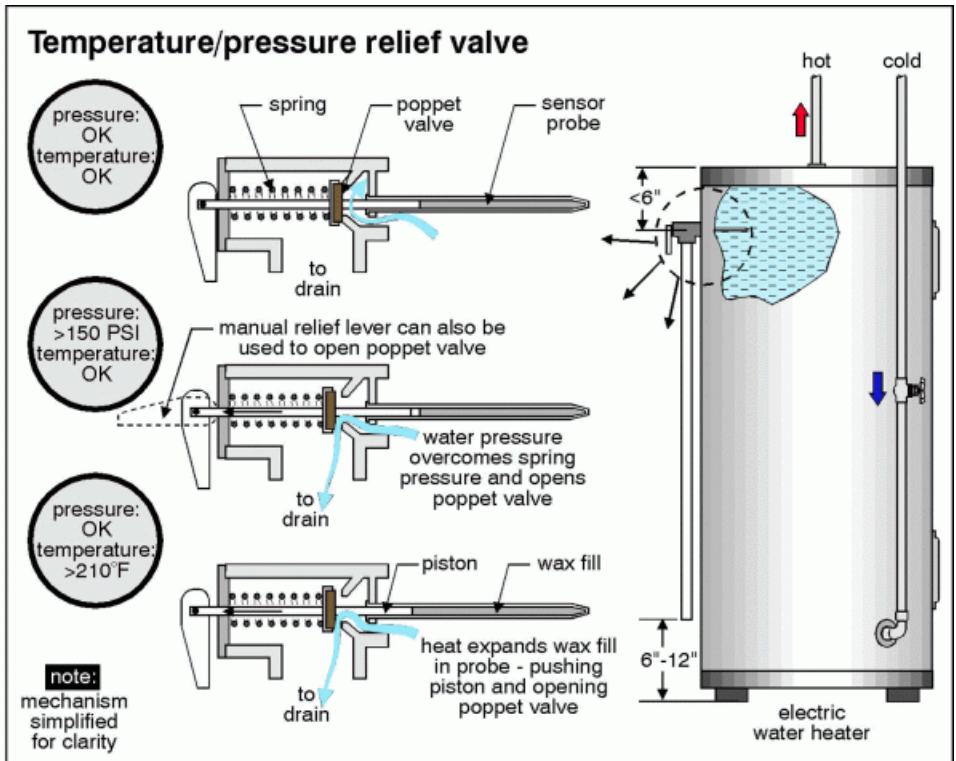
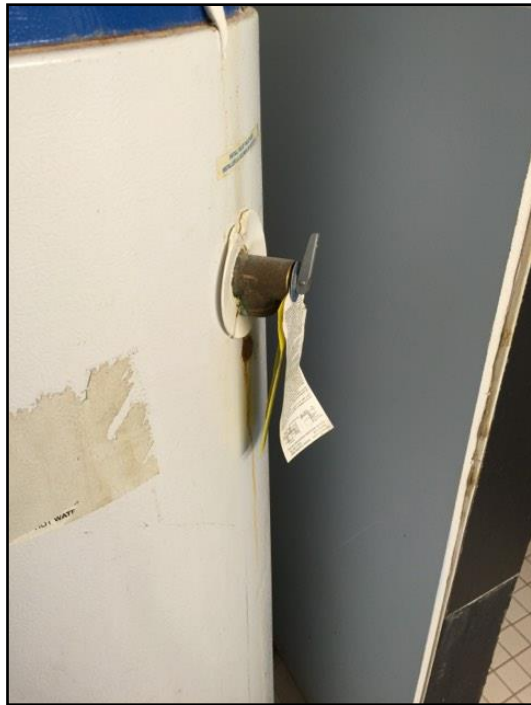
47. Condition: • [Discharge tube missing](#)

Implication(s): Scalding

76. Discharge tube missing

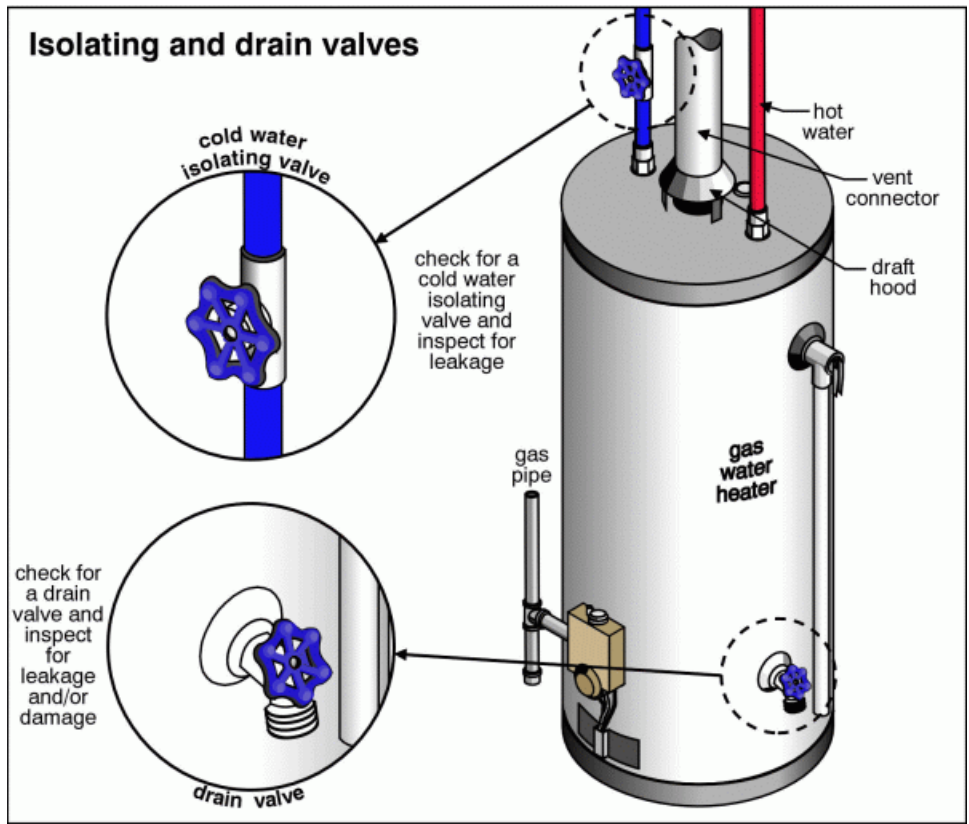
48. Condition: • [Missing](#)

Implication(s): Increased maintenance costs

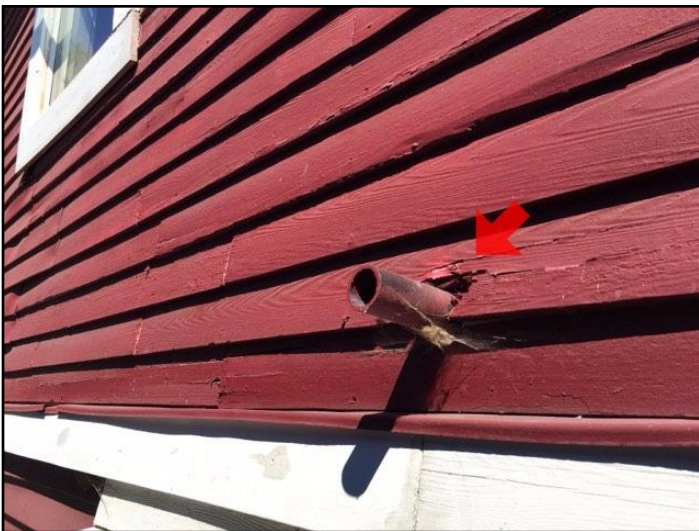
49. Condition: • These plastic pipes appear to be abandoned. They were likely the old drainage lines before the house was lifted.

Implication(s): They pose an insect or rodent entry risk and make it hard to weatherproof the siding in these locations. They should be removed or capped inside the wall and sealed up.

77. Abandoned Drain Pipes

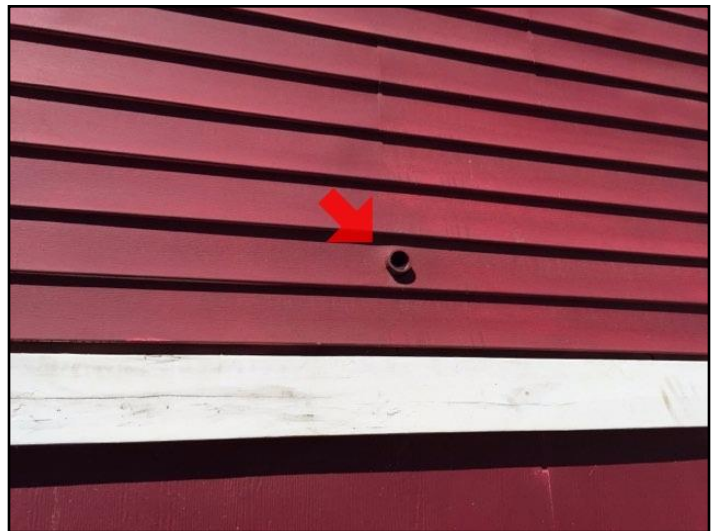
78. Abandoned Drain Pipes

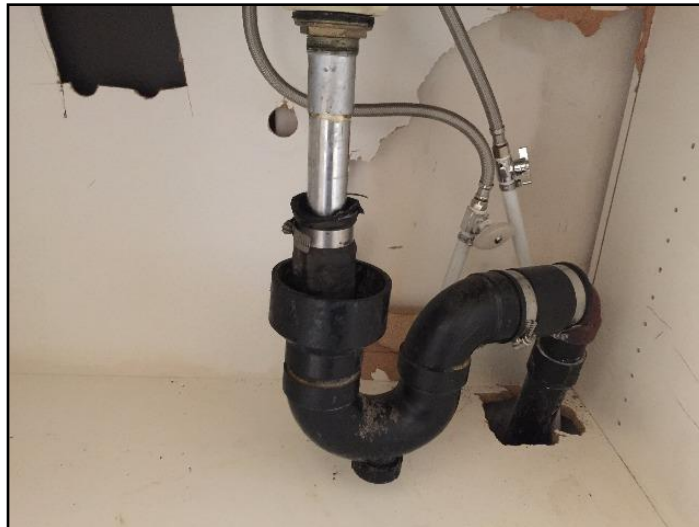
50. Condition: • S-Trap

Implication(s): May allow sewer gases to enter the building.

79. S-Trap

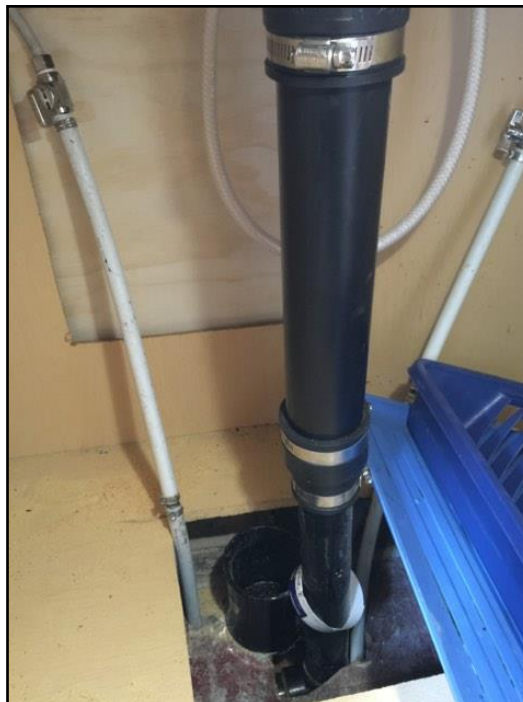
51. Condition: • [Missing](#)

Implication(s): Sewer gases entering the building

80. No Visible P-Trap

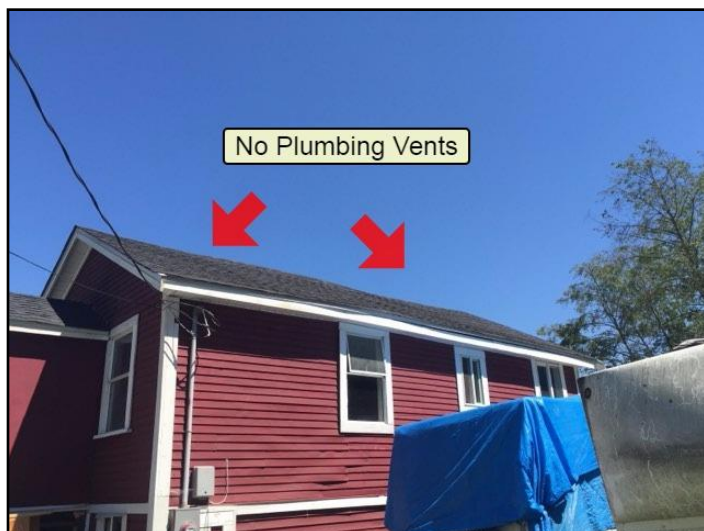
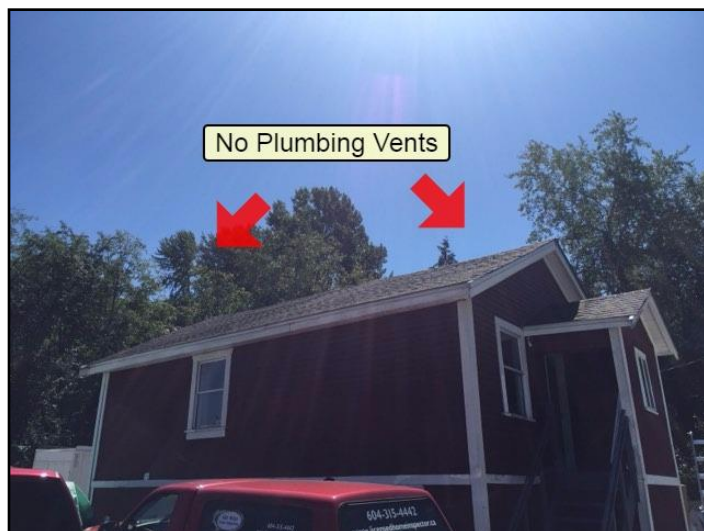
52. Condition: • [Missing](#)

81. Missing

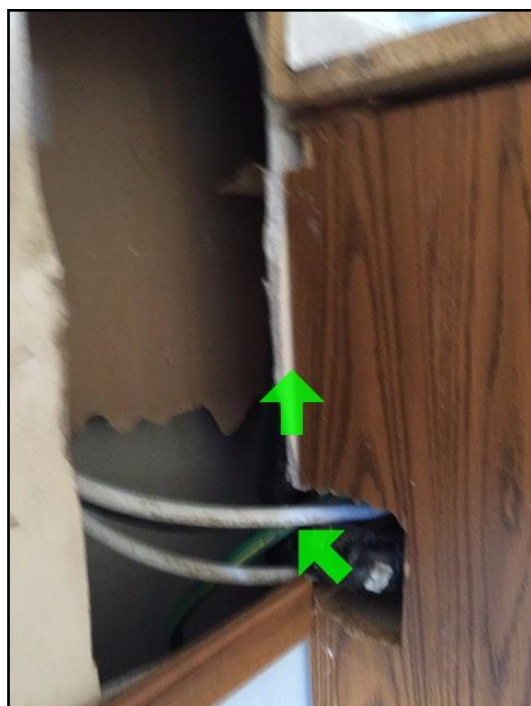
53. Condition: • Sink drain inoperative. This unusual installation seems to defies gravity.

83. Flow of Drain

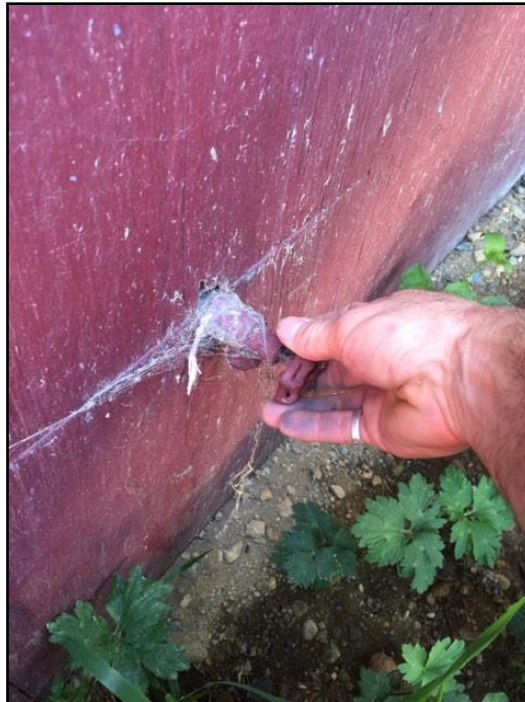
54. Condition: • [Inoperative](#)

85. Hose Bib Inoperative

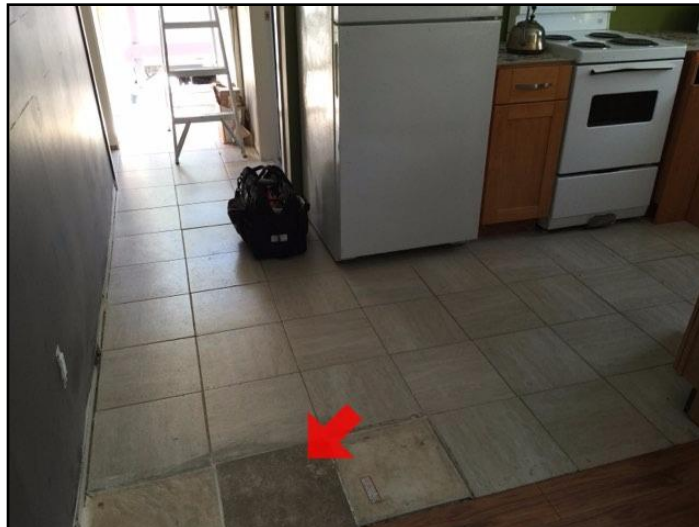
98. *Tile*

56. Condition: • [Loose or missing pieces](#)

Implication(s): Cosmetic defects | Trip or fall hazard

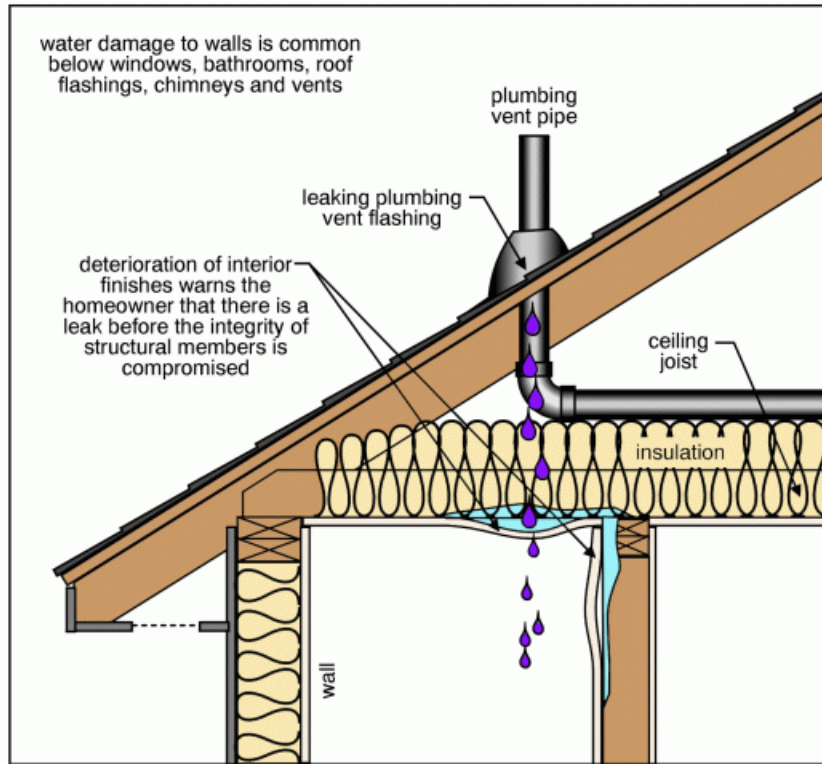
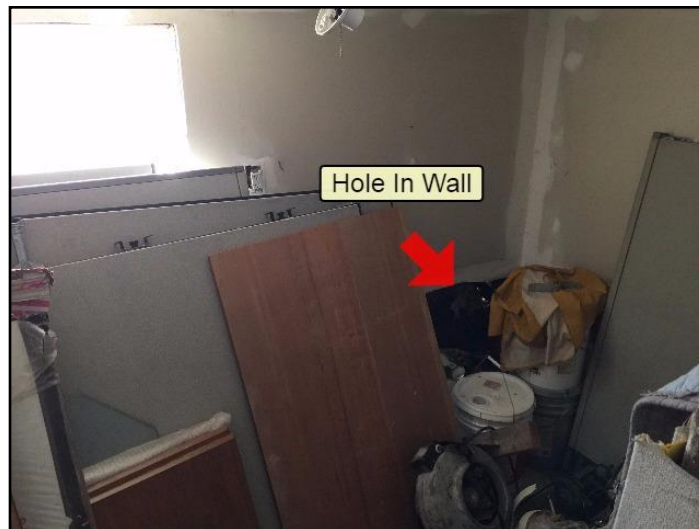
58. Condition: • Damaged

99. Damaged

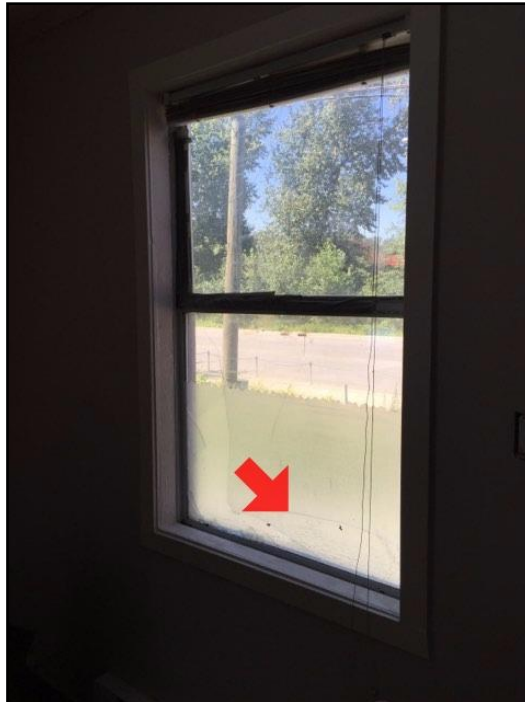
59. Condition: • [Cracked](#)

Implication(s): Cosmetic defects | Physical injury

100. Cracked

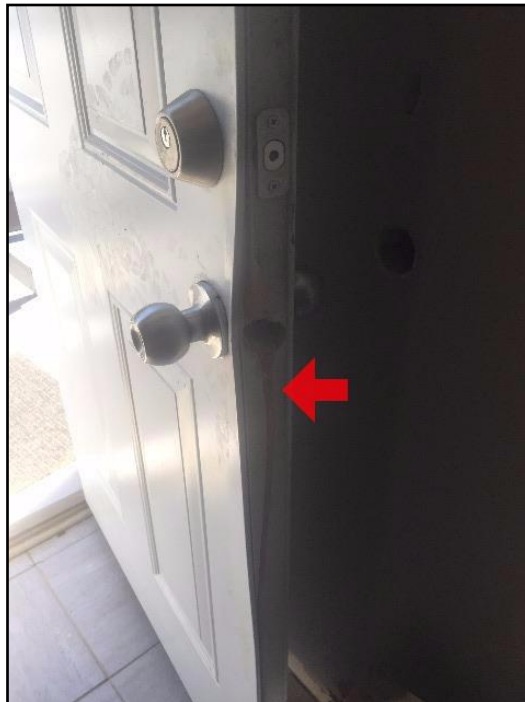
60. Condition: • [Damage](#)

101. Damage

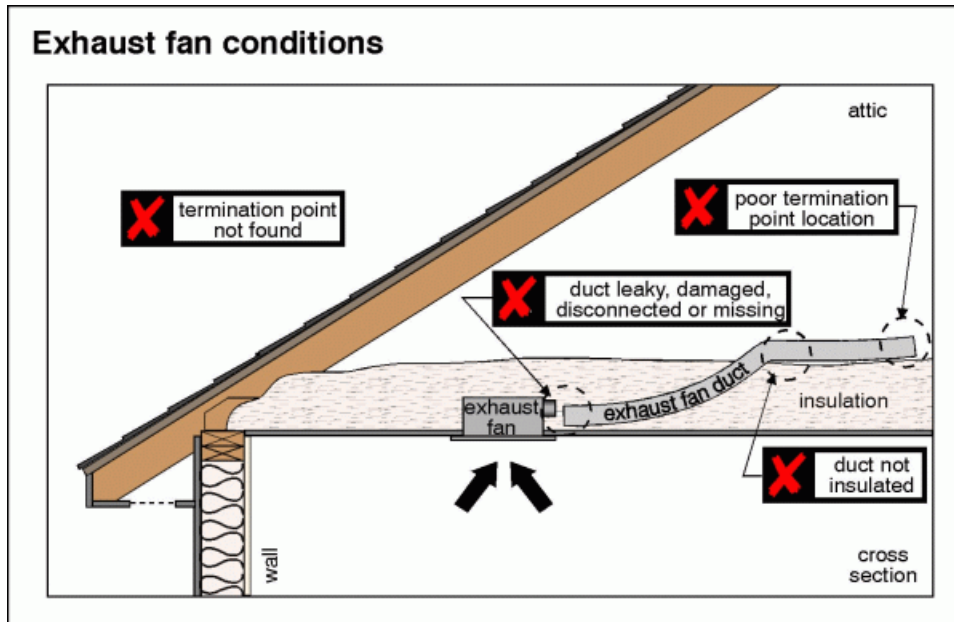
63. Condition: • [Poor termination location](#)

Implication(s): Chance of condensation damage to finishes and/or structure

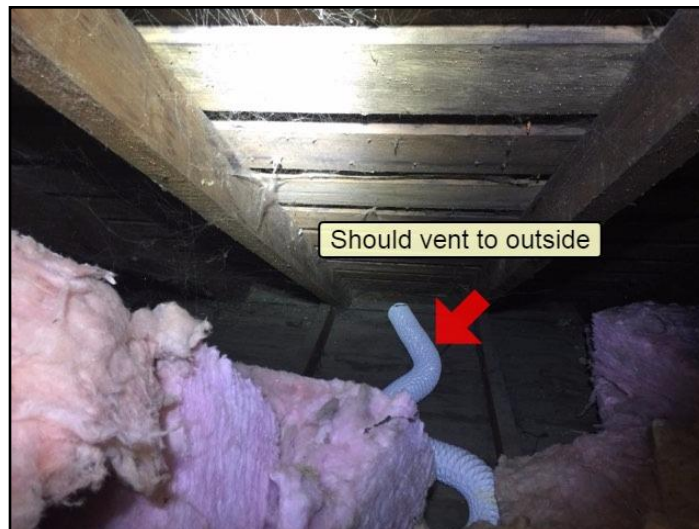
64. Condition: • [Not vented to exterior](#)

Implication(s): Chance of condensation damage to finishes and/or structure

102. Bathroom Fan Exhausting into attic space
