Rusk Professional Property Inspection

Confidential - Property Inspection Report - Confidential

442 Report Rd, Sample, Ohio 45866
Inspection prepared for: Mr. & Mrs. Sample Report
Date of Inspection: 3/28/2014

Inspector: Gary Rusk
Phone: 419-203-2481
Email: ruskpropertyinspect@gmail.com

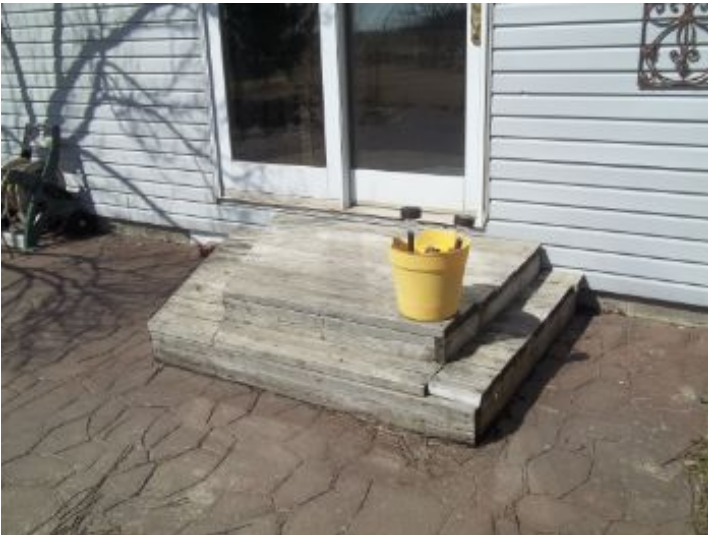
Wood steps to sliding glass door needs cleaned and sealed

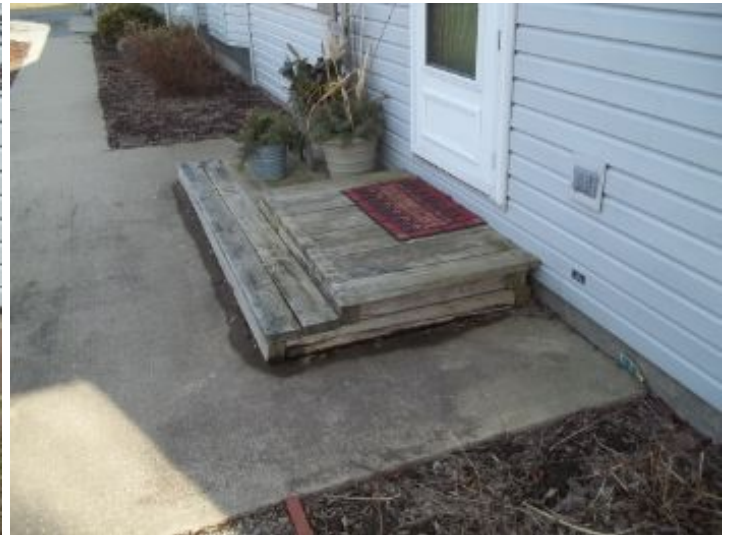
Materials: Wood steps front and back
Observations:
• Rot was found at the base of the front step. A qualified contractor should evaluate and repair as necessary. All rotten wood should be replaced or removed.

Front step is starting to rot at the bottom, where it is in contact with the concrete

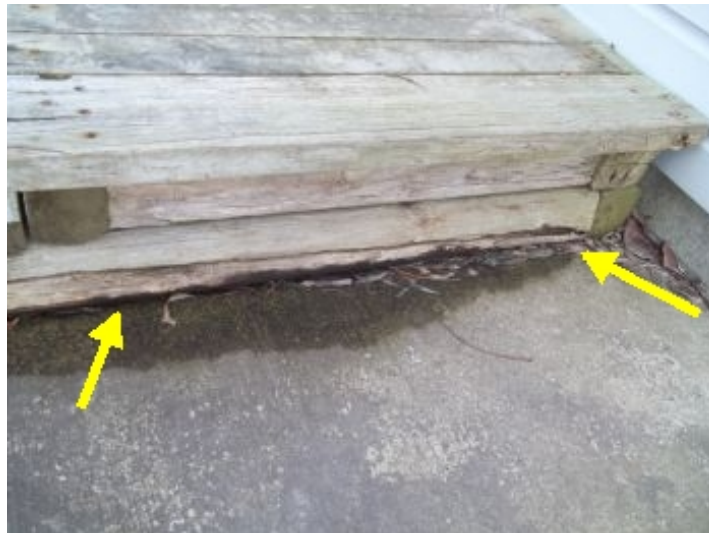
Step starting to rot

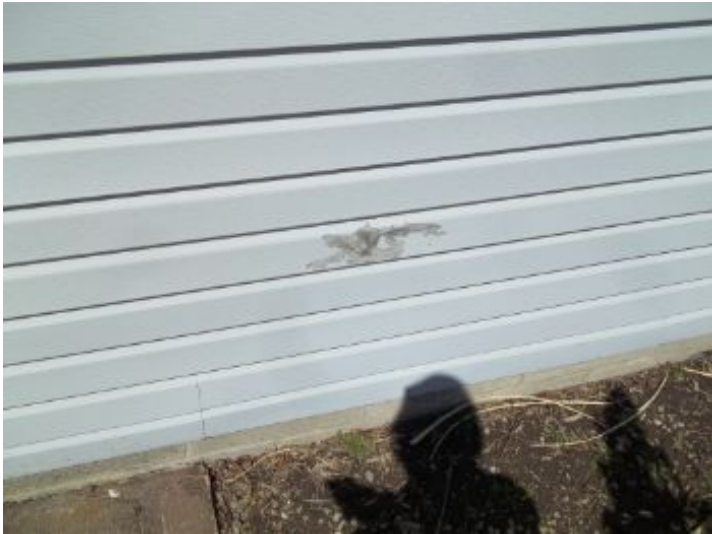
Caulk used to repair siding

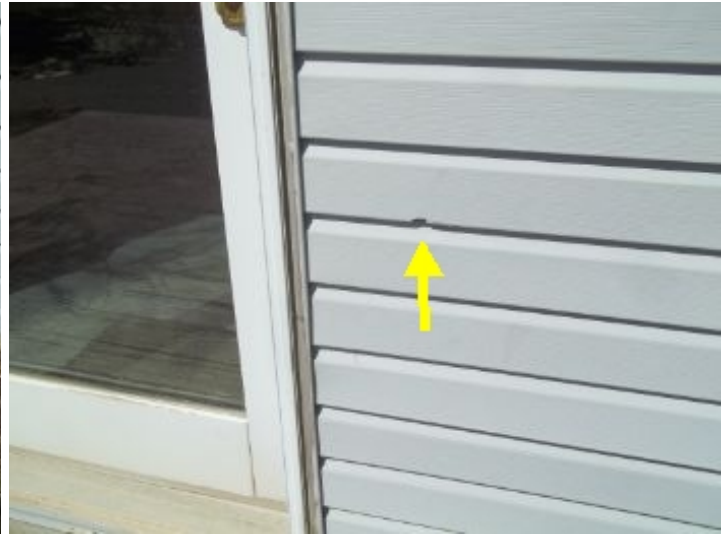
Hole in siding, right side of sliding glass door

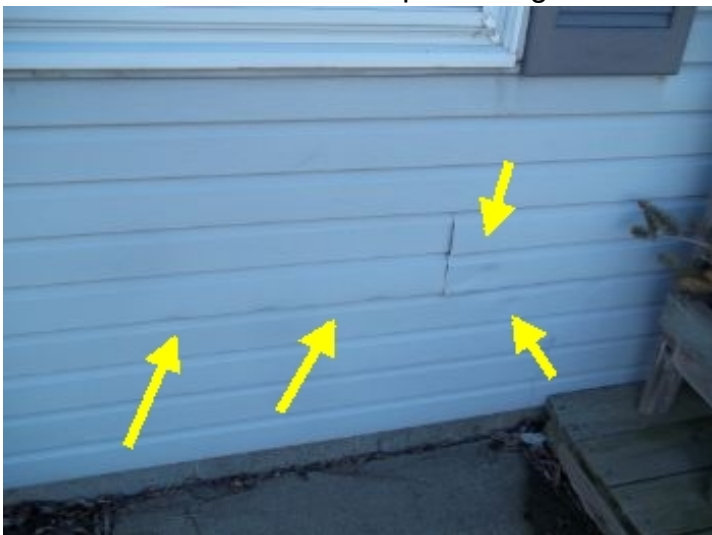
Damaged siding on the front of the house

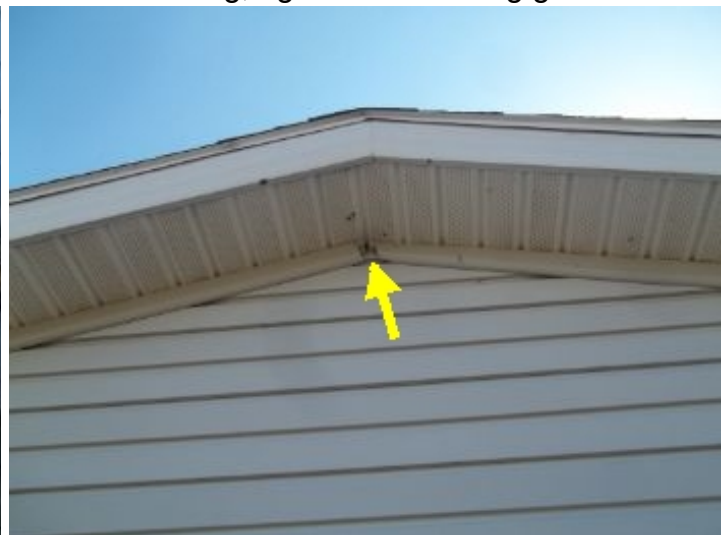
Gap in the top finish trim

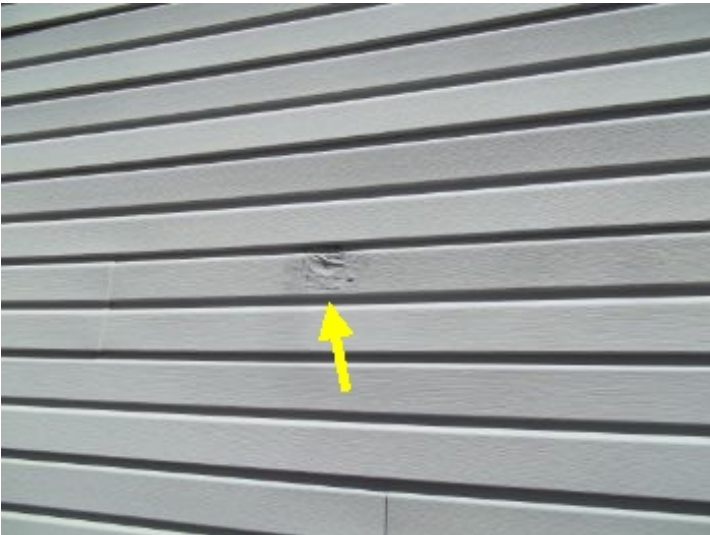
Poor repair/patch

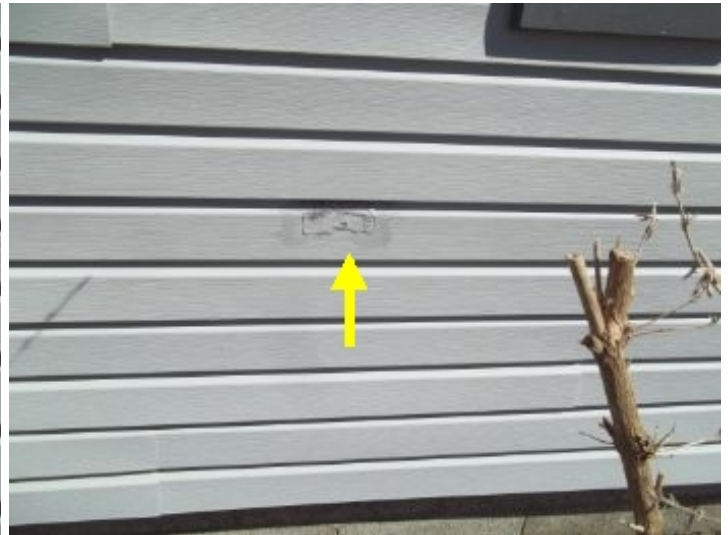
Another patch

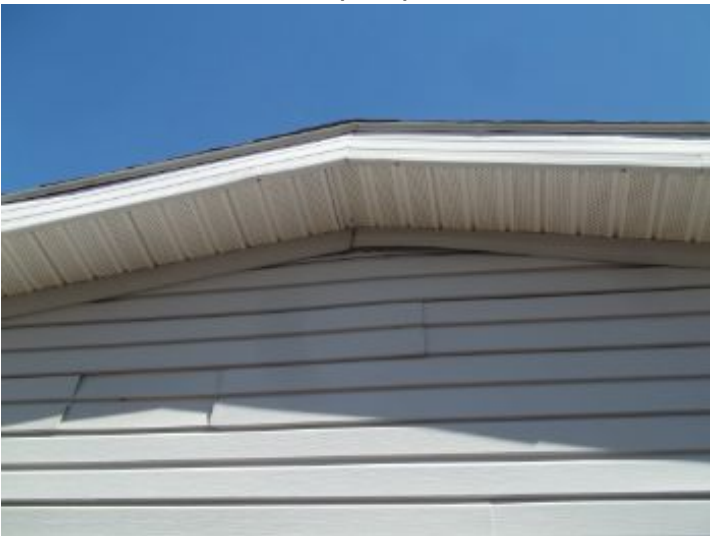
Loose siding and top piece of siding missing

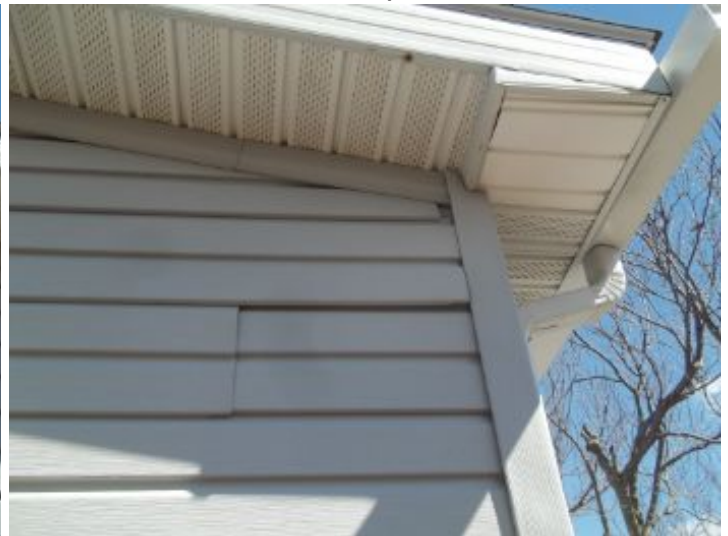
Loose siding west side of house

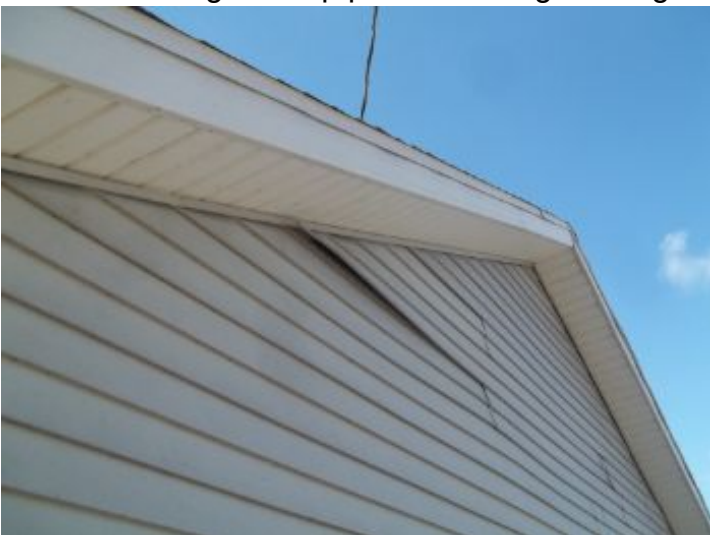
loose siding east side of garage

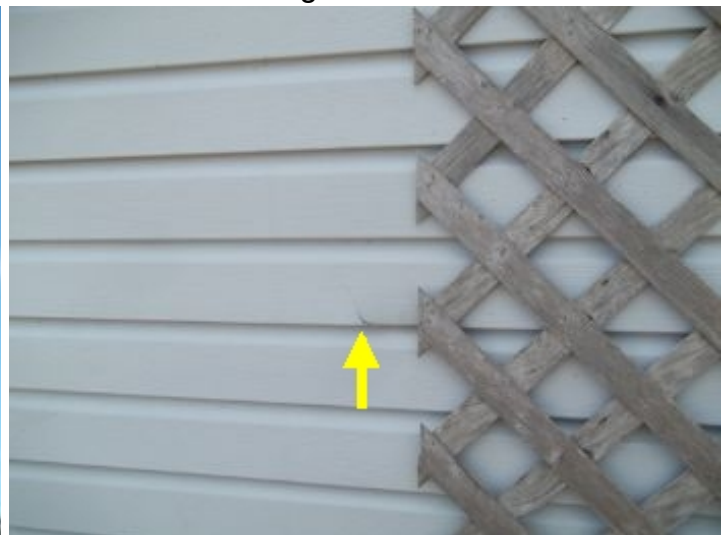
Crack in siding

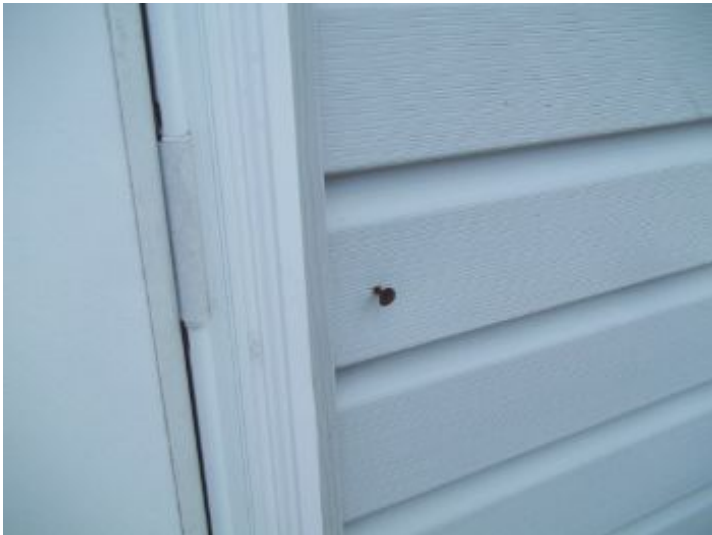
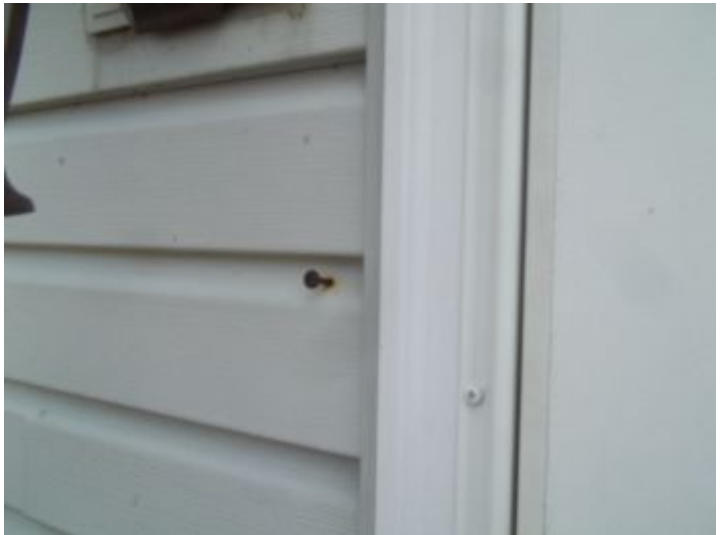
nails need removed

and sealed

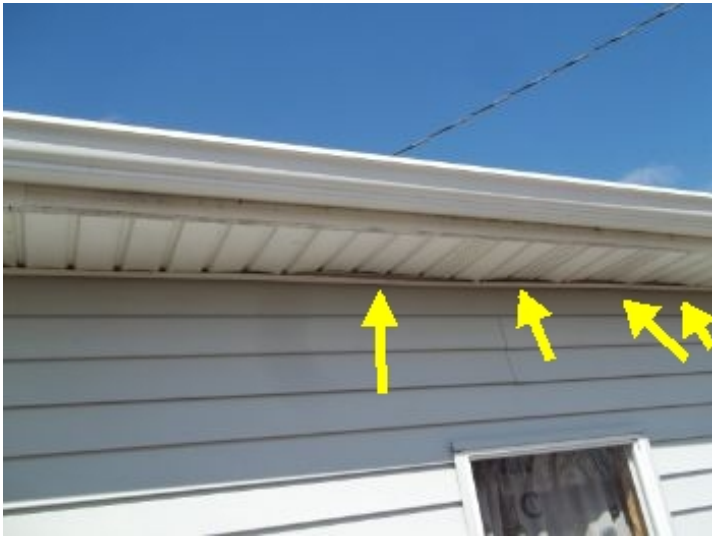
- Soffit at rear of garage loose/falling off. Needs repair to prevent water and/or rodents from entering garage.

Soffit loose on the back of the garage

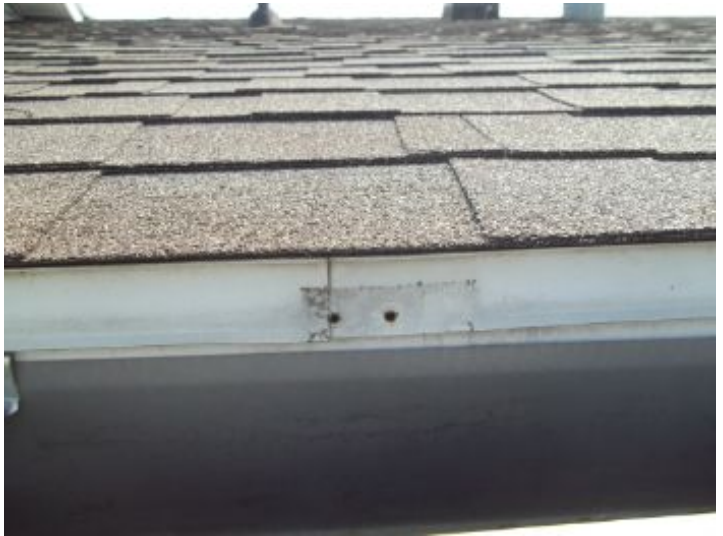
Holes need sealed where the old gutters were removed

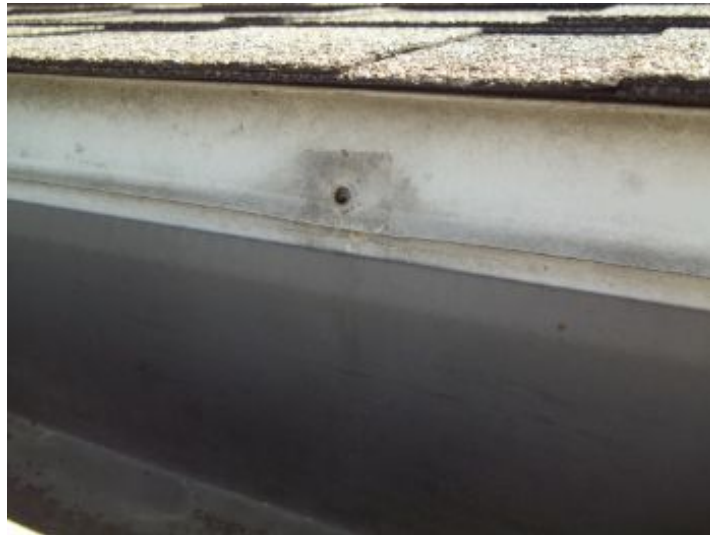
holes need sealed

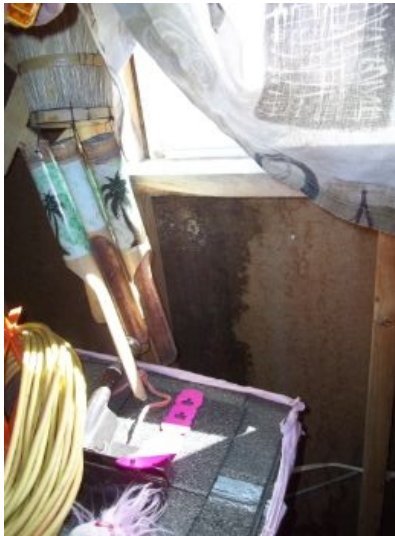
- Rear garage window leaking, sub sheeting was wet under the window

Rear garage window leaking, sub sheeting was wet under the window

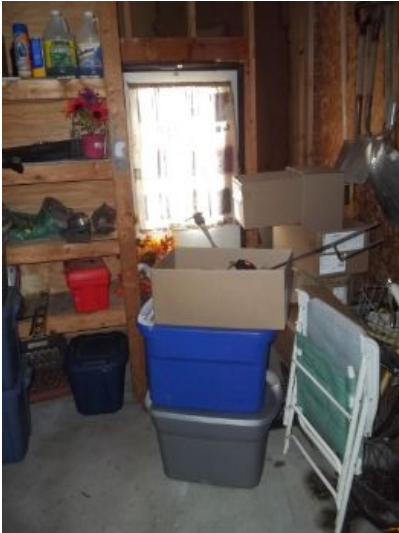
Rear door to garage not inspected

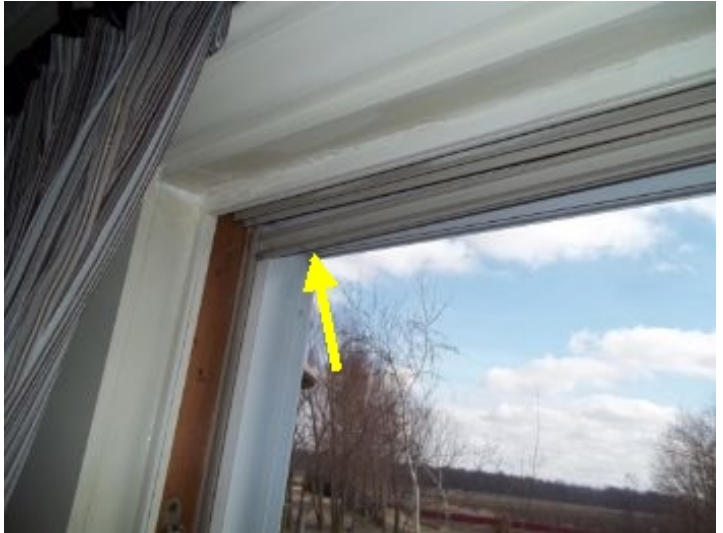
Loose seal trim on the sliding glass door

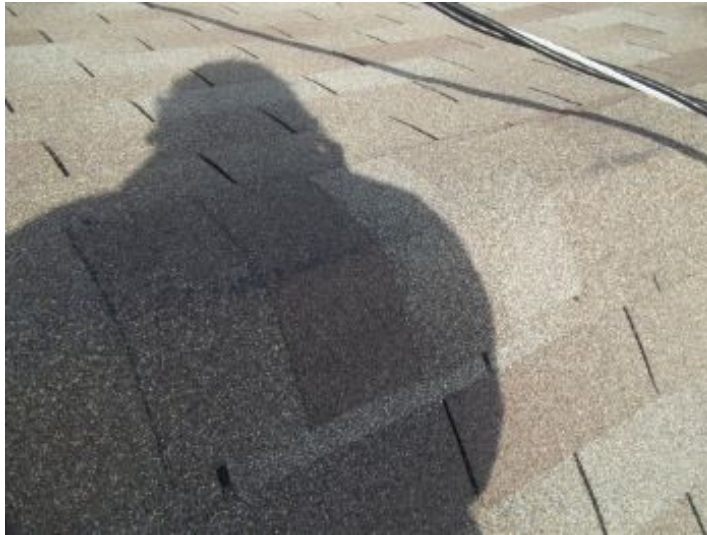
- Roof appeared serviceable with no deficiencies noted at time of inspection, except slight damaged to the ridge cap on the garage from the overhead service cable rubbing the cap when the wind blows. No prediction of future performance or warranties can be offered.

Ridge cap being damaged by the utility overhead service drop cable

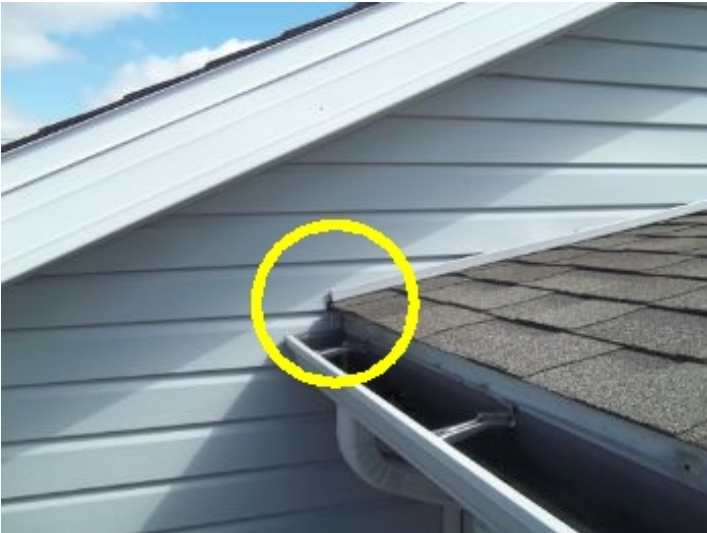
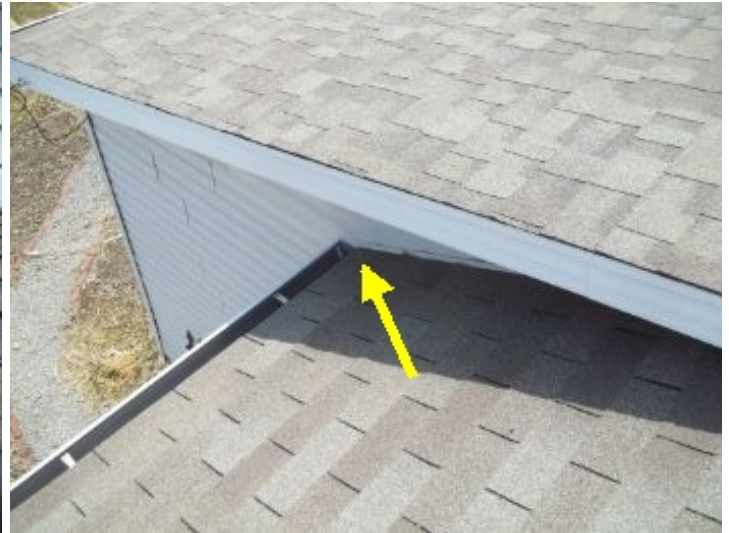
Roofer should have installed a kick-outs so water does not run behind the siding

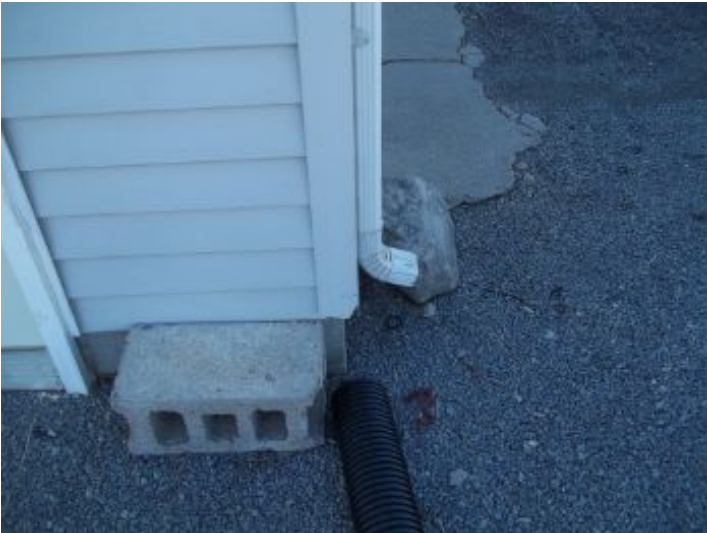
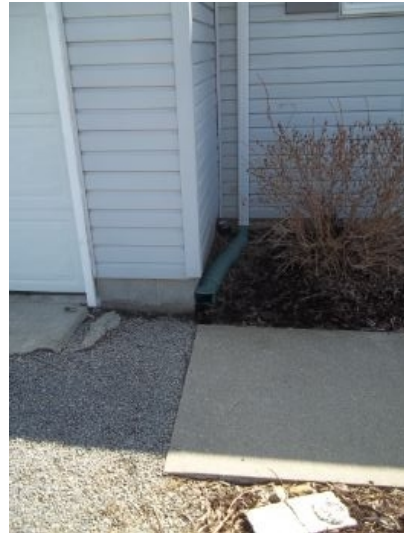
Downspouts discharging to close to the foundation

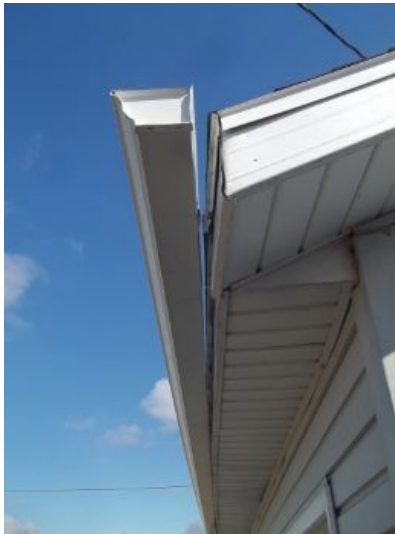
Gutter loose on front of garage and front wall and roof bowed out

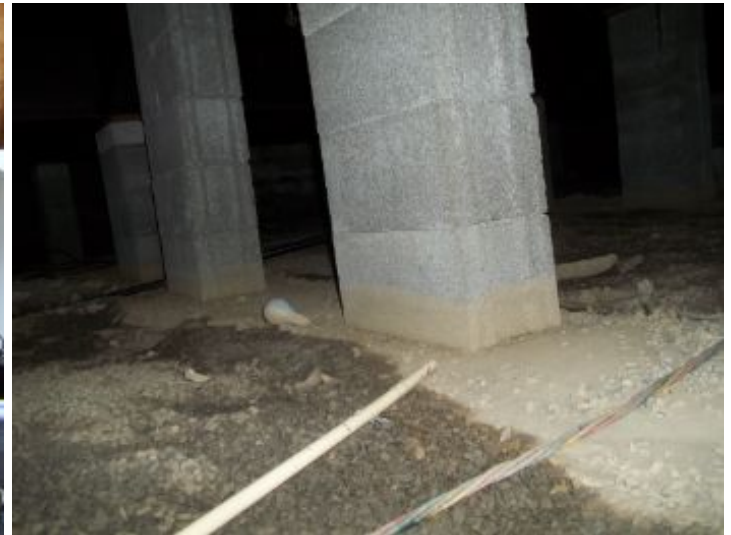
- Evidence of prior water intrusion was found in one or more sections of the crawl space. For example, sediment stains on the vapor barrier or foundation, and/or efflorescence on the foundation. Accumulated water is a conducive condition for wood destroying insects and organisms and should not be present in the crawl space. The client(s) should review any disclosure statements available and ask the property owner(s) about past accumulation of water in the crawl space. The crawl space should be monitored in the future for accumulated water, especially after heavy and/or prolonged periods of rain. If water is found to accumulate, a qualified contractor who specializes in drainage issues should evaluate and repair as necessary. Typical repairs for preventing water from accumulating in crawl spaces include:

Evidence of prior water intrusion was found in one or more sections of the crawl space.

- Repairing, installing or improving rain run-off systems (gutters, downspouts and extensions or drain lines)
- Improving perimeter grading
- Repairing, installing or improving underground footing and/or curtain drains

Ideally, water should not enter crawl spaces, but if water must be controlled after it enters the crawl space, then typical repairs include installing trenches, gravity drains and/or sump pump(s) in the crawl space.

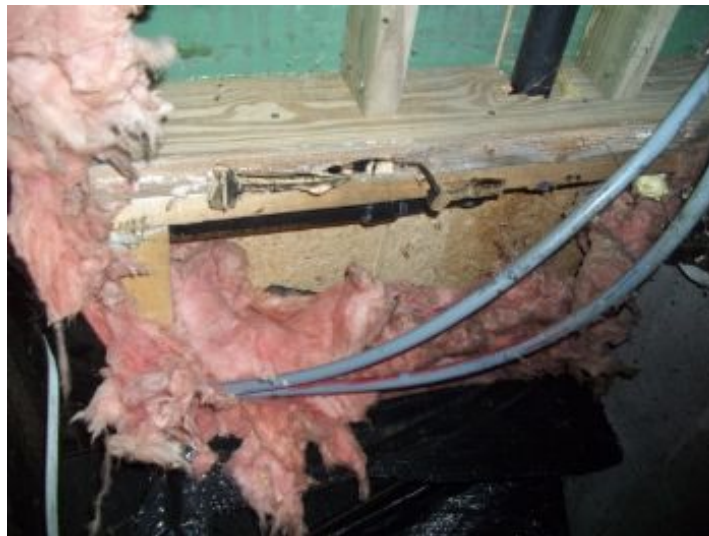
Bottom board damaged insulation missing

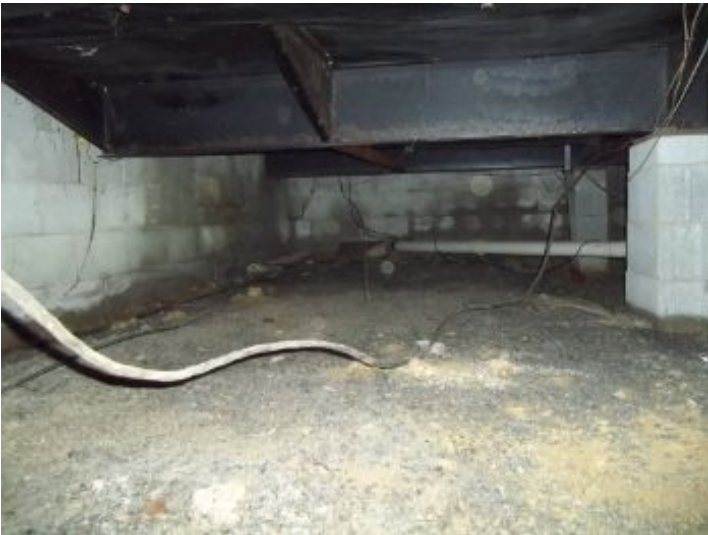
Materials: This is a manufactured home and the piers for the frame are not not too the manufacturers or state required specifications. If your loan provider requires an engineered report the house will require an additional 8 piers installed. (There are nor piers installed within 2 feet of the foundation walls, the distance between foundation walls and first/last piers is about 8 feet.)

No piers at the end of steel frame

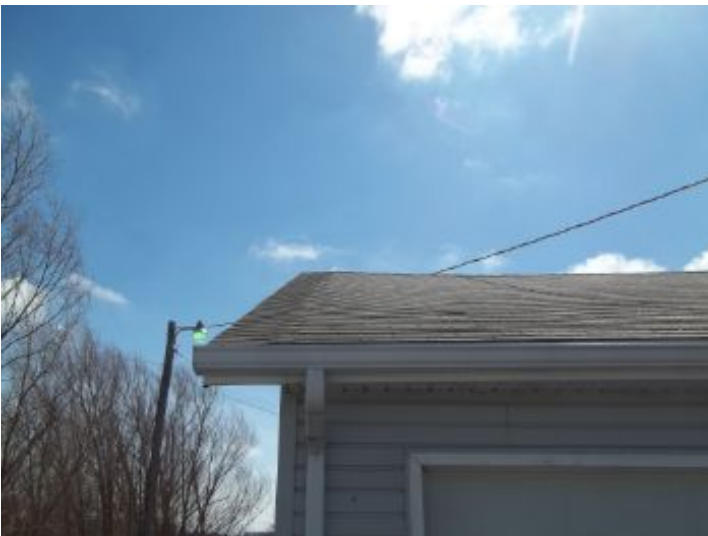
East side gable overhang sagging

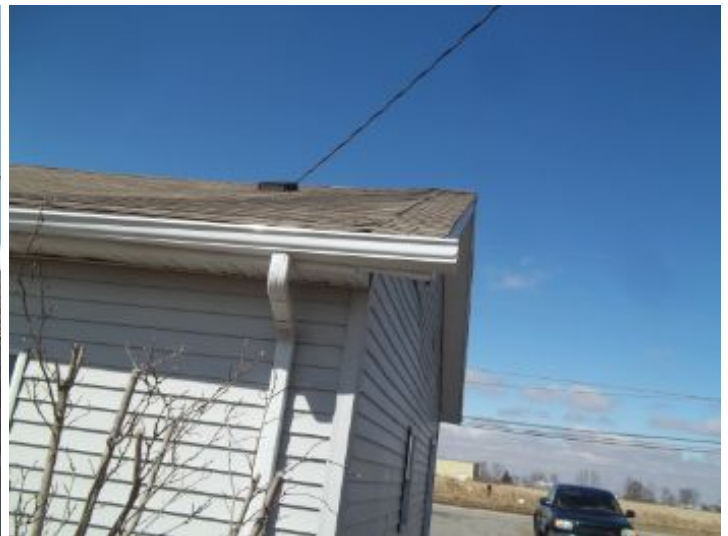
- The framing for the garage roof is substandard, they used 2 x 4 lumber (they should of used at the very minium 2 x 6 lumber) for the rafters and ridge beam. No cross ties (ceiling joist) were installed to keep the roof from sagging and walls pushing out. The ridge is now sagging, rafters are sagging, the front and back of the garage is bowed out. The gable overhangs look like they were added as an after thought and appear at be sagging. Recommend having a general contractor review the roof system for repair or replacement.

Garage rafters sagging

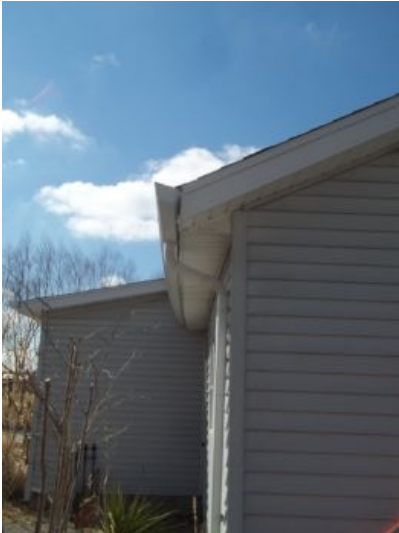
Roof and wall bowed out from roof sagging

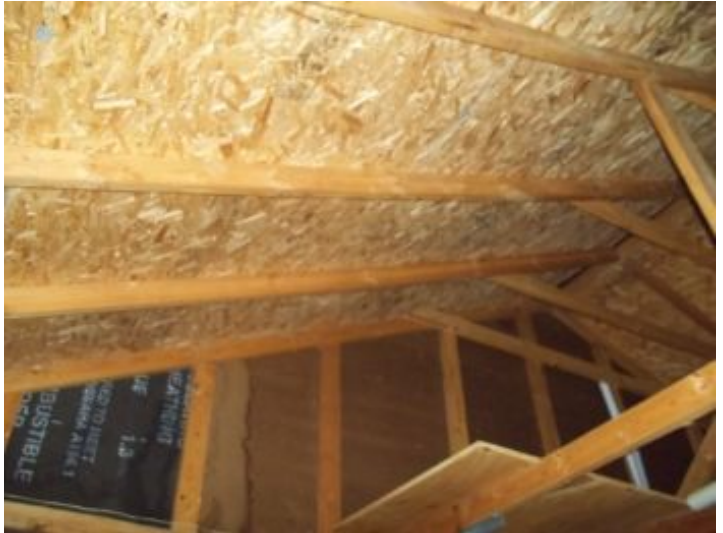
Dangerous roof framing, not to any building standards

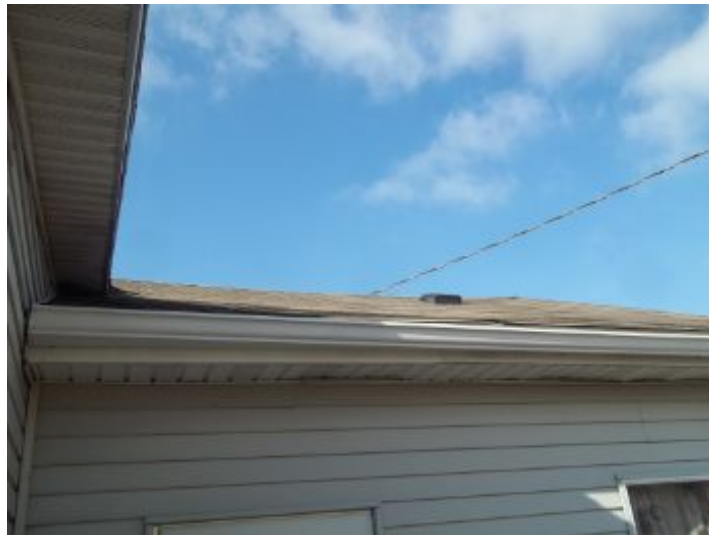
Garage roof sagging

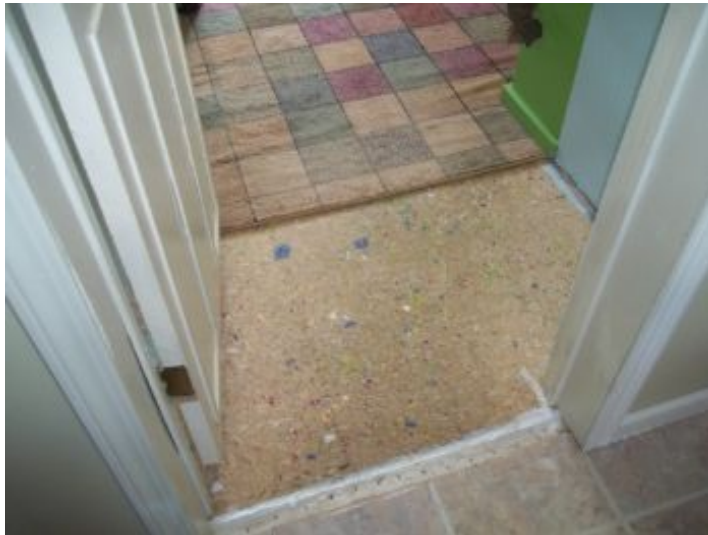
No floor covering in center bedroom

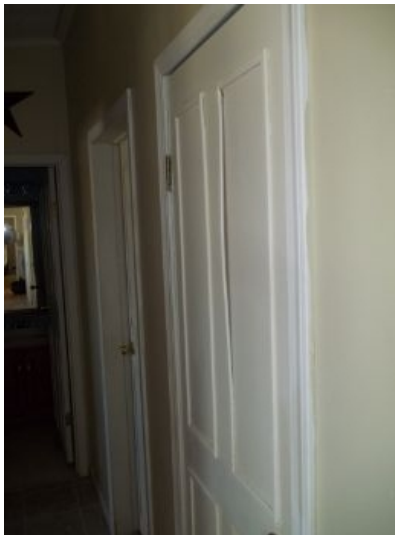
- Most of the doors need some repair or adjustment; such as trim secured, striker plate missing, doors binding - ect. 2 of the closet doors are missing.

Door trim coming loose on several of the doors

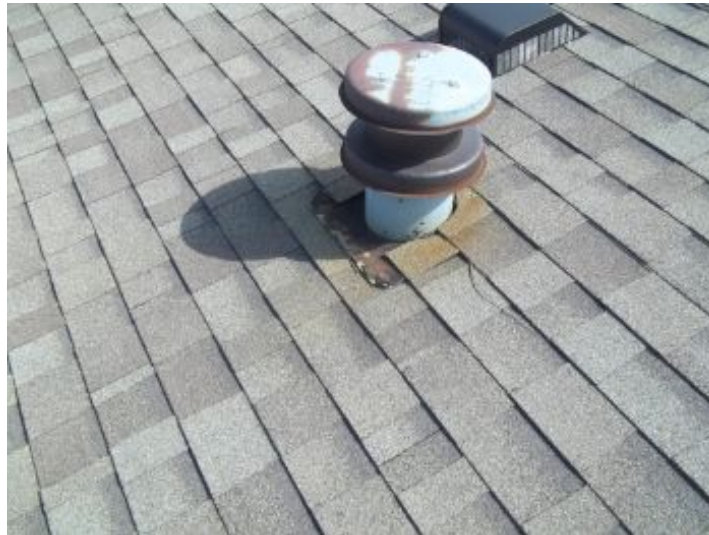
- The visible portions of the vent pipes appeared functional. Except as noted
- Rust noted at top exterior chimney flue cap at roof. Recommend cleaning and painting.

Furnace vent stack needs cleaned and painted

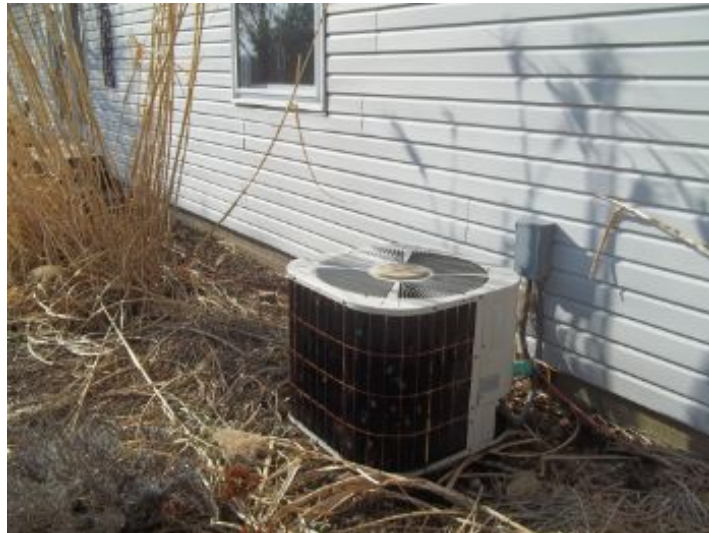
- The outdoor air temperature was below 60 degrees Fahrenheit during the inspection. Because of this, the inspector was unable to operate and fully evaluate the cooling system.
- The estimated useful life for air conditioning compressors is 8 to 15 years. This unit appears to have exceeded this age and may need replacing at any time. Recommend budgeting for a replacement in the near future.

Data missing from AC unit, appears to be original equipment

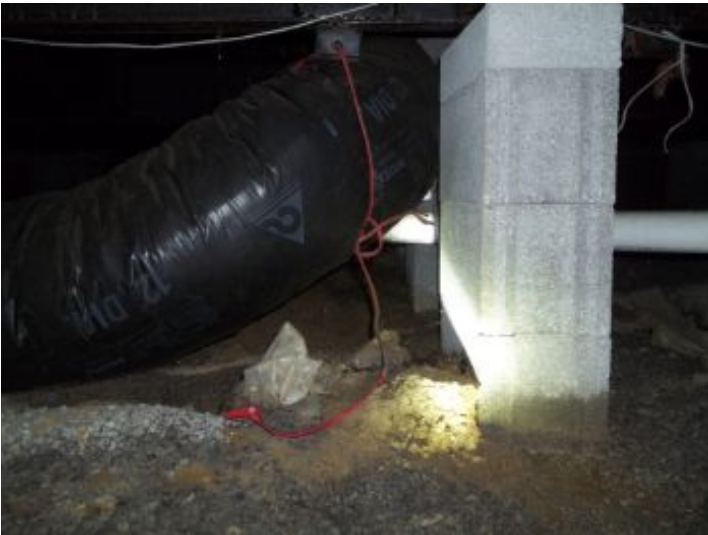
- Duct system not visible except for the 12 inch flex duct connect the 2 duct systems together. It is not properly supported, part of it is lying on the crawlspace ground/gravel and part is supported with the cable from the electric brake system from the axle. The duct should not be lying on the ground/grave. If water gets in the crawlspace it could ruin the duct. The duct should be strapped with wide duct strap at least 12 inches above the ground, the electric cable could damage the flex duct or reduce the air flow.

Duct not properly supported

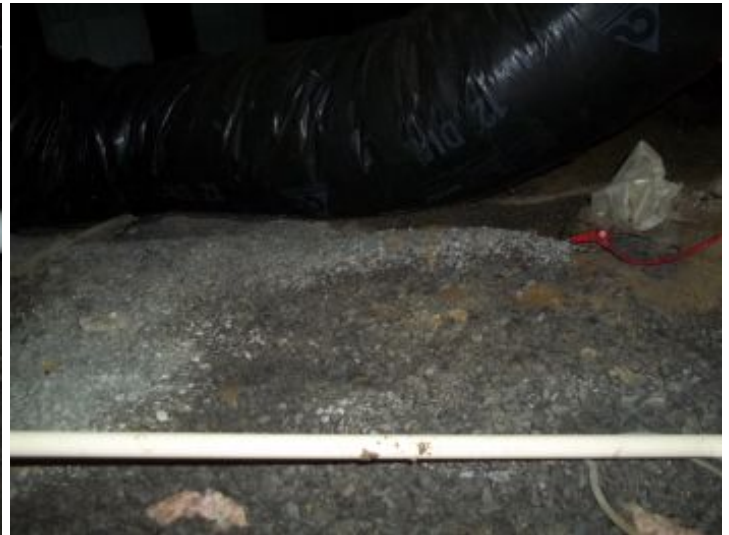
Crossover duct is lying on the ground

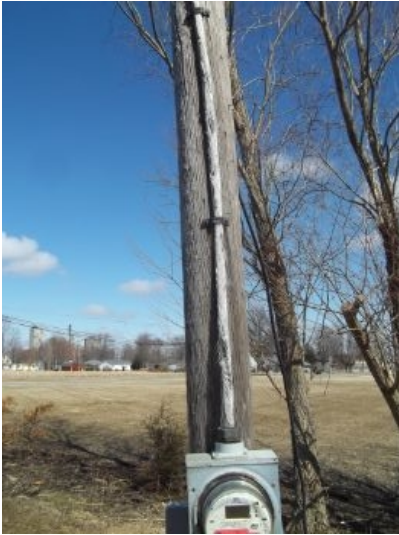
- **SAFETY CONCERN:** Sheathing on the wire coming out of the service meter to the overhead triplex cable is deteriorated and frayed, exposing the ground wires.
- The utility service stranded triplex cable are rubbing the roof ridges shingles when the wind blows. This is a safety hazard for shock since the cable is being damaged when it comes in contact with the roof ridge. People walking on the roof may also come into contact with the service drop wires. The utility company and/or a qualified electrician should evaluate and repair as necessary.

Sheathing on the wire coming out of the service meter to the overhead triplex cable is deteriorated and frayed

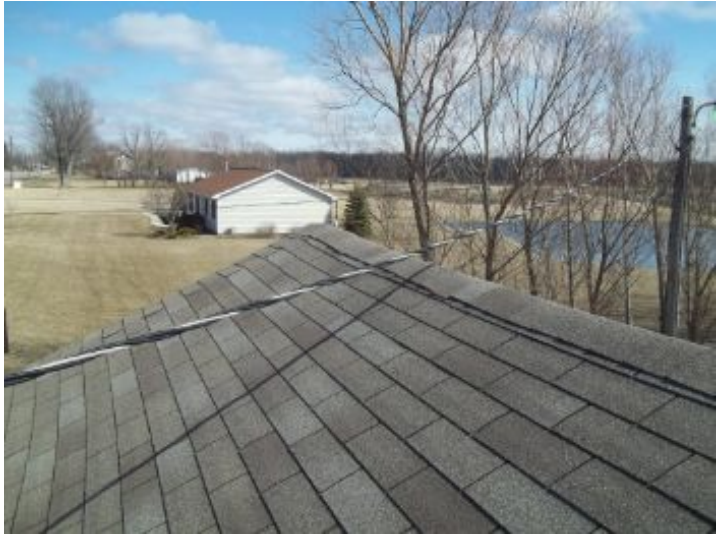
Improper clearance on utility service drop

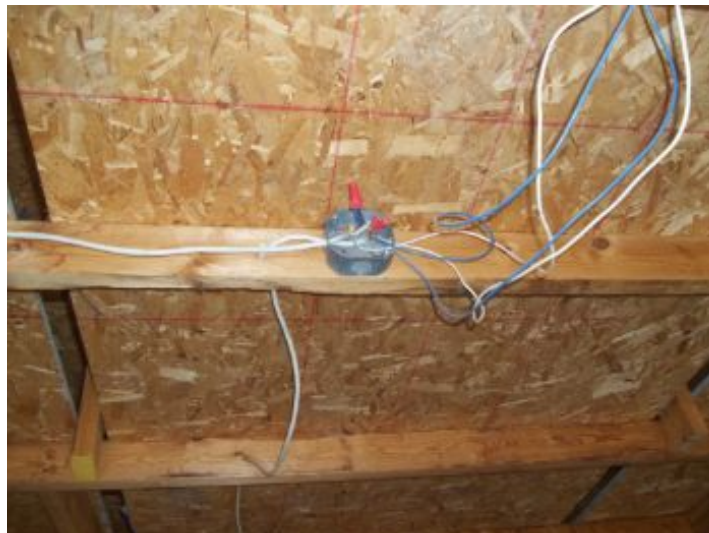
- Visible wiring appeared functional, at time of inspection; except as noted. Cover plate missing from junction box in the garage. No cable/wire connectors to secure or protect the wires in the junction box.

Cover plate missing, cable connectors missing

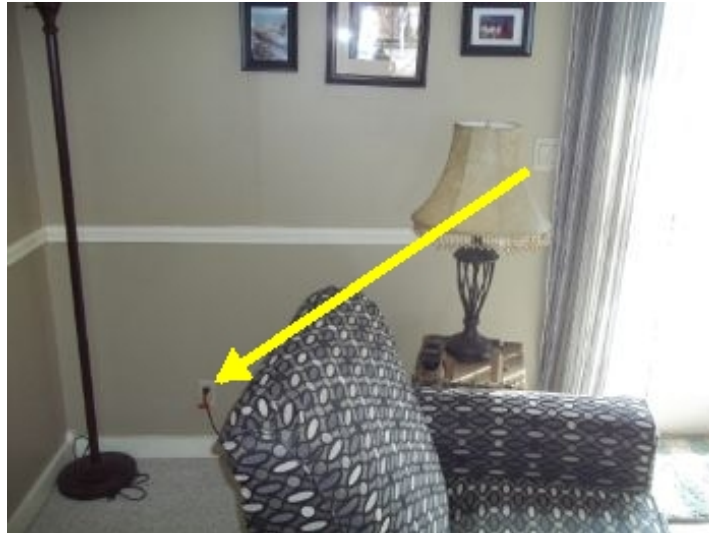
Light switch controls this outlet

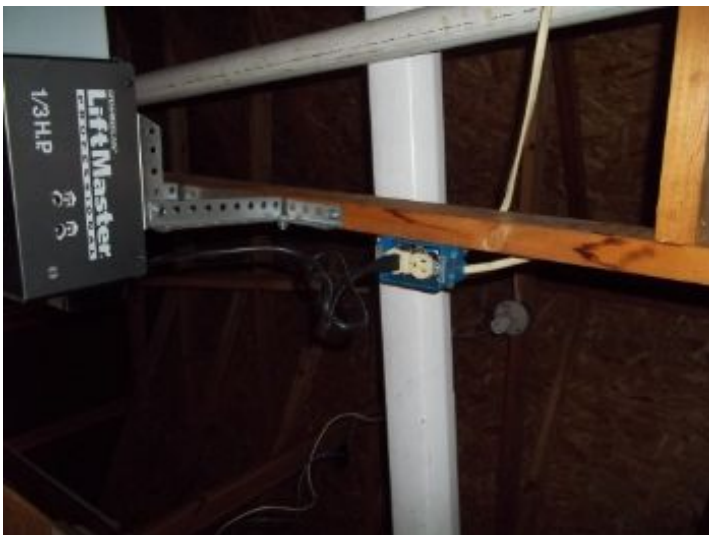
- A representative number of receptacles were tested and are generally serviceable, unless otherwise noted. Receptacles covers missing in the garage all outlets

cover plate missing

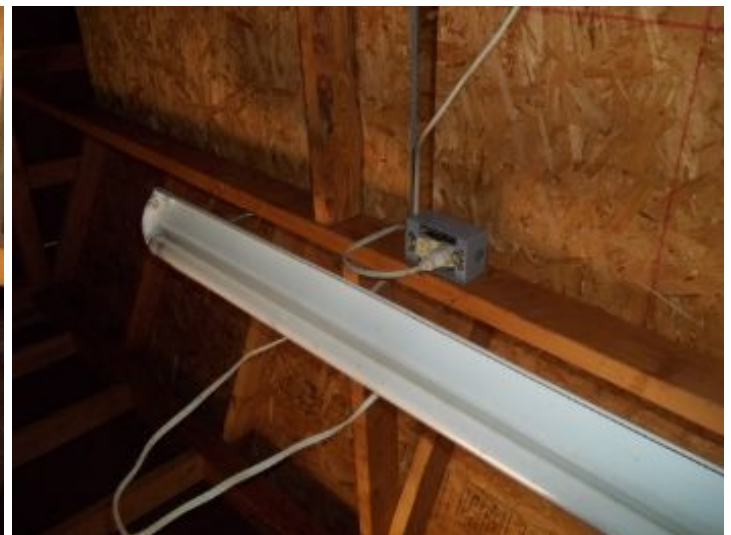
Cover plate missing

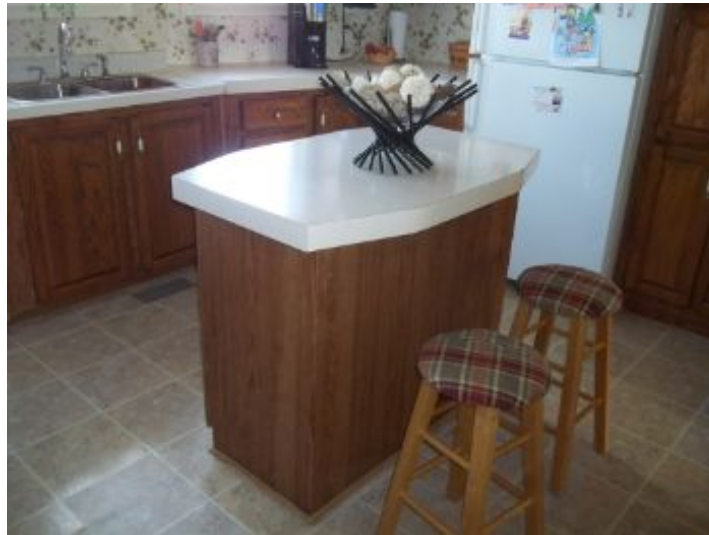
No outlet on island cabinet

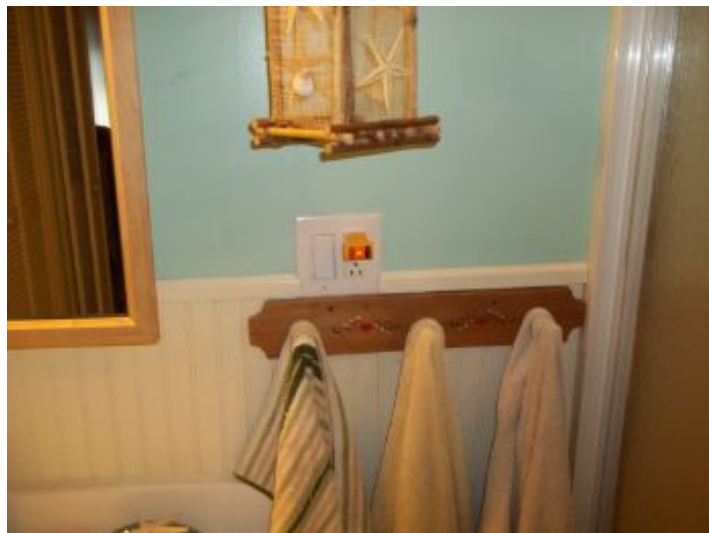
- The GFCI outlets in both bathrooms are controlled by the light switch to the master bathroom light. Nether outlet is grounded.
 - Test GFCIs monthly to ensure proper operation.
 - There appears to be no GFCI protection at the kitchen and garage. These are the locations in and around the home when GFCIs were first required:
- 1973 - Outdoor Receptacles
 - 1975 - Bathroom Receptacles
 - 1978 - Garage Receptacles
 - 1981 - Whirlpools and Tubs
 - 1987 - Receptacles Near Kitchen Sinks
 - 1990 - Receptacles in Unfinished Basements and Crawl Spaces
 - 1993 - Receptacles Near Wet Bar Sinks
 - 1996 - All Kitchen Counter-Top Receptacles

GFCI outlet not grounded, also has no power when the bathroom light switch in the master bedroom is off

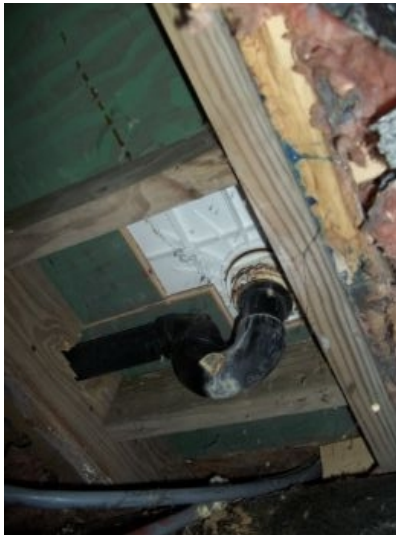
- Water was run through the fixtures and drains. Functional drainage was observed.
- Shower drain is leaking. Recommend a plumber to review for repair.

Shower drain appears to have a leak

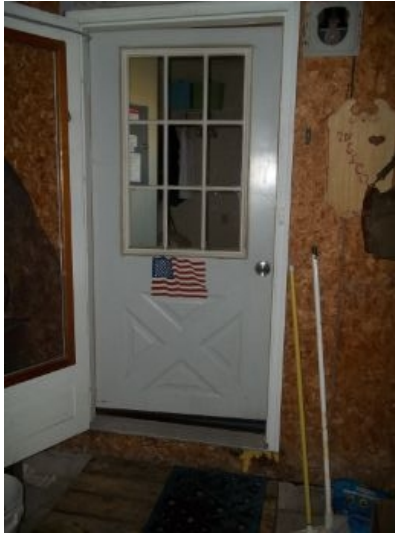
The door between the garage & house is not a fire rated door. This may not have been required when originally built. Fire doors are fundamental to the integrity of fire barriers which provide resistance to the spread of fire, smoke, and toxic gasses. This means that should a fire occur in the garage, this door does not afford protection until fire-rescue people arrive. This door should be replaced with a fire rated door.
