**Inspection reference: 1235**

**Confidential Inspection Report**  
**43 Somewhere Ave.**  
**Any Town, MD 12345**

**April 24, 2018**

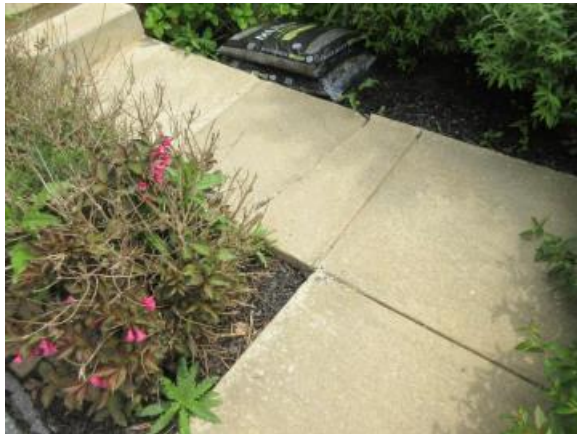
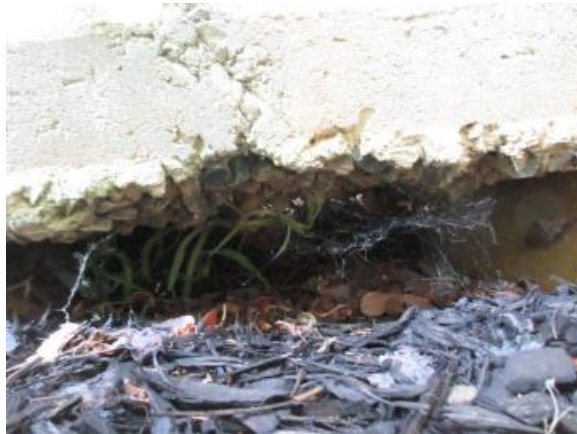
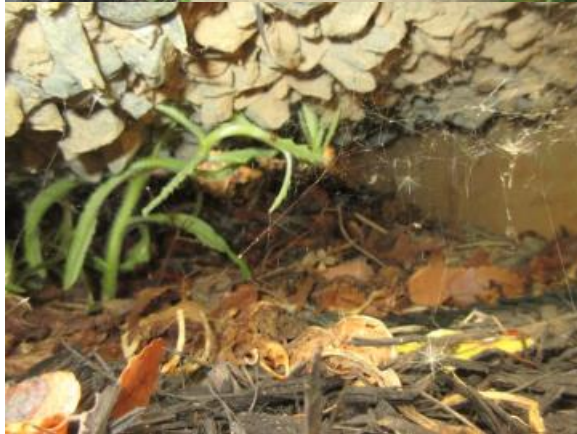
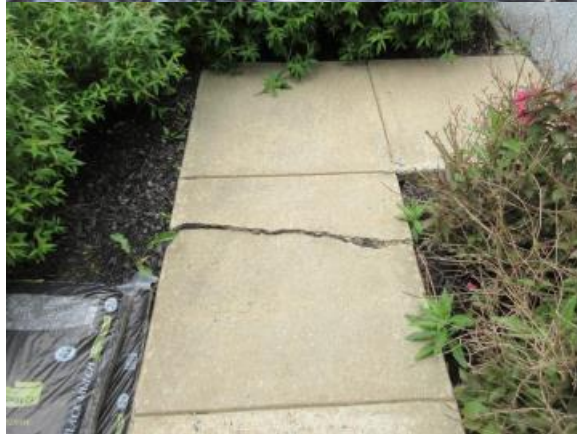
OK	RM	RR	SC	NI	
2.1 Driveway:	⊙	○	○	○	○	○	Driveway Type: Asphalt.
2.2 Walks:	○	○	⊙	○	○	○	Sidewalk type: Concrete, The ground has settled underneath the sidewalk that is next to the front step, this has compromise the integrity of the support for the sidewalk. There is about a 5-inch gap space underneath. Also, about 4-6 feet out, the concrete has dropped and cracked. Recommend repair by a licensed concrete contractor.

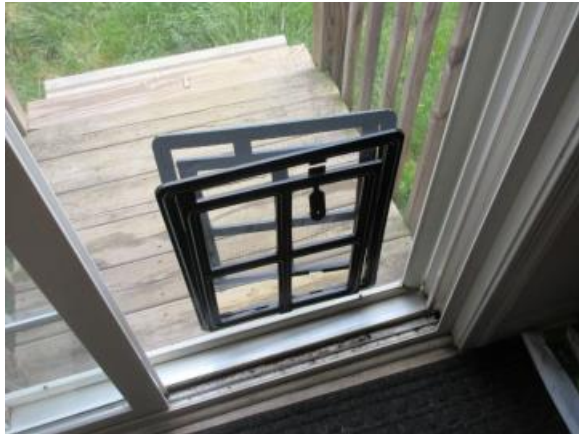
3.3 Main Entry Door:	<input checked="" type="radio"/>	<input type="radio"/>	<input type="radio"/>	<input type="radio"/>	<input type="radio"/>	Hardware is operational.			
3.4 Rear Entry Door:	<input type="radio"/>	<input type="radio"/>	<input checked="" type="radio"/>	<input type="radio"/>	<input type="radio"/>	The screen for the sliding glass door has a dog door on it. It is not secured properly, a new screen on the door will be needed.

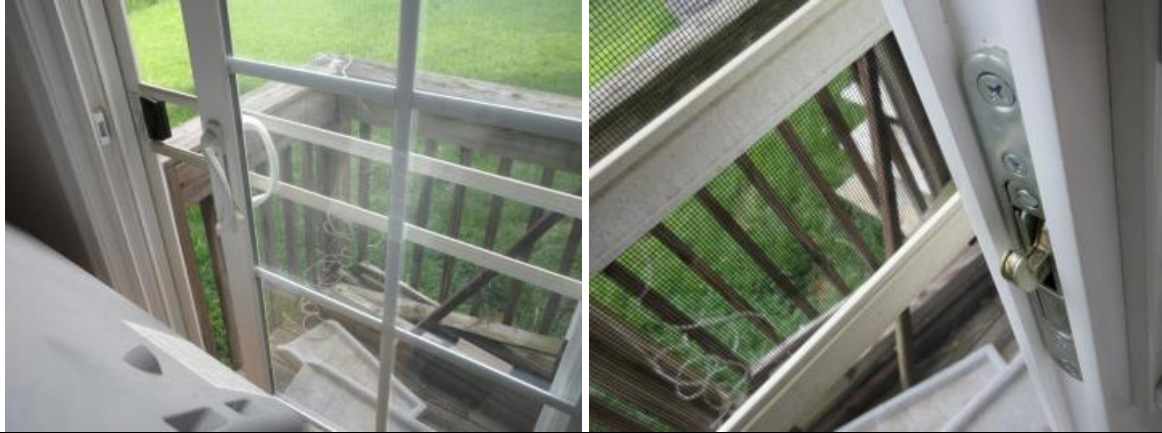
3.5 Other Entry Doors:	<input type="radio"/>	<input type="radio"/>	<input checked="" type="radio"/>	<input type="radio"/>	<input type="radio"/>	Sliding glass door that goes to deck without steps does not latch or lock properly. I recommend repair by a licensed building contractor.			
------------------------	-----------------------	-----------------------	----------------------------------	-----------------------	-----------------------	---	--	--	--

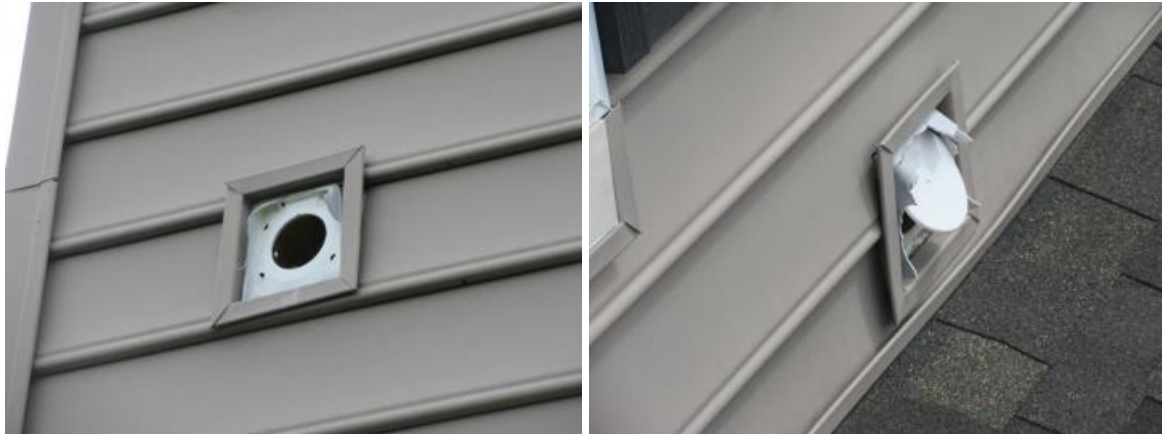
| 3.10 Exterior Walls: | ○ | ○ | ⊙ | ○ | ○ | | | There are 2 broken vents that should be replaced animals and weather elements can enter through opening. Recommend repair by a licensed building contractor. |

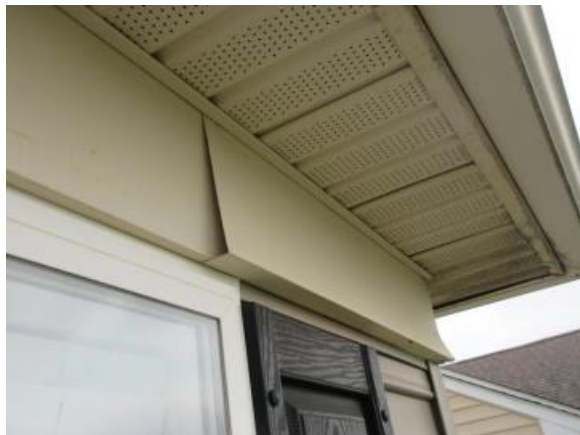
- 4.7 Type & Condition:      Part of the back fascias is coming off. I recommend repair by a licensed building contractor.

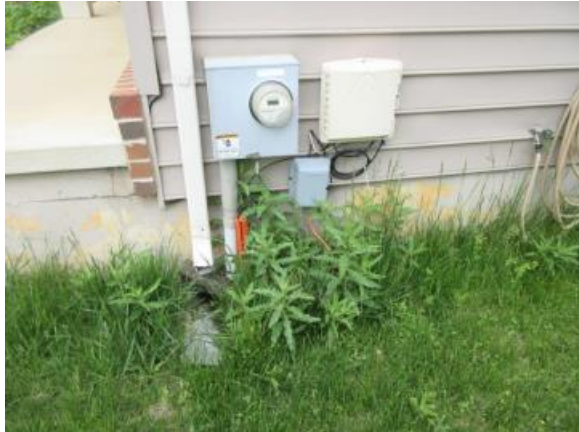
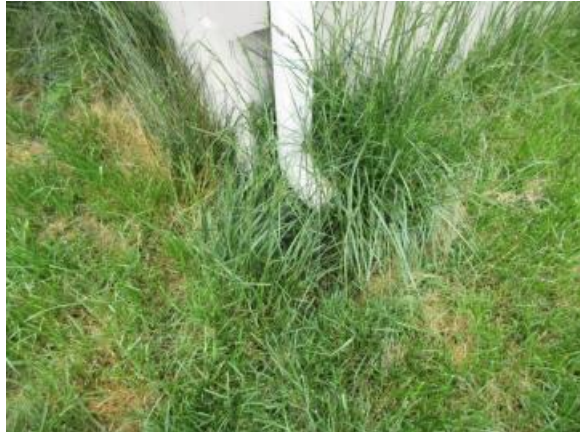
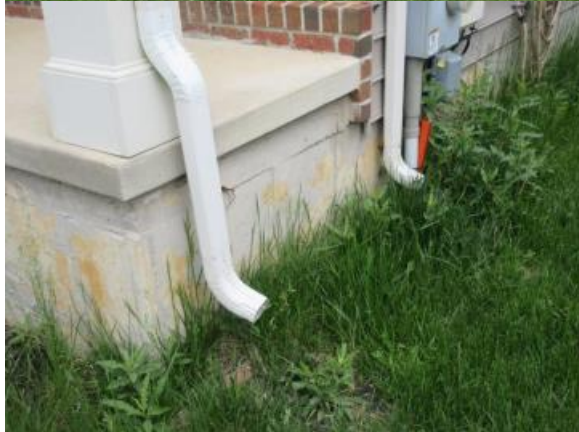
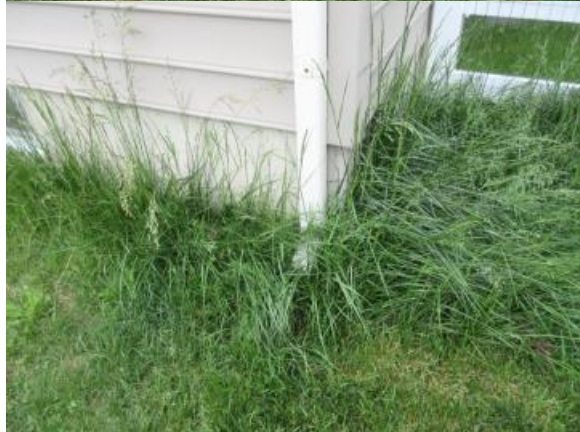
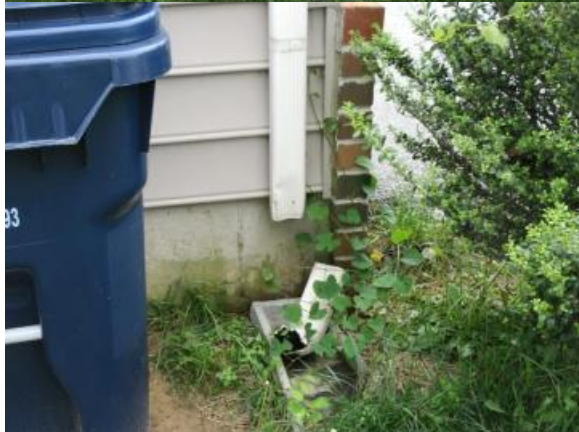
4.8 Type & Condition:                   ○   ⊙   ○   ○   ○   ○   OK RM RR SC NI  
Gutters and downspout materials are aluminum. Extend downspouts to route rainwater away from the building.

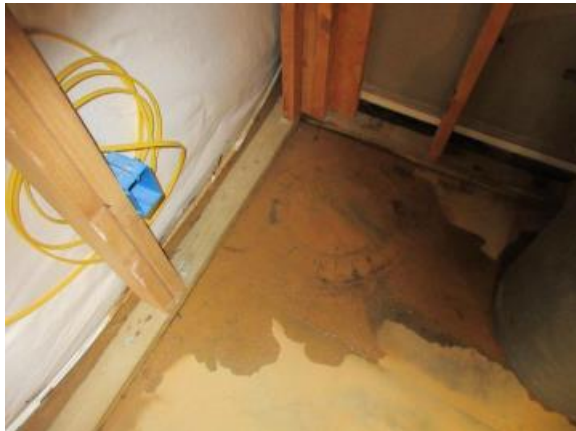
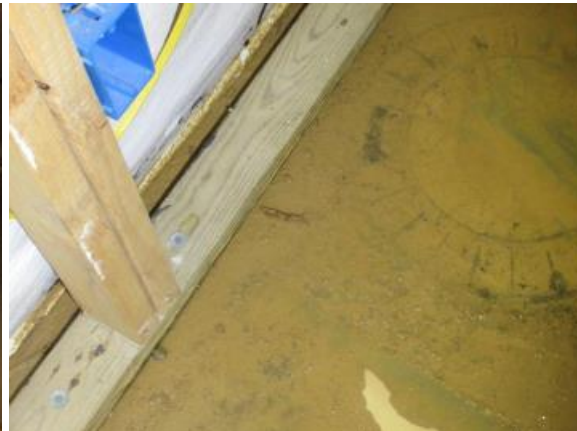
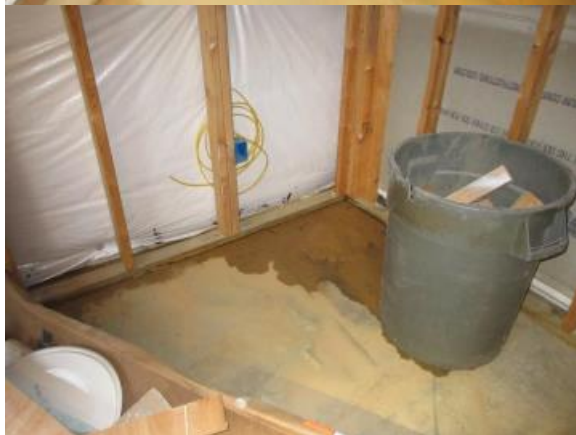
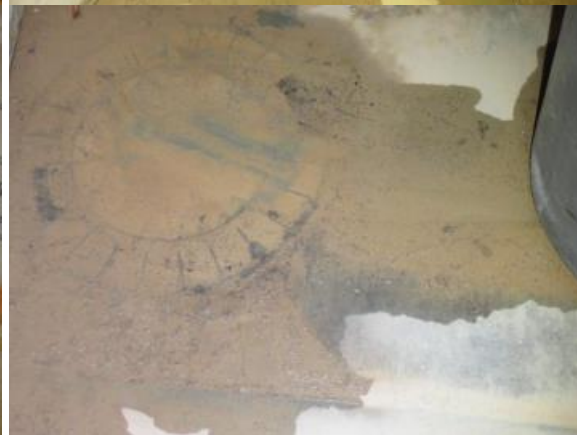
There's insulation on the walls around perimeter of the basement. There is an active leak coming from underneath the insulation and appears to be the exterior wall. It is unknown the source of the leak, but with evidence of dirt and water I am assuming that there is a crack in the wall. The insulation will have to be removed to verify where the leak is coming from. Recommend repair by license concrete contractor.

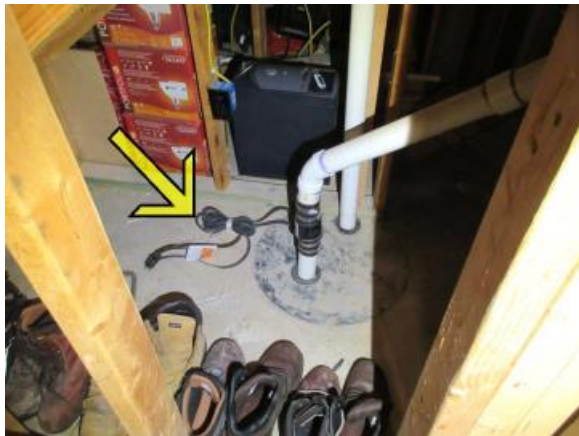
OK	RM	RR	SC	NI	
5.3 Floor:	<input checked="" type="radio"/>	<input type="radio"/>	<input type="radio"/>	<input type="radio"/>	<input type="radio"/>	Concrete, cracks were noted in the slab floor. Unless otherwise noted, the cracks appeared to be nothing more than curing cracks.
5.4 Windows:	<input checked="" type="radio"/>	<input type="radio"/>	<input type="radio"/>	<input type="radio"/>	<input type="radio"/>	There are basement level windows. The windows installed in the basement level appear to be egress accessible in case of an emergency.
5.5 Other Observations:	<input type="radio"/>	<input type="radio"/>	<input checked="" type="radio"/>	<input type="radio"/>	<input type="radio"/>	There is a sewage pump located in the basement, the sewage pump was not connected to an electrical circuit recommend having a sewage pump connected to verify proper operation.

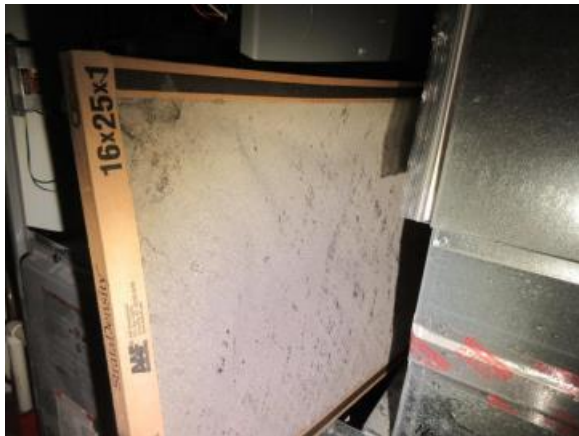
The filter is in need of cleaning or replacement. Replacing or cleaning filters every 30 to 45 days is recommended.

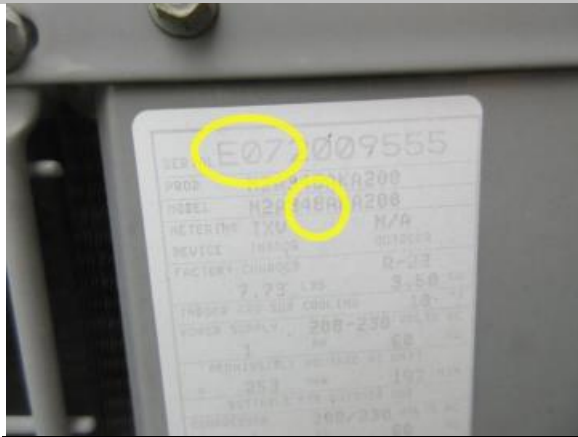
2 F Cooling not adequate.

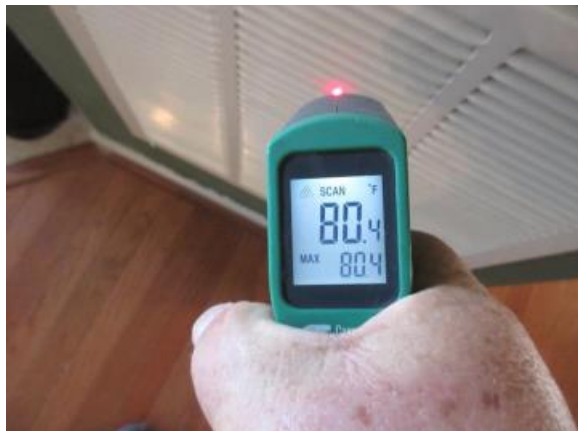
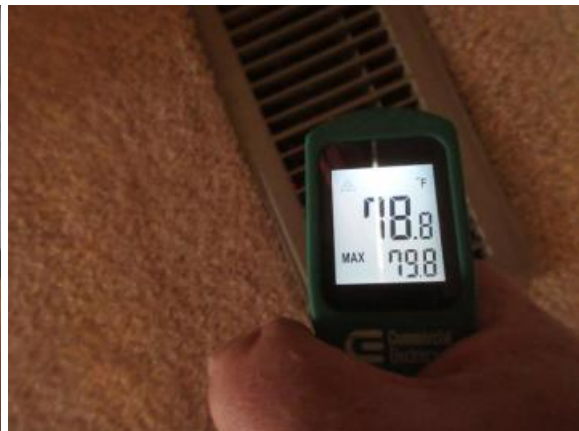
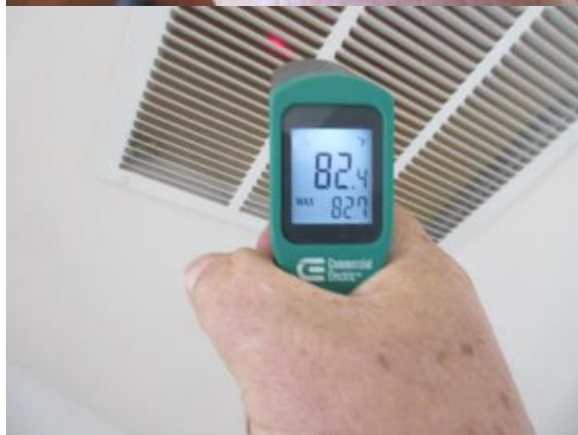
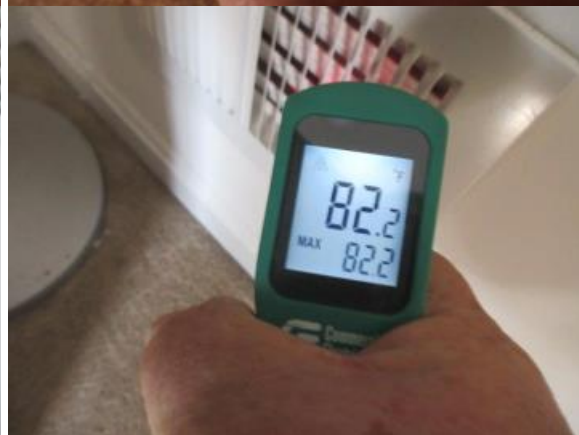
System condition is not working properly. Temperature drop should be within 15-20 degrees. 1st Floor temperature drop is 2 degrees after running for over 1 hour. 2nd Floor temperature drop is 0 degrees. Recommend repair by a licensed HVAC contractor.

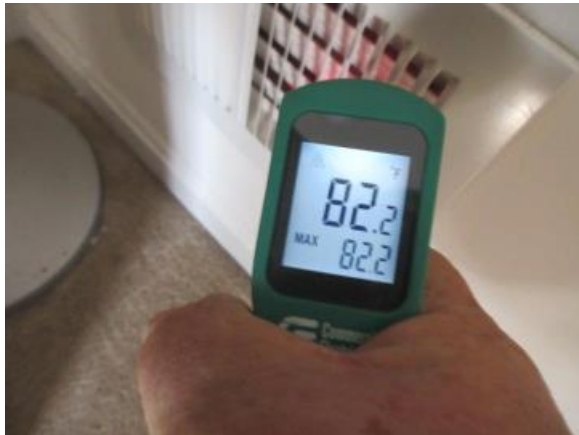
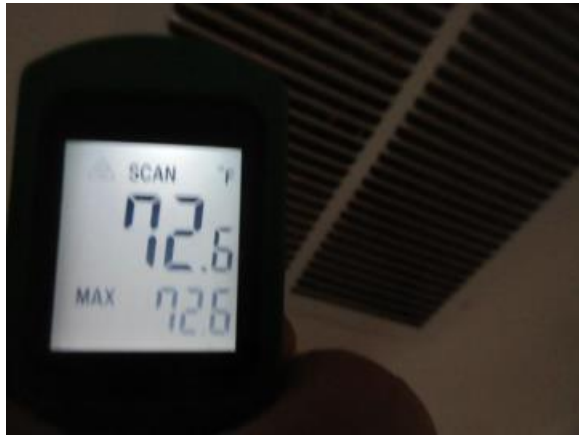
6.22 System Condition:  OK  RM  RR  SC  NI  
 Excessive Cooling - Recommend repair by a licensed HVAC contractor.

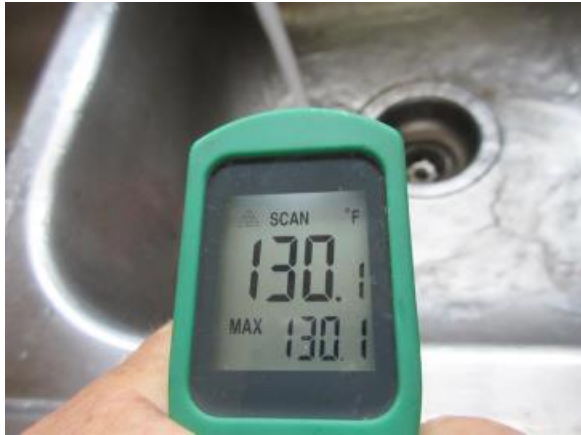
7.12 Condition:	<input checked="" type="radio"/>	<input type="radio"/>	<input type="radio"/>	<input type="radio"/>	<input type="radio"/>	Appears serviceable.
7.13 Condition: Temperature	<input type="radio"/>	<input type="radio"/>	<input checked="" type="radio"/>	<input type="radio"/>	<input type="radio"/>	Temperature is 130 degrees, anything over 120 can cause burns and scalding. I recommend temperature be turned down.

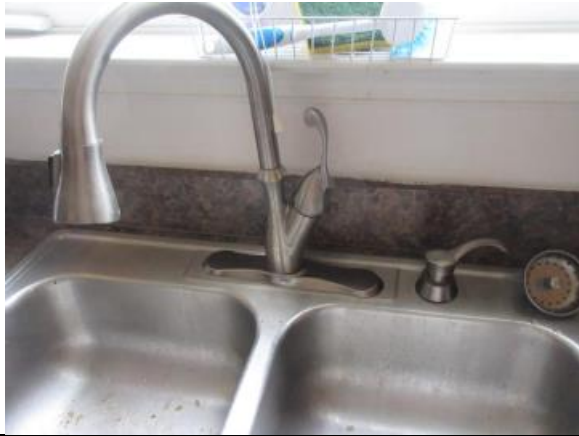
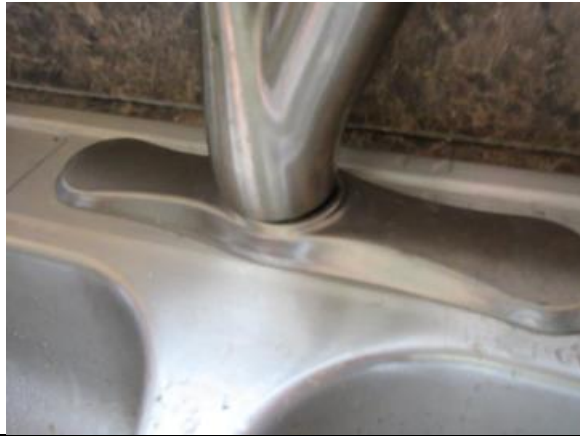
The main fixture is loose and will need Tightening or replacement. Recommend repair by a licensed plumbing contractor.

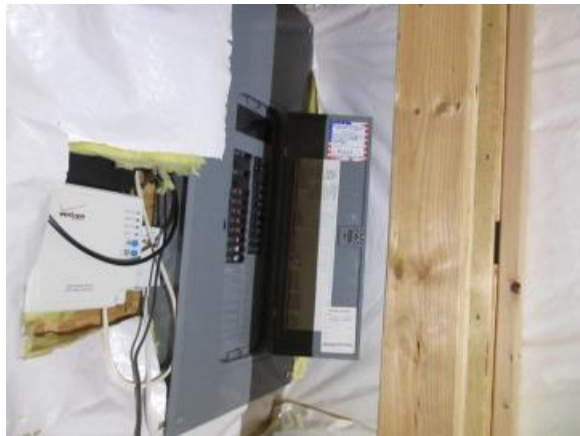
Basement, There should be three feet of clearance in front of the panel. There is a wall that has been installed directly in front of the electric panel. This wall is not finished, but when it is finished it will not have the 3 feet of clearance. I recommend rearranging the wall to be able to have three feet of space before it is finished.

8.3 Main Panel Location:	<input type="radio"/>	<input checked="" type="radio"/>	<input type="radio"/>	<input type="radio"/>	<input type="radio"/>	Basement. There should be three feet of clearance in front of the panel. There is a wall that has been installed directly in front of the electric panel. This wall is not finished, but when it is finished it will not have the 3 feet of clearance. Recommend rearranging the wall to be able to have three feet of space before it is finished.
--------------------------	-----------------------	----------------------------------	-----------------------	-----------------------	-----------------------	---

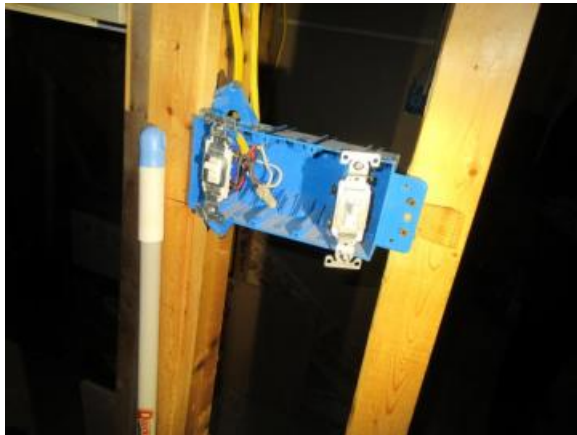
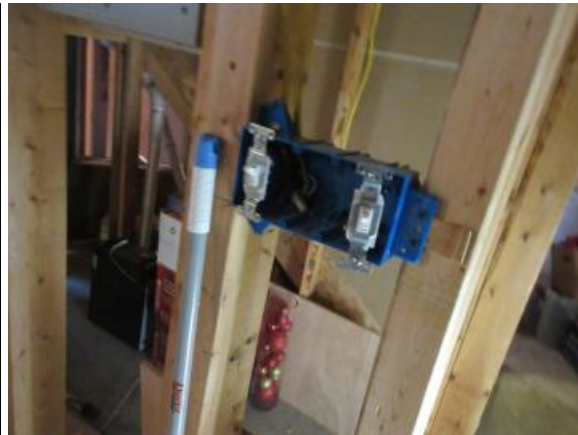
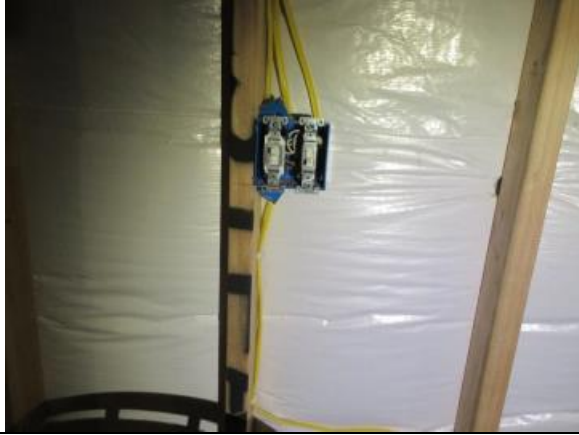
The basement is starting to be renovated for a finished basement, it is unknown if a permit has been pulled for this renovation. There are numerous electrical switches that do not have covers on them, and have exposed wiring. It is unknown if the exposed wiring is connected to a live circuit. Recommend repair by a licensed electrical contractor.

8.8 General:	⊙	○	○	○	○	Switches appear serviceable except for those that are noted in the basement area.
8.9 Basement:		○	○	⊙	○	The basement is starting to be renovated for a finished basement, it is unknown if a permit has been pulled for this renovation. There are numerous electrical switches that do not have covers on them, and there is exposed wiring. It is unknown if the exposed wiring is connected to a live circuit. Recommend repair by a licensed electrical contractor. Note: Pictures are just a small representation of the defects, Contractor should review entire basement for defects.

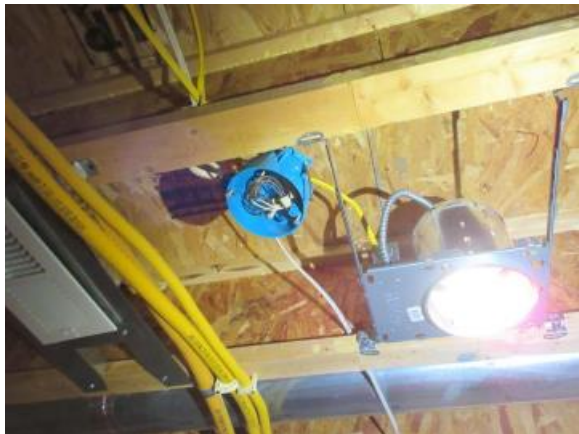
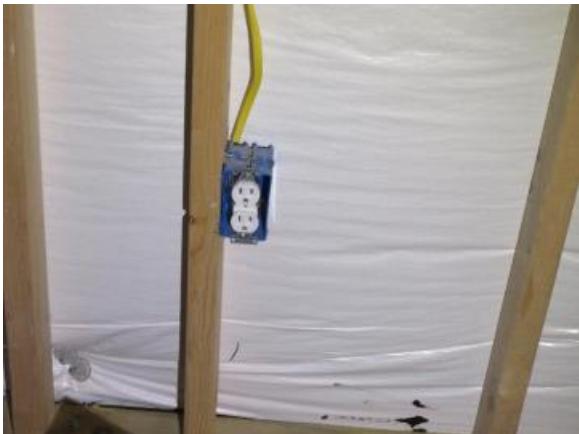
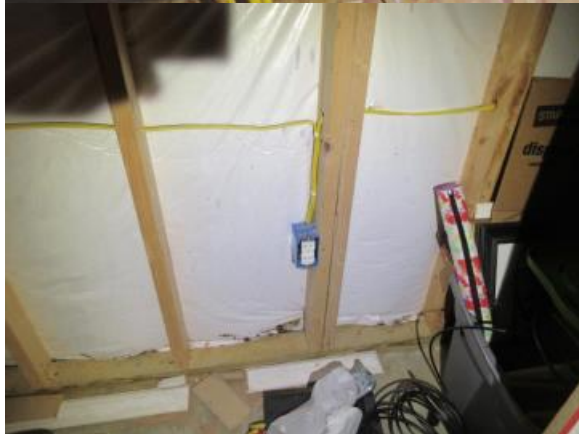
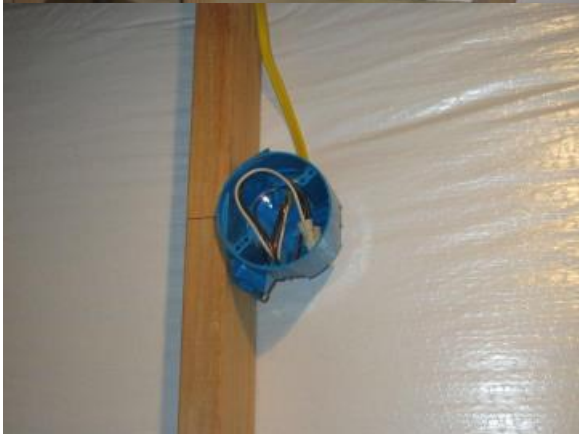
⊙	○	OK	RM	RR	SC	NI	
8.10 General:	⊙	○	○	○	○			A representative sampling of outlets was tested. As a whole, outlets throughout the house are in serviceable condition. Outlets appear serviceable except for those that are noted in the basement area.
8.11 Exterior Walls:	⊙	○	○	○	○			Outlets are satisfactory.
8.12 Basement:	○	○	○	○	○			The basement is being renovated but there are numerous electrical outlets that do not have covers and open junction boxes which create a safety issue. I recommend repair by a licensed electrical contractor. Note: Pictures are just a small representation of the defects, Contractor should review entire basement for defects.

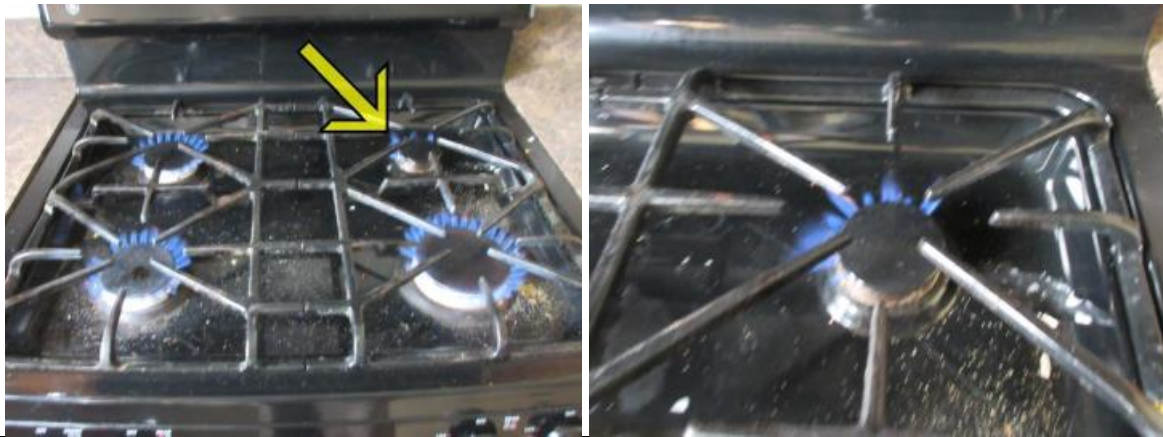
<input type="radio"/>	<input checked="" type="radio"/>	<input type="radio"/>	<input type="radio"/>	<input type="radio"/>	<input type="radio"/>	
			OK	RM	RR	SC	NI
9.1 Type & Condition:	<input type="radio"/>	<input checked="" type="radio"/>	<input type="radio"/>	<input type="radio"/>	<input type="radio"/>	<input type="radio"/>	The back burner did not light properly this may need a good cleaning.

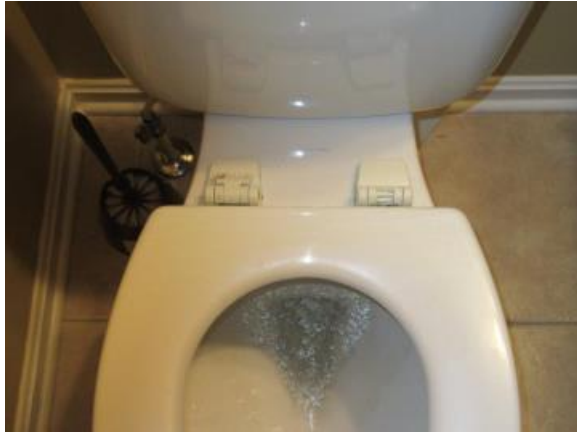
10.5 Master Bath:	⊙	○	○	○	○			General condition appears serviceable.
10.6 1st Floor 1/2 Bath:		○	⊙	○	○	○		Toilet seat is broken. A replacement will be needed.

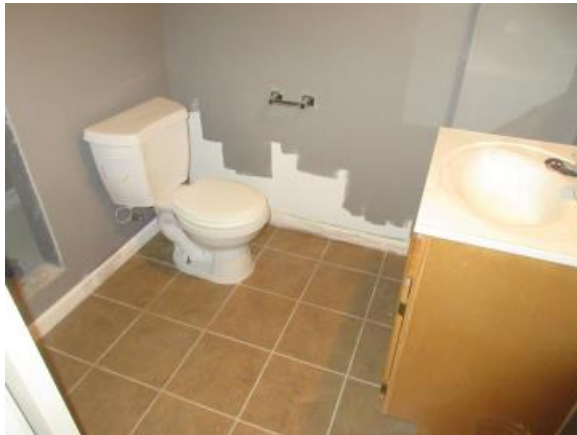
10.7 Bath Between Bedrooms:	⊙	○	○	○	○			General condition appears serviceable.
10.8 Other Bath: Basement	○	⊙	○	○	○			Not working, recommend toilet be hooked up to verify proper operation.

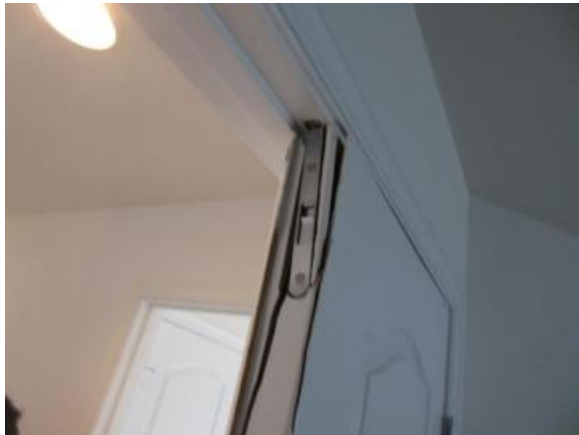
OK	RM	RR	SC	NI	
11.1 Overall Interior Door Condition:	⊙	○	○	○	○	○	General condition appears serviceable. Except that which is noted in the master bedroom.
11.2 Master Bedroom:		○	○	⊙	○	○	Damage viewed at the top of the door, Recommend repair or replacement by a licensed building contractor.

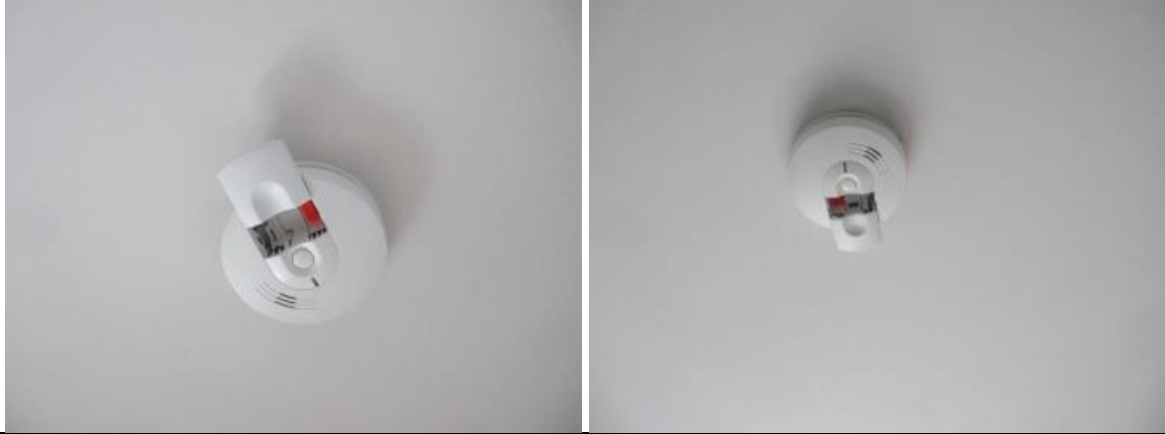
11.9 Comments:                   ○   ○   ⊙   ○   ○   OK RM RR SC NI  
Several smoke detectors did not have batteries in them, recommend reinstalling batteries to verify proper operation of smoke detectors.
