Derby Consulting LLC

Home Inspection Report

Inspected on Mon, Sep 26 2016 at 8:45 AM

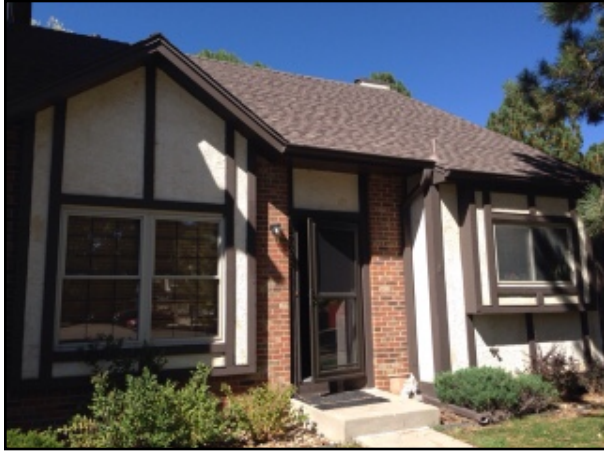
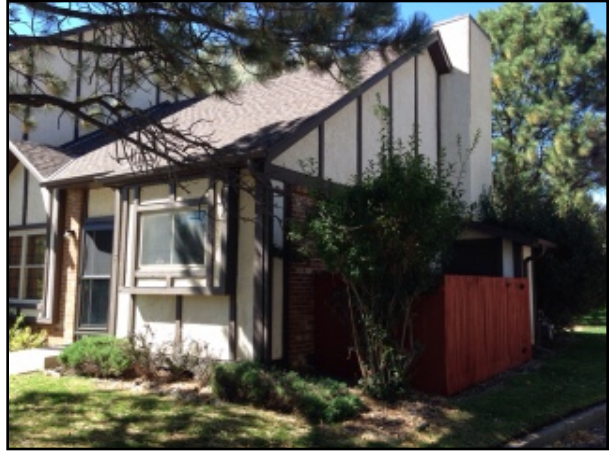
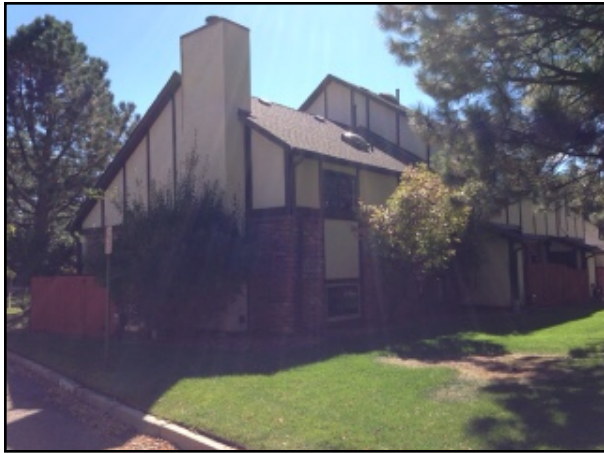
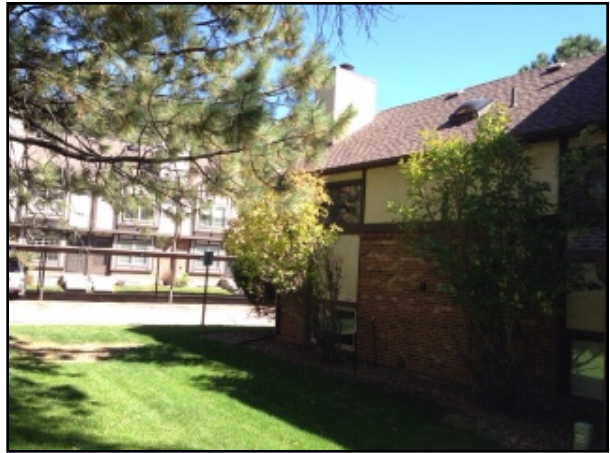
The HOA appears to have an effective maintenance schedule for buildings and grounds.

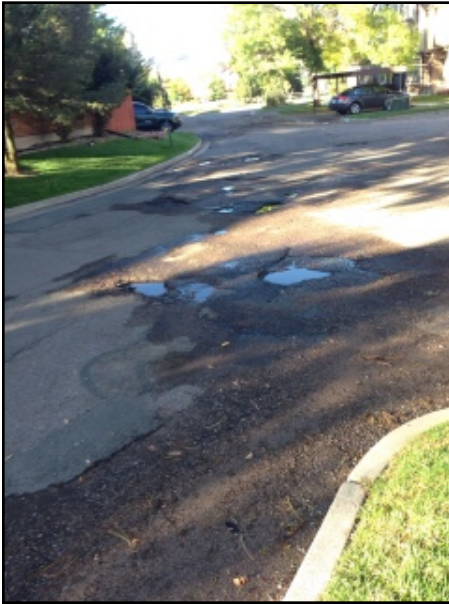
Figure 3-1

While the grounds and buildings are effectively maintained, the asphalt through out the community is at or past its effective life. Strongly recommend buyer contact the HOA to determine future plans for asphalt replacement. Lack of an effective plan will likely diminish the future value of this home.

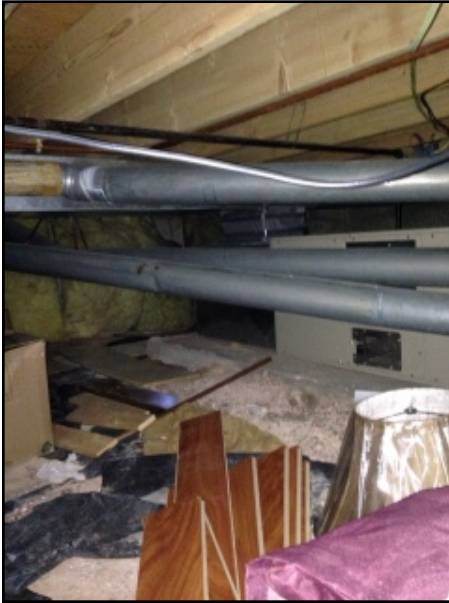
Figure 5-1

Comment 5:
General condition of crawlspace.

Comment 6:
Recommend installing vapor barrier.

Comment 8:
Recommend installing insulation around the rim board.

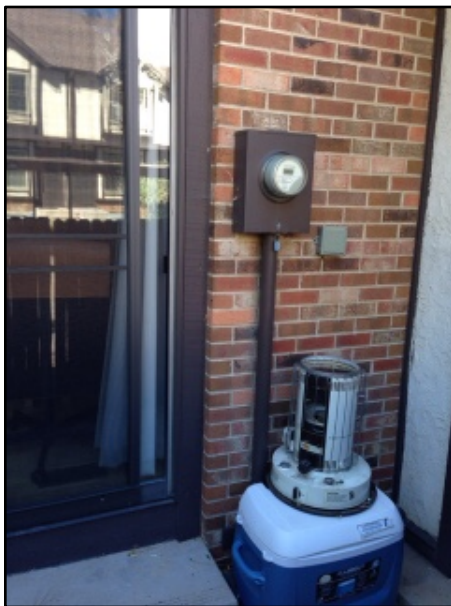
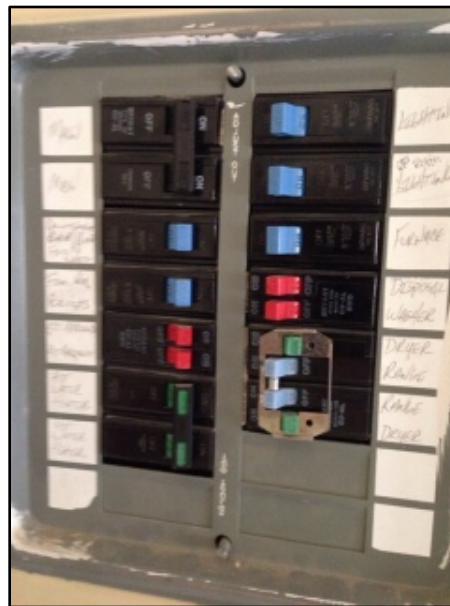
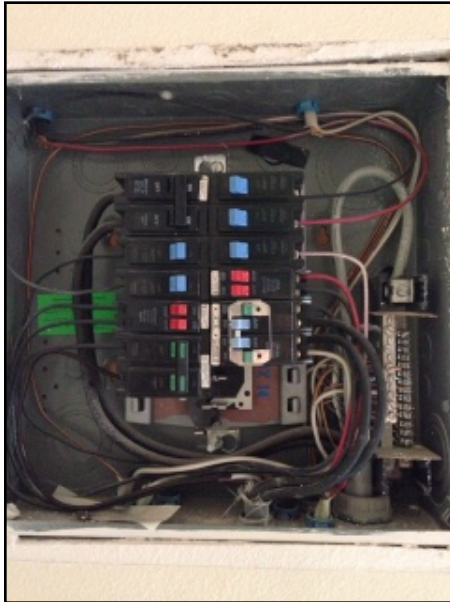
Panel was installed in 1984. Condition is good. Main service feeds are aluminum cable.

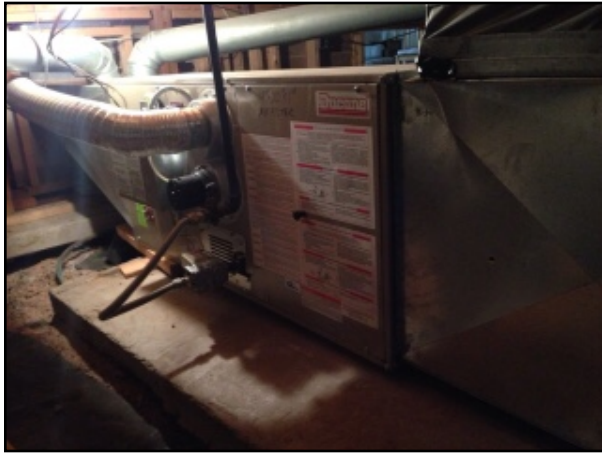
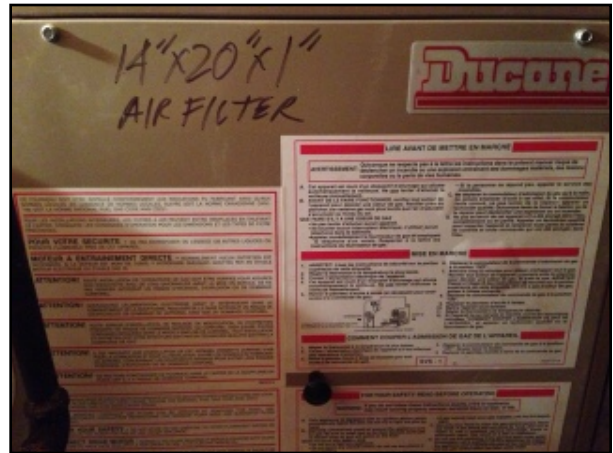
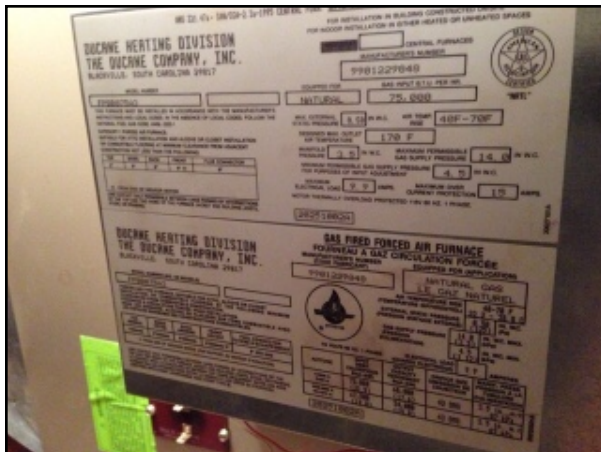
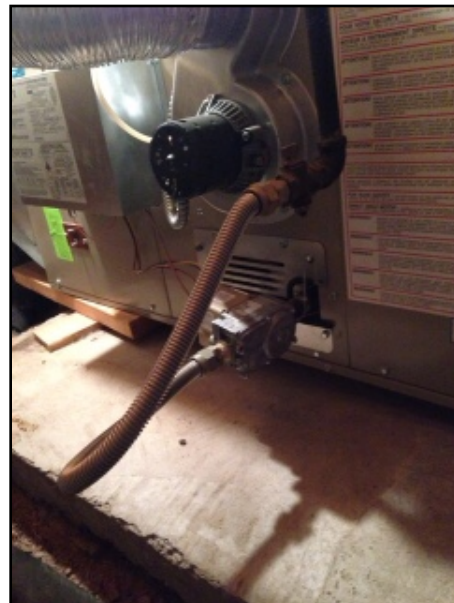
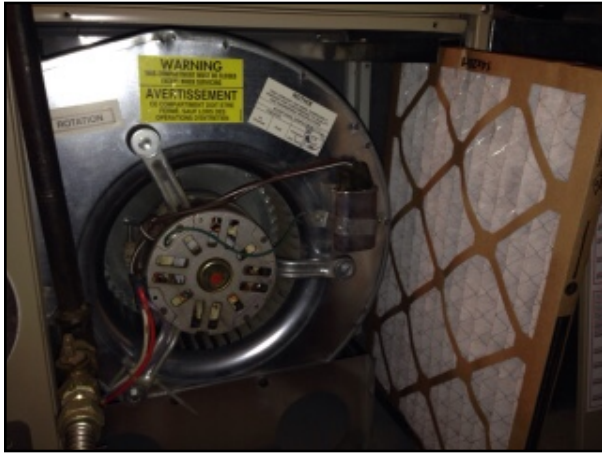
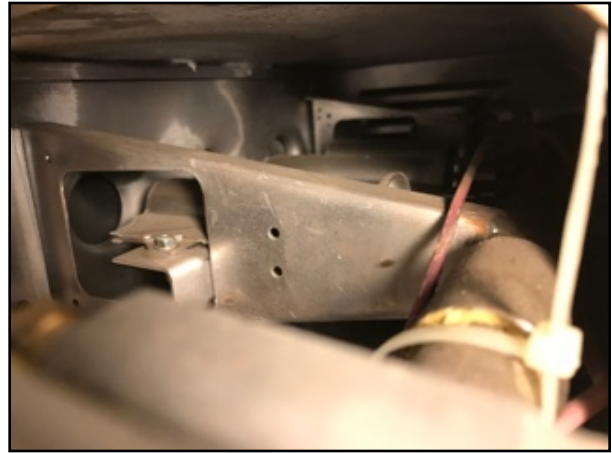
Comment 10:
Conventional furnace: typical life expectancy 20 to 25 years.

Comment 11:
Installed 1999.

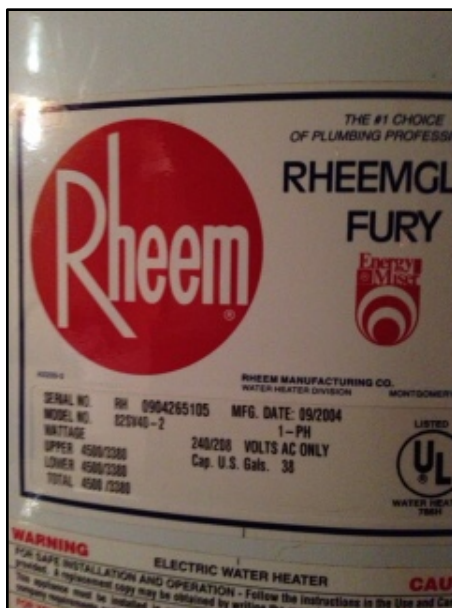
Figure 12-1

Water heater installed in 2004. Average life expectancy of a hot water heater is 12 to 15 years. This water heater appears to be in good condition.

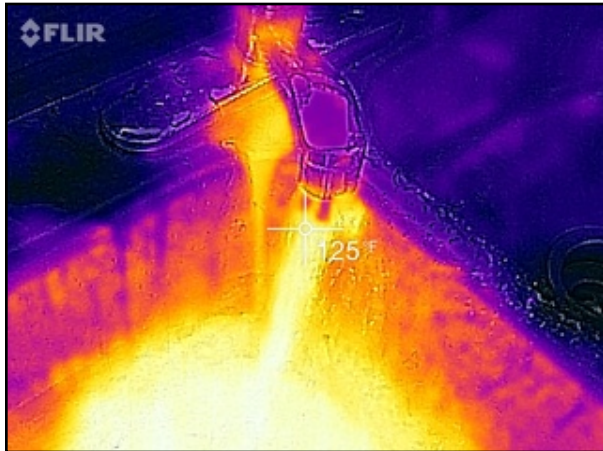
Figure 13-1

Water temperature kitchen sink is 125°. This is 5° above the recommended maximum temperature level. This presents a potential scald danger.

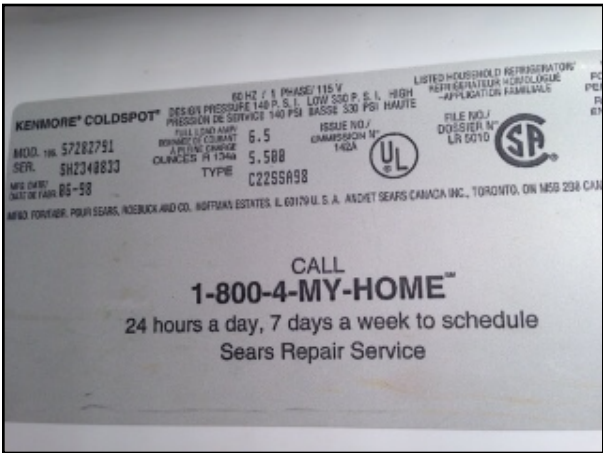
Figure 14-1

Comment 14:
Refrigerator: Kenmore Coldspot: fair condition.

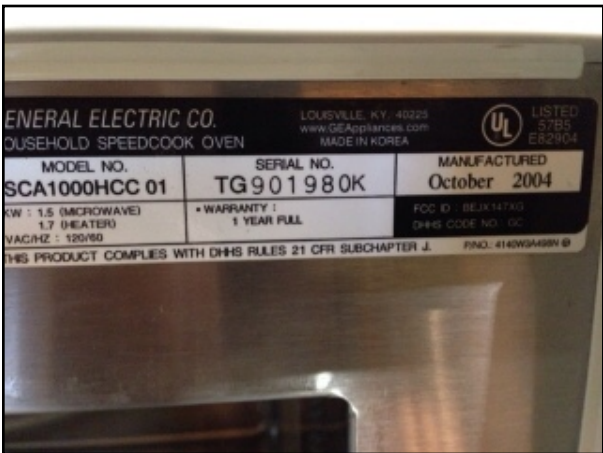
Figure 15-1

Comment 15:
Microwave: GE profile: manufactured 2004: expected life 8 to 10 years. Condition fair.

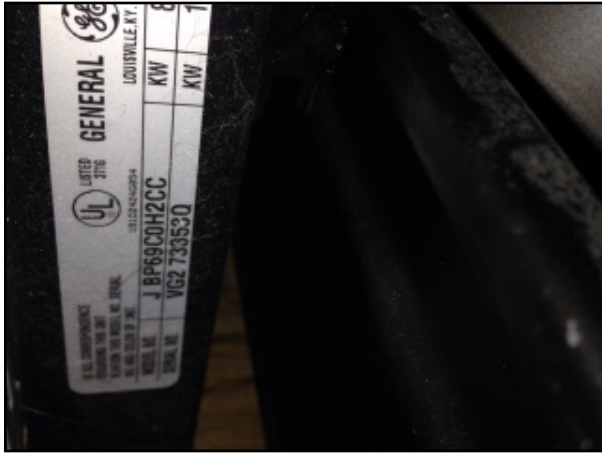
Figure 16-1

Range: manufactured November 2004. Condition good.

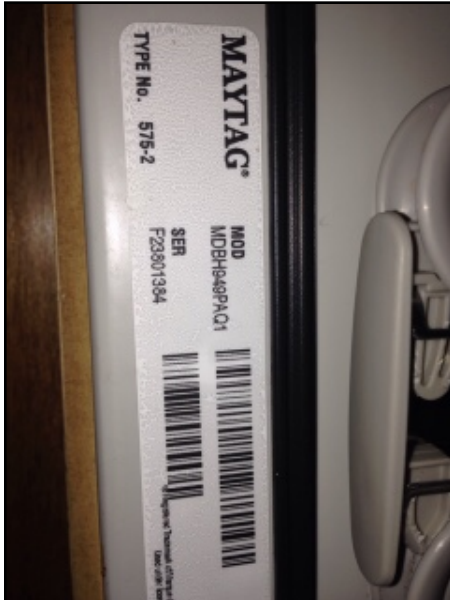
Figure 17-1

Dishwasher: Maytag: manufactured 1992. Condition fair.

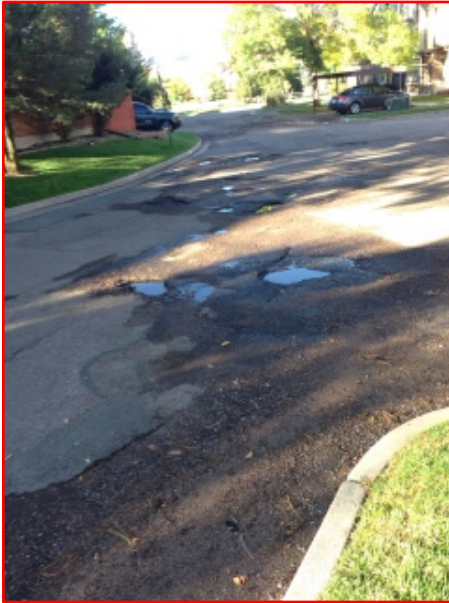
Figure 3-1

1) While the grounds and buildings are effectively maintained, the asphalt through out the community is at or past its effective life. Strongly recommend buyer contact the HOA to determine future plans for asphalt replacement. Lack of an effective plan will likely diminish the future value of this home.

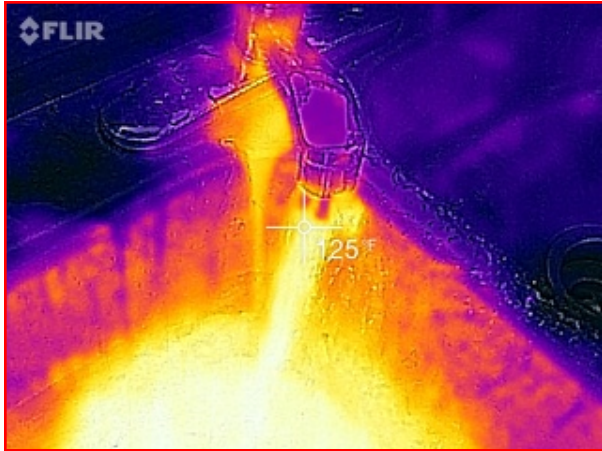
Figure 13-1

4) Water temperature kitchen sink is 125°. This is 5° above the recommended maximum temperature level. This presents a potential scald danger.

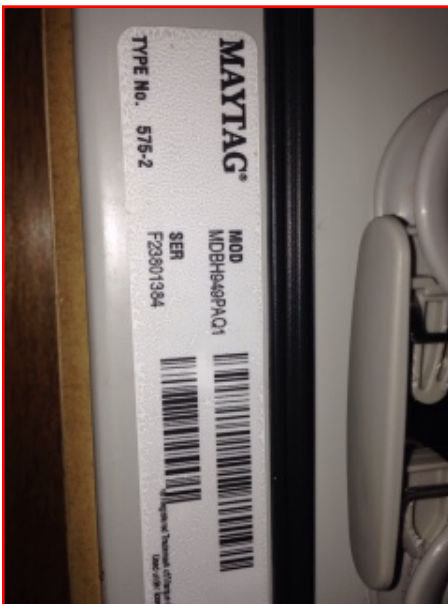
Figure 17-1

5) Dishwasher: Maytag: manufactured 1992. Condition fair.
