A BRAND NEW SHOWER?

By Ted Kellogg Style Tile 936.344 TILE (8453)

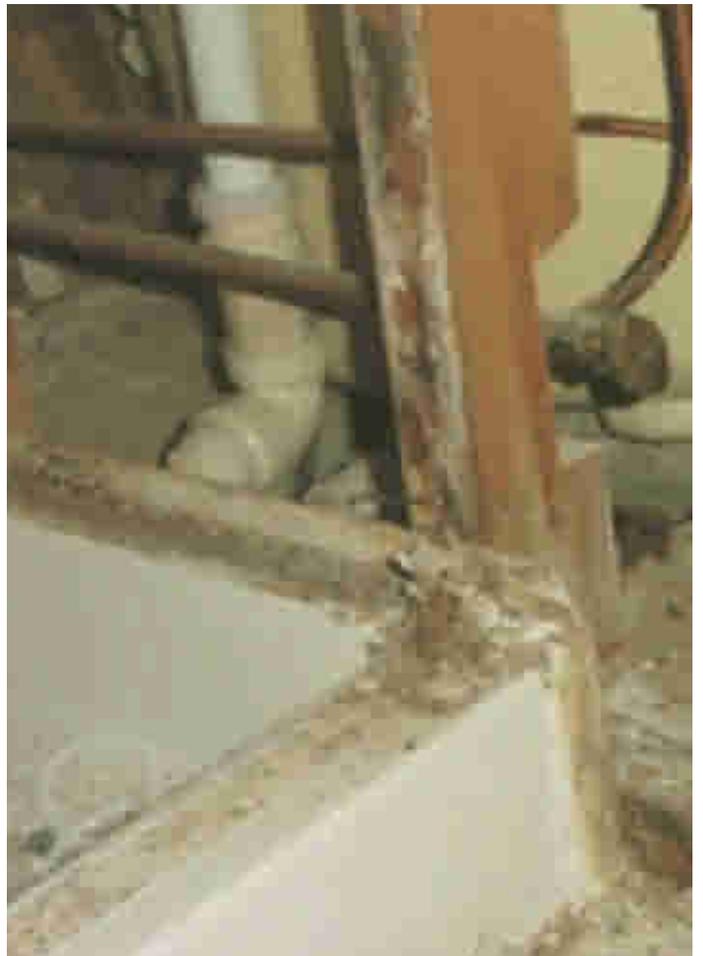
(Above) Further removal of the greenrock exposes the deterioration of the wood framing members. This damage is caused from getting wet and drying out repeatedly.

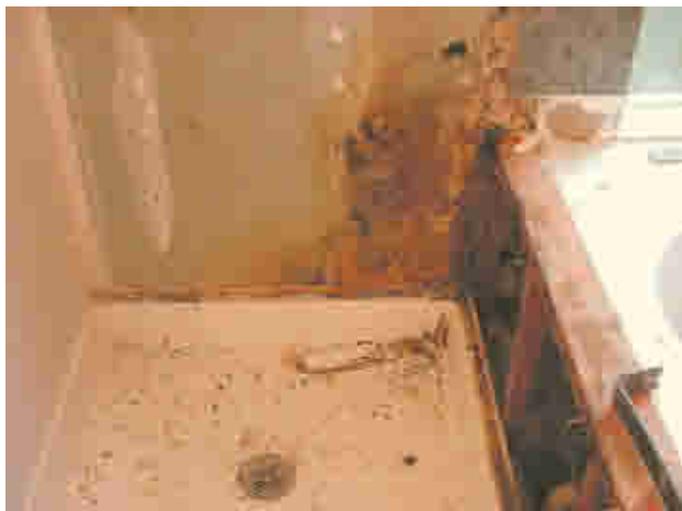
.....far from it! This shower area is approximately six years old, and as evidenced by the picture has been well taken care of, and certainly qualifies as “good housekeeping.”

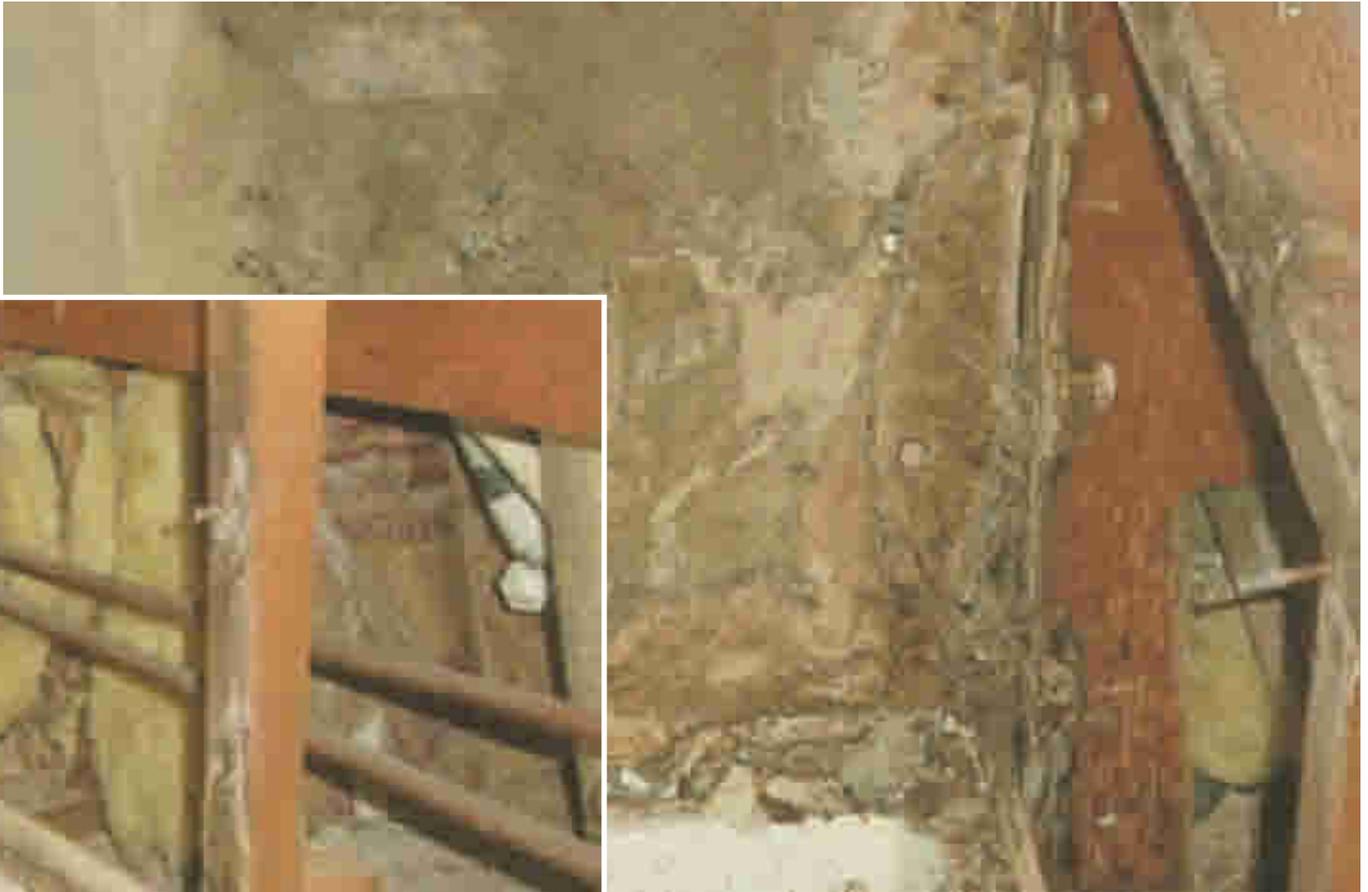
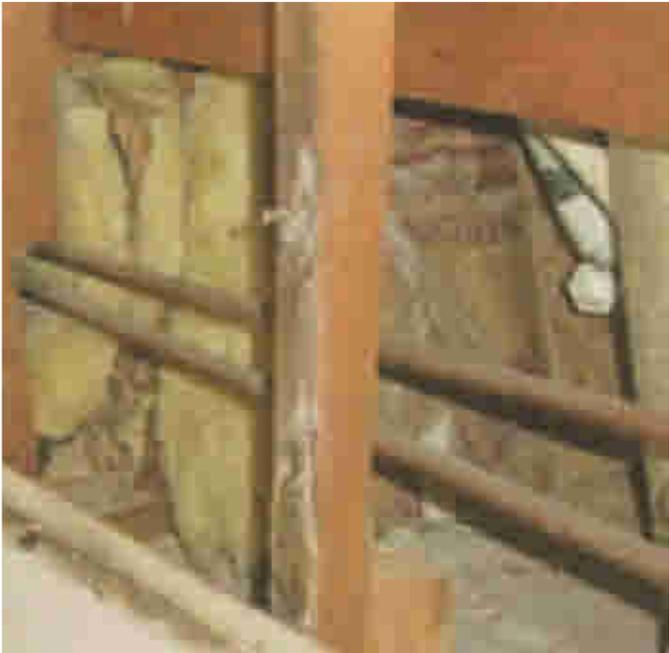
(Above) Additional close up damage mold can cause when moisture wicks behind the shower walls.
