Thermography Inspection

SAMPLE REPORT

Thermal inspection conducted on all functioning plant equipment prior to seasonal start-up. Recommend second report be conducted during plant operation.

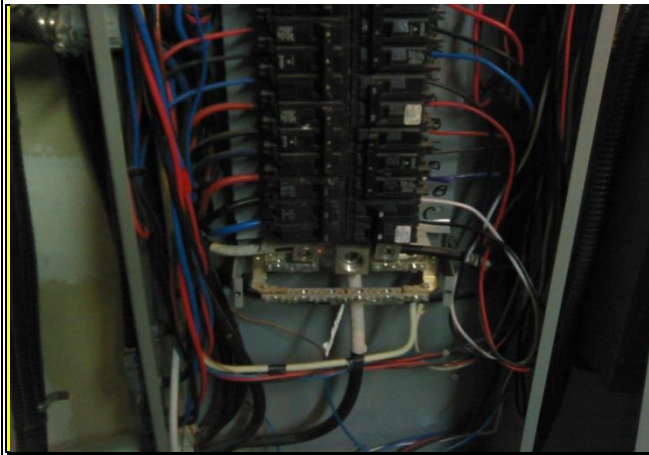
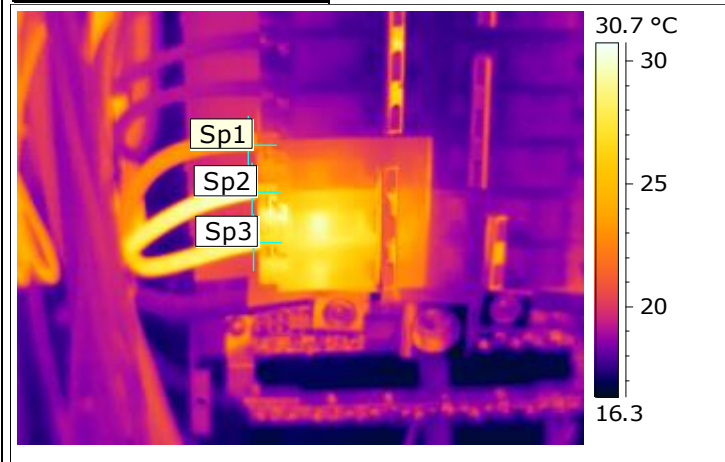
Location	West Electrical Room
Panel	Refrigeration Panel A - MOD116
Equipment	Condensing Unit #9
L1	28
L2	46
L3	46
Fault	Current Imbalance

Sp1 Temperature	23.4 °C
Sp2 Temperature	30.3 °C
Sp3 Temperature	29.4 °C

This circuit breaker supplies condensing unit nine. Compressor current draw imbalance found during inspection. Follow up required.

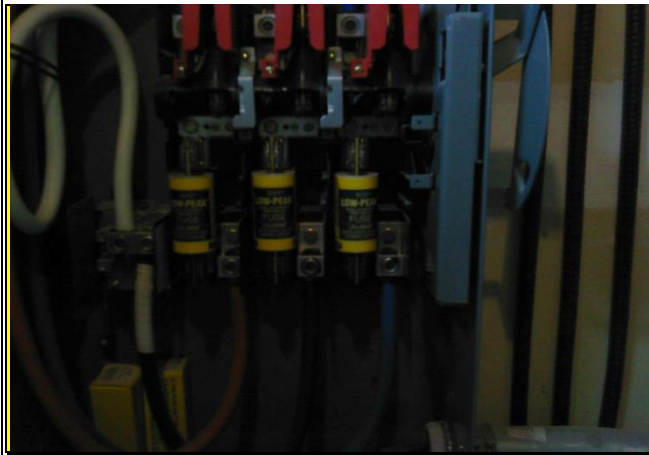
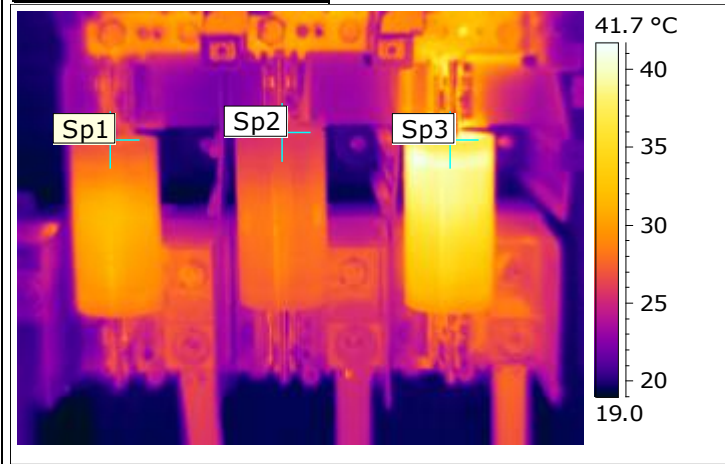
Location	West Electrical Room
Panel	10HP Water Pump Motor Panel Disconnect - MOD121
Equipment	10HP Pump Panel
L1	60
L2	60
L3	65
Fault	High temperature difference

Sp1 Temperature	26.8 °C
Sp2 Temperature	24.7 °C
Sp3 Temperature	36.8 °C

Identified a temperature discrepancy found on main line power supplying motor pump panel. Load analysis to be included on pump panel report. Refer to page 14.

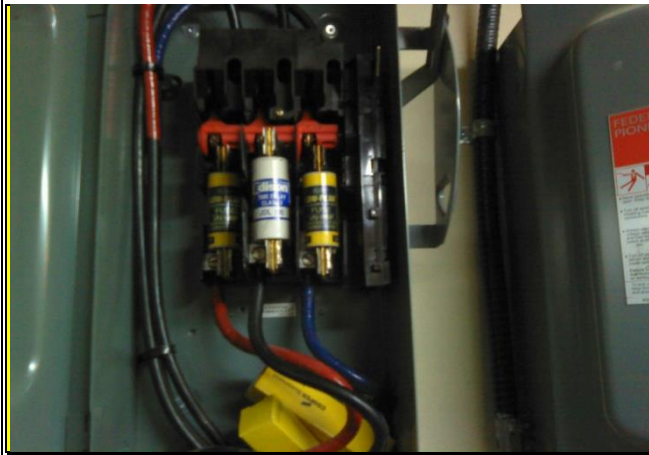
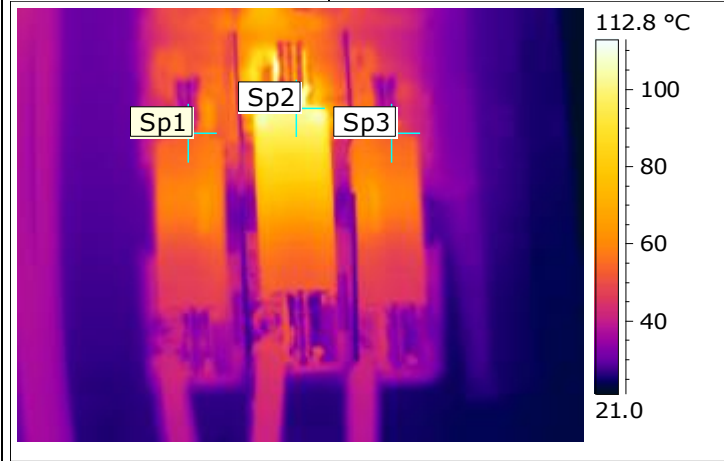
Location	West Electrical Room
Panel	Refrigeration Panel B Disconnect - MOD122
Equipment	Refrigeration Panel B
L1	64
L2	54
L3	76
Fault	Current Imbalance

Sp1 Temperature	47.0 °C
Sp2 Temperature	100.9 °C
Sp3 Temperature	53.1 °C

Current imbalance found. Follow up required to check panel loads and connections.

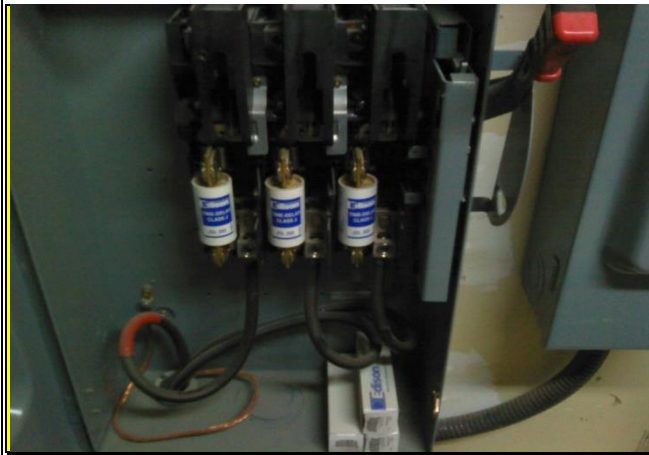
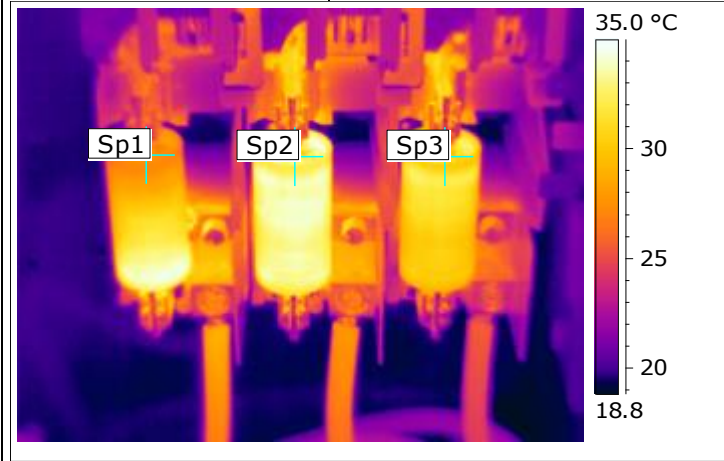
Location	West Electrical Room
Panel	Refrigeration Transformer Disconnect - MOD127
Equipment	Refrigeration Transformer
L1	57
L2	69
L3	62
Fault	Current Imbalance

Sp1 Temperature	27.5 °C
Sp2 Temperature	32.9 °C
Sp3 Temperature	31.4 °C

Current imbalance identified and follow up required to test loads.

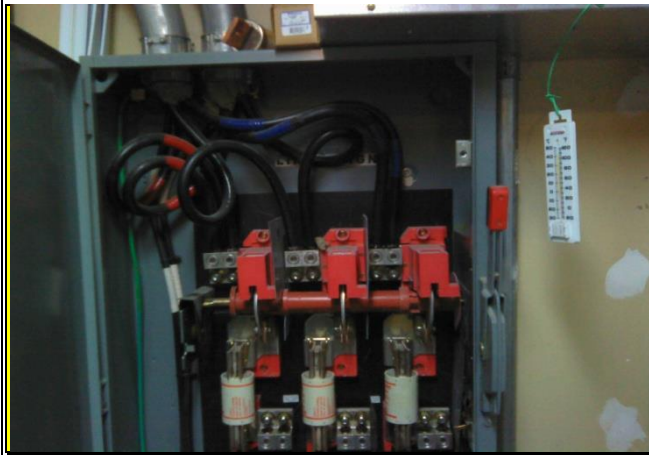
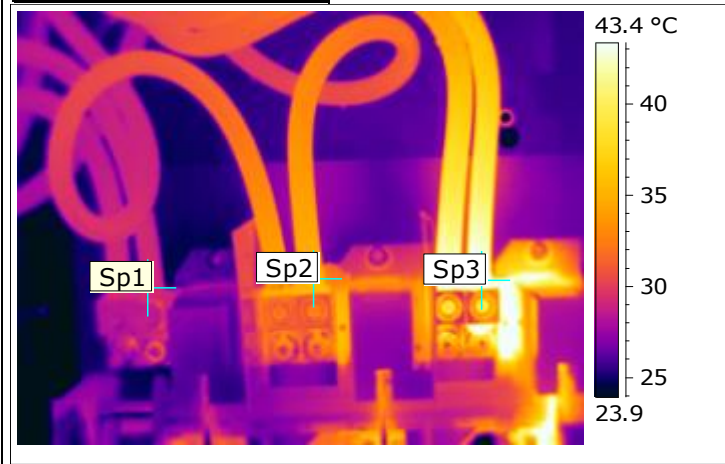
Location	West Electrical Room
Panel	Main Line Disconnect - MOD129
Equipment	Building
Fault	Loose electrical connection

Sp1 Temperature	29.2 °C
Sp2 Temperature	35.4 °C
Sp3 Temperature	44.2 °C

Loose electrical connection on L3 of main line disconnect supplying all electrical loads fed from West Electrical Room.

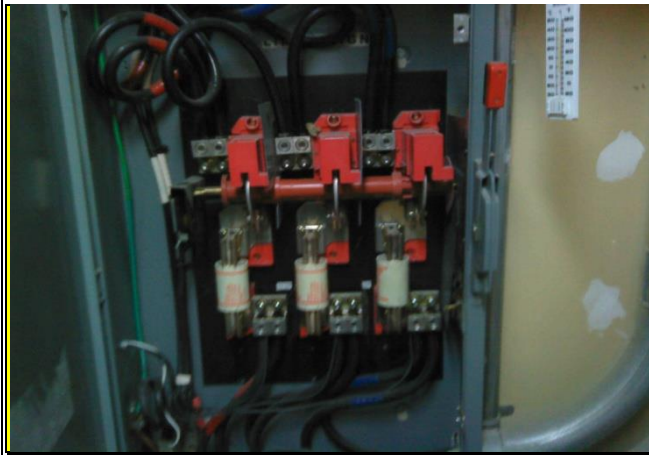
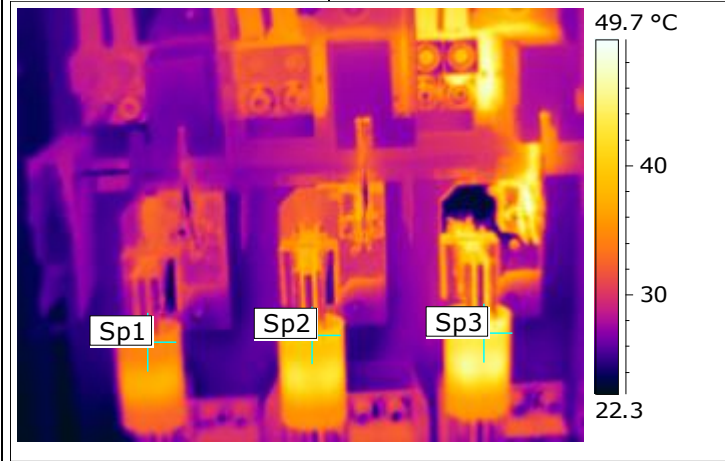
Location	West Electrical Room
Panel	Main Line Disconnect - MOD129
Equipment	Building
Fault	Loose electrical connection

Sp1 Temperature	34.6 °C
Sp2 Temperature	39.3 °C
Sp3 Temperature	43.9 °C

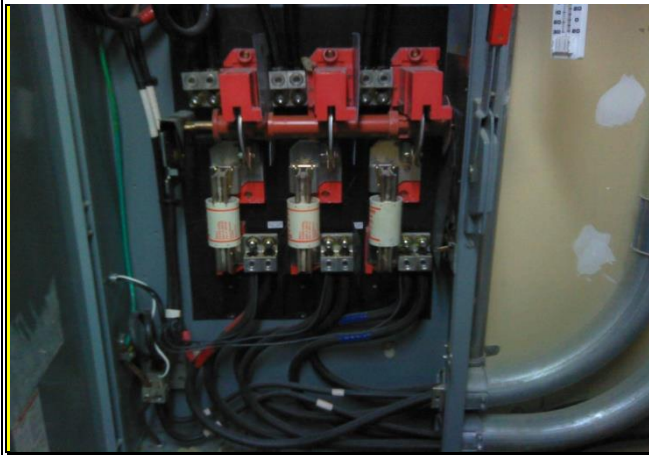
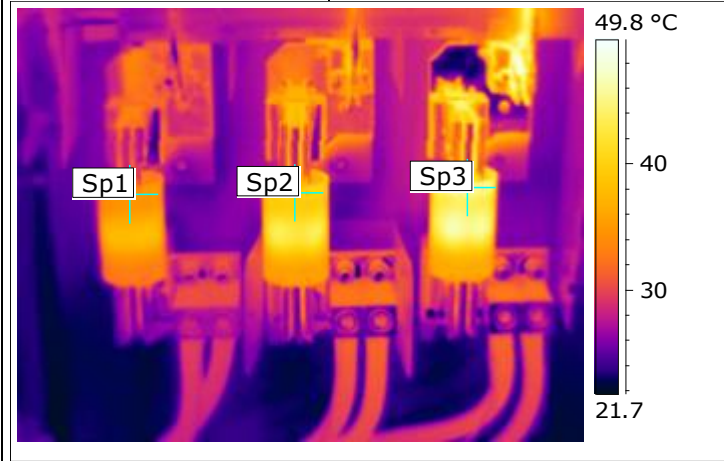
Location	West Electrical Room
Panel	Main Line Disconnect - MOD129
Equipment	Building
Fault	Loose electrical connection

Sp1 Temperature	35.1 °C
Sp2 Temperature	40.0 °C
Sp3 Temperature	45.5 °C

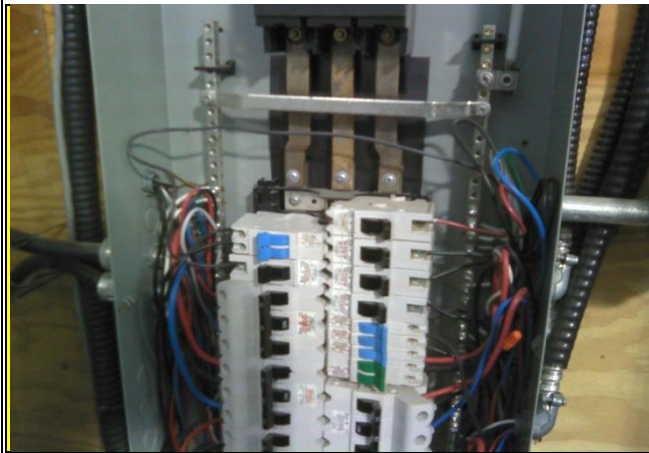
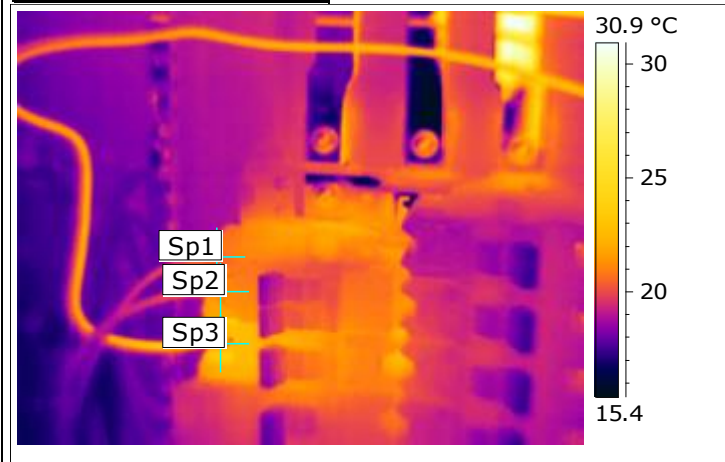
Location	East Cluster Buster Area
Panel	Mechanical Panel D - MOD145
Equipment	N/A
Fault	Loose electrical connection

Sp1 Temperature	20.3 °C
Sp2 Temperature	20.9 °C
Sp3 Temperature	23.3 °C

Loose electrical connection found on panel. Tightened by electrical contractor during time of inspection.

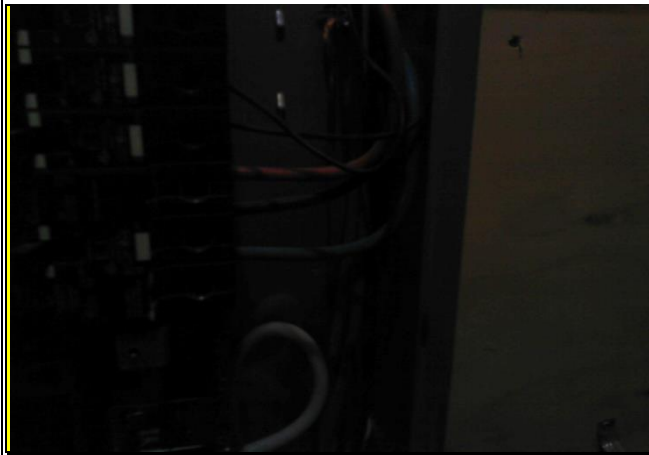
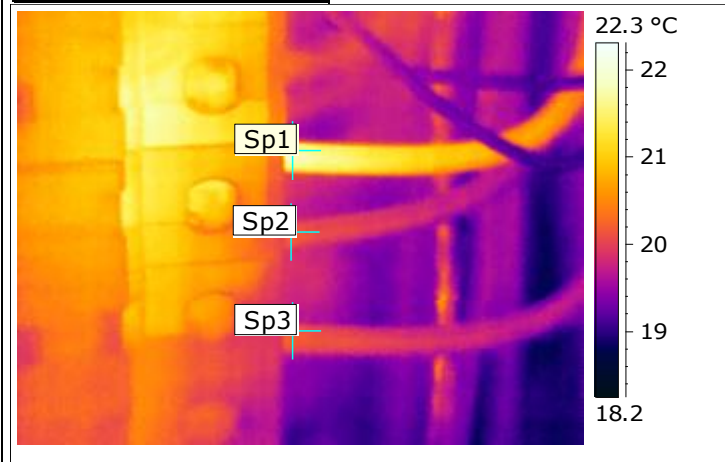
Location	Second Floor Electrical Room
Panel	Comms Room Panel 9 - MOD147
Equipment	N/A
Fault	Loose electrical connection

Sp1 Temperature	21.8 °C
Sp2 Temperature	20.2 °C
Sp3 Temperature	20.1 °C

Loose electrical connection found on panel. Tightened by electrical contractor during time of inspection.

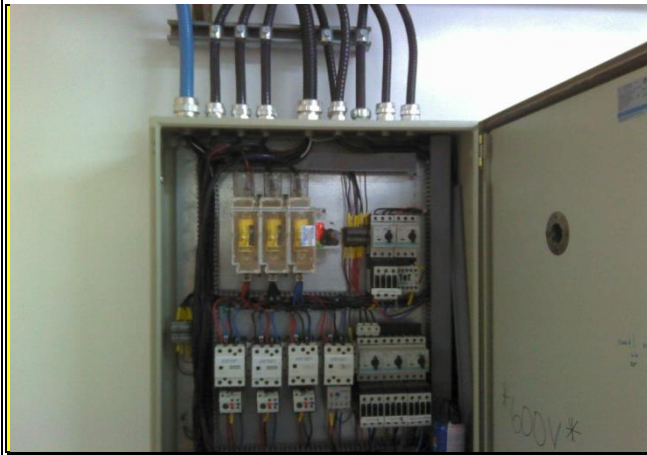
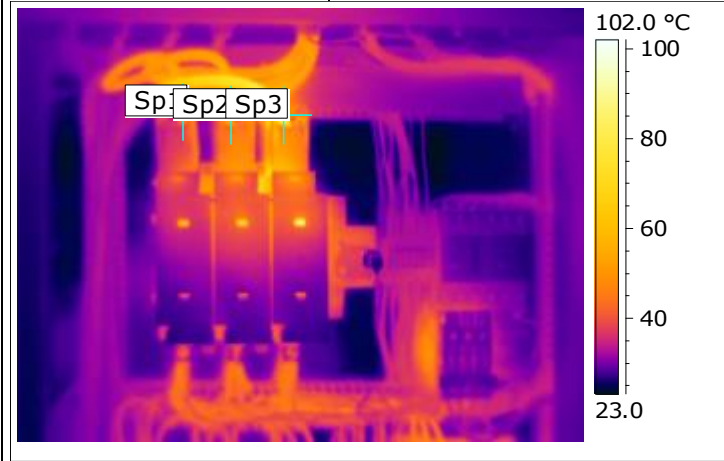
Location	Hydro Cooler Area
Panel	10 HP Water Pump Motor Controller - MOD154
Equipment	Hydro Cooler Chilled Water Circulating Pumps
Fault	Load Imbalance or Poor Connection

Sp1 Temperature	55.4 °C
Sp2 Temperature	58.3 °C
Sp3 Temperature	98.1 °C

Motor load imbalance or circuit connection fault. Follow up required.

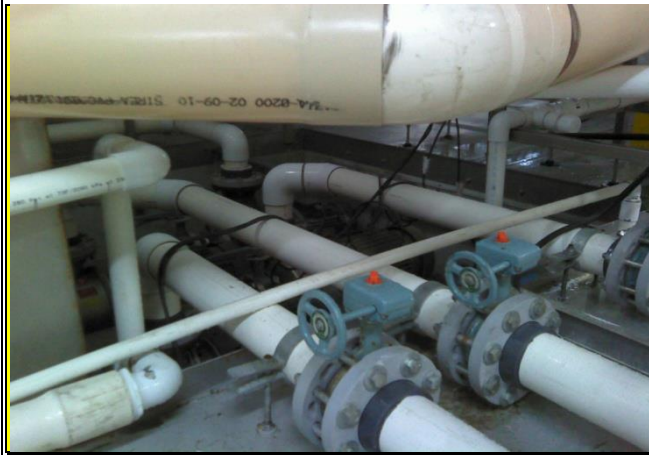
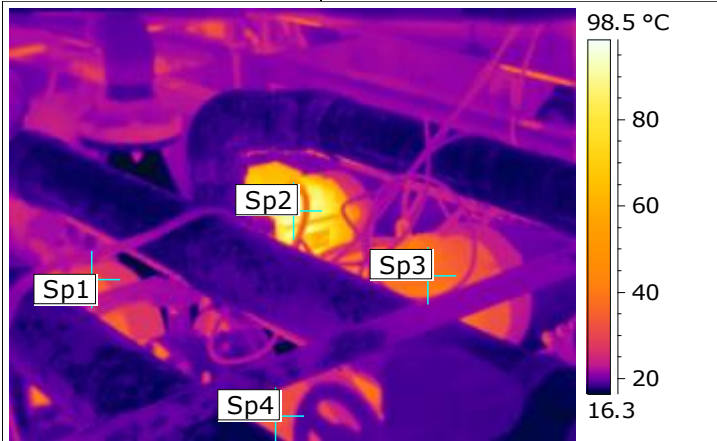
Location	Hydro Cooler Area
Equipment	Unitec Pump
Model	Bronzoni
Fault	High Temperature

Sp1 Temperature	34.8 °C
Sp2 Temperature	91.3 °C
Sp3 Temperature	37.9 °C
Sp4 Temperature	32.9 °C

Pump found to be operating above manufacturer temperature specifications. Follow up required.
