Location:

2730 Pinewood Dr.

Inspected On:

***A+* Detection Home Inspection, LLC**

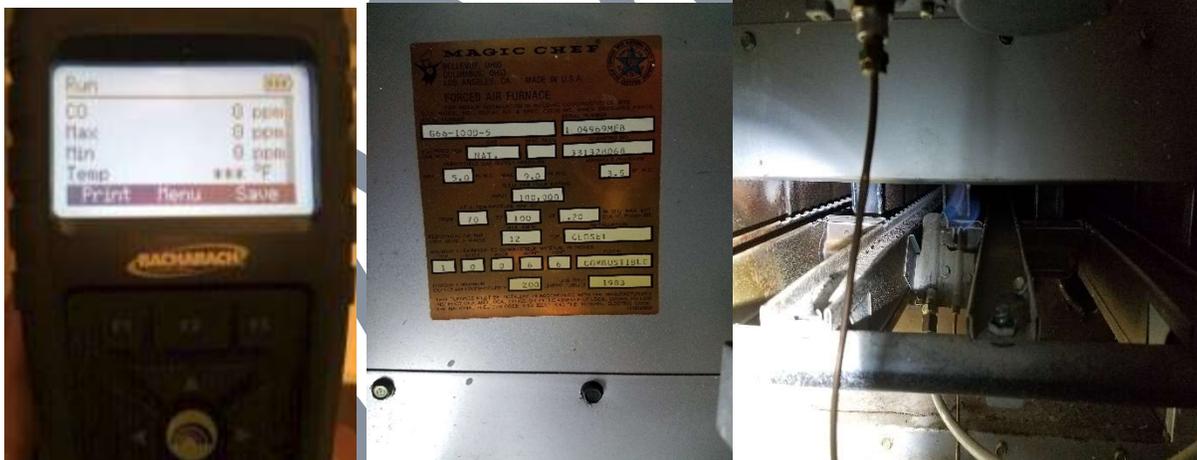
The burners were inspected and found to be clean and in good working order. No carbon monoxide was detected during the test of the gas forced air furnace.

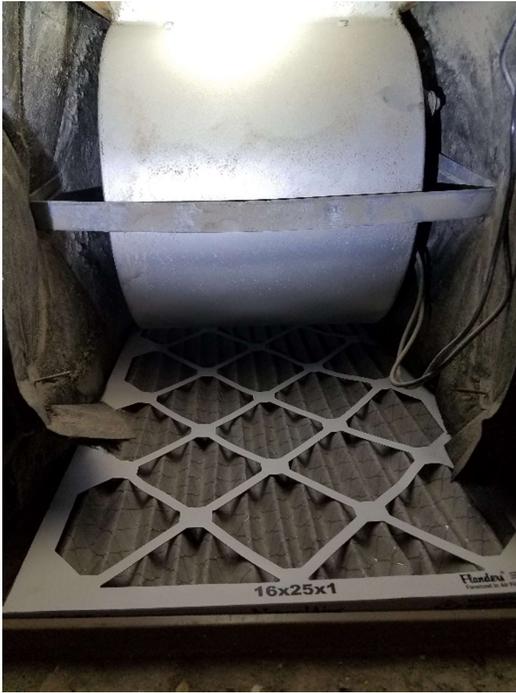
AIR FILTERS The air filter for the heating unit is a conventional, Disposable filter. 16x25x1

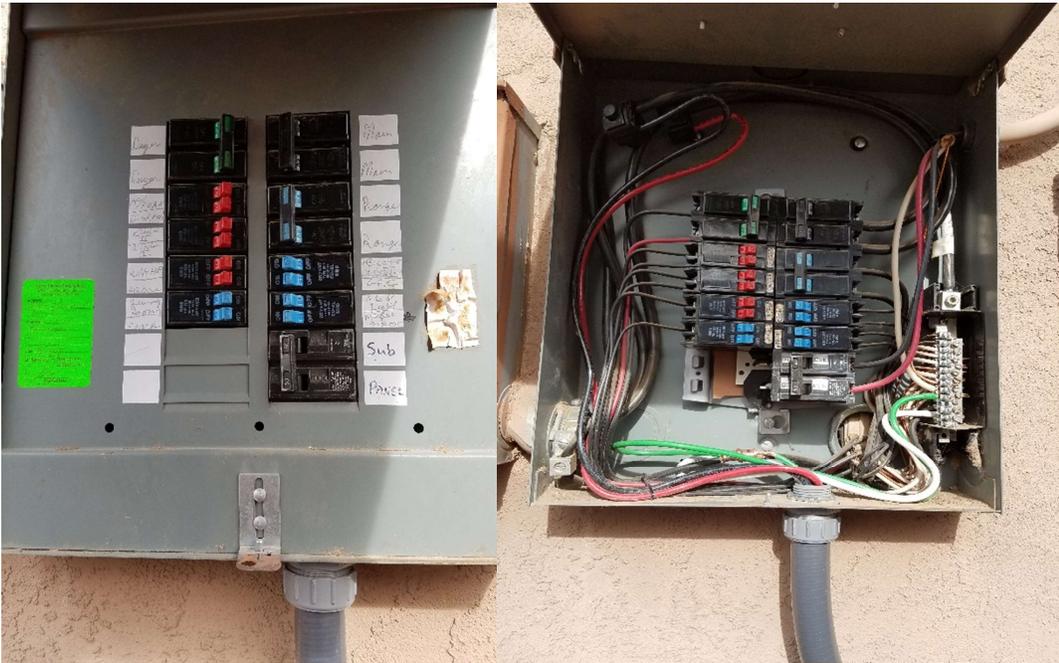
The main electrical service panel is outside on the left side of the building.

Appears to provide labeling.

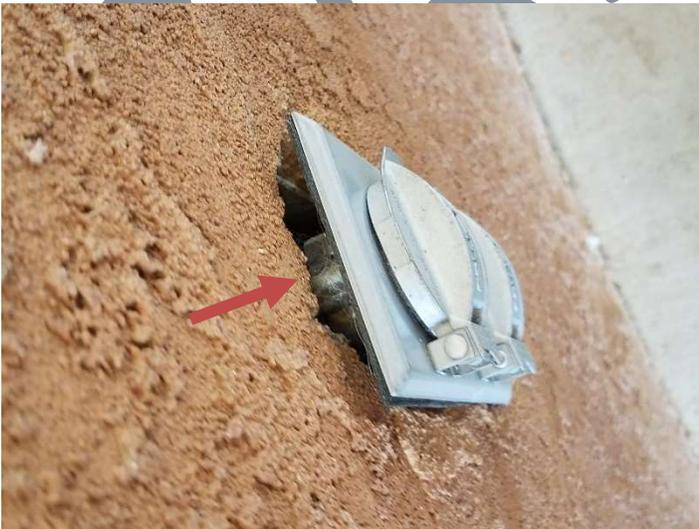
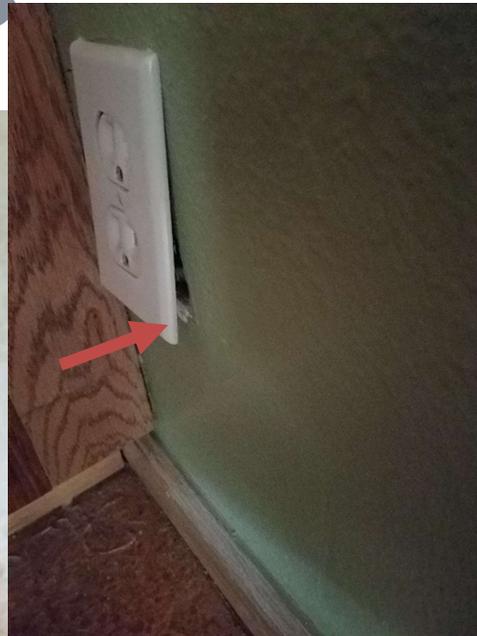
Two receptacles, one interior and one exterior, outlet boxes viewed to be dismantled protruding from wall.

Outdoor receptacle box near front entrance is protruding from wall and is recommend for an electrician to fix. Picture available in [Electical](#)

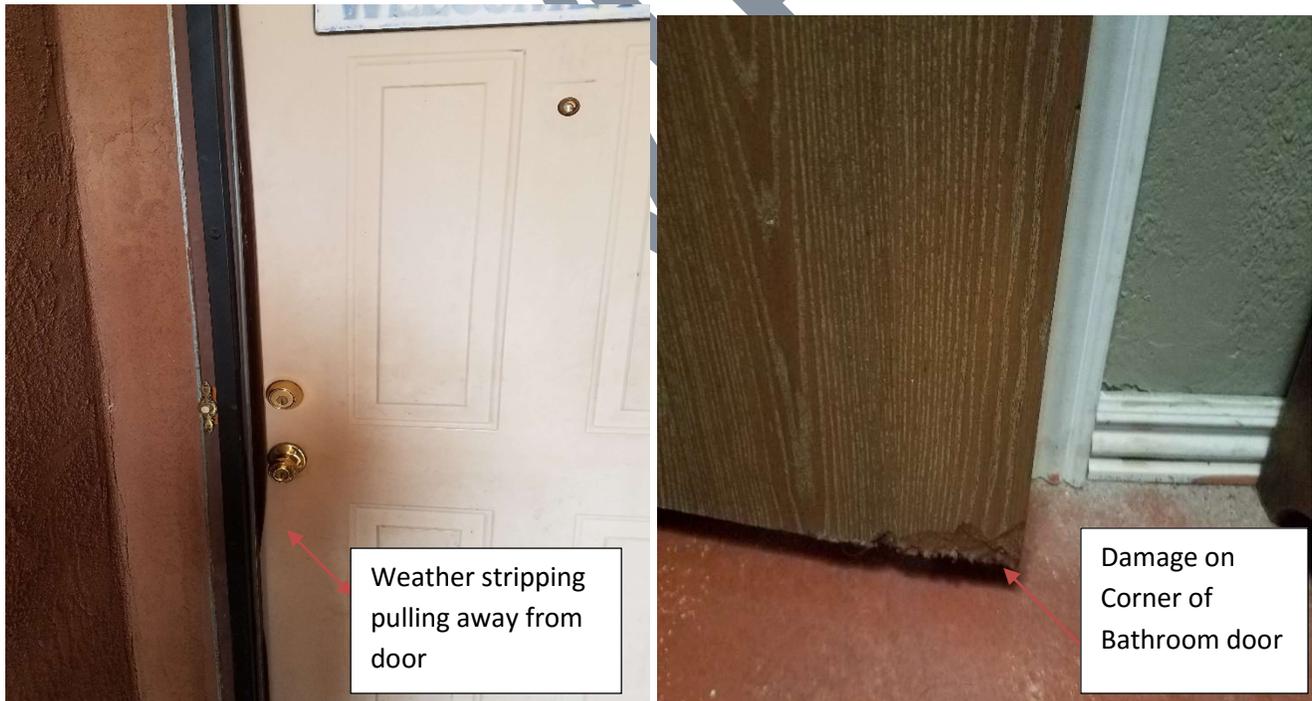
Front door weather stripping will need to be replaced.

Minor Damage on bottom corner of Bathroom door

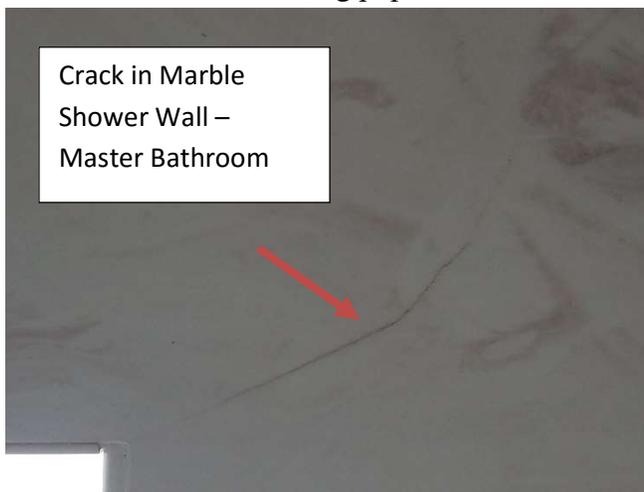
Cracks appear to be in the master shower walls. Filling appears to be applied.

One Master sink is missing pop-drain

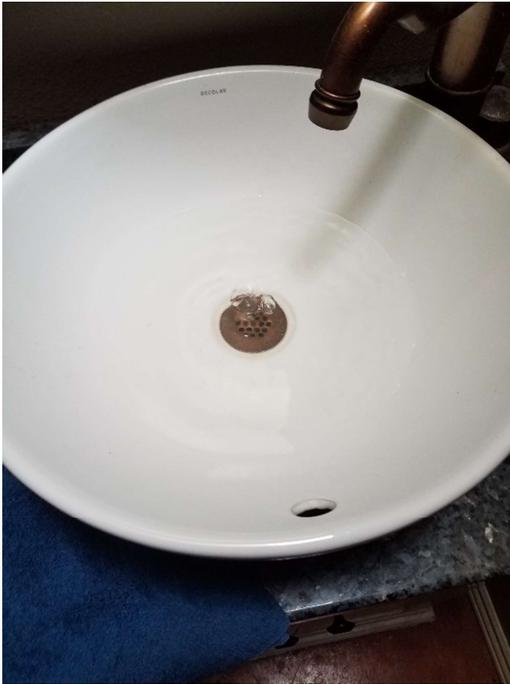
Sink functional drainage is not sufficient, More than likely an interference in the drainage.

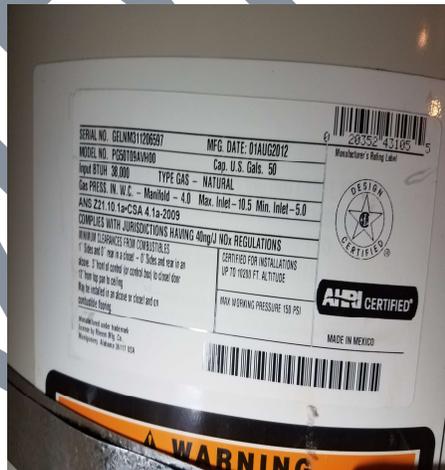
Earthquake strap regulations are in place

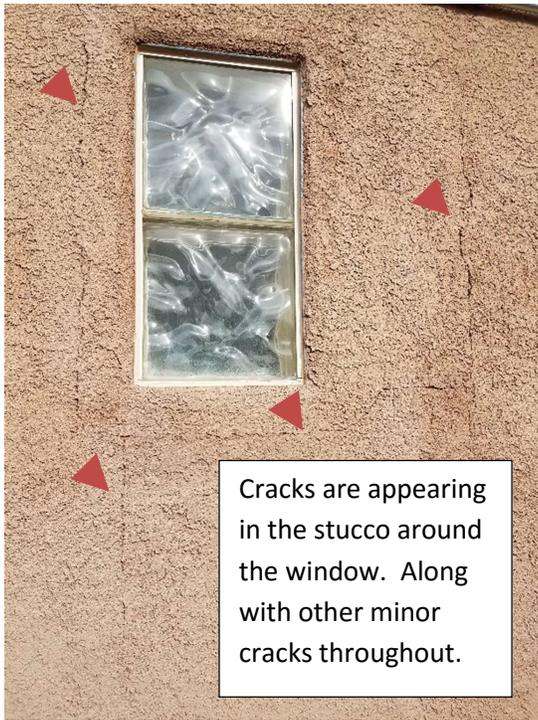
The stucco is cracked in various areas and will need to be repaired.

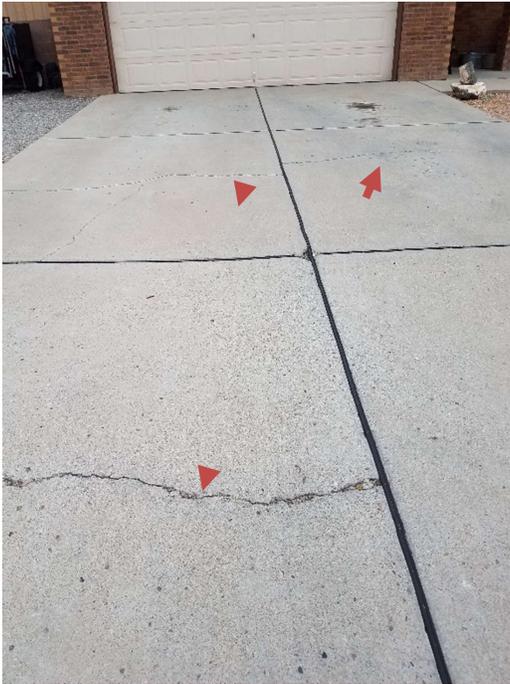
There are several cracks. This is primarily a cosmetic condition and is not affecting driveway performance. Repairs can be performed to restore the driveway's appearance.

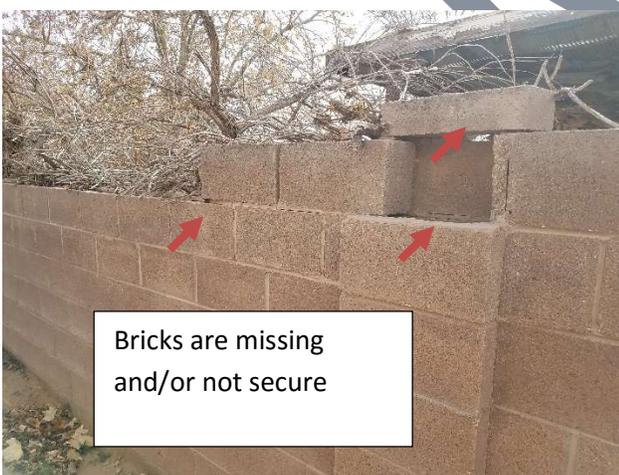
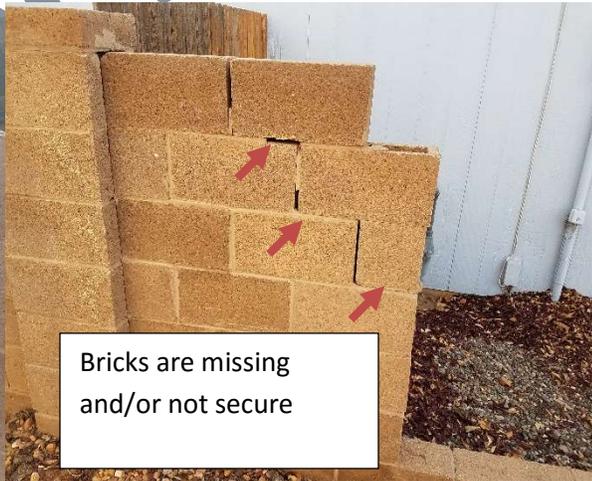
There are several loose cinder blocks along the wall. This needs to be repaired before further damage, and reflects safety concerns.

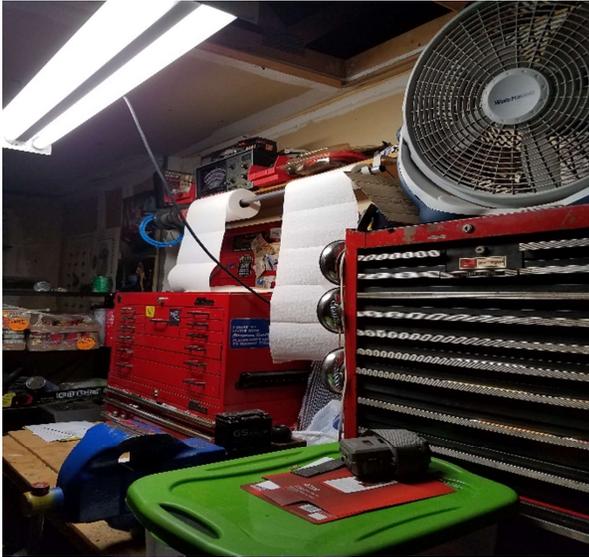
UNABLE to inspect Attic, Attic Entrance was blocked

Attic Entrance does not have a cover

Highly recommend re-inspection when area is clear.

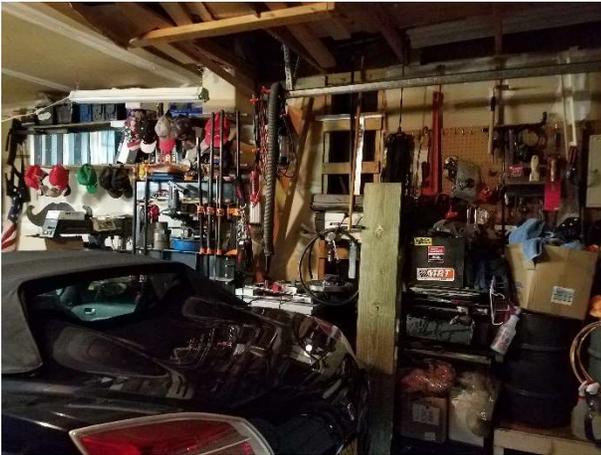
Garage walls are not Inspected. View was blocked. We advise seller to clear out garage for re-inspection
